Can detrimental carbonation of cement or lime-stabilised road base layers, and the occurrence of biscuit layers as a result of carbonation, be controlled by proper construction techniques only?

C J Semmelink, N J J Jooste, J E Raubenheimer

APPENDIX

Photographs taken during an investigation by Semmelink and Botha in 2001

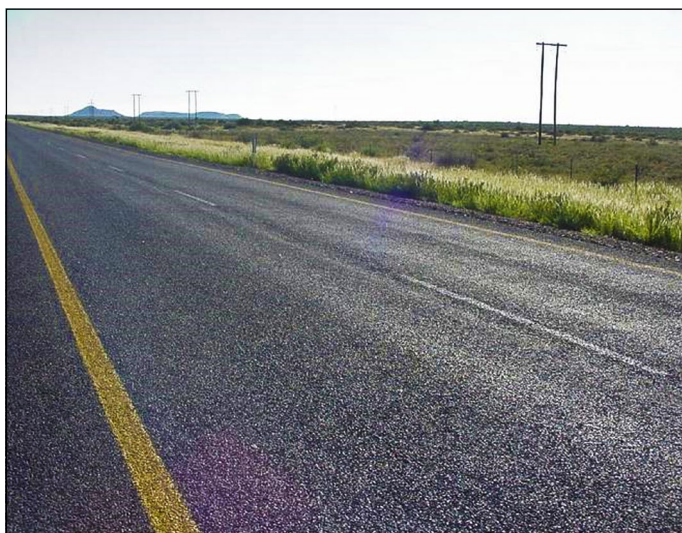
Photograph 1 General condition of the road surface (2001)

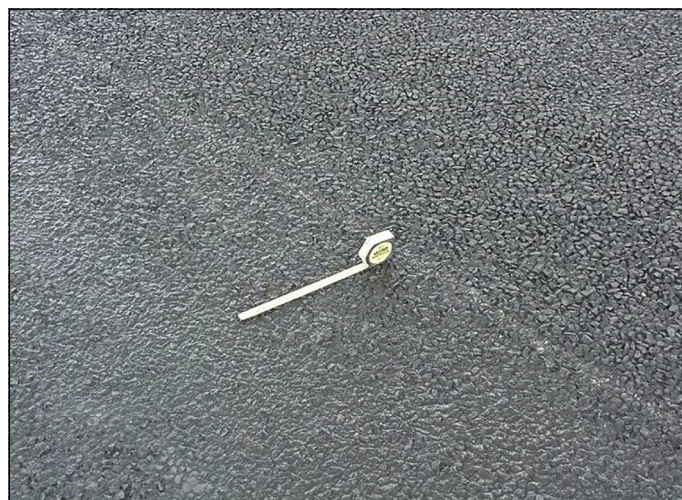
Photograph 2 Close-up of the road surface in a next-to-the-wheel track (2001)

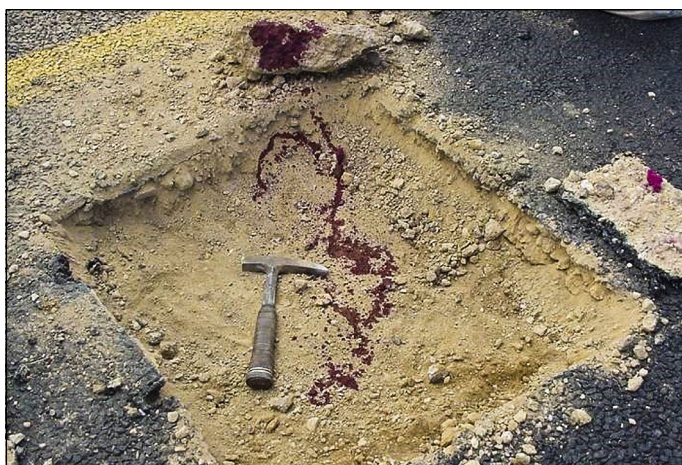
Despite the presence of free lime from the cement, the surface ravelled under the surfacing because there was no inter-particle suction force between the particles, due to the dry material. However, because it is usually moist (damp) below the surfacing, one can reason in this case as well that the dryness of the material was not caused by evaporation of moisture through the prime and bituminous road surfacing, but was possibly caused by exceedingly high intra-particle suction forces of certain minerals (e.g. illite-smectite) in

the material matrix that sucked the inter-particle water into the mineral particles themselves to form part of the chemically bound water, which can only be driven off at exceedingly high temperatures in the region of 600°C. Thus normal oven-drying at 100°C will not show the presence of the chemically bound water at all. This is why the authors are convinced that this damage is caused by a water-driven reaction, despite the fact that no proven chemical reaction or proven physical explanation for this dry powdery layer could be given in this case.

Photograph 3 The dry powdery layer just below the surfacing; note the dark pink colour of phenolphthalein indicating free lime (2001)

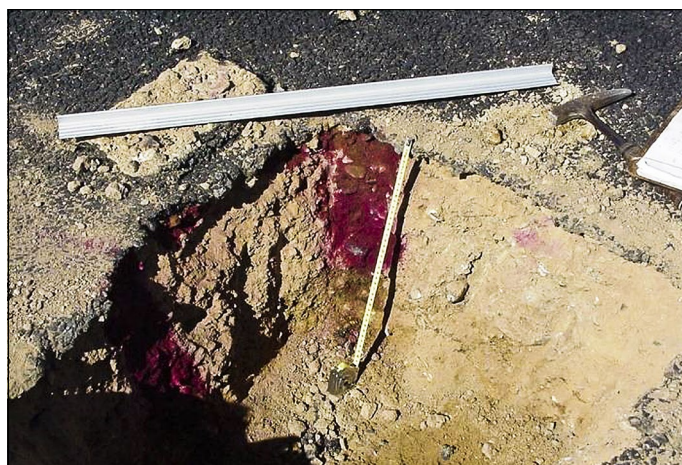
Photograph 4 Dark pink colour of phenolphthalein visible through the whole depth of the stabilised layer, indicating free lime through the whole layer depth (2001)

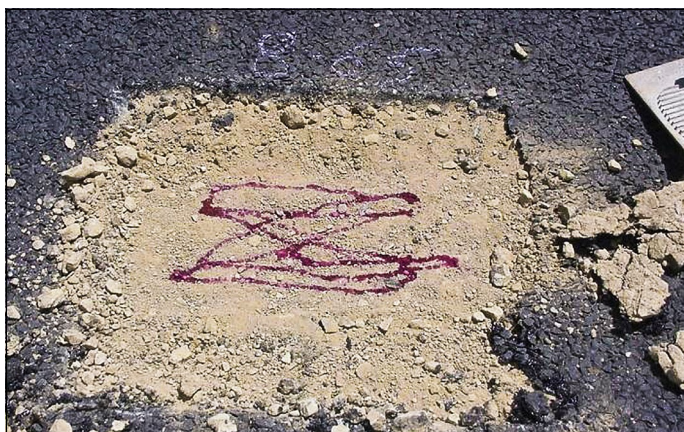
- The authors of this paper are of the opinion that the statement in the 2010 TREMTI paper by Paige-Green (2010) is incorrect, as the dark pink colour of the sprayed phenolphthalein solution on the so-called carbonated material found in the survey done in the investigation as set out in the Appendix, contradicts this statement. One would further expect the whole surface of the “poorly cured” stabilised layer evaluated (see Appendix)

Photograph 5 The pink colour of phenolphthalein solution on the loose powdery layer indicates that the layer had not carbonated (2001)

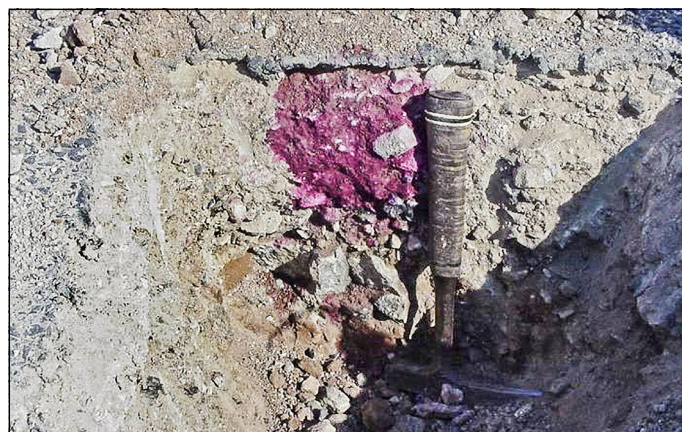
Photograph 6 The dark pink colour of the phenolphthalein solution through the total layer depth indicates that the layer was uniformly stabilised and not carbonated (2001)

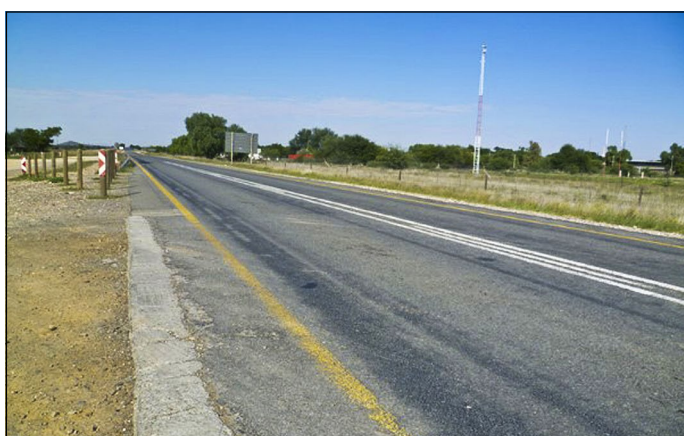
to be affected by the detrimental “carbonation”, which is not the case either. In actual fact, this particular road shown in the Appendix has been trafficked for more than ten years without any major surface failures. Keep in mind that all loose surface material had been removed from the stabilised road surface before priming and surfacing the road. From the evidence presented it should be clear that in at least 50% of the cases this loose powdery layer is probably caused by an as yet undefined water-driven reaction which is beyond the control of the road builder and therefore not construction-related. Lowe and Von Solms (1986) came to a similar conclusion.

Photograph 7 General surface condition of the road; note the absence of pothole repairs indicating that road is still very much functional (March 2012)

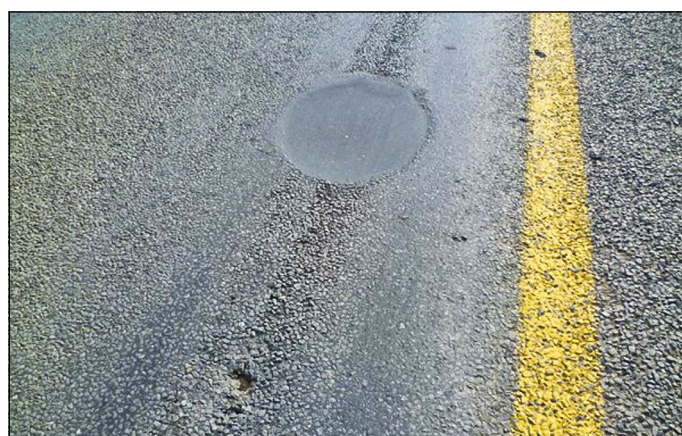
Photograph 8 Close-up of the wheel track showing that the general condition of the surfacing is still in a reasonable condition, with one small pothole (March 2012)
