Determination of the degree of thermal exposure to the lower head of the Three-Mile Island Unit 2 nuclear reactor using metallography

Synopsis

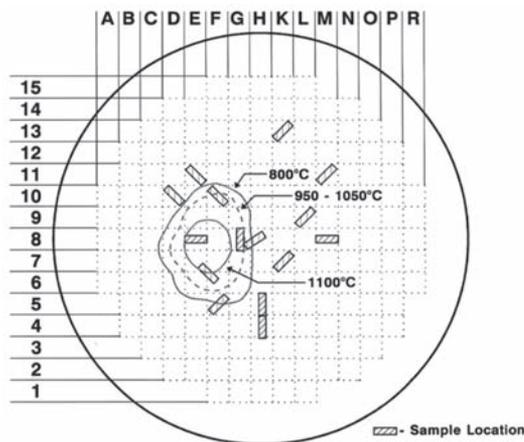
Figure 1—Schematic showing the boat-shaped specimen locations relative to the debris pile, and temperatures obtained during the incident

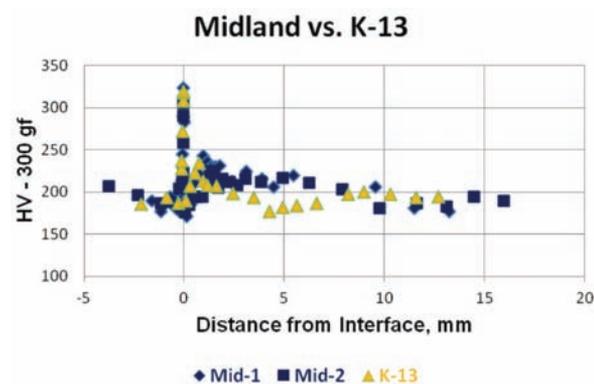
One of the initial steps taken by the VIP team was to test the hardness of specimens going from the 308L cladding across the interface and into the A533 Gr B base metal, using two Rockwell scales. This data was converted to Vickers hardness for ease of plotting. The writer decided to do actual Vickers tests, using a low load (300 g force) to assess the hardness variations with more sensitivity due to the smaller indent size. Figure 6 shows the data comparing two different Midland as-received specimens to the TMI-2 K-13 specimen. K-13 was chosen as it was well away from the debris pile and should reflect the initial, pre-incident condition in the TMI-2 lower head. The only significant difference between the Midland as-received and the K-13 specimen would be the difference in stress relief time, 23.8 h for the Midland head and 50 h for the TMI-2 head. Note that the hardness profiles are quite similar. We observe a rapid increase in hardness at the interface, followed by a drop in hardness in the adjacent heat-affected zone. These changes are due to carbon in the base metal diffusing to the cladding and forming carbides, which depleted the adjacent base metal of carbon. K-13 was decarburized more than the Midland specimens.

Figure 6—Vickers hardness traverses at 300 g force for two as-fabricated Midland specimens and the K-13 TMI-2 specimen, which was not under the debris pile (see Figure 1)

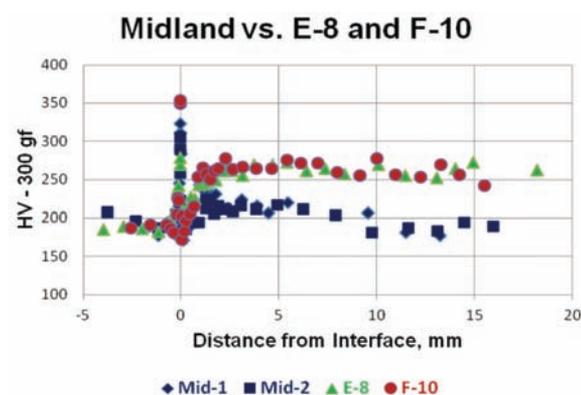
Figure 7 shows similar Vickers traverses comparing the as-fabricated Midland specimens to the traverses for E-8 and F-10, near the centre of the debris pile and expected to experience the highest temperatures.

Note that the hardness in the heat-affected zone of the A533 GrB head was much higher than the normal base hardness (180-200 HV in the head more than 10 mm below the cladding-base metal interface. The A533 GrB head below the cladding, after the decarburized zone (from about 1 mm and below) was in the range of 250-270 HV for both E-8 and F-10. This clearly shows the the temperature in this region was above the upper critical temperature for A533 GrB.

Figure 7—Vickers hardness traverses of the two Midland as-fabricated specimens compared to TMI-2 E-8 and F-10 specimens under the head in the highest temperature region. E-8 and F-10 were heated above the Acs and formed a harder, untempered bainitic structure after the incident

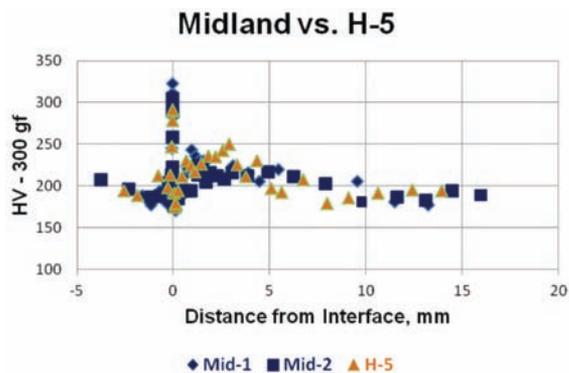
Figure 8 shows a Vickers travers on H-5, compared to the Midland as-fabricated specimens. Note that higher hardnesses were obtained from a depth of approximately 1 mm to 3 mm below the interface, indicating this region did become re-austenitized during the incident. Figure 9 compares the Vickers hardness traverses for E-8 and F-10, which saw the highest temperatures, and H-5, which was lightly re-austenitized, and F-5 which was not heated above

Figure 8—Vickers hardness traverse for H-5 compared to the Midland specimens. This plot shows that H-5 was re-austenitized to a depth of at least 3 mm

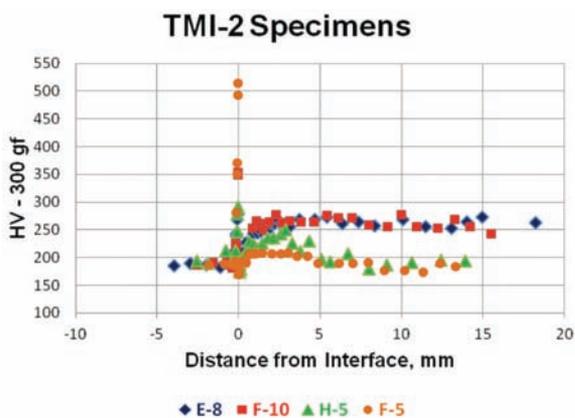
the upper critical. F-5 exhibited the highest hardness at the interface from carbide precipitation, most likely during the stress relief operation, not exclusively from the incident.

Figure 9—Comparison of the Vickers traverses for E-8 and F-10, which definitely saw elevated temperatures, to traverses for H-5 (shown in Figure 8 compared to the Midland specimens), which was lightly re-austenitized, to F-5 which was not heated above the upper critical temperature by the incident. F-5 had the highest hardness from carbide precipitation at the interface

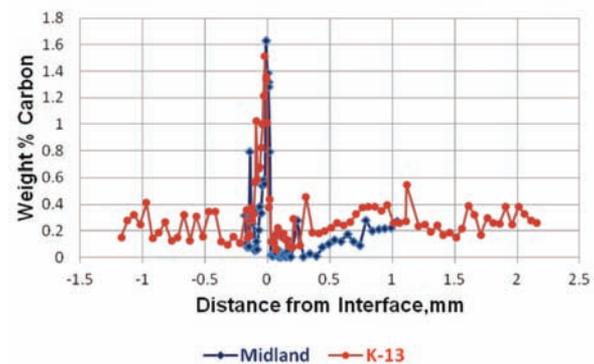
Midland vs. K-13

Figure 11—Quantitative EMPA carbon analysis for the Midland specimen, shown in Figure 10, and K-13, which was basically in the as-fabricated condition

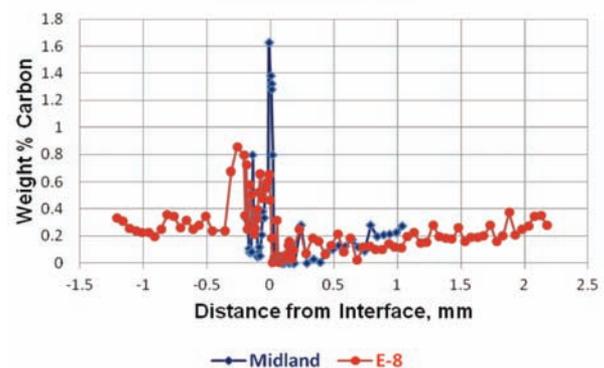
Midland vs. E-8

Figure 12—Carbon traverses for E-8 compared to the Midland specimen, revealing a substantial difference. The carbon peak in the cladding is about 0.85%, and further into the cladding. There is a region about 0.3 mm into the cladding with high carbon content. The HAZ is more heavily decarburized than for the Midland and the K-13 specimen

exhibits decarburization in the HAZ somewhat worse than the Midland specimen. The cladding in E-8 is significantly more enriched in carbon than Midland or K-13 the specimens.

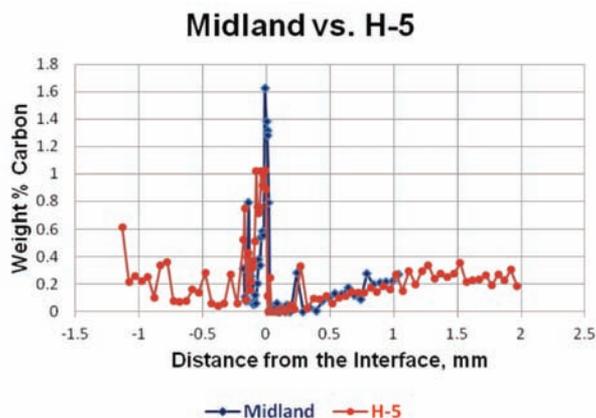
Figure 13 shows the carbon profile for H-5 compared to the Midland specimen. The peak carbon in the cladding is lower at 1 wt%, but there is again more carbon in the cladding than in the Midland specimen. In the HAZ, both specimens gave nearly identical results, even with increased carbon at a depth of about 0.25 mm. Figure 14 shows a carbon profile for M-11 compared to the Midland specimen. M-11 reached a peak of about 1% carbon, like H-5. Again, it has a higher overall carbon content in the cladding. There was a total loss of carbon in the HAZ adjacent to the interface, but the carbon analyses were not continued to the desired depth.

Figure 13—Carbon profile for H-5 compared to the Midland specimen. The peak carbon in the H-5 cladding is about 1%, but otherwise the curves are quite similar

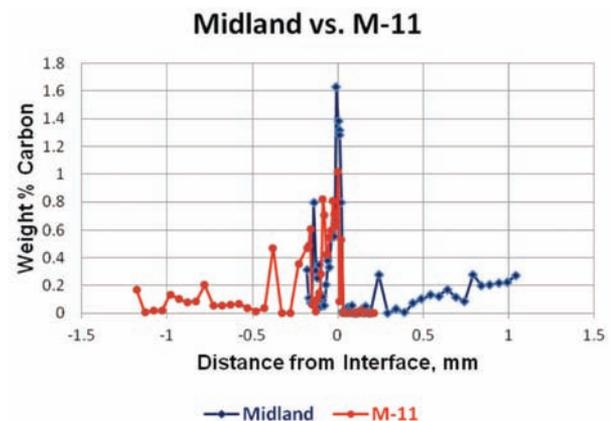
Figure 14—Carbon profile for TMI-2 specimen M-11 showing a peak carbon of 1 wt%, similar to that in H-5

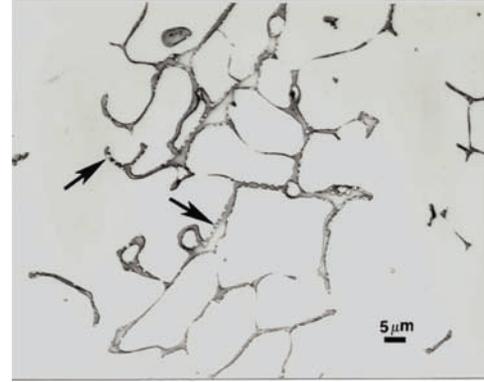
Figure 17—Example of the delta ferrite in specimen M-11, which has not fully broken up in this region and begun to spheroidize. The arrows point to the location of carbides that have gone into solution during the event (modified Murakami's reagent, 1000X)
