Management of the Nkomati Mine crusher slope failure

by R. Armstrong* and K. Moletsane†

Synopsis

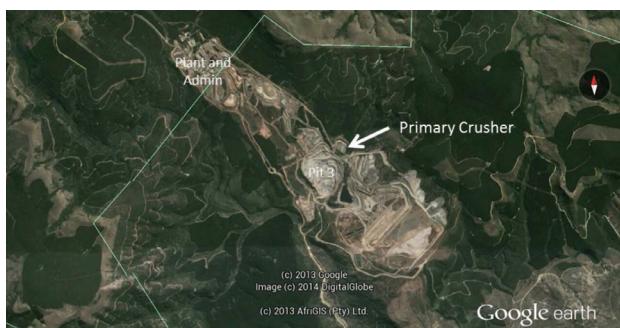
Due to limited available level ground, a weathered rock slope was cut at the base of a mountain spur in order to create a flat platform for construction of the primary crusher plant and run-of-mine stockpiles (Figure 3). As space is limited around the mining area, ore processing at Nkomati is based on a high reliability of flow of material through the crusher plant, with minimal usage of other and

Figure 3—Location of the primary crusher in the mine complex

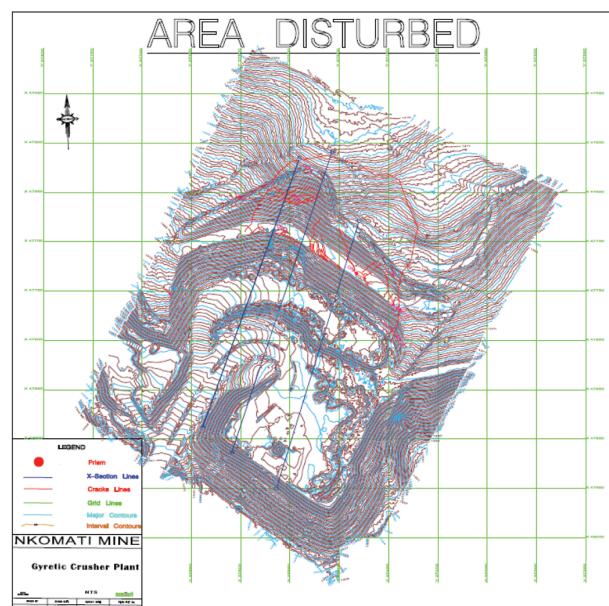
Cracks were observed early in the rainy season of 2012 high up on the slope together with an increase in displacement measured on the survey monitoring system (Figure 4). This prompted a review of the slope instability and the requirement of a management plan that would ensure

Figure 4—Location of cracks on the primary crusher slope

the safety of the personnel working at the primary crusher area, and also prevent unnecessary downtime for the crusher. Leading up to the review, the mine redeployed the open pit slope stability radar to augment the total station monitoring and dumped a waste rock buttress at the toe of the failure.

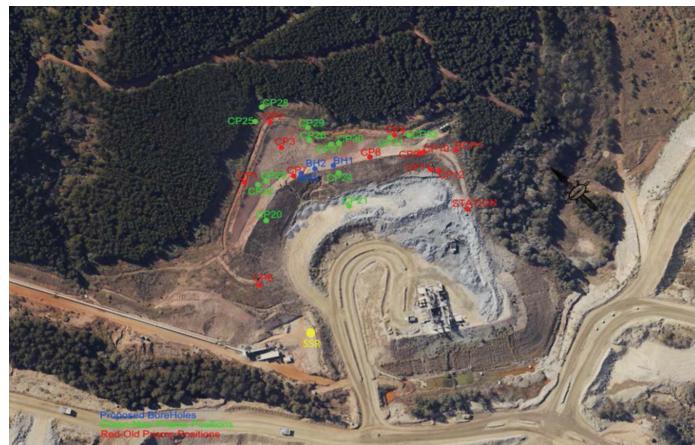
Following the recommendations in the 2010 review, Nkomati installed an Optron robotic total station to the south-east of the slope together with 15 reflective prisms which were measured several times a day (Figure 5). Measurements taken in the early (pre-sunrise) morning were used for regular surveillance of the slope. Following the detection of slope movement, the Groundprobe slope stability radar was redeployed from the open pit and stationed to the south-west of the slope to supply pseudo-real time slope monitoring.

Figure 5—Location of the primary crusher slope monitoring

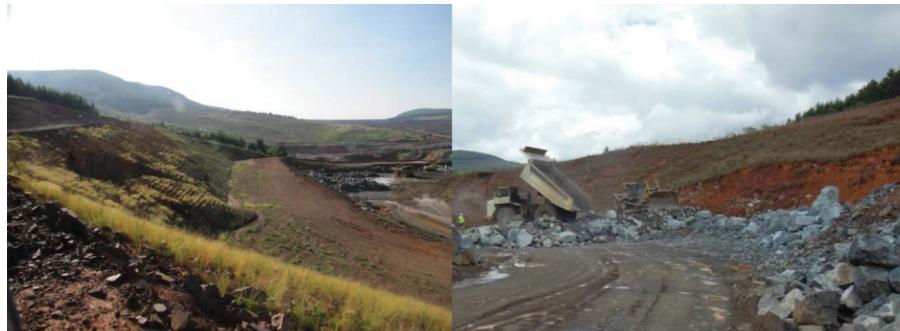
Observations of the slope indicated that degradation of the toe had occurred resulting in undercutting of the slope. At the time of inspection (December 2012), waste rock was in the process of being dumped at the slope toe in an attempt to buttress the failure. Figure 6 shows a comparison of the toe of the slope in 2010 (left) and December 2012 (right). Based on the height of the TR100 dump truck the slope was undercut by 5 m (vertically) above the buttress. The undercutting of the toe resulted in an increase of the overall slope angle from 23° to 25°, the 2° increase being well within the sensitivity of the slope as determined in the 2010 report.

Figure 6—Comparison of the slope toe in 2010 (left) and in December 2012 (right)

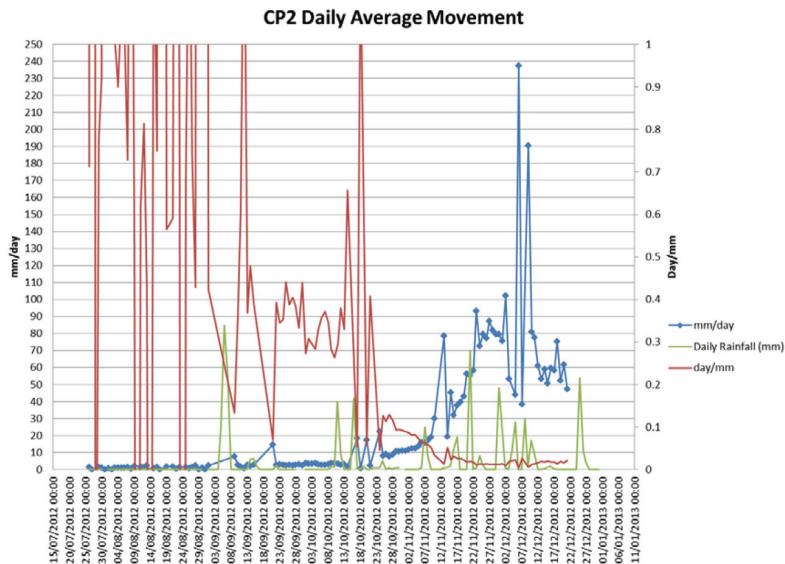
Figure 7—Survey monitoring results compared to daily rainfall

A comparison of the survey monitoring results and measured rainfall is presented as Figure 7. It is evident that the movement of the slope is related to major rainfall events.

The combination of the *in situ* groundwater and the oversteepening of the slope is considered to be the driving factor for the slope instability.

Observations of rainfall and slope monitoring records indicate that there is a significant increase in slope movement following large rainfall events. It was recommended that any rainfall event greater than 20 mm should be considered a 'trigger' event and monitoring data should be reviewed and the area evacuated if necessary.
