# Investigation of the mechanism for fire-side corrosion in coal-fired boilers in South Africa

Furnace wall tubes from 600 MW subcritical boilers at three coal-fired power stations were sampled and the fireside deposits examined to determine the mechanism of fireside corrosion. This involved an in-depth investigation into the morphology and composition of the fireside deposits and the conditions of the furnace that enable this type of attack. SEM-EDS analysis revealed high concentrations of oxygen, iron, and sulphur, QEMSCAN and XRD analyses identified the presence of  $\text{Fe}_3\text{O}_4$ ,  $\text{Fe}_2\text{O}_3$ ,  $\text{FeS}$ , and  $\text{FeS}_2$ . Differential thermal analysis showed thermal activities at temperatures of 500–600°C, 900–1100°C, and 1100–1250°C, which are associated, respectively, with  $\text{FeS}_2$  oxidation to  $\text{FeS}$  and  $\text{Fe}_2\text{O}_3$ , at 475–525°C, formation of aluminosilicates at 925–1100°C, and melting of  $\text{FeS}$  around 1190°C. The absence of sodium and potassium eliminates the contribution of molten alkali sulphates to the corrosion. The consistent coexistence of iron sulphide and iron oxide is indicative of the substoi

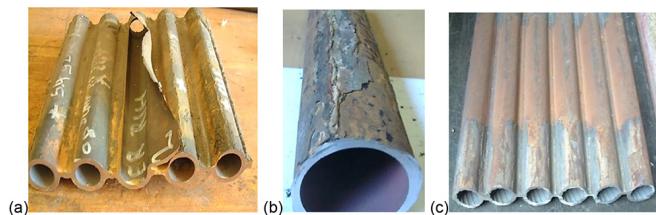
The hard and thick sintered deposits with loosely bonded ash on the fireside of the tubes from the three power stations are shown in Figure 3. The deposit thicknesses were a maximum of 0.975 mm, 0.6 mm, and 0.57 mm for stations A, B, and C respectively. Wall thinning was observed on the cross-sections of the tubes, with the fireside generally showing significant thinning and the cold side exhibiting a uniform wall with minimal thinning. Figures 4 and 5 show the localized wall thinning on the fireside of tubes from stations A and C at the location encompassing a 120° angle of the tube circumferentially (referred to as the 10 o'clock and 2 o'clock positions). One of the ruptured tubes from Station A is shown in Figure 3a. This tube failed due to significant wall thinning and excessive build-up of pressure.

The wall thickness measured on the fireside of Station A tubing varied from 0.1 to 4.93 mm. This implies that the tubes with the original wall thickness of 5.6 mm experienced wall losses ranging from approximately 11.9 to 98.2%. Station C, having tubes, with original wall thickness of 7.5 mm and remaining wall

Figure 3—Furnace wall tubes from (a) Station A, (b) Station B, and (c) Station C, showing the fireside deposit. Ruptured tube from Station A is shown in (a)

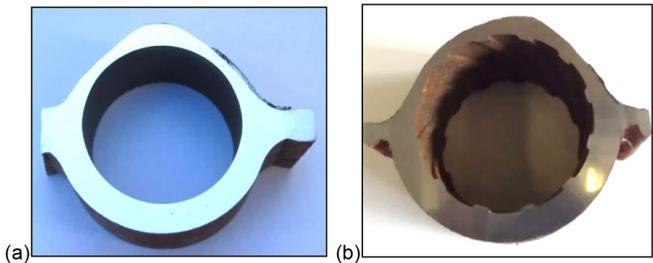
Figure 5—Cross-section specimens of tubing from (a) Station A and (b) Station C showing localized wall thinning on the fireside

thicknesses of 2.92 to 3.4 mm, experienced relatively lower wall loss, estimated at 45.2 to 65.33%.

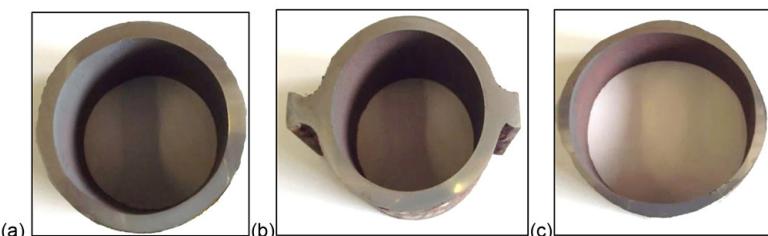
Tubes from Station B showed different features compared to stations A and C. Unit 1 tubes revealed general wall thinning around the circumference. Unit 8 showed wall thinning only on the fireside. Unit 3, on the other hand, showed a completely different picture; inconsistent wall thinning was observed on both the fireside and non-fireside as shown in Figure 6. Observations on tubing from Station B suggest that in addition to fireside corrosion, there may be other forms of attack taking place. Different fireside deposits were also observed on Station B tubing. Units 1 and 3 had hard and thin sintered brown deposits, whereas unit 8 had loosely bonded grey ash deposits. The wall thickness of the tubing from Station B ranged from 1.76 to 5.54 mm. Based on a 6 mm installed wall thickness, the highest wall thinning was measured at 68.57%.

Figure 6—Cross section specimens of Station B tubing showing (a) uniform wall thinning on fire- and cold sides of unit 1, (b) wall thinning on fireside of unit 8, and (c) inconsistent wall thinning around the tube of unit 3

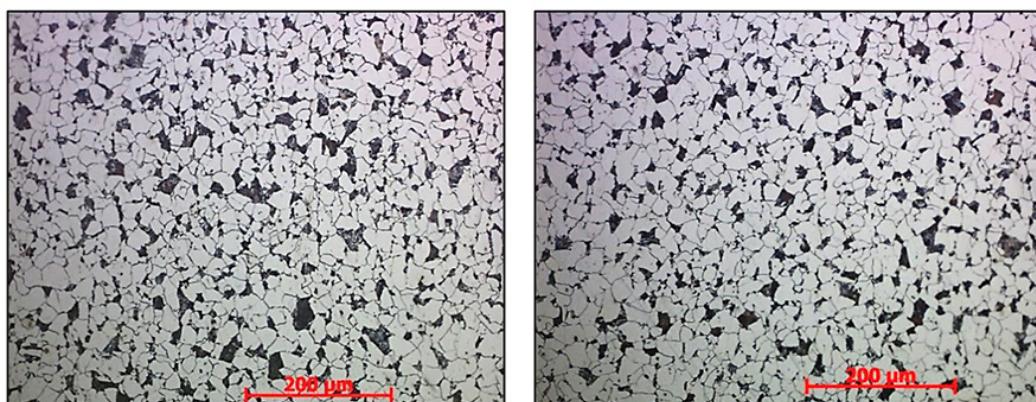
The microstructures observed on tubing samples from the three power stations were the same on both fireside and cold side, as shown in Figure 7. They consisted of well-spheroidized and degenerated carbides, still grouped in the original pearlitic pattern, in a ferrite matrix. A spheroidized microstructure is typical of service-exposed 16Mo3 and A106 Grade B tubing operating at moderately elevated temperatures. A similar appearance between the fireside and cold side indicates that the flame-exposed (fire-) side of the tubing was not significantly hotter than the casing (cold) side.

Figure 7—Microstructure of sidewall tubing from Station A on (left) fireside, and (right) cold side

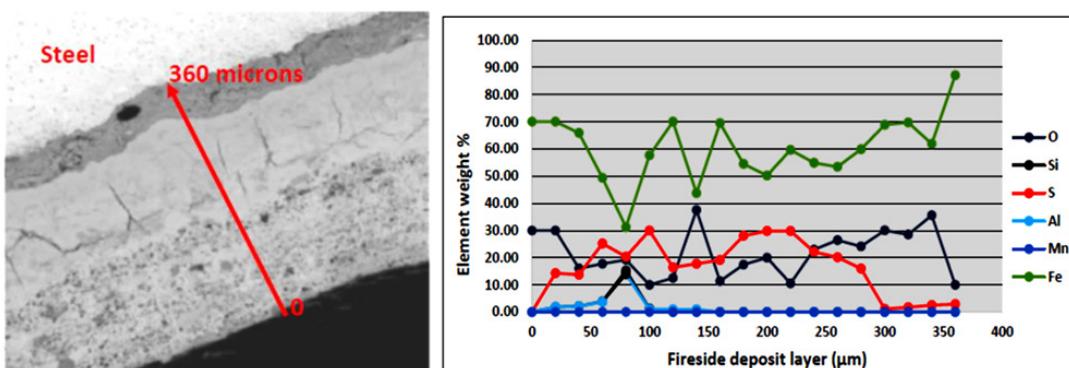
Figure 8—Unit 3 of Station A showing Fe-O rich inner layer, moderate Fe-S and Fe-O middle layer, and Fe-S, Fe-O, and fly ash outer layer

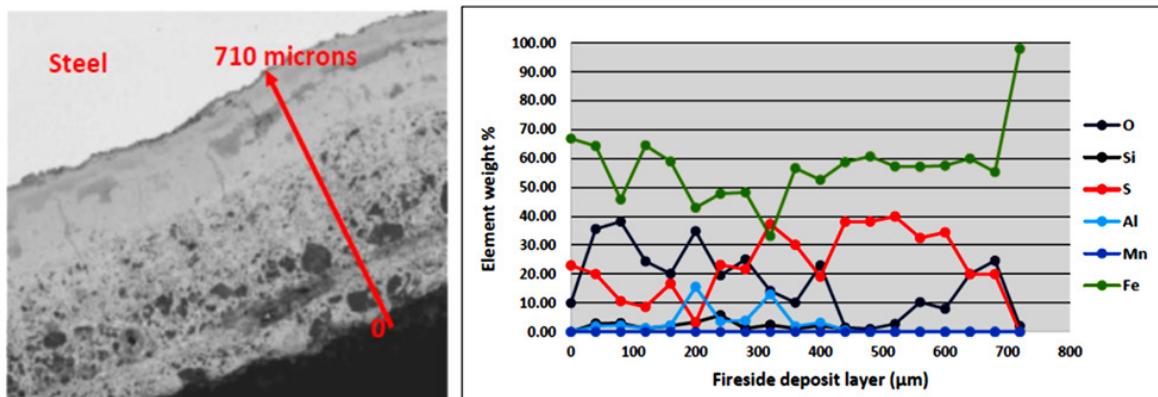
Figure 9—Unit 1 of Station A showing Fe-O rich inner layer, Fe-S middle layer, Fe-S and Fe-O outer layer with particles of fly ash and unburned coal

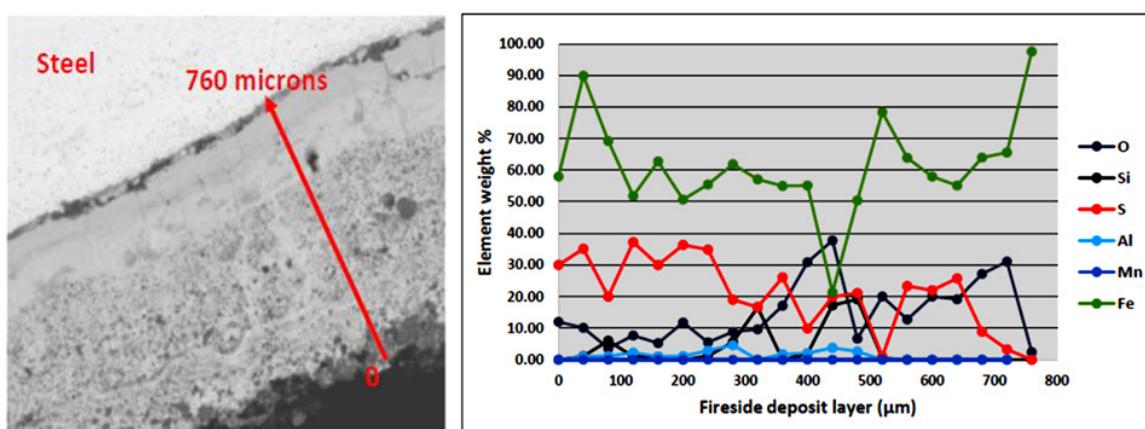
Figure 10—Unit 4 of Station A showing Fe-O rich inner layer, Fe-S rich middle layer, Fe-S/Fe-O outer layer with fly ash particles

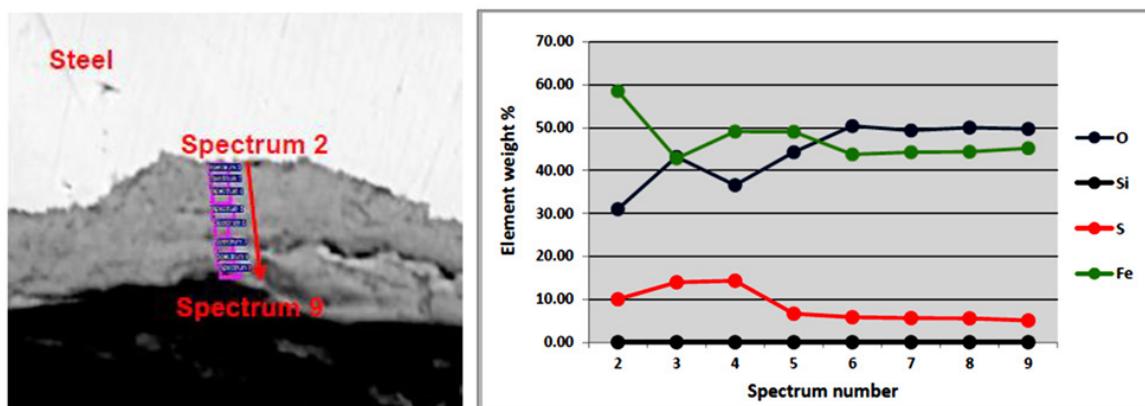
Figure 11—Unit 8 of Station B showing Fe-O rich inner layer with moderate S, and Fe-O rich outer layer with low concentration of S

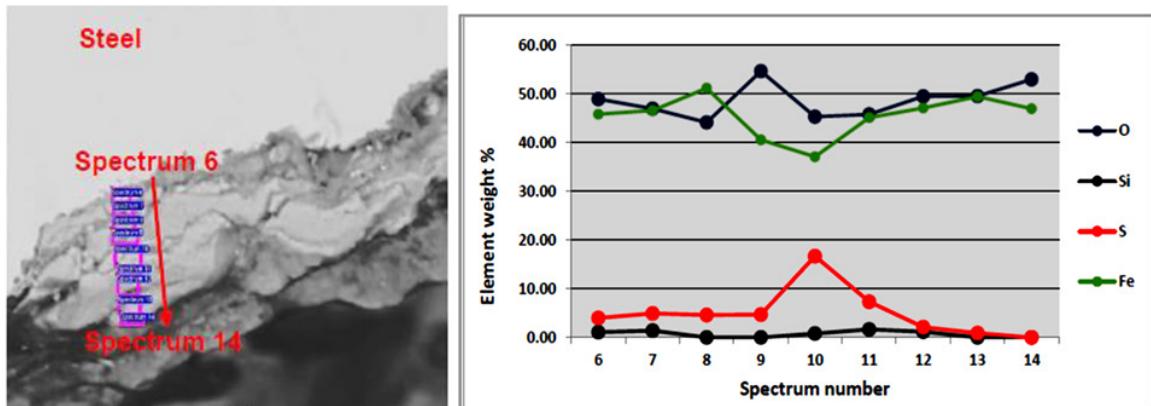
Figure 12—Unit 3 of Station B showing Fe-O rich inner and outer layers with low S, and Fe-O rich middle layer with higher levels of S

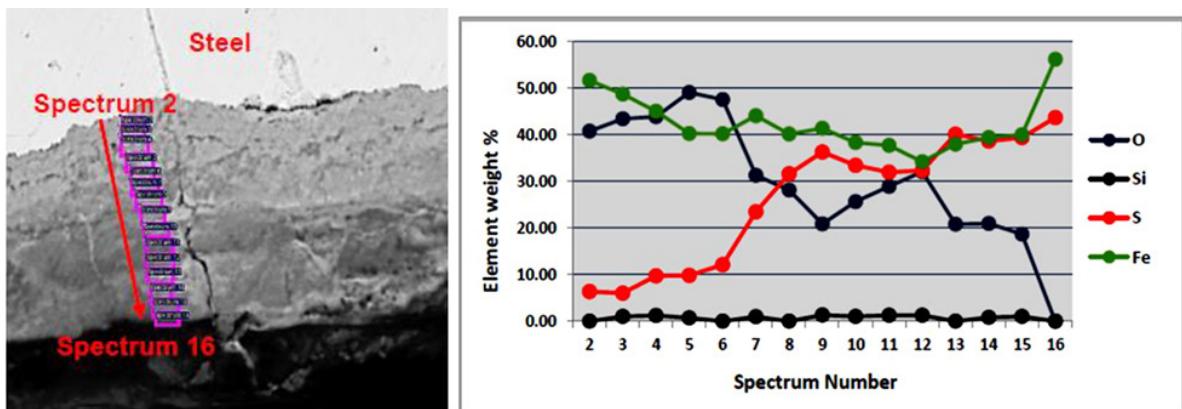
Figure 13—Unit 1 of Station B showing Fe-S rich inner and middle layers with low O, outer layer rich in Fe oxide with higher levels of sulphur and fly ash

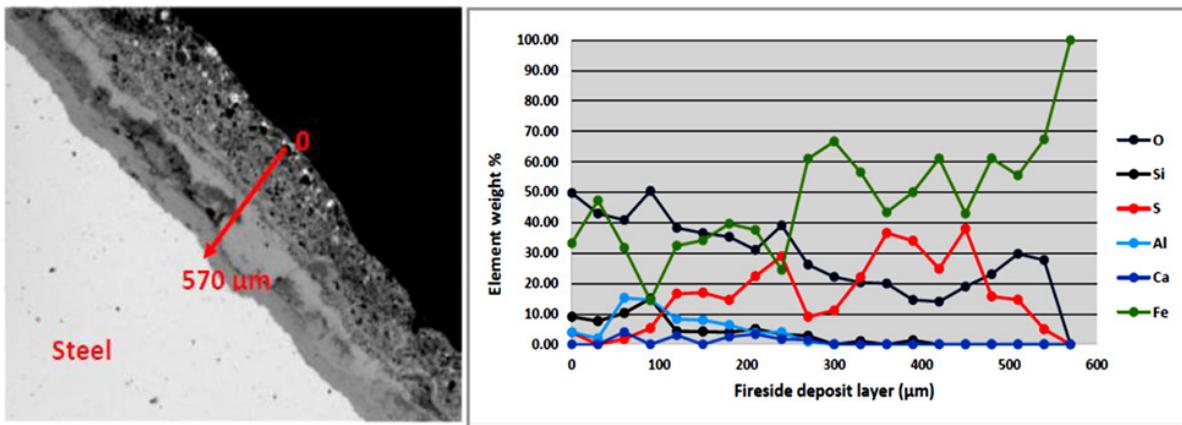
Figure 14—Unit 4 of Station C showing Fe-O rich inner and outer layers and moderate levels of Fe-O and Fe-S in the middle layer. High concentration of fly ash in the outer layer

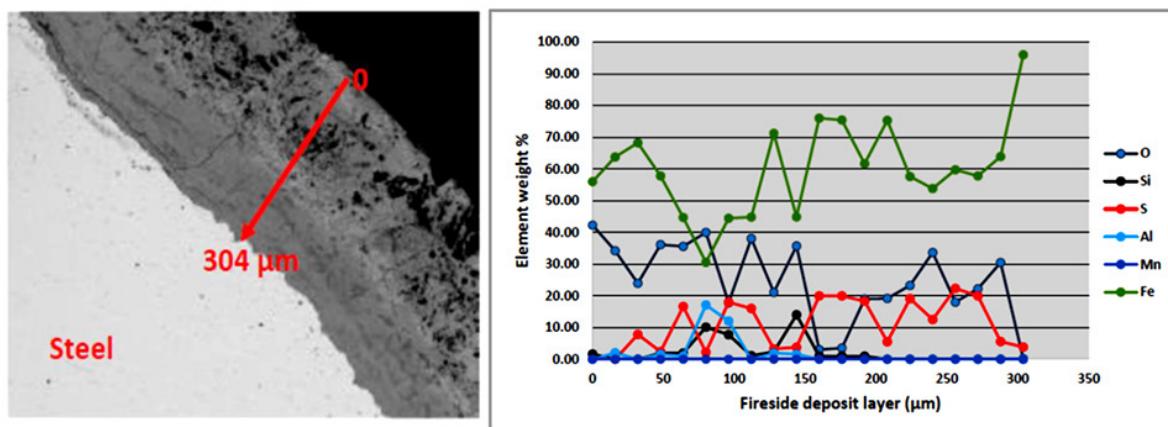
Figure 15—Unit 6 of Station C showing Fe-O rich inner and outer layers, low levels of S, and Fe-O/Fe-S middle layer. Low levels of fly ash particles in the outer layers

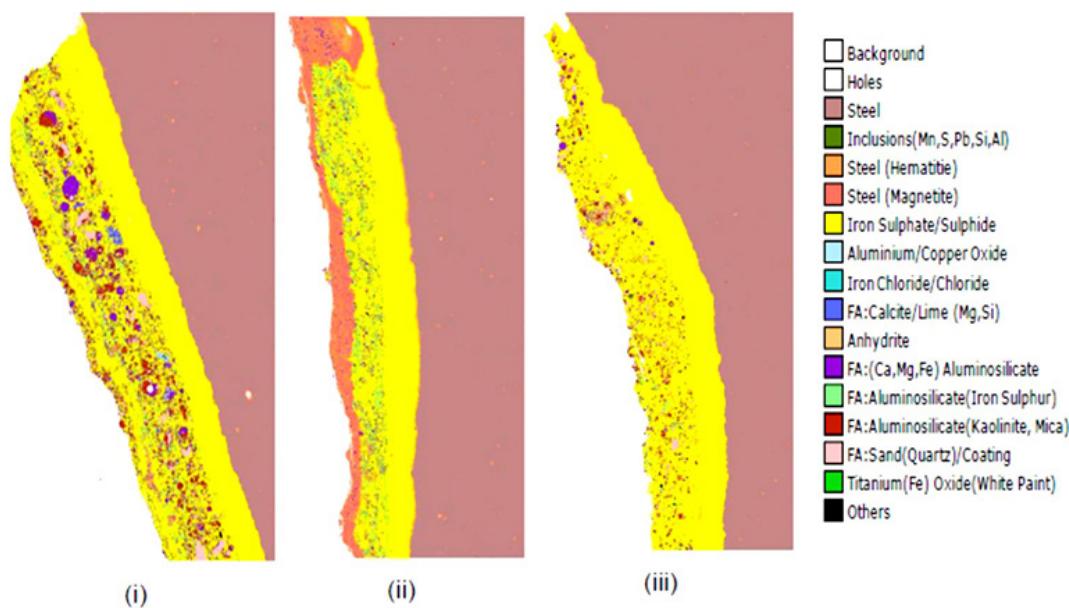
Figure 16—QEMSCAN characterization of the fireside deposits from Station A for (i) unit 1, (ii) unit 3, and (iii) unit 4

There was no evidence of sodium or potassium associated with the sulphur in any of the samples from stations A and C. The presence of sulphide phases coexisting with iron oxide is indicative of substoichiometric conditions in the furnace and/or on the tube surfaces.

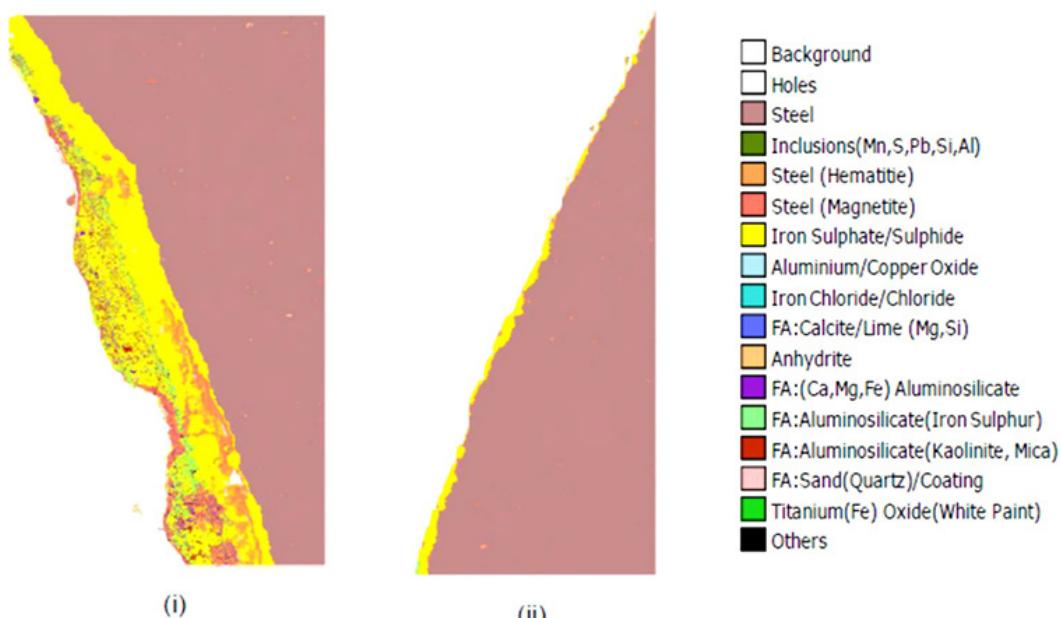
Figure 17—QEMSCAN characterization of the fireside deposits from Station C for (i) unit 4 and (ii) unit 6

**Station C:** The fireside deposit on the tubes from both units of Station C showed high levels of pyrrhotite. Differences were seen in the concentrations of magnetite; the fireside deposit from unit 6 had higher concentrations than unit 4. The difference in the morphology of unit 4 and unit 6 fireside deposits may be indicative of the different furnace environments. The high concentration of pyrrhotite and iron oxide phases in unit 6 samples suggests the existence of alternating oxidizing and reducing conditions, whereas in unit 4 it appears that conditions were reducing for a longer time, which resulted in the formation of pyrrhotite and minimal iron oxide phases.

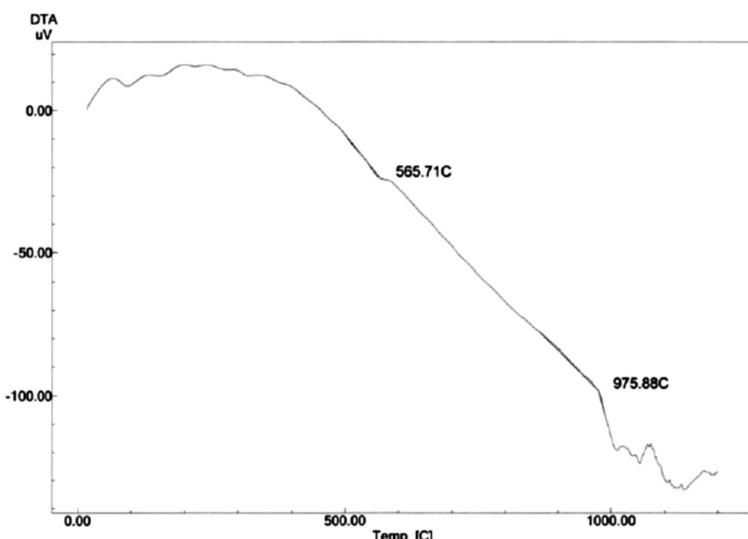
Figure 20—Thermal behaviour of the fireside deposit on Station A tubing sample

DTA results for stations A and B revealed similar thermal behaviour. Peaks were generally measured at temperatures from 950 to 1250°C. On isolated samples from stations A and B, lower temperature activities were indicated at 565°C and 541°C respectively, as shown in Figures 20 and 21. These thermal activities seem to correlate with a survey reported by Bryers (1995) on the thermal behaviour of minerals commonly found in coal. Bryers showed that kaolinite transforms into metakaolinite at temperatures around 500°C, which further transforms into other forms of aluminosilicate at around 925°C and 1100°C. At
