# Void filling and water sealing in a decline in the Kalahari Manganese Field

by I. Serepa<sup>1</sup> and N.C. Steenkamp<sup>1</sup>

## Synopsis

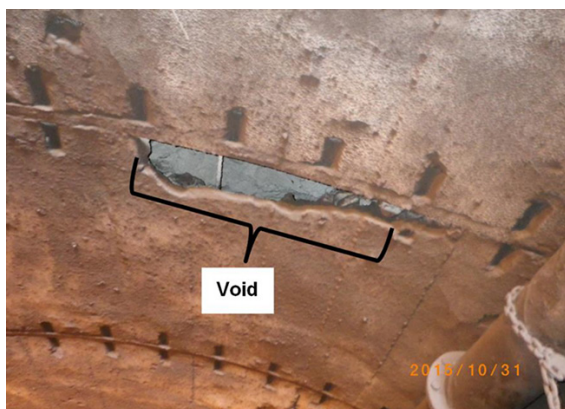
A borehole camera was used to inspect the condition of the voids behind the concrete lining, as well as to estimate their size. It was observed that the hangingwall of the voids showed a possible original hangingwall of the decline (Figure 3). The possible original hangingwall was supported by shotcrete and, in some areas, cribbing made up of gumwood planks and metal beams (Figure 4). The voids were not backfilled. In some areas the voids were filled with loose rocks that seemed to have been derived from the collapsed hangingwall (Figure 5).

Figure 3—Void behind the concrete lining of the decline

The initial voids were formed when the gap between the original excavation and the concrete lining was not filled. This interpretation is supported by the fact that no voids were identified in areas where the concrete lining is not installed. The size of the voids increased due to self-mining and exposure of the rock to groundwater.

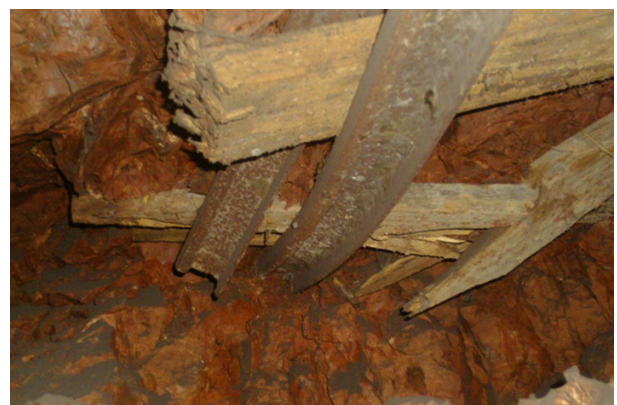
Figure 4—View inside a void showing cribbing support along the red clay section of the decline

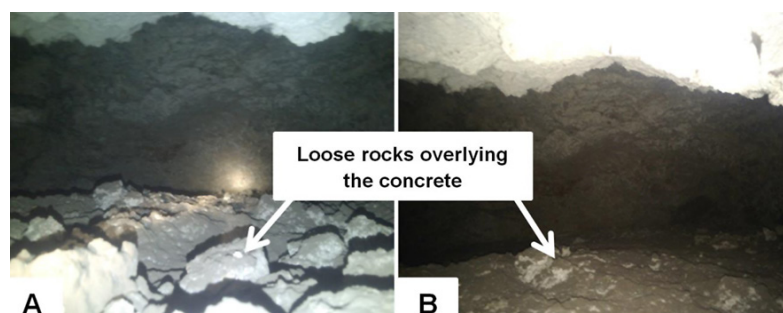
Figure 5—Loose rocks from the collapsed hangingwall

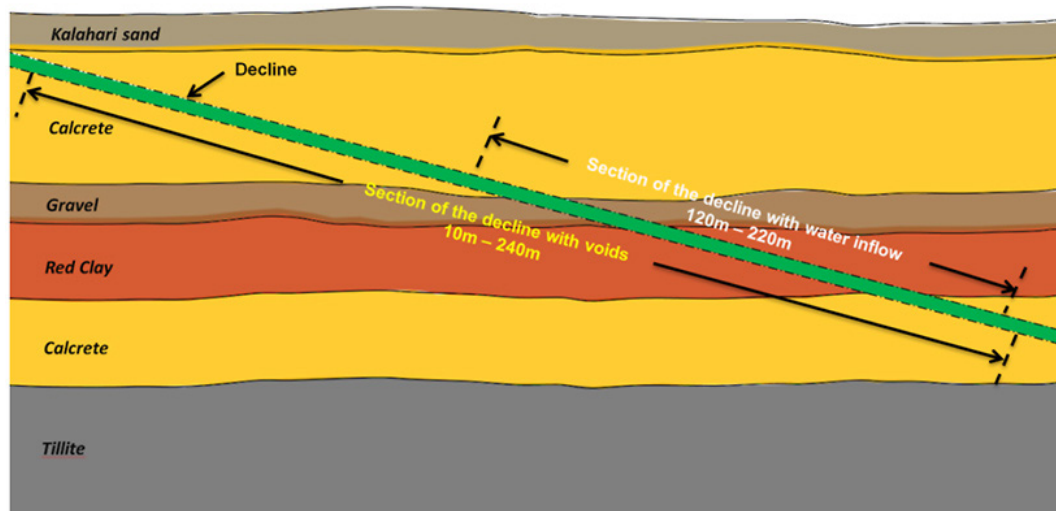
comprised predominantly of calcrete. The calcrete is underlain by gravel and red clay units (Figure 6). The red clay, unlike the calcrete and the gravel, is not permeable. As a result, laminar flows of groundwater occur in the gravel and calcrete units and the red clay unit is kept damp. Figure 6 shows groundwater ingress into the decline at sections where the decline intersects the aforementioned rock units.

Figure 6—Section of the local stratigraphy where the decline is developed

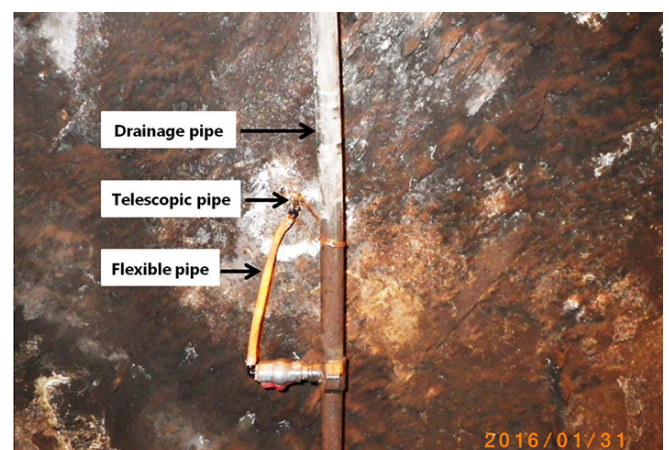
Figure 10—Telescopic pipe installed in the decline

Water sealing commenced once void filling was completed. Water sealing was started by grouting the five rows of holes that were drilled down-dip of the water area. One row was sealed at a time; starting with the footwall holes (holes 1, 7, and 8) followed by the sidewall holes (holes 2 and 6) and then the hangingwall holes (holes 3, 4, and 5). A hole was considered to be completely grouted when the water-sealing fluids started seeping out of the hole being grouted or another hole that had not yet been grouted. Once the bottom barrier had been completed, water sealing was undertaken in the water area. It commenced at the top of the decline and progressed down-dip so as to direct the water down the decline to the bottom barrier. Two telescopic pipes were installed in the water area to allow water to drain off. The telescopic pipes are connected to flexible pipes which direct the water into a drainage pipe, as illustrated in Figure 10. The water is then fed along the water drainage channel to the bottom of the decline, from where it is further handled by the underground water management system.

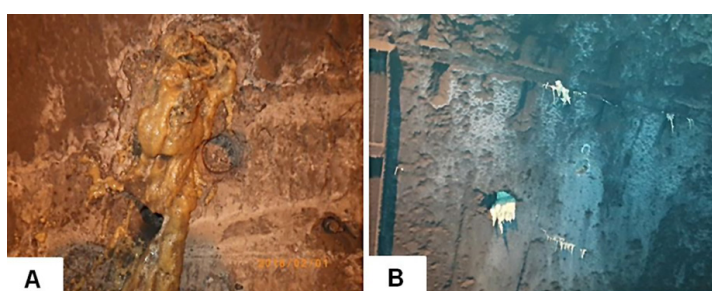
Figure 12—Void filling that has penetrated cracks on the concrete lining of the decline

Void filling was completed successfully. Stability was achieved without affecting the integrity of the concrete lining. Evidence of the effectiveness of the void filling is visible in the decline. The void-filling material penetrated cracks in the concrete lining as illustrated in Figure 12.

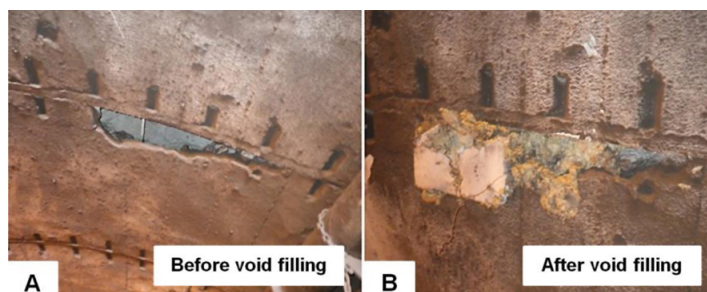
Figure 13—Void filling on row 71

Figure 13 shows photographs of one of the voids before and after being filled.

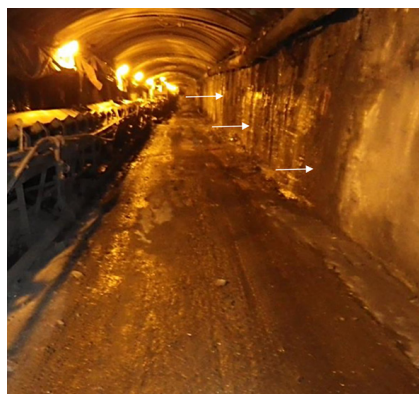
Water sealing was also completed successfully. The water volumes after the completion of the project were found to have decreased compared to the same period the prior year. Figures 14 and 15 show the ingress surface areas along the decline before and after completion of the project. The ingress of groundwater into the decline has been reduced to some residual dampness. Figure 16 shows photographs of a portion in the main water ingress area before and after water sealing and grouting.

Figure 14—The main water area before grouting. The white arrows indicate wet sidewall

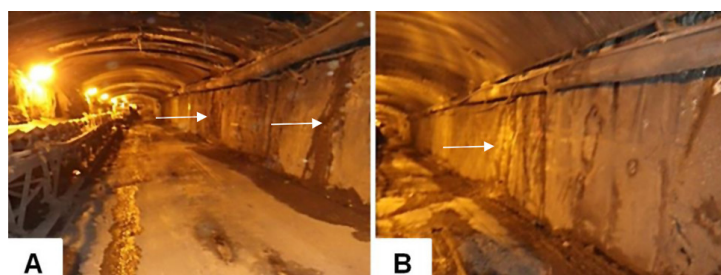
Figure 15—The main water area after grouting. White arrows indicate wet sidewall positions

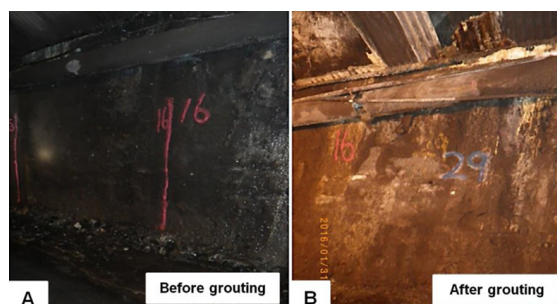
Figure 16—Row 16 before and after grouting
