# First use of geological radar to assess the conservation condition of a South African rock art site: Game Pass Shelter (KwaZulu-Natal)

F. Huneau<sup>a\*</sup>, S. Hœrlé<sup>b</sup>, A. Denis<sup>a</sup> and A. Salomon<sup>b</sup>

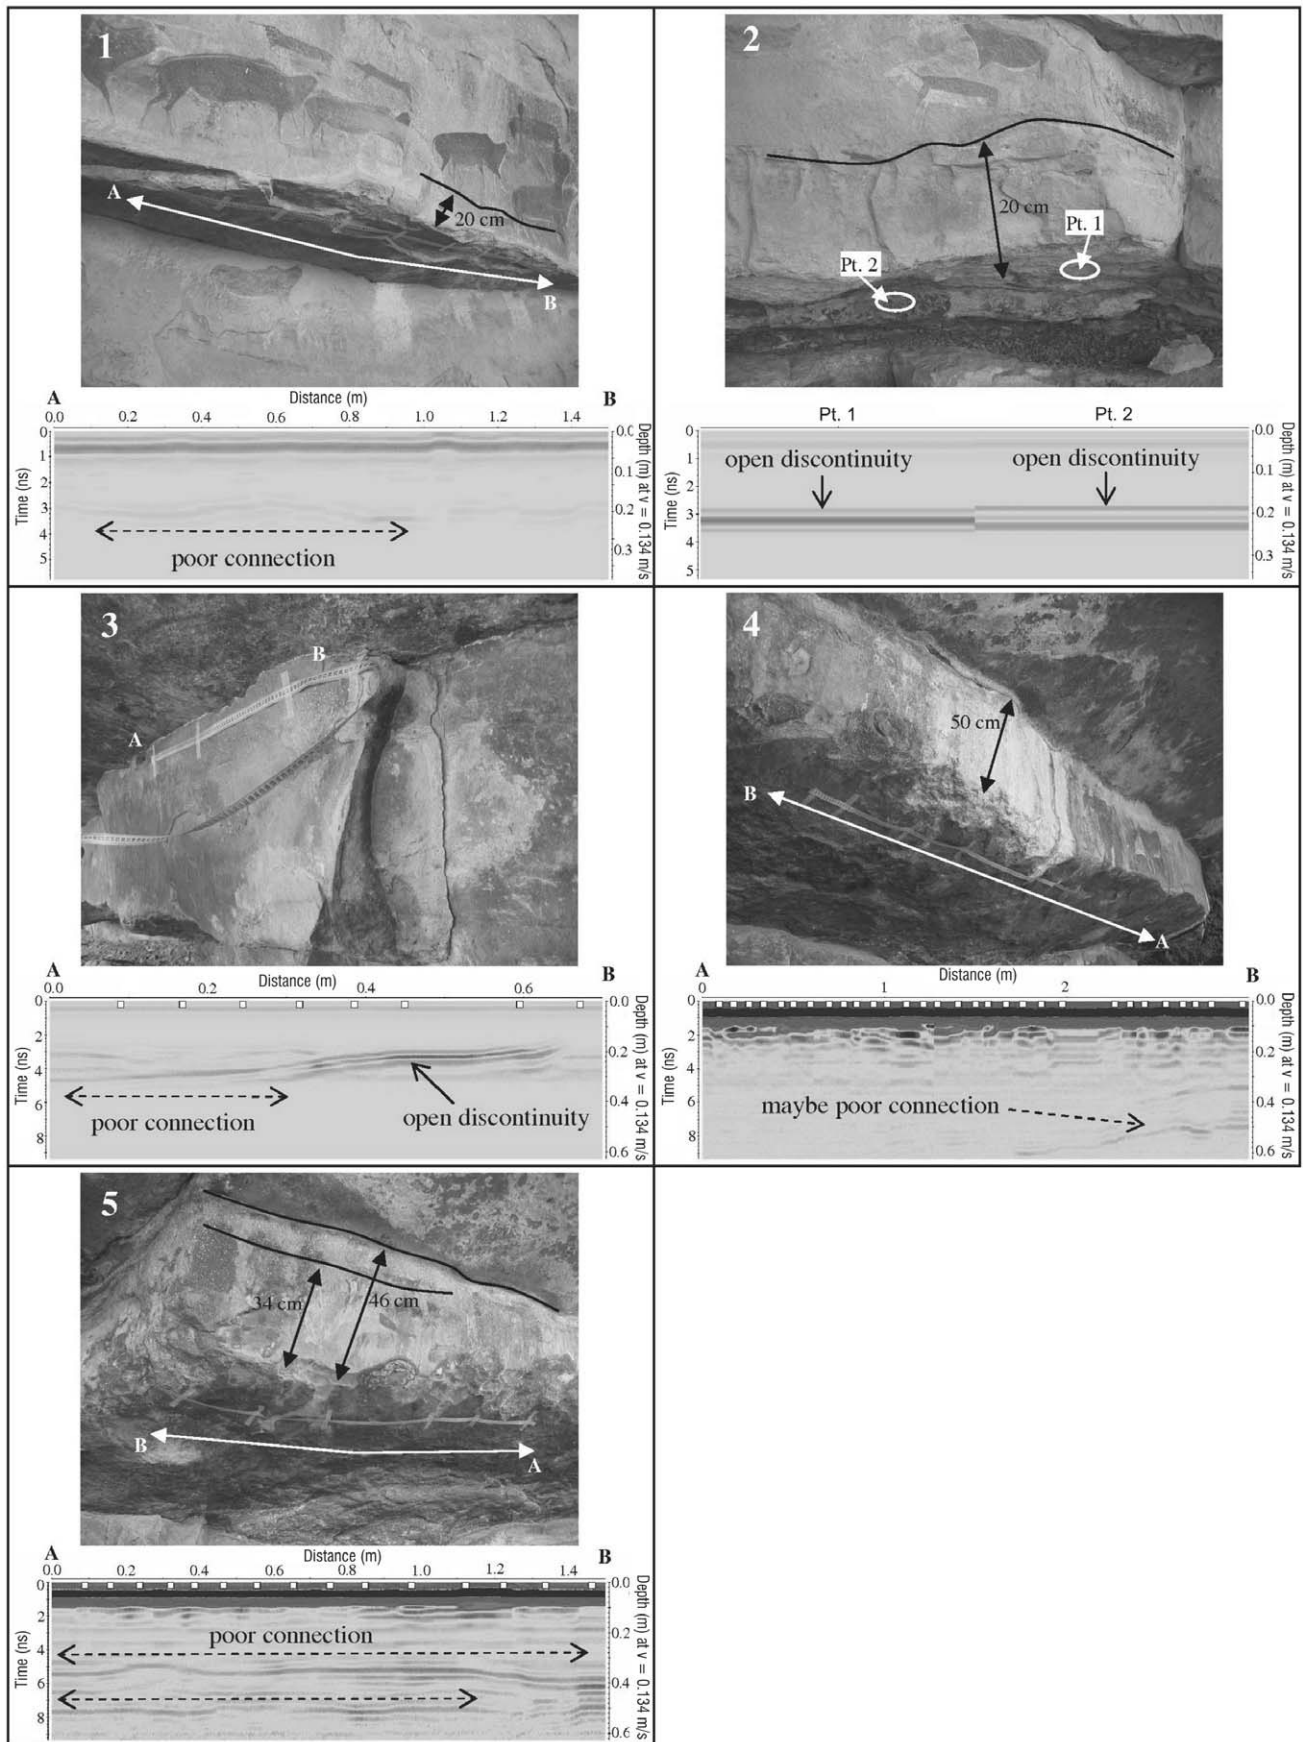
**Figs 1–5.** 1, View of the Main Panel and radargram showing the extension in depth of a discontinuity apparent on the surface; 2, view of the Main Panel and two point measurements showing the opening in depth of a discontinuity that appears closed on the surface; 3, view of a large slab with several paintings and radargram confirming the detachment of this slab over most of its length; 4, view of the Dying Eland Panel. Although water seepage (it was dry at the time of the survey) suggests a discontinuity, the radargram fails to show any; 5, view of the far left of the Dying Eland Panel. The radargram shows two parallel discontinuities developing in depth, and the probable poor attachment of the left part of this overhanging panel. A 2-m measuring tape is shown on all the figures.

A wave of high amplitude, nearly continuous over the entire profile, is clearly shown between 20 and 25 cm (Fig. 1), consistent with a thin clay joint locally visible on the surface. This important discontinuity is a risk for the conservation

of the panel located just above which carries most of the paintings of the site. Although no sign of short-term instability is so far visible on the surface, the radargram indicates that the joint lacks cohesion. It also shows that infiltration water passes through this joint, thus potentially increasing the instability of the panel.

Because the rock geometry does not allow a continuous profile under this layer, two point measurements were made instead. These measurements show the presence of an interface between 18 and 25 cm (also visible on the surface) that goes deep into the rock (Fig. 2). Although it appears closed on the surface, where no sign of short-term instability has yet appeared, the radar image shows that the interface is clearly discontinuous in depth.

Figure 3 shows a slab with a significant detachment visible to the naked eye. The aim of the radar measurement was to evaluate the detachment in depth and over the entire length of the slab. The radargram shows that the slab is detached over its entire length and with potential short-term instability. A radargram recorded of an area with water seepage, suggesting the possibility of an open discontinuity, failed to confirm, after processing, a clear discontinuity (Fig. 4). The blurred shape of the radargram results from strong amplification of the waves that increases measurement noise. Nevertheless, the strong amplification on part B (the zone with maximal oozing) possibly shows a discontinuity at about 50–60 cm. At the time of the measurement (during austral spring), the surface was dry and no water was seeping, which may explain the poor contrast.

The aim of the measurement depicted in Fig. 5 was to confirm the presence of an open discontinuity (at the layer upper joint) possibly causing instability of the overhanging slab. When the signal is strongly amplified, the radargram shows the probable presence of two interfaces, detected at 35 and 50 cm. The joints observed on the surface are, therefore, continuous in depth and contain moisture, as they are easily detected by radar.

It is now possible to undertake precise monitoring focusing on the most unstable parts of the painted panels. At GP special attention should be paid to the evolution of the thin clayey joints, as they constitute the main source of instability of the rock layers. Gauges may be installed to follow the opening of the discontinuities identified as potential sources of instability, thus allowing for timely remedial action.
