# The collapse of Johannesburg's Klip River wetland

T.S. McCarthy<sup>a\*</sup>, V. Arnold<sup>a,b</sup>, J. Venter<sup>a,c</sup> and W.N. Ellery<sup>d</sup>

The Klip River wetland south of Johannesburg has long been economically important to the region, initially as a source of water, and latterly as a purifier of polluted water arising from the western section of the Witwatersrand urban-industrial-mining complex. A geomorphological investigation into the current state of the wetland has revealed that the upper reaches, which receive polluted water from old gold mines, are in reasonable condition, apart from a few sections that have been severely degraded by peat mining. The lower reaches, however, are in an advanced stage of collapse. A network of irrigation canals, dug to support intensive agriculture during the early part of the last century, provided nuclei for the development of major channels as discharge of treated sewage water increased in the latter portion of the century. The channels have become interconnected, and an almost continuous, single channel has formed downstream of the sewage works. The problem is likely to have been exacerbated by a falling water table in

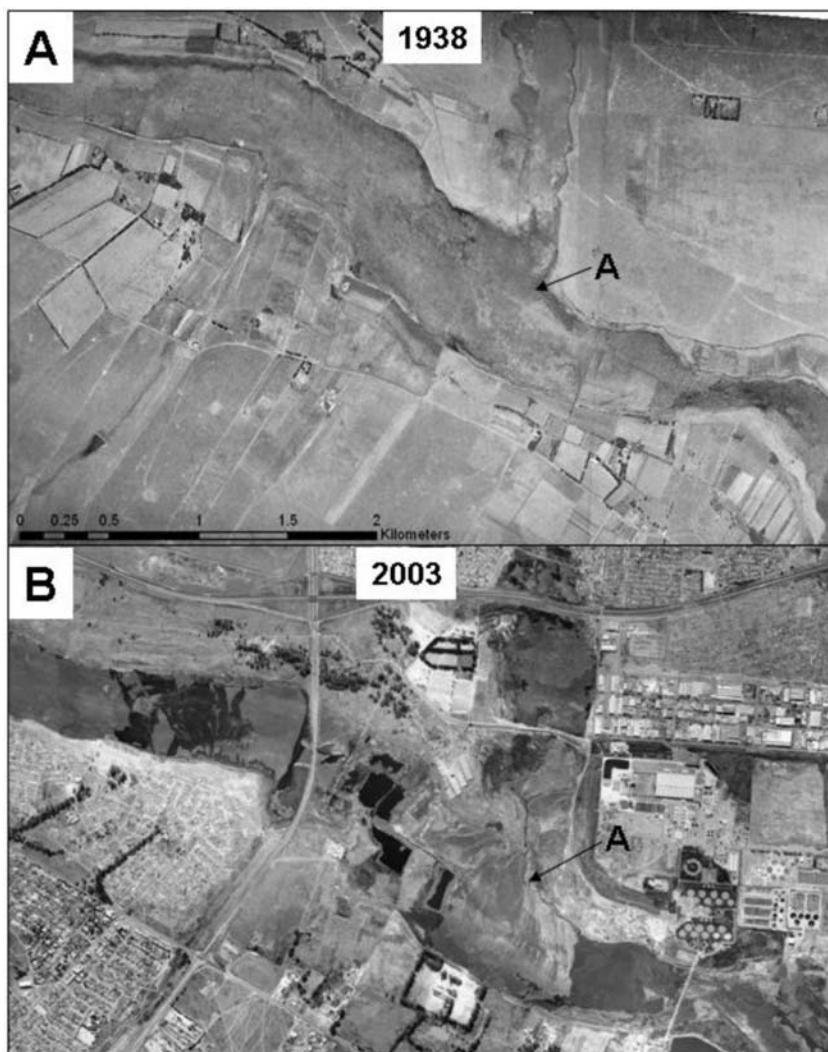
The 1938 photography shows the wetland to consist of an extensive reed bed (Fig. 3A). Irrigation canals had been dug along the fringes of the reed bed. The wetland in the 2003 aerial photographs is very similar in

Fig. 3. The wetland in the Lenasia area in (A) 1938 and (B) 2003. See Fig. 2 for location.

appearance (Fig. 3B) apart from an apparent slight increase in width, suggesting minimal macroscale anthropogenic influence. The irrigation canals are no longer evident, but were seen during aerial reconnaissance. They are heavily encroached by *Phragmites* reeds. Anthropogenic impact in this section of the wetland appears to be minor. Although heavy metal concentrations in the peat are high, as mentioned above, the vegetation does not appear to be adversely affected. As seen today, this section probably provides the best approximation of the appearance and hydrological functioning of the wetland, prior to the onset of gold mining on the Witwatersrand. Unfortunately, the area has not escaped completely unscathed, as some mining of peat has taken place in the very far western extremity of the wetland and especially in the area east of the Klipspruit Valley road crossing, which has left extensive bodies of open water in the wetland (Figs 3B, 4).

Sewage treatment works have been established at Olifantsvlei, and one of the contact dams appears to have been constructed in the wetland itself. Discharge of water into the Klipspruit tributary from the sewage works appears to have led to widening of an old irrigation furrow (A in Figs 3A, B).

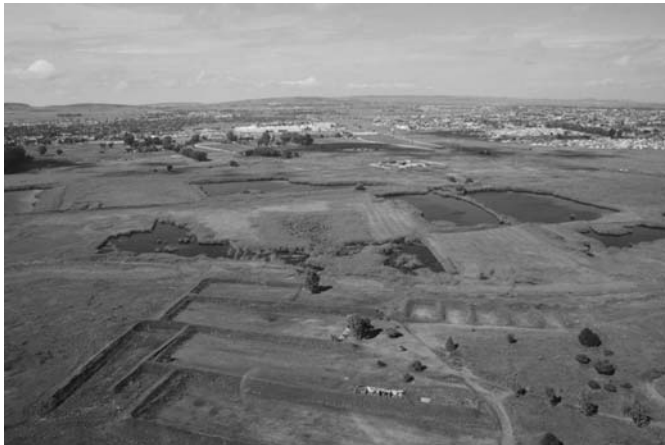
**Fig. 4.** Aerial view of the open water bodies left from peat mining in the area east of Klipspruit Valley Road, Lenasia.

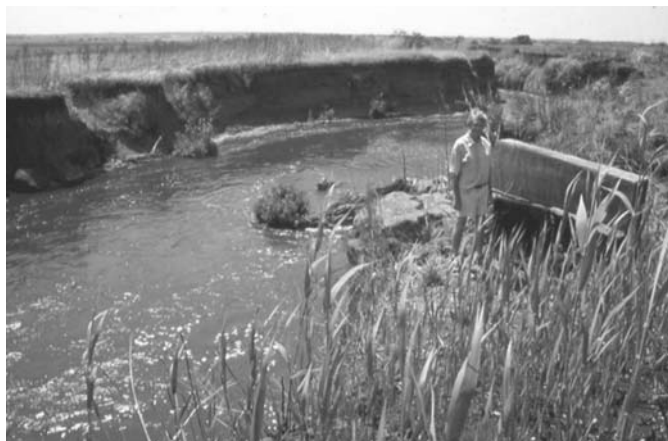
The extent of incision is further illustrated by a surveyed topographic profile extending from the pump to the northern bank of the wetland (Fig. I online). The water level at the time the pump station was constructed was determined from rust marks on the pipes in the sump, and this provides an indication of water level in the wetland at the time the pump was in use (late 1980s and possibly early 1990s). The banks of the incised channel

**Fig. 5.** Photograph showing the extent of channel incision at the inlet (concrete structure next to figure) to the irrigation pump shown in Fig. G. Figure G provides an aerial view of this location.

lie at a higher elevation than the former water level in the wetland, a consequence of the fact that the channel has incised along a former irrigation canal located outside the wetland.

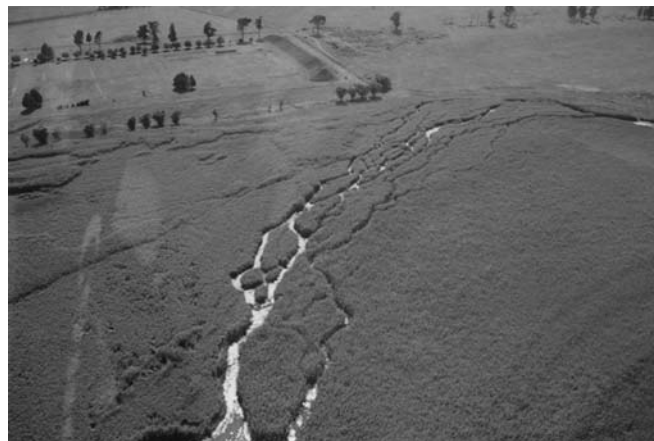
**Fig. 6.** Aerial photograph showing the final stages of the formation of a single channel in the Zwartkoppies reach of the wetland (reach E in Fig. 1(B)).

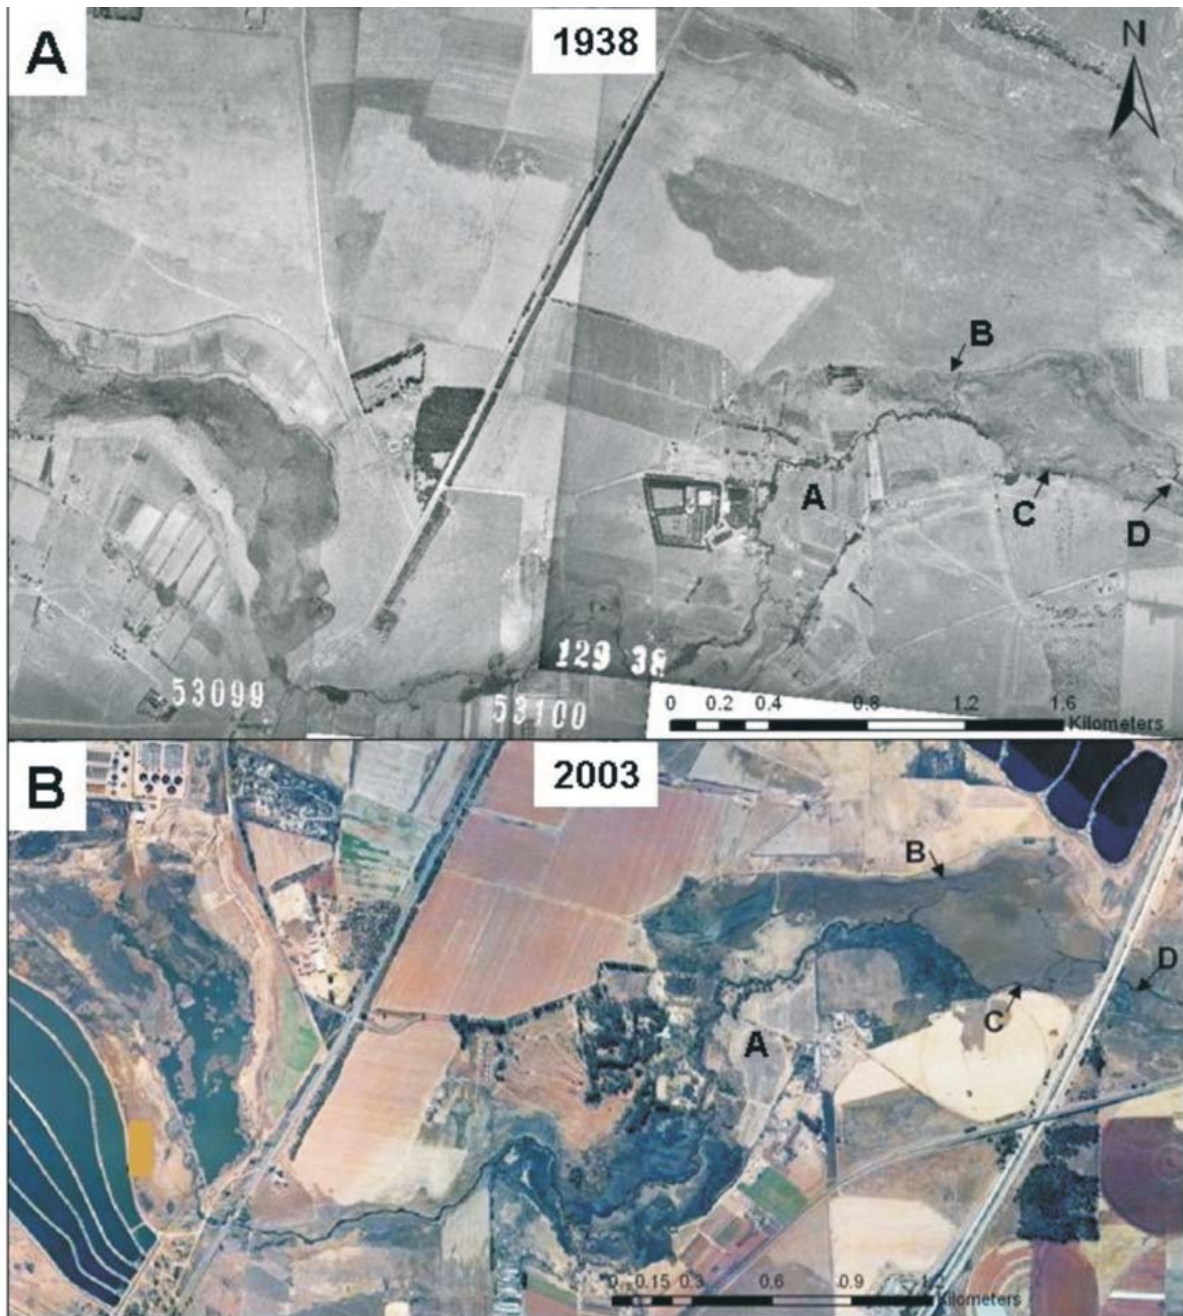
There appears to have been little wetland development in the upper portions of this reach in 1938, and the river formed a single channel. Some of the wetland may have been converted to agricultural land prior to 1938 (A in Fig. A in supplementary material online). Floodplain wetlands reappeared further downstream, but some of the river discharge had been diverted into canals on the north and south banks (B and C, respectively, in Fig. A(A)). In the 2003 photographs the river is similar to 1939, although the channel has widened substantially. Most of the changes that are evident have taken place in the lowermost reach. The bridge for the N1 motorway was built to accommodate the central channel in the wetland (D in Figs A(A) and (B)). The central channel has developed a series of headcuts that are propagating upstream to link with the remnants of the south bank canal (Fig. B in online supplement).

**Fig. A.** The wetland in the area between the Golden Highway (R553) and the N1 motorway in (A) 1938 and (B) 2003. See Fig. 2 for location.

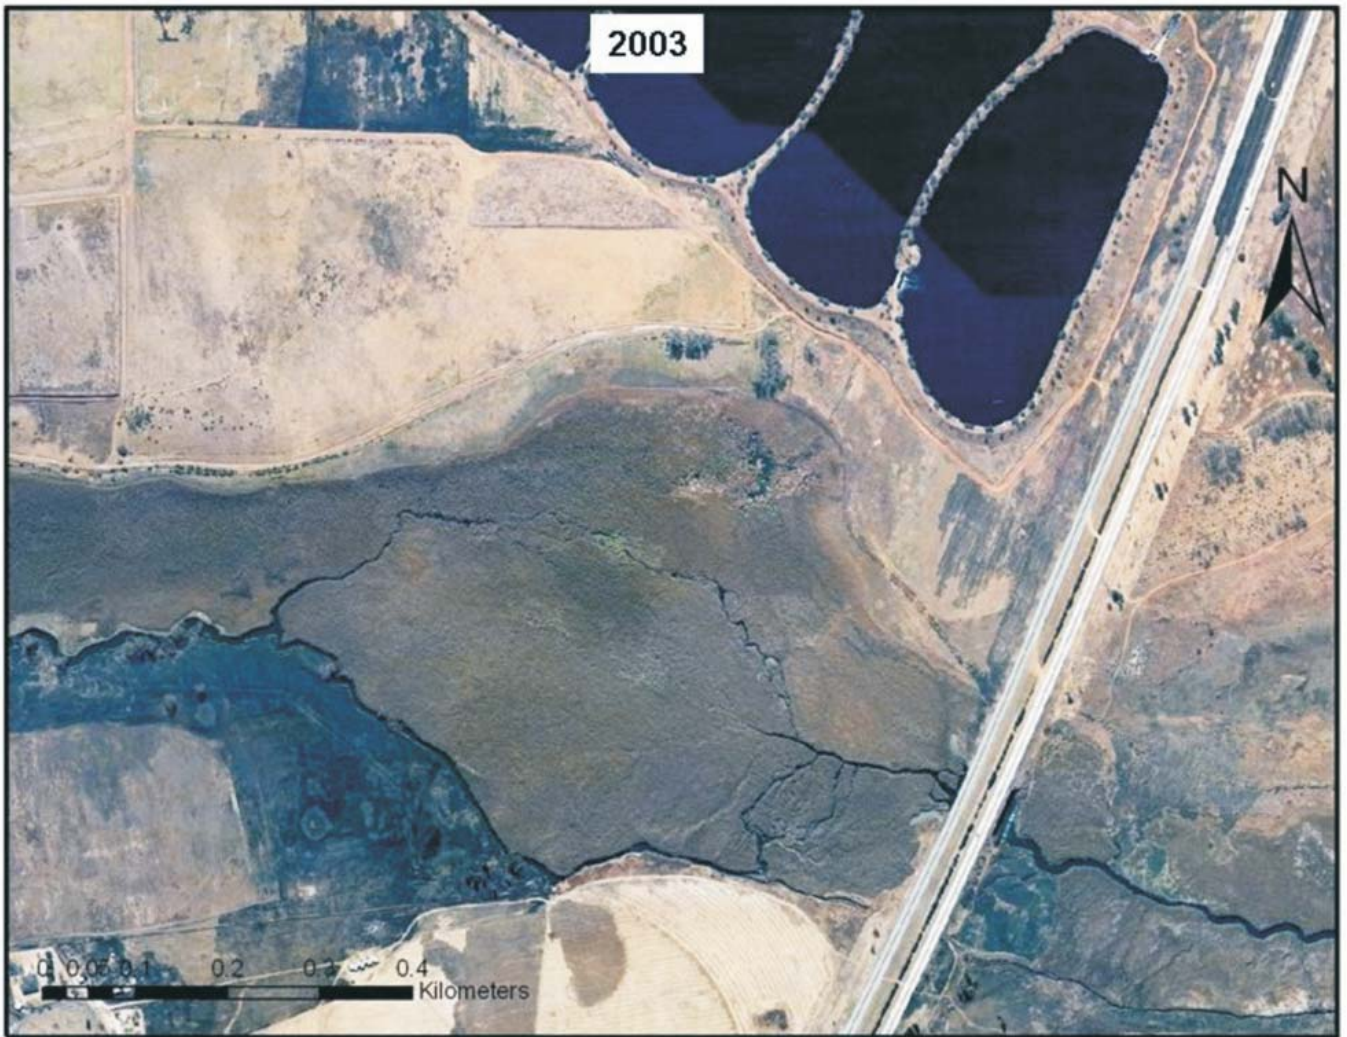
**Fig. B.** Detail of the wetland at the N1 motorway crossing. See Fig. 2 for location.

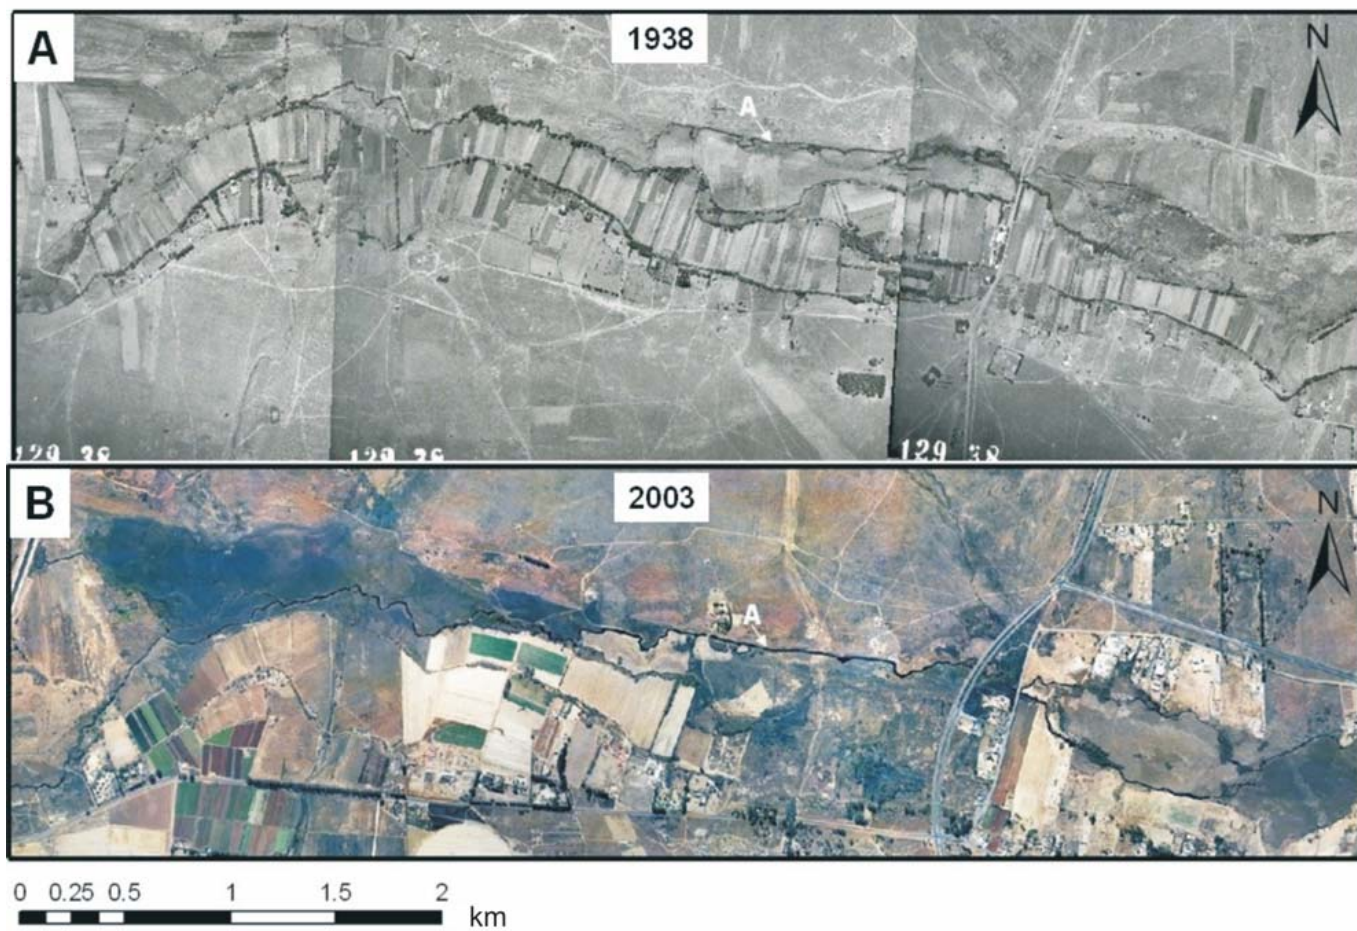
This reach of the floodplain was intensely farmed by 1938 (Fig. C(A) online) and the course of the river was largely manipulated. Irrigation canals carried much of the water through the reach. It may formerly have consisted of a *Phragmites* reed bed. Downstream of the bridge at Jackson's Drift, the water can be

By 2003, agriculture had declined along this reach of the river (Fig. C(B)) and the irrigation canals were largely dysfunctional. Flow had become confined to the irrigation canal along the northern bank of the wetland (A in Fig. C(B)), which had widened considerably. Downstream of the bridge at Jackson's Drift, flow continued to disperse into the extensive wetland as in 1938, but discrete channels now extended further into the wetland on the north and south banks (Figs D(A) and (B) online).

**Fig. C.** The wetland between the N1 and Kibler Park in (A) 1938 and (B) 2003. See Fig. 2 for location.

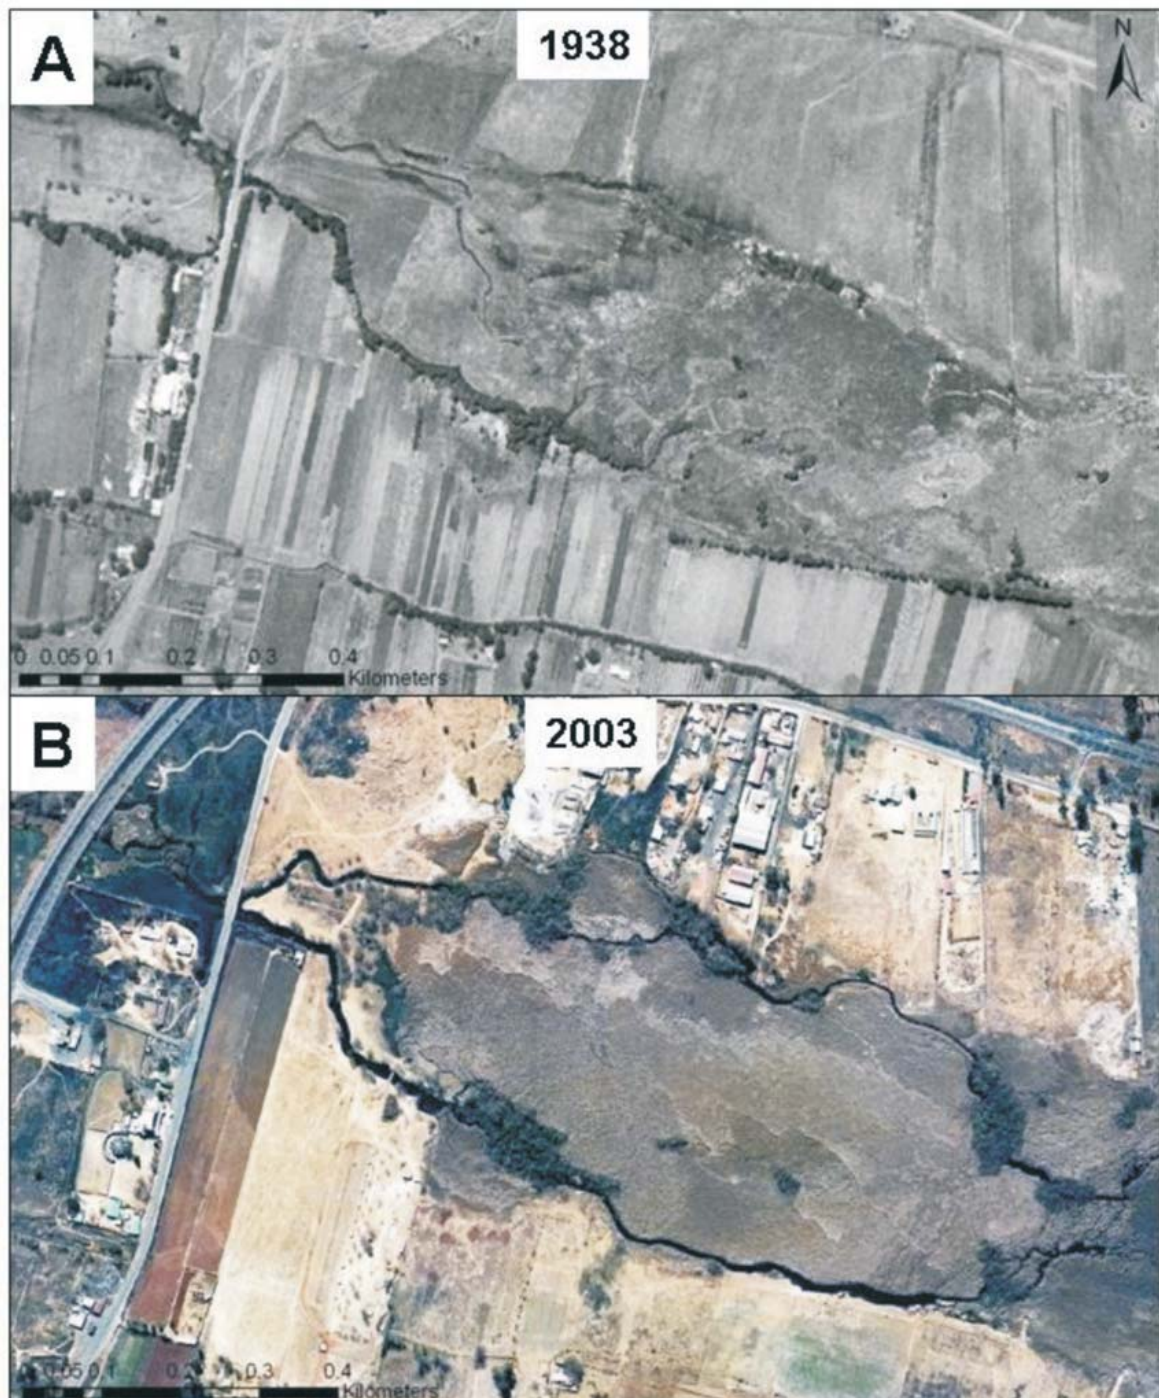
**Fig. D.** The wetland in the Jackson's Drift area in (A) 1938 and (B) 2003. See Fig. 2 for location.

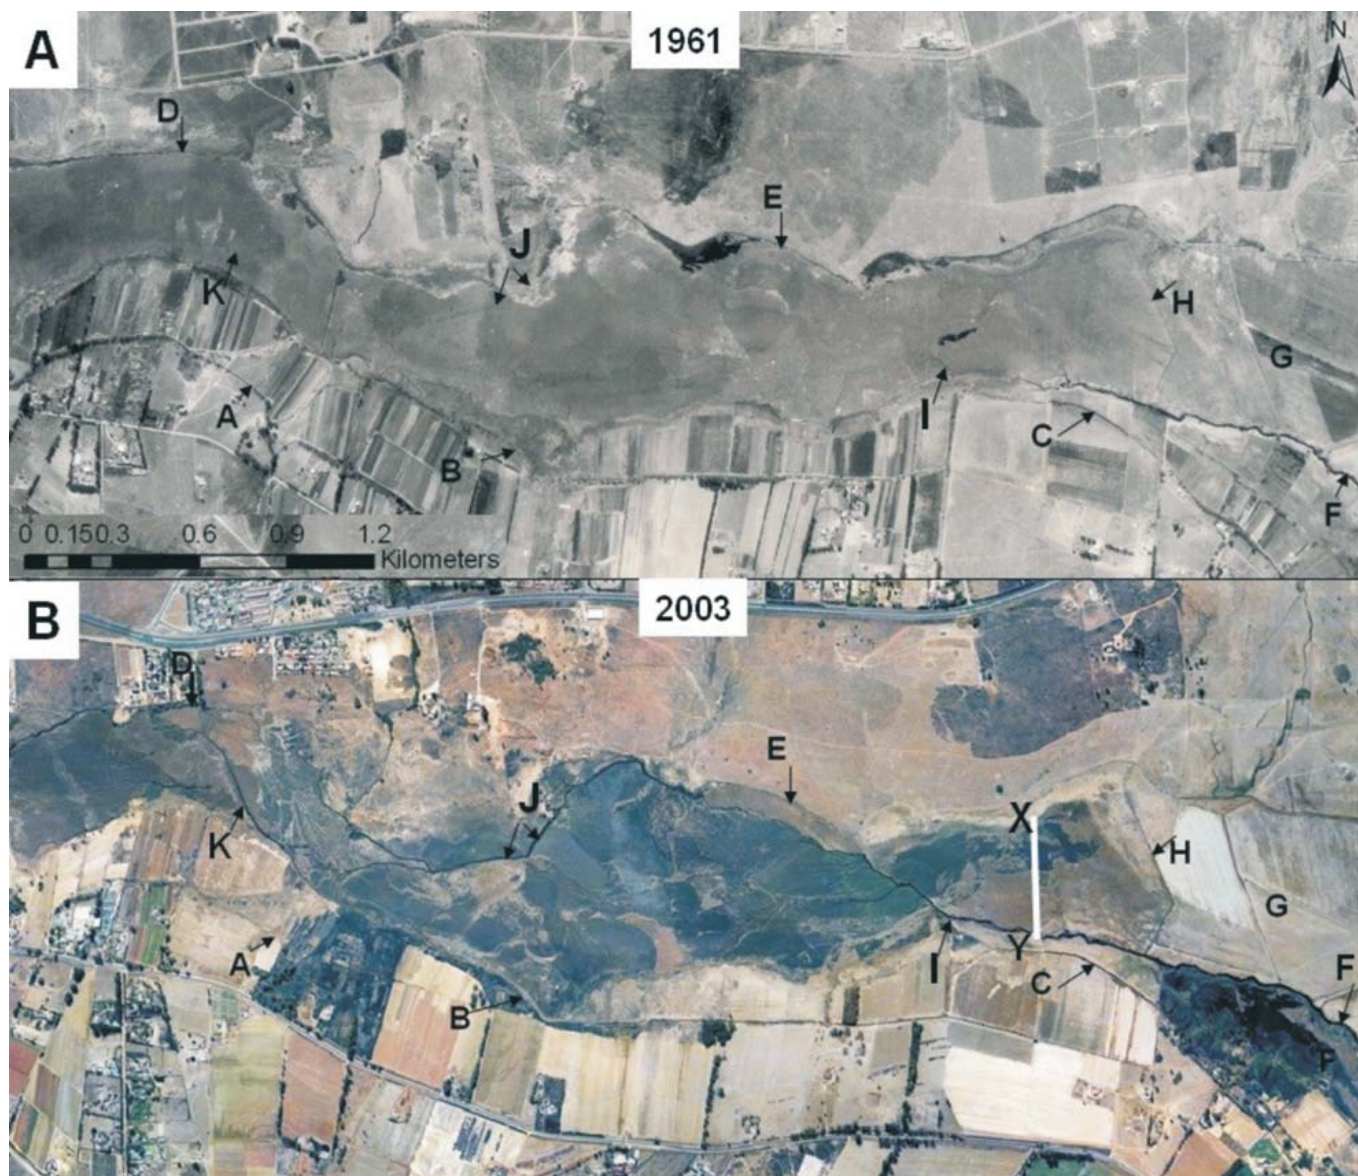
The reach was almost entirely covered by *Phragmites* wetland in 1961, and flow was apparently distributed across the wetland, as still occurs in the Lenasia section discussed above. Several irrigation canals had been cut on the south (A to C in Fig. E(A) online) and north banks (D, E in Fig. E(A)). Many of these canals were supplied with water by drains cut diagonally into the wetland at their heads (e.g. I in Fig. E(A)).

Flow had been fully diverted into a single channel on the south bank in the eastern section on Kromvlei (F in Fig. E(A)), using drains dug across the wetland (H in Fig. E(A)). These collected water that flowed through the upstream reed bed and diverted it to the canal on the south bank. This was evidently done to facilitate draining of the wetland to the downstream for agriculture (area G in Fig. E(A)). These diversions were carried out prior to 1952.

The wetland in the western extremity of this reach was still largely intact in 2003, with minor channel development. Opposite Kibler Park, however, a wide channel had formed across the wetland along a former diagonal drain. This had linked through to a greatly widened former diagonal drain and irrigation canal on the northern bank (J in Fig. E(B)). Downstream, the canal on the south bank (F in Fig. E(B)) had widened substantially, and had extended upstream across the wetland along a diagonal drain (I in Figs E(A) and (B); Fig. F online). A number of diffuse channels were eroding headward into the wetland upstream of the canal (Fig. F). Aerial reconnaissance has shown that one of these feeder channels has since linked through to the widened canal on the north bank, and the channel is now continuous from Kibler Park to Kromvlei.

**Fig. E.** The wetland between Kibler Park and Kromvlei in (A) 1961 and (B) 2003. See Fig. 2 for location.

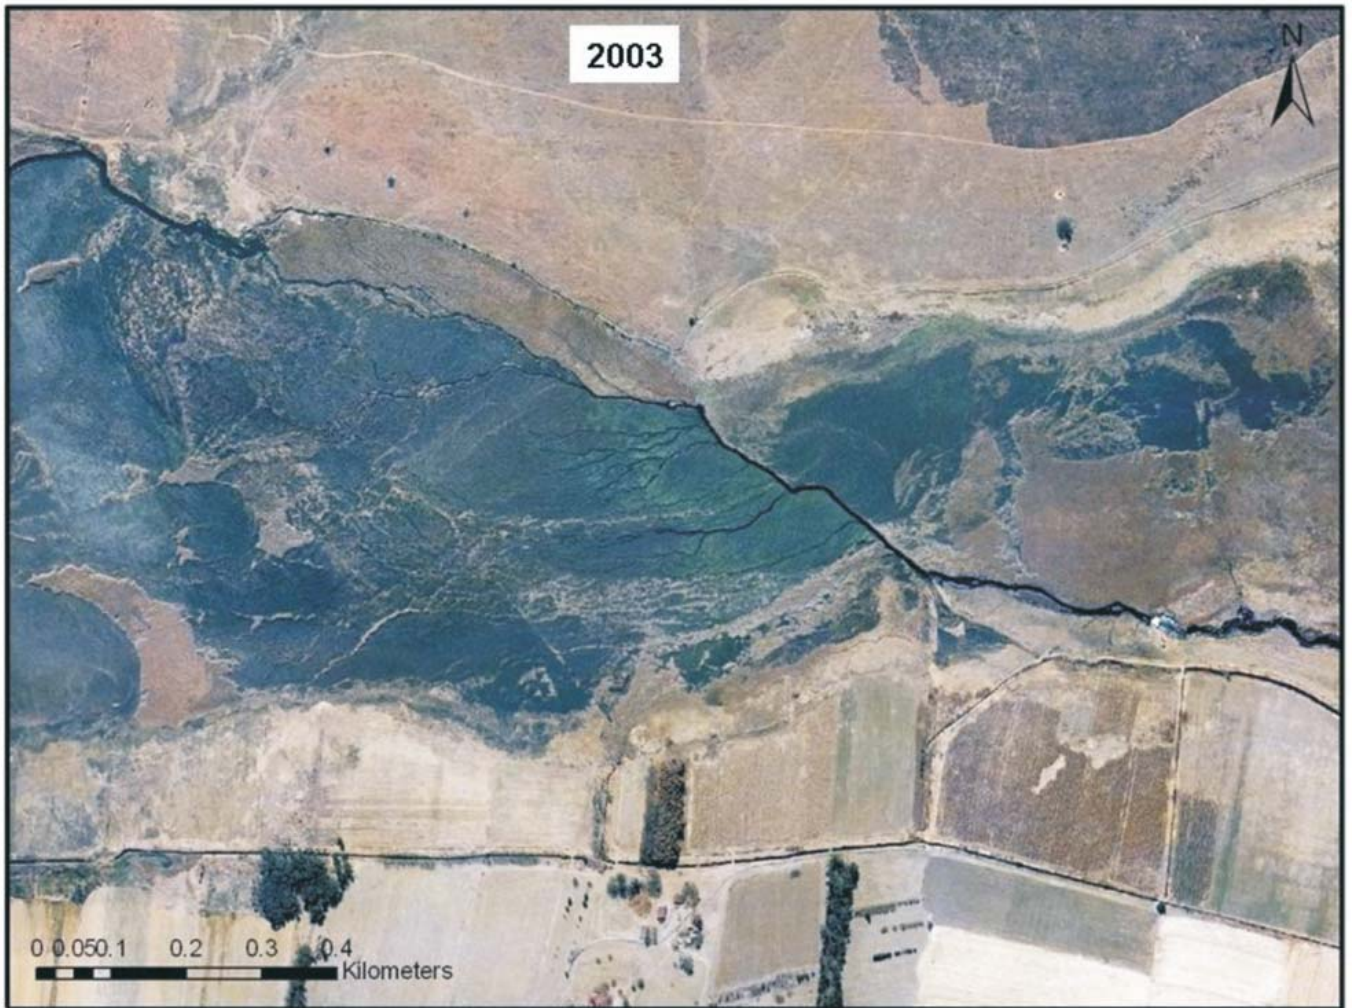
**Fig. F.** The wetland in the Kibler Park area in 2003. See Fig. 2 for location.

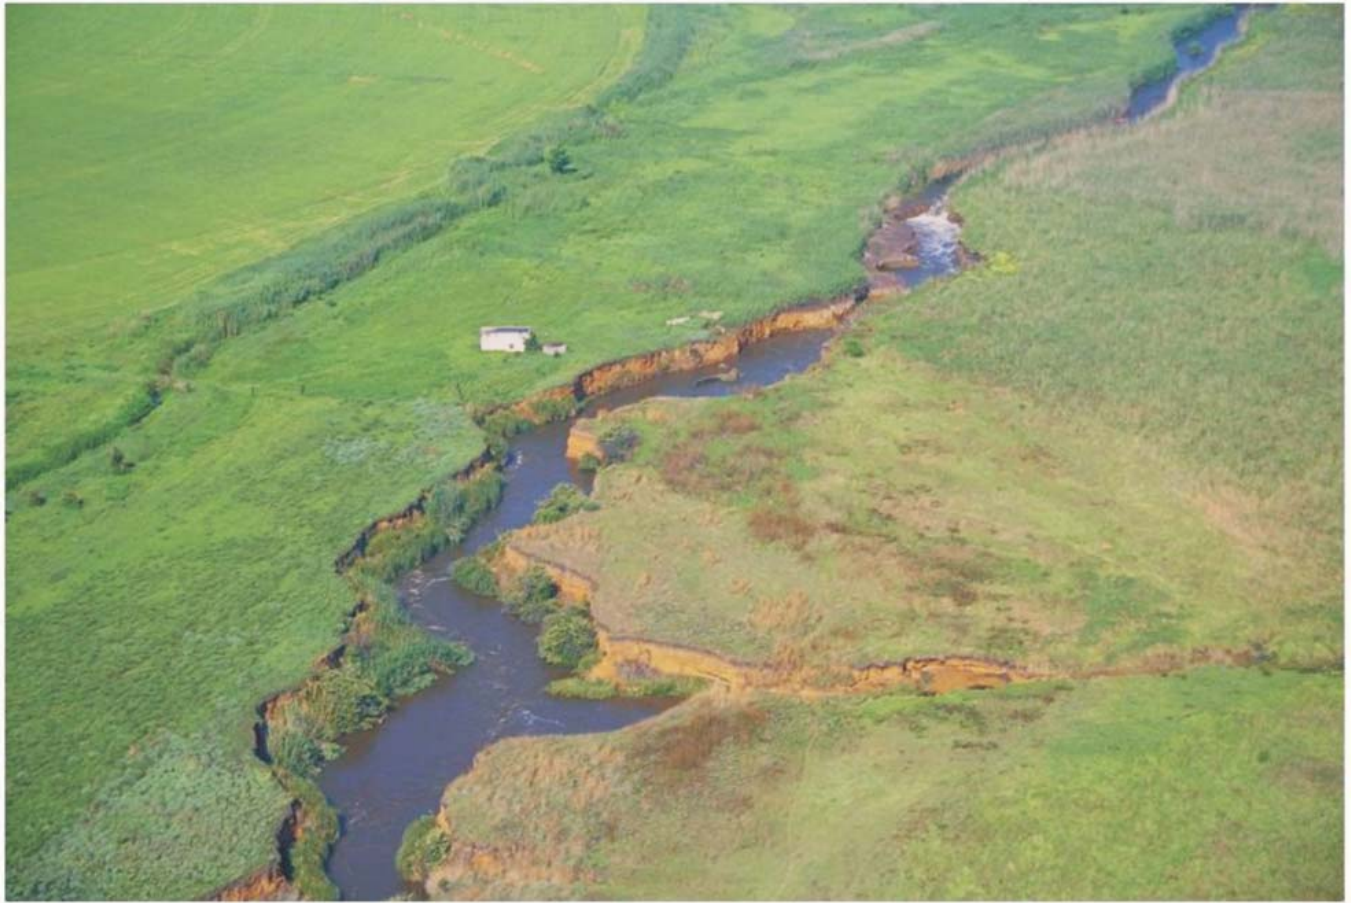
The channel on the south bank (F in Fig. E(B)) is undergoing rapid incision (Fig. G online). The extent of incision is difficult to gauge from aerial photographs, but field measurements indicate that the water surface at the pump station seen in the centre of Fig. G has been lowered by 2.5 m since the pump was erected in 1983 (Fig. 5). This incised reach has a nick point at its head with a 2 m waterfall (Fig. H online). Incision of this channel has also led to incision of the drain across the wetland (H in Fig. E(B)), resulting in a deep gully entering the main channel on the north bank (Fig. G).

**Fig. G.** Aerial view of an incised channel on the south bank of the wetland. The direction of view is upstream and the field of view encompasses the channel on the extreme right of Fig. F. The building in the centre of the photograph is an abandoned pump house. The sump is located in the small structure to the right of the building. A nick point (waterfall) is visible in the channel a short distance upstream of the pump station.

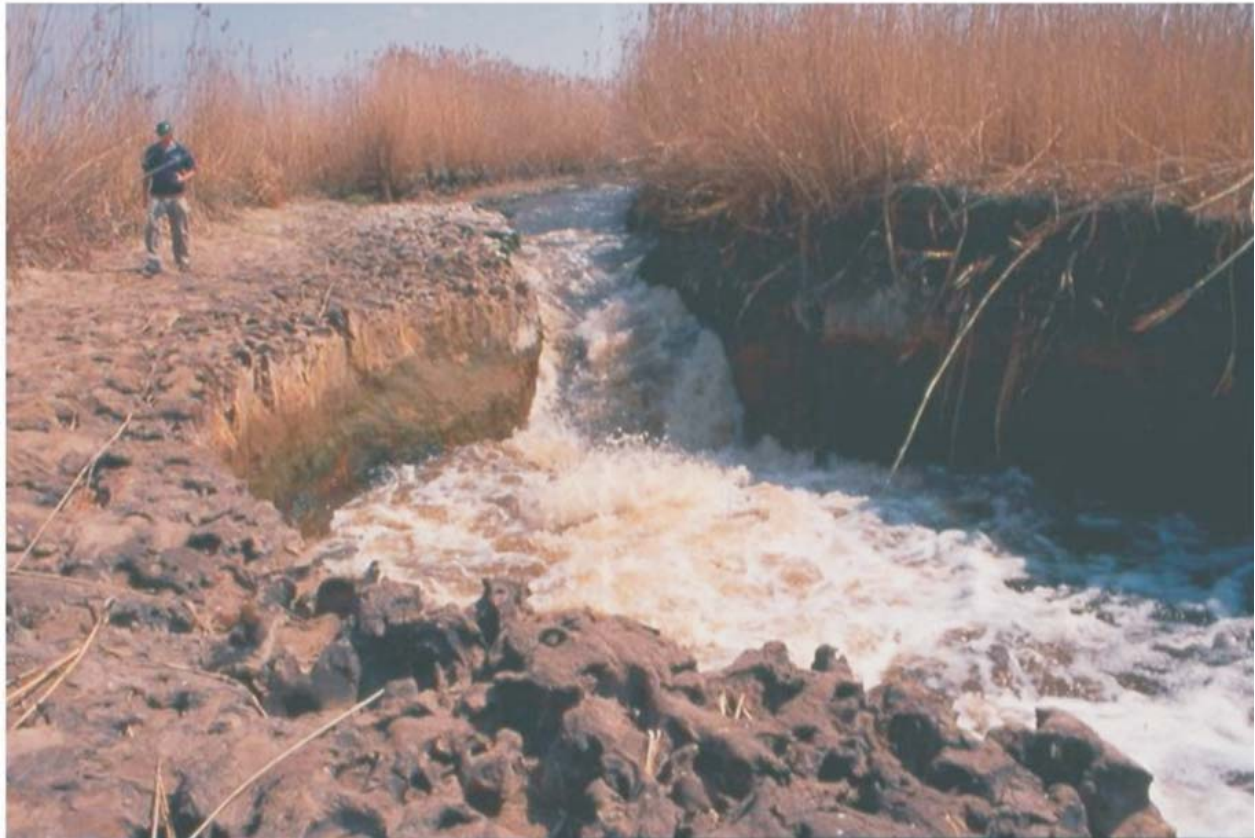
Fig. H. A ground view of the nick point visible in Fig. G.

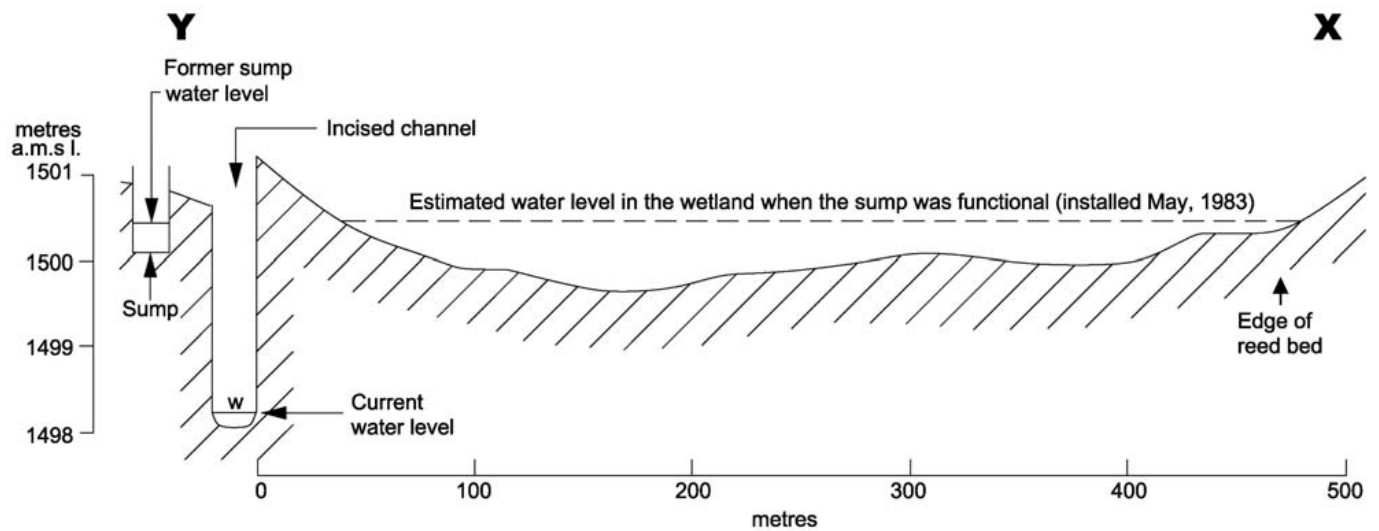
Fig. I. A topographic profile extending from the sump of the pump station in Fig. G to the northern margin of the wetland (line XY in Fig. E(B)).

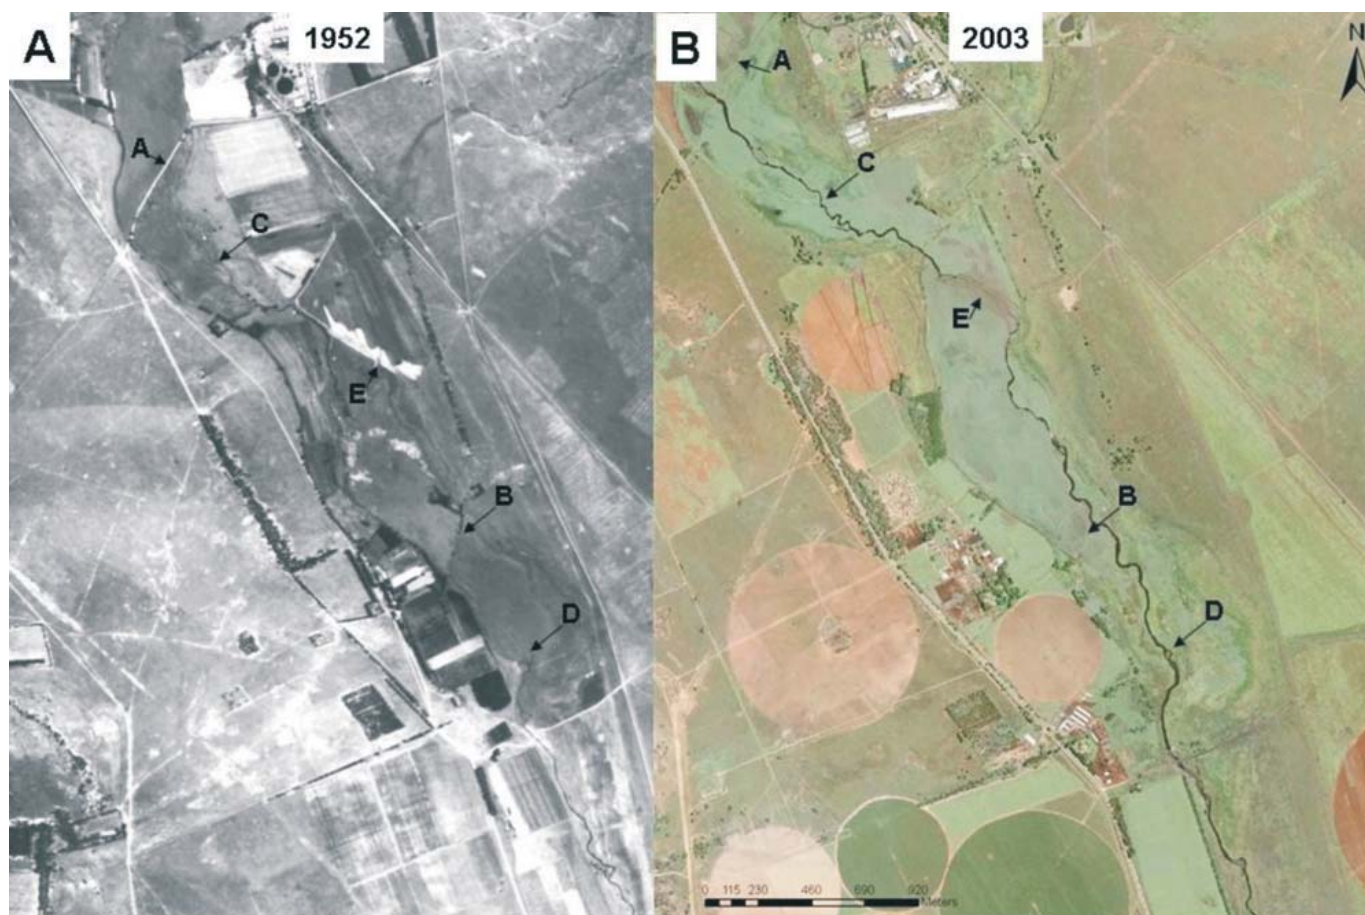
The lowermost reach of the wetland, in the vicinity of the Zwartkoppies pump station, was also not covered by the 1938 photography, and the earliest photographic record we have was acquired in 1952. Anthropogenic impacts evident at that time were an elevated road across the wetland to the pump station (A in Fig. J(A)) and an underground pipeline across the wetland (B in Fig. J(A)). A number of openings had been built under the road to allow through-flow of water. Canalization had begun in the central portion of the wetland with pronounced head-cuts migrating upstream towards the elevated roadway (C in Fig. J(A)). Elsewhere, the wetland appears to have been functional. The wetland converged to a single channel at its termination, with some evidence of head-cutting (D in Fig. J(A)).

**Fig. J.** The wetland in the Zwartkoppies area in (A) 1952 and (B) 2003. See Fig. 2 for location.

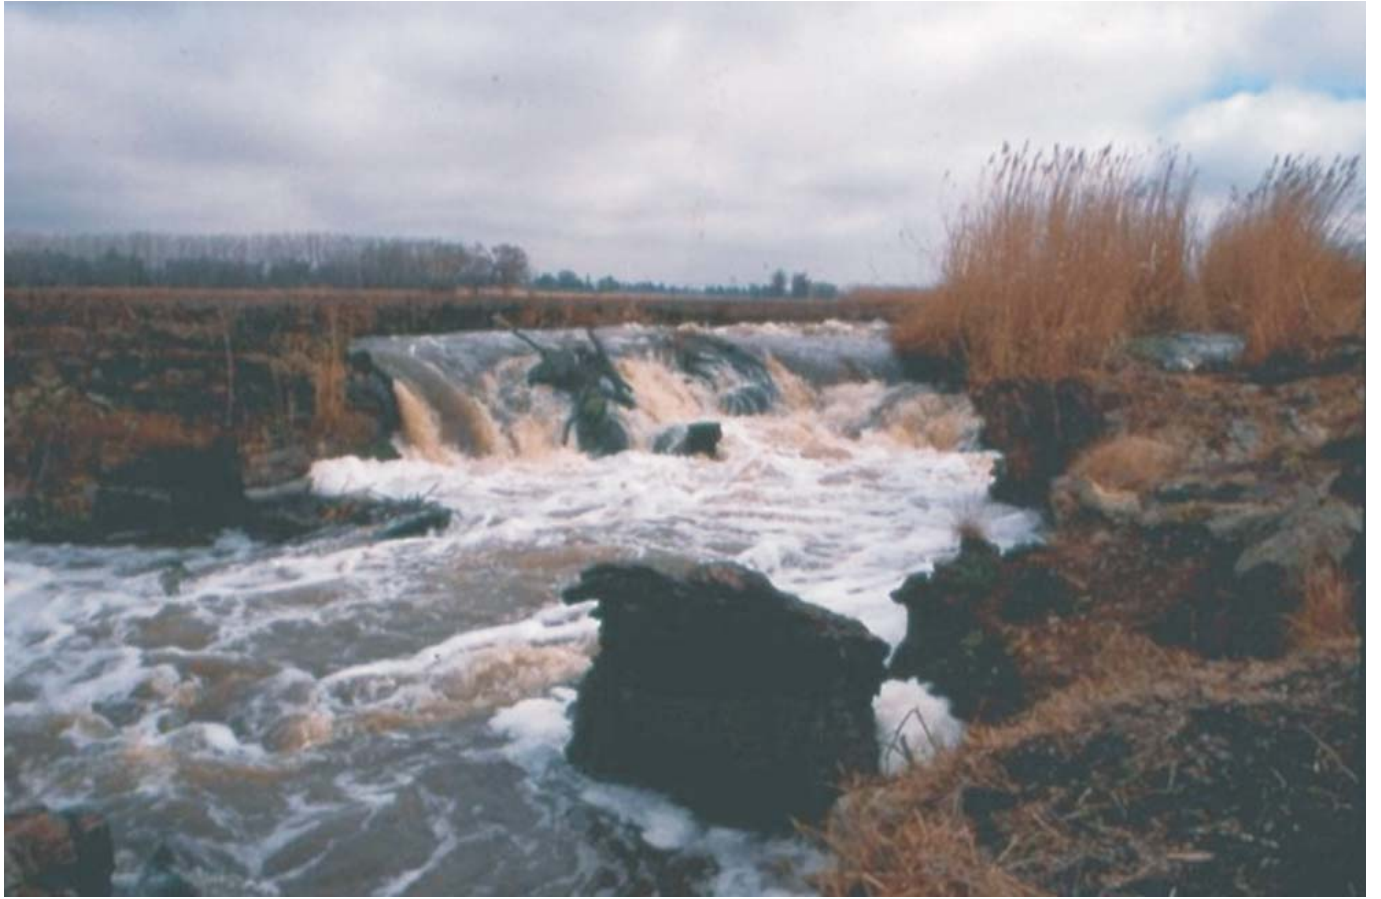
**Fig. K.** Channel incision in the Zwartkoppies reach of the wetland has exposed a rock barrier, resulting in a waterfall.
