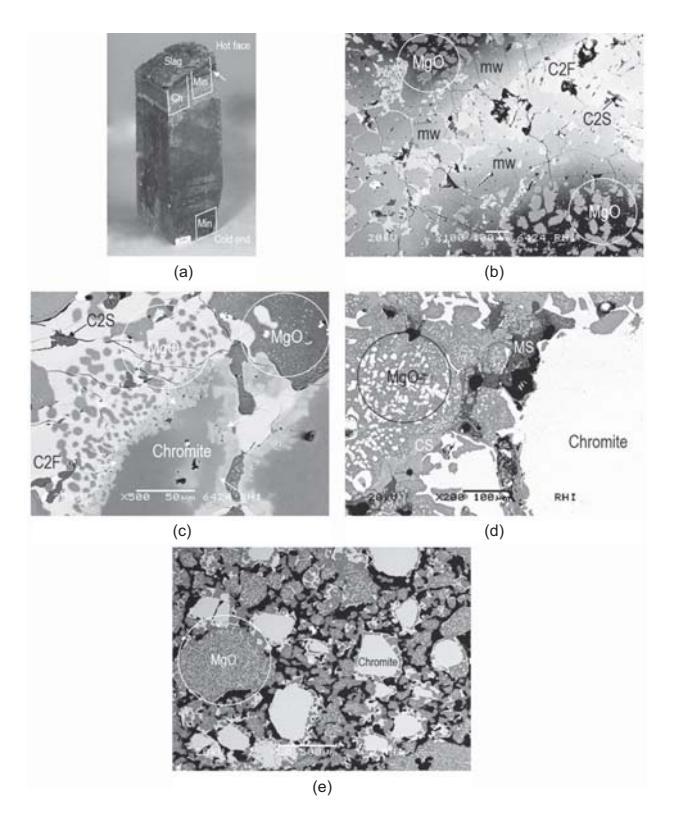
The post-mortem investigation was carried out on used refractory (magnesia-chromite brick of type 60:40) from the working lining of the TBRC at Stillwater Mining Company. The refractory life was 105 heats. The residual brick thickness was 170–180 mm. The immediate refractory hot face was slightly declined and covered with a thin coating of slag (Figure 1a). Cracks running parallel to the brick hot face could be observed.

The mineralogical investigation revealed the following microstructural changes and areas (Figures 1b–1d):

- At the immediate hot face a 0–2 mm reaction layer consisting of Fe-Ni-Cr-(Mg-Co) oxide, Ni-Fe-Cu-Co-Mg oxide, and Ca-Fe oxide of the type dicalcium ferrite (C₂F) was observed (Deer, Howie, and Zussman, 1992)
- Behind this to a depth of approximately 15 mm from the hot face, the microstructure had degenerated completely and was brittle. The typical microstructure

of the product containing coarse grains and fines was no longer visible, and the individual brick components could barely be distinguished. Owing to iron oxide enrichment of the magnesia component, an Mg-Fe oxide of magnesia-wüstite type had formed (Figure 1b). Chromite was heavily corroded by iron oxide (Figure 1c), a reaction resulting in the formation of Mg-Ni-Al-Cr-Fe oxide

- > In the zone and area between 15–25 mm from the hot face the brick microstructure had been infiltrated by Ca-Al-Fe oxide. The oxide filled the pores. Owing to diffusion the chromite rims were enriched in iron oxide. These iron oxide-containing melts tend to equilibrate with chromite. Therefore the margins of chromite crystals already showed a higher iron content. Nevertheless, the chromite composition was not homogeneous with respect to iron content: the diffusivity of iron ions was not sufficient to achieve chemical equilibrium in the time available. Additionally, microscopic inspection showed that magnesia fines and calcium silicates acting as binder phases had been lost. Nevertheless, the reaction products were not present at the same location. Microscopic investigation of the cold end helps to explain this (see below)

- Below this, up to a depth of approximately 35 mm from the hot face, the brick microstructure was infiltrated with Cu-Fe sulphide and Ni-(Fe) sulphide

- ➤ At the refractory cold face the sulphur-based corrosion of the magnesia and the interstitial phase within the magnesia were visible. The main reaction products were Ca sulphate and Mg sulphate (Figure 1d). Obviously, sulphur attack caused the corrosion observed in the vicinity of the hot face. Melts containing Mg²⁺, Ca²⁺, and SO₄²⁻ percolated to the cold end, where the temperature remained above the respective invariant points. The separation of the reaction products from the reactants hindered chemical equilibrium close to the hot face. Therefore conditions for corrosion were maintained.

Figure 1e shows the virgin brick microstructure for comparison. The brick is based on fused magnesia-chromite and chromium ore.

Figure 1–(a) Macroscopic view of used magnesia-chromite brick from the TBRC. Partly declined brick hot face covered with a thin coating of slag. A crack is parallel to the hot face (arrow). Samples for chemical analysis (Ch) and phase-chemical examination (Min) are indicated. (b) Microstructural detail approximately 5 mm from the hot face. Corroded magnesia-component (MgO) with the formation of magnesiawüstite at rims (mw). Calcium ferrite (C_2F) enriched with Cr_2O_3 . Dicalcium silicate (C_2S). (c) Microstructural detail approximately 10 mm from the hot face. Severe corrosion of chromite. At rims of chromite, formation of Ni-Ca-Mg-Fe-Al-Cr oxide (white arrows). (d) Microstructural detail of brick cold end. Sulphur attack of the magnesia component (MgO) and interstitial phase. Mg sulphate (MS) and Ca sulphate (CS) are the main reaction products. (e) Microstructural detail, with original brick microstructure for comparison. Magnesia component (MgO)

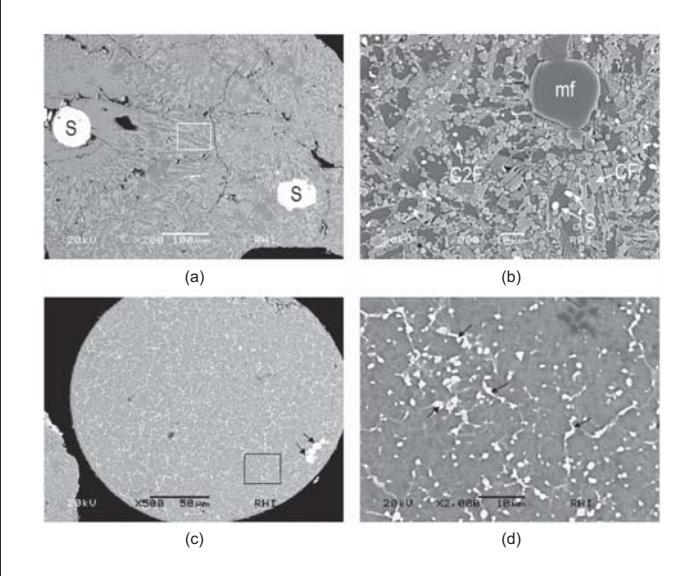
The slag is a Ni-, Cu-, and S-rich Ca-Fe oxide (calcium ferritic-type slag – Table II). The main slag components include two different Ca-Fe oxides (one of type C_2F) and Ni-Mg-Fe-(Cr)-(Co) oxide of type magnesia-ferrite (Figures 2a and 2b).

From phase chemical examination and X-ray diffractometry, we determined the main components of solid nickel matte to be Fe-Ni sulphide (pentlandite), Ni sulphide, and Cu-Fe sulphide (chalcopyrite) (Figures 2c and 2d). A Pt-

Figure 2—(a) Typical microstructural detail of granulated calcium ferritic slag with Cu-(Fe)-Ni-(Pd) sulphide inclusions (S). (b) Detail from Figure 2a. Ca-Fe oxides of type calcium ferrite (CF) and dicalcium ferrite (C2F). Ni-Mg-Fe-(Ca)-(Cr)-(Co) oxide of type magnesia-ferrite (mf). Sulphide inclusions (S). (c) Typical microstructural details of granulated matte. Pd, Pt-enriched Cu-Fe-Ni sulphide (arrows). (d) Detail from Figure 2c

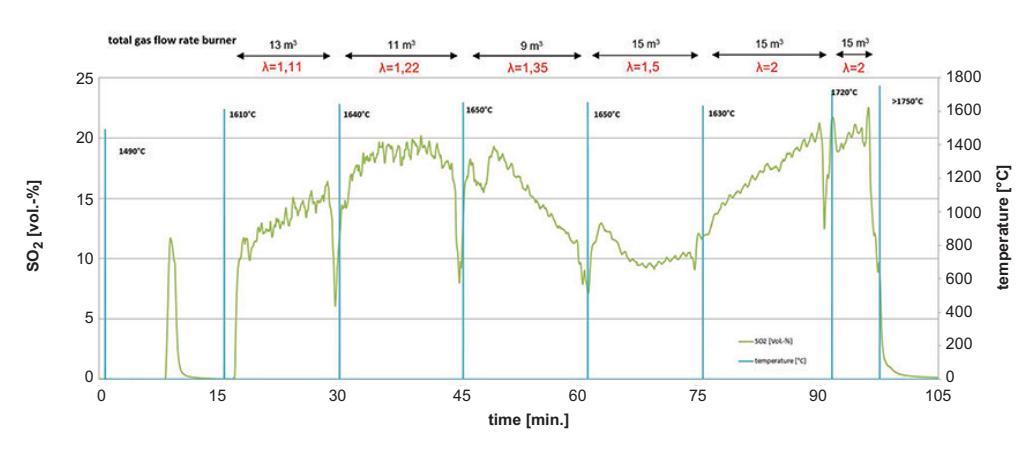
Figure 4—An example of temperature measurement during the first two TBRC tests. The temperature was continuously measured by a thermocouple in the TBRC gas room. For process control a discontinuous temperature measurement of the liquid matte was taken every 15 minutes, shown as spikes in the chart. Additionally, λ and the total gas flow rate were recorded

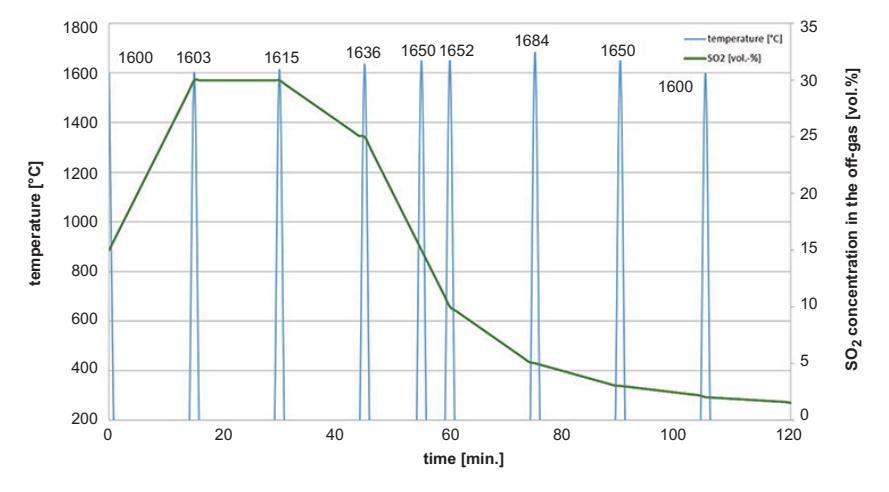
As mentioned, unlike tests 1 and 2, the subsequent trials 3 and 4 were carried out under constant temperature. In test 3, λ was varied under a constant gas flow rate, whereas in test 4 the burner capacity was varied under constant λ . With both variations the same result was achieved; nevertheless, the control of the furnace was much easier when maintaining the burner power at constant λ (Figure 5).

Figure 5-Example of the temperature and SO2 content of the off-gas during tests 3 and 4. For process control the temperature of the liquid matte was measured (discontinuously) every 15 minutes, shown as spikes in the diagram

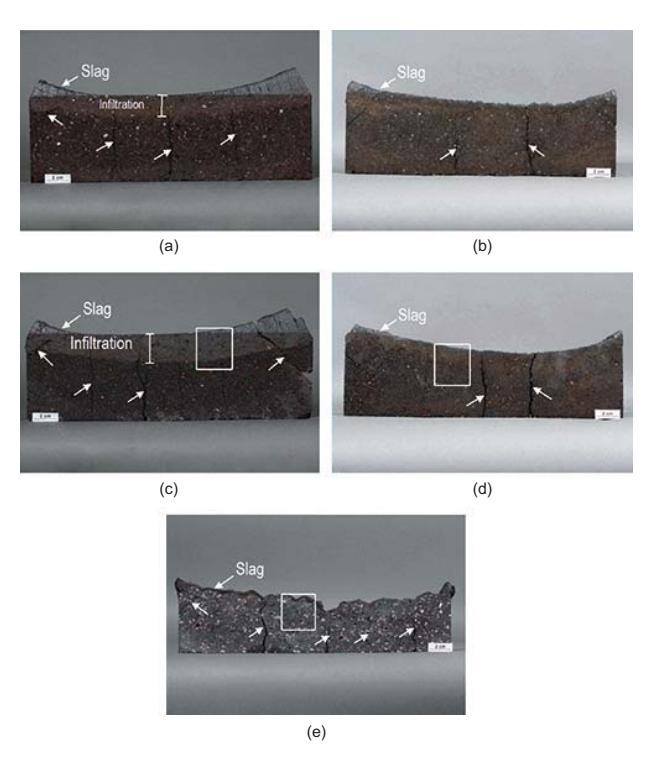
All brick samples tested showed cracks caused by thermal shock during kiln operation. In the magnesia-chromite brick brands, either minimal or no wear was visible (Table VI). The greatest infiltration depth was identified in MCB1. The high wear observed for the alumina-chromia brick ACB1 can be

Figure 6-Cross-sectional view of selected magnesia-chromite MCB4 (a, b), MCB1 (c, d), and alumina-chromia ACB1 (e) bricks after the rotary kiln test at 1500-1550°C (left side: a, c, e) and 1650°C (right side: b, d). A slag coating covers the immediate brick hot face. Crack formations are indicated with white arrows. Polished sections were prepared from the portions indicated by white rectangles

explained by crack formation caused by thermal shock from the initial testing and subsequent loss of refractory

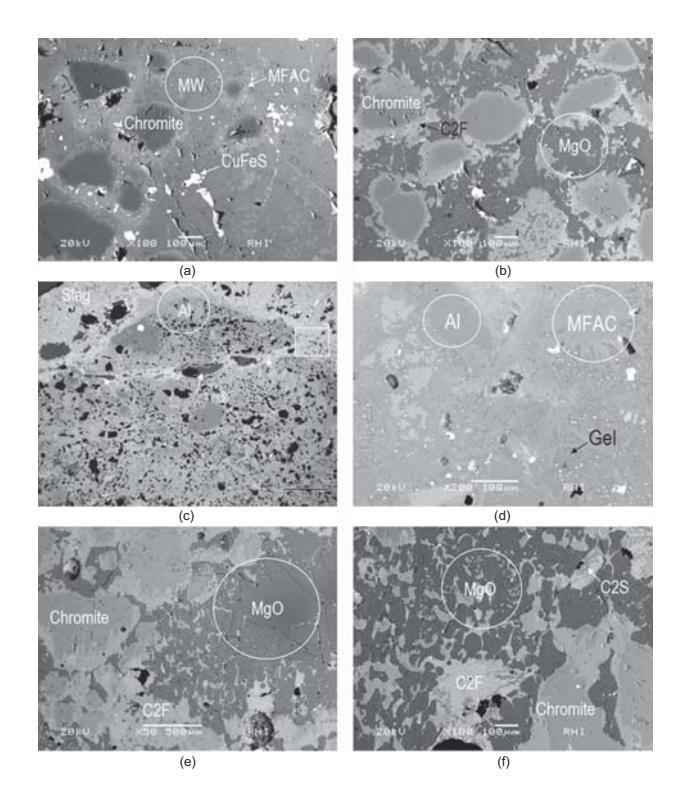
The main microstructural changes to the magnesiachromite bricks investigated, after the rotary kiln test, are summarized below (for example MCB1, see Figures 7a and 7b).

The immediate brick hot face was covered with a 1–2 mm thick reaction zone. Within this area the magnesia component was completely dissolved. Only some chromite relics were still visible. Below the reaction zone a deep-reaching infiltration by calcium ferrite and corrosion of the brick microstructure was observed.

Figure 7a-b-Microstructural details in the magnesia-chromite brick MCB1 after the rotary kiln test at 1500-1550°C, approximately 2 mm (a) and 10 mm (b) from hot face. Severe corrosion and degeneration of the brick microstructure. Corroded magnesia (MgO) and chromite. Formation of Ni-rich magnesia-wüstite, (Ni)-Fe-Mg oxide (MW), Mg-Fe-Al-Cr oxide of spinel structure (MFAC), calcium ferrite (C₂F) enriched with Cr₂O₃, and CuFeS from matte infiltration. Figure 7c-d Microstructural details of the alumina-chromia brick ACB1 after the rotary kiln test at 1500-1550°C. (c) Immediate brick hot face. Below the slag coating, infiltrated and corroded brick microstructure was observed. The crack that formed parallel to the hot face is partly filled with slag (arrows). Corroded fused alumina (Al). (d) Detail from Figure 7c, showing degenerated, recrystallized, and infiltrated brick microstructure. Mg-Fe-Al-Cr oxide of spinel structure (MFAC). The Ca-Al silicate is gehlenite, Ca2Al2SiO7 (Gel). Figure 7e-f Microstructural details of the magnesia-chromite brick MCB1 after rotary kiln test at 1650°C. Corrosion of the magnesia and chromite was significantly higher than in the first rotary kiln test at 1500–1550°C. Corroded MgO and chromite. Calcium ferrite (C₂F) enriched with Cr₂O₃. Dicalcium silicate (C₂S)

In the infiltrated and completely degenerated brick microstructure (0–5 mm from the hot face) the single brick components could no longer be distinguished. The high supply of Fe oxide resulted in the formation of a low-melting Ni-rich magnesia-wüstite ([Ni]-Fe-Mg oxide). The chromite and chromite precipitates (Routschka and Wuthnow, 2012) were corroded. Owing to the corrosion of chromite, (Ca)-Mg-Fe-Al-Cr oxide and (Ca)-Fe-Cr-Al oxide of spinel structure formed. In Figure 7a the brick is partly infiltrated by matte.

In the case of the alumina-chromia brick ACB1 (Figures 7c–d), infiltration of the microstructure can be traced over the entire polished section (0–20 mm from the hot face). Nevertheless, the greatest microstructural changes were observed in the area 0–2 mm from the hot face. In that area of the brick, pore-filling infiltration, recrystallization of a Cr-corundum–bearing matrix, corrosion of a Zr mullite, and the formation of Mg-Fe-Al-Cr oxide and (Na)-Ca-Al silicate of

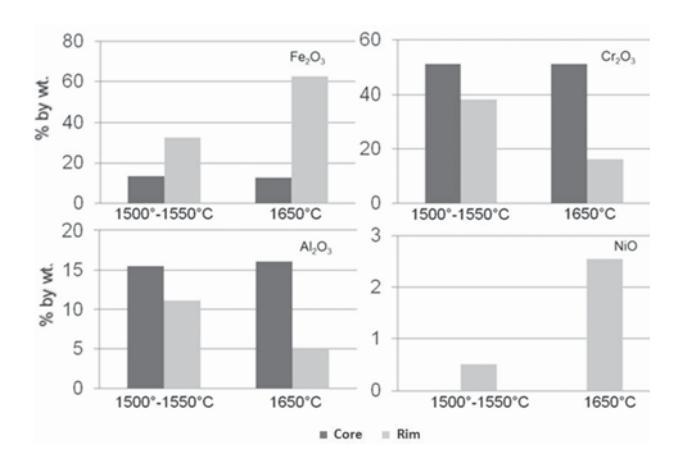
Figure 8—Magnesia-chromite brick MCB1. Significant differences in the chemical composition of chromite at the rim and core at two different test temperatures

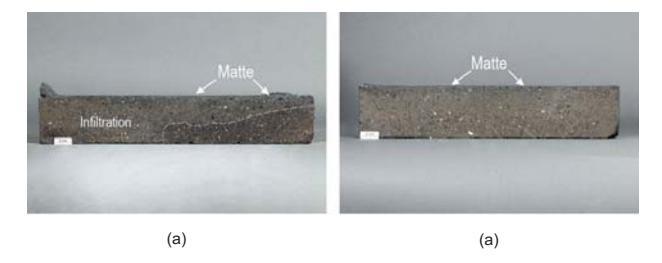
During the first two tests in the pilot TBRC none of the tested magnesia-chromite brick brands showed wear. In cross-section, the deeply infiltrated brick microstructure over the whole cross-section (approx. 60 mm from the hot face) was visible (Table VIII). Only in the case of brick MCB6 was the infiltration depth 47 mm from the hot face (Figure 10a).

Figure 10—Cross-sectional view of selected magnesia-chromite brick MCB6 after TBRC trials 1 and 2 (a), and 3 and 4 (b). Matte coating covering the immediate brick hot face

After tests 3 and 4, all tested magnesia-chromite bricks showed almost no wear, although a deep-reaching infiltration of the brick microstructure over the complete cross-section (Figure 10b) was observed.

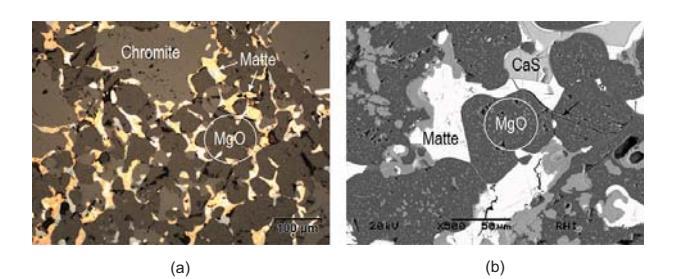
- ➤ All samples showed a thin reaction zone (0-2 mm from the hot face). Within this zone a strongly degenerated and recrystallized brick microstructure was visible. The coarse grains and the matrix fines in the brick could no longer be distinguished. The magnesia component was highly enriched in Fe oxide and Ni oxide. The chromite precipitates and the rims of chromite grains were also enriched in these oxides
- Below the reaction zone a deeply infiltrated brick microstructure could be observed. The main infiltrate was a (Cu)-Fe-Ni-bearing sulphide (Figure 11a)
- During the first two tests, the corrosion of magnesia by sulphur was minimal
- During the final two tests (3 and 4), the corrosion of magnesia fines and the coarse magnesia grains by sulphur was significant. Idiomorphic and newly precipitated MgO crystals and Ca sulphate were also observed (Figure 11b).

Figure 11 – Typical microstructural details of MCB6 after trials 3 and 4. Reflected-light microscopy (a) and scanning electron microscopy (b). Approximately 10 mm from the hot face. Infiltrated and corroded brick microstructure, showing corroded magnesia component (MgO), mickel matte, and idiomorphic Ca sulphate (CS)
