The impact of artisanal mining on rehabilitation efforts of abandoned mine shafts in Sutherland goldfield, South Africa

Keywords: Artisanal Gold Mining; Abandoned Mine Shafts; Sutherland Goldfield; South Africa.

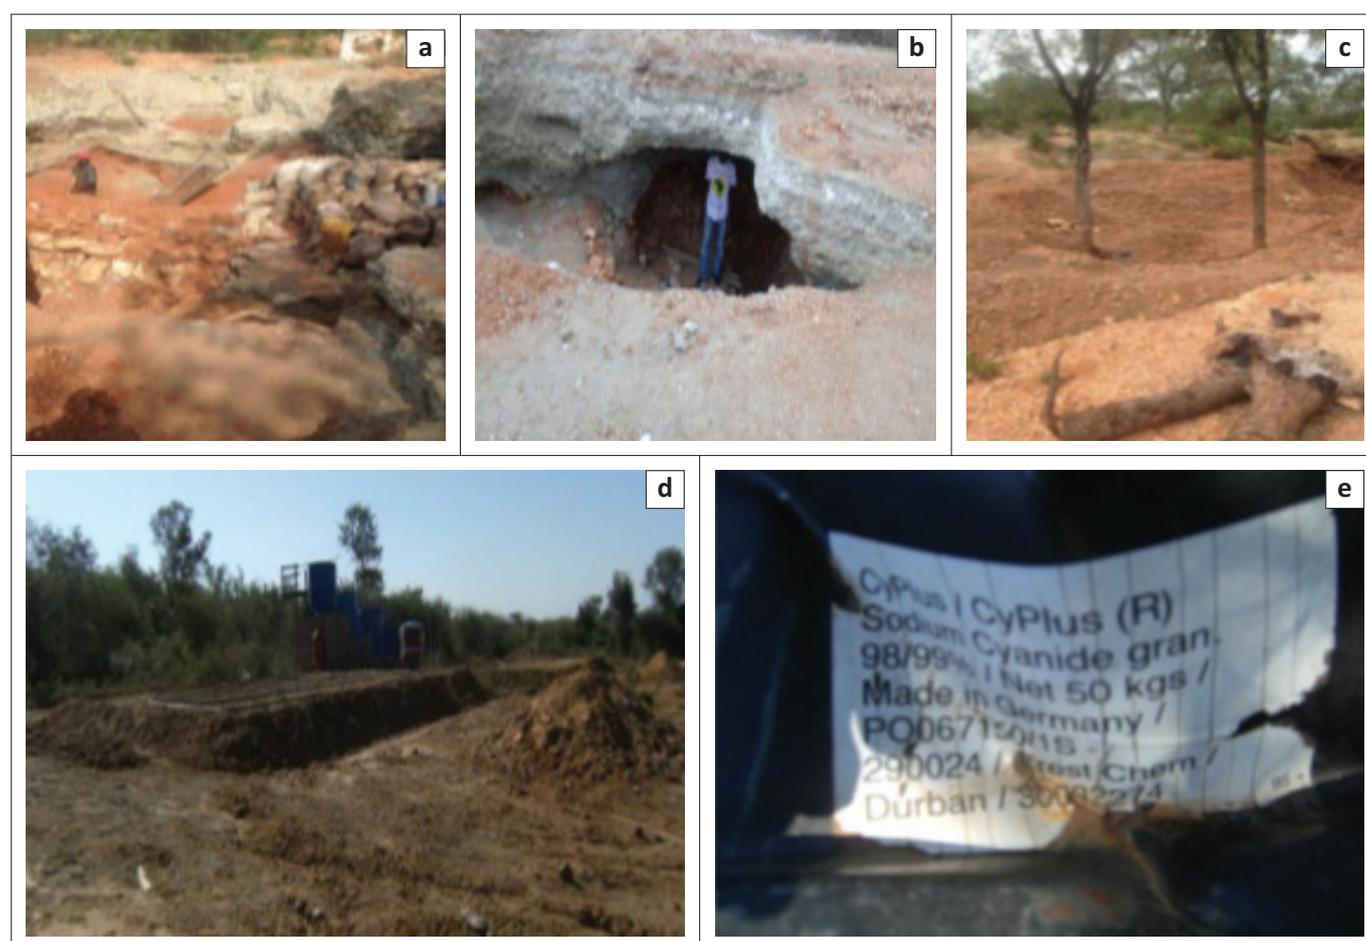
Artisanal gold mining in the Sutherland goldfield involves digging and collection of gold-bearing fine sediments from historic or abandoned mine sites. In the collection of sediments, the artisanal miners target abandoned mining sites, especially the abandoned shafts, mineral processing areas and dilapidated buildings. They dig shallow pits below the foundations of abandoned concrete structures, including the shaft collars. The excavated material is sieved in shallow pits (as shown in Figure 2a) to ensure that only sand-size material is collected, whilst gravel and boulders are dumped outside the pits as waste. In some cases, excavations that are approximately 2 m deep have taken a form of underground adits at about 3 m below the surface (see Figure 2b). This puts in risk the lives of both the miners and children who mostly play around the operation site as their parents and/or guardians are involved in excavation and material collection activities. Dangerous diggings were also identified under

FIGURE 2: Artisanal mining at the Sutherland goldfield: (a) Fine gravel digging operations, (b) hazardous excavation at Louis Moore Mine, (c) the impact of excavations on trees around New Union Mine, (d) an abandoned cyanide heap leaching setup (e) and an empty container of the leaching chemical used.

sealed shaft collars and below high structures, such as silos and tall walls of abandoned buildings. These have contributed significantly to the instability of the shafts sealing structures as well as the dilapidated buildings and mineral processing plant infrastructure (those are silos and concrete mounting structures).

The diggings have affected the vegetation growth in the areas where artisanal gold mining happens around the abandoned mine sites. This is because of the fact that the operation of sediments collection has led to cutting and uprooting of trees that have over the years grown in the abandoned mine sites (see Figure 2c).

In addition, the artisanal miners at New Union Mine attempted extracting gold from the mine tailings using cyanide heap leaching method. In this method, the tailings material was piled up to 0.5 m onto the impermeable floor (cemented floor). The stacked material, shown in Figure 2d, was then sprayed with sodium cyanide solution. As the processing solution (cyanide solution) percolates into the heaped tailing material, it liberates and mobilises the remnants of gold into the solution to form an impregnated solution. The solution containing gold was being collected through cemented (impermeable) solution channels into solution tanks buried in the ground.

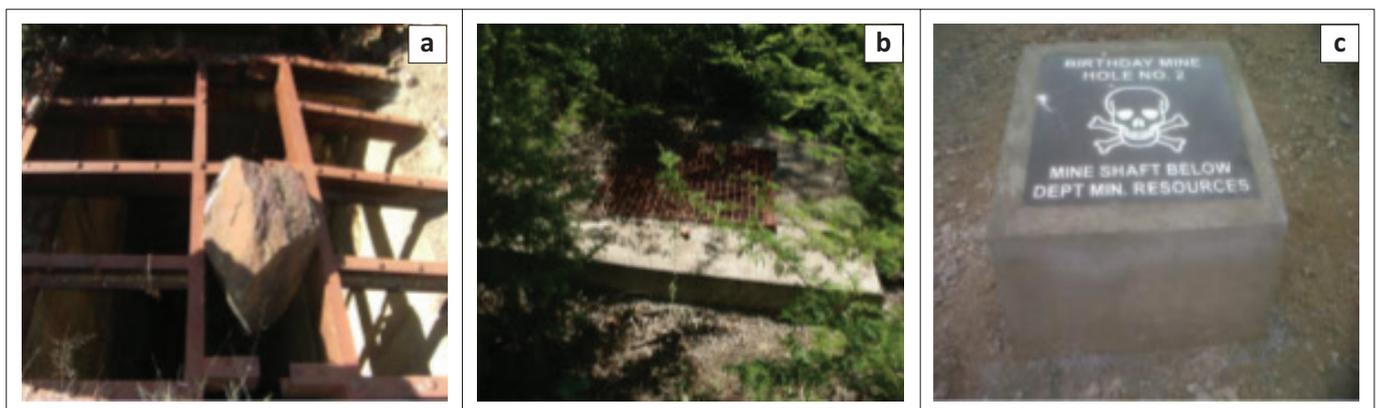
There are three shaft closing strategies that were used in addressing the safety concerns of abandoned shafts in the Sutherland goldfield. The main focus of shaft closing operations in the area was to reduce or eliminate the physical hazards associated with the abandoned mine shafts. The strategy employed earlier in closing open shafts was placing a steel grate (see Figure 3a) on the shaft in order to prevent both human and animals from falling into the shafts. All the mine shafts that were previously closed but now opened at New Union Mine were closed using this mine shaft closing technique. There was no evidence of the use of steel grate closure in other mines. In general, the steel grate mine closing structure had a disadvantage of being easily removed by artisanal or illegal miners who wanted to gain access to underground workings with the purpose of mining the remnants of the deposit. Moreover, the steel used to build this shaft closing structures attracted the members of the community to destroy the structure, thus leaving the shafts open again.

The second shaft closing approach involved completely and/or partial sealing of the shaft with reinforced concrete applied concurrently with steel grate, and in some cases it was applied with steel wire screen closure (see Figure 3b). Shafts closed in this manner were easily opened by artisanal miners by simply removing the steel wire screen or destroying the concrete structure. In some cases, artisanal miners mined the material below the concrete shaft collars, thus removing the foundation of the shaft closing structure and that of the entire shaft collar. The evidence of the use of this shaft closing strategy was identified in four of the studied abandoned mine sites, namely, Louis Moore, Franke, Birthday and Klain Letaba.

The currently implemented strategy involves the installation of a massive concrete plug at about 3 m – 10 m below the surface of the earth. According to the Department of Mineral Resources (2010), the concrete plugs do not contain any metallic reinforcing materials that may attract community members to destroy the plugs in search of these materials. The plugs are completely buried under the ground, with

FIGURE 3: Shaft-closing structures at Sutherland goldfield: (a) heavy steel grate, (b) steel wire screen and concrete and (c) concrete plugs with landmark.

only about 2.5 tonnes of concrete landmark being exposed on the surface (see Figure 3c). In all mine shafts where the concrete plug closing approach was used, they have not been affected by artisanal mining operations. However, cases of theft of granite slabs placed on landmarks were reported. This shaft closure option has so far been only used in closing mine shafts at Birthday Mine. Table 1 presents the summary of the current state of all the identified mine shafts around the abandoned mine sites in the Sutherland goldfield.

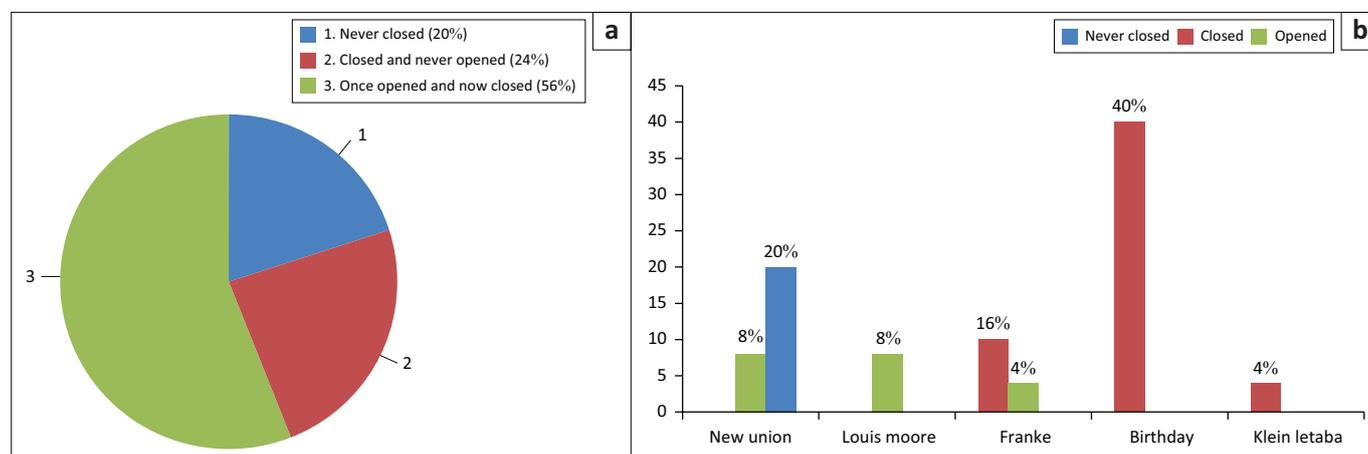
FIGURE 4: (a) The impact of artisanal mining on the rehabilitation efforts of abandoned mine shafts and (b) state of mine shafts in the five abandoned mines in the Sutherland goldfield.

worth mentioning that although the mine shafts at Birthday Mine were found closed (see Figure 4b), several inappropriate strategies were used to close these shafts before, but all failed. The evidence of destruction of the shafts closing structures was identified in all the studied abandoned mine sites except Klein Letaba Mine.
