Impact of retrofitting work on vulnerability reduction of local buildings in Kabul, Afghanistan

Keywords: retrofitting; non-engineered buildings; training; local masons; Kabul; damage ratio; behaviour modifier factor; vulnerability index.

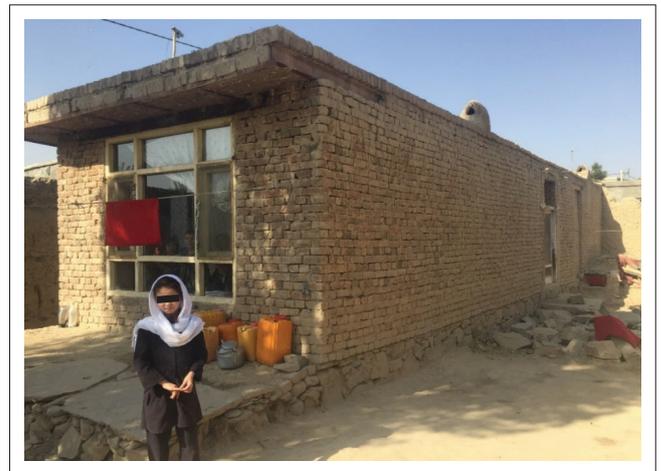
This type of building is generally constructed with one or two storeys. As shown in Figure 3, the structure consists of load-bearing walls constructed using burnt bricks and cement mortar. The thickness of the load-bearing wall can range from 20 cm to 35 cm. In this typology, the ceiling is covered by placing IPE140 beams at approximately 1 m

intervals and filling the distance between them with burnt bricks and gypsum paste. In order to ensure lateral stability of the ceiling, each panel is constructed with a maximum deflection of 2 cm. However, owing to the concave shape of the panels, the plaster thickness from below the ceiling has to be increased in deep parts, which makes the structure heavy because it is a vaulted brick ceiling. In addition, this type of ceiling construction is vulnerable to lateral seismic loads and can easily collapse.

FIGURE 3: A single-storey burnt brick masonry house with a flat roof.

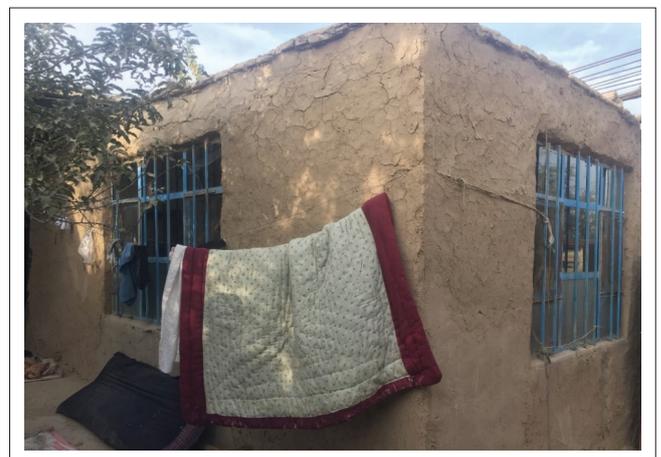
Figure 4 illustrates a sample of sun-dried brick masonry buildings in which the structural system also includes load-bearing walls, but they are constructed using sun-dried clay bricks. In this type of building, the wall thickness is at least 40 cm and, in some cases, it increases to 80 cm. The ceiling is often covered with wooden joists 10 cm – 15 cm in diameter, placed at 50-cm intervals and then covered with a 2 cm – 3 cm thick wooden plate and a 20 cm – 30 cm thick cob for waterproofing. However, this makes the ceiling very heavy. Sometimes, the cob is also used for the wall plaster. In some cases, a basement floor is also constructed in these buildings, which makes them even more vulnerable to lateral seismic loads.

FIGURE 4: A single-storey mud brick masonry house with a flat roof.

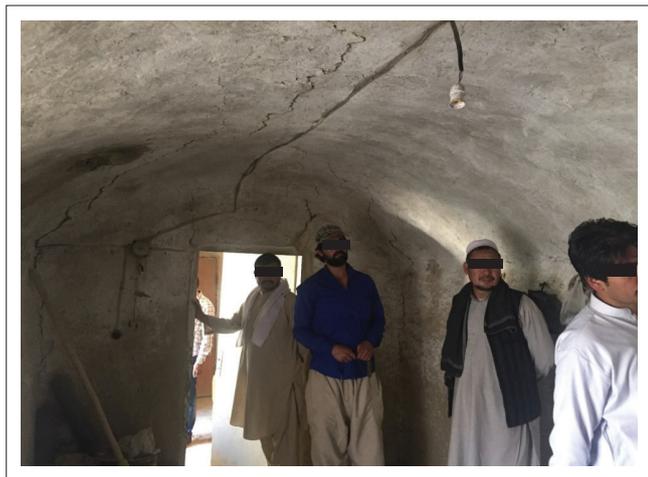
FIGURE 5: A single-storey mud brick masonry house with a barrel-shaped roof.

This type of building also utilises load-bearing walls with a thickness of 40cm – 80cm and are made of sun-dried clay brick. However, the ceiling cover consists of sun-dried bricks and is barrel- or dome-shaped. Figure 5 shows an example with a barrel roof, which has some horizontal and diagonal cracks. These buildings also have weak resistance to lateral loads and can easily collapse.

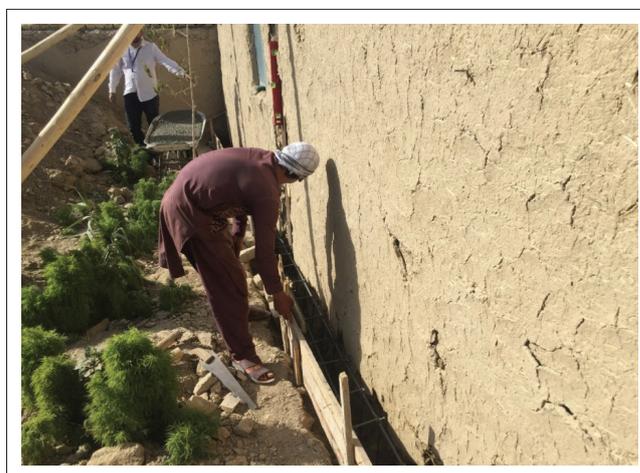
For masonry houses without any foundation, an RCC ring (60 cm × 50 cm beams) was tied around the structure near the bottom on the outer side of the walls to ensure the house's stability during an earthquake, as shown in Figure 6. For this task, masons excavated and levelled the area around the house, constructed a 1 cm – 2 cm layer of plain cement concrete (PCC), added steel bars reinforcements, performed shuttering and then prepared concrete. The excavation of the foundation ring was carried out carefully until an appropriate levelled surface was achieved. In special cases, to ensure stability of the existing walls, additional wooden or steel supports were considered.

The 28-day cylinder strength of the concrete for this element was 250 kg/cm². The mix design included 2 parts gravel, 2 parts sand, 0.5 part cement and 1 part water. During the actual work, for one bag of cement, at least 30 L of water was considered. The water used for the concrete was clean, without any additional materials. After finishing the concrete work, it was kept wet for 14 days post implementation.

The reinforcement used for this purpose contained six D10 ribbed steel bars at the top and bottom with D8 stirrups at each 25 cm interval. In addition to horizontal bars and stirrups, the RCC ring needed to be attached to the existing wall. For this purpose, three L-shaped D10 additional bars (30 cm length) at 25 cm intervals were applied. The steel bars

FIGURE 6: Implementing an additional RCC foundation ring.

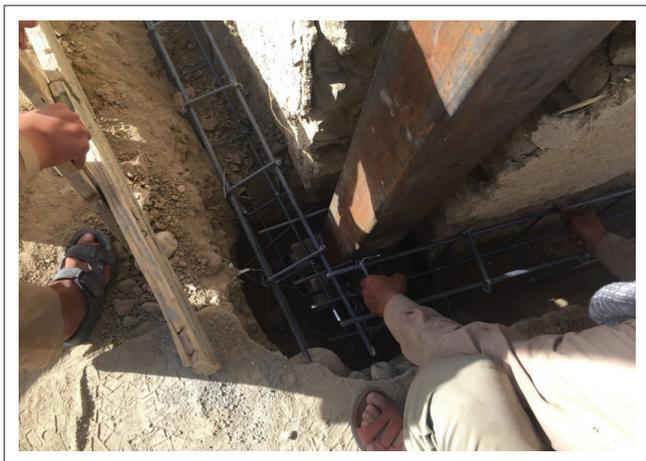
FIGURE 7: Placing vertical tie inside the foundation ring.

the existing roof was in good condition, horizontal ties were installed inside the house under the existing roof. In such cases, an appropriate connection between existing joists and new horizontal ties was considered. In addition, vertical ties adhered to the existing wall with a D8 steel strap at 75 cm intervals. These straps were threaded on both sides and tightened through nuts and bolts with a steel plate on the other side of the wall. In cases where access to the other side of the wall was impossible (i.e. because of a neighbouring house), the straps were inserted inside the wall and any empty space was filled with grout. In order to make an appropriate connection and to complete the load path between the vertical tie and the RCC foundation, additional steel bars were welded at the bottom of the vertical tie where it was connected to the foundation.

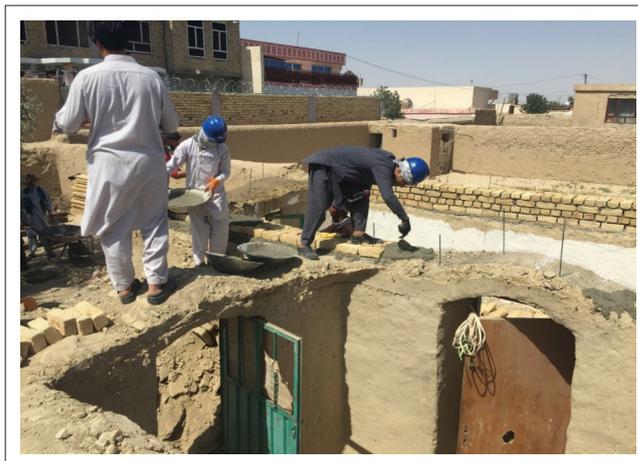
After demolishing the roof and before applying the horizontal ties, some additional brick works on the top of the existing wall were performed, and a steel bar and a mesh were used to properly connect the RCC ring to the existing wall, as shown in Figure 8. To ensure good connection, additional 2 m long D12 steel bars were applied at 50 cm intervals. The lengths of these steel bars were reduced for the top of the openings. A drilling machine was used to measure the wall thickness before implementing these straps. The horizontal tie for this purpose was 30 cm in height and its width was equal to the wall thickness. There were four D10 horizontal steel bars, and D8 stirrups were placed at 25 cm intervals.

FIGURE 8: Additional brick works on the top of the existing wall and making connection using steel bars.

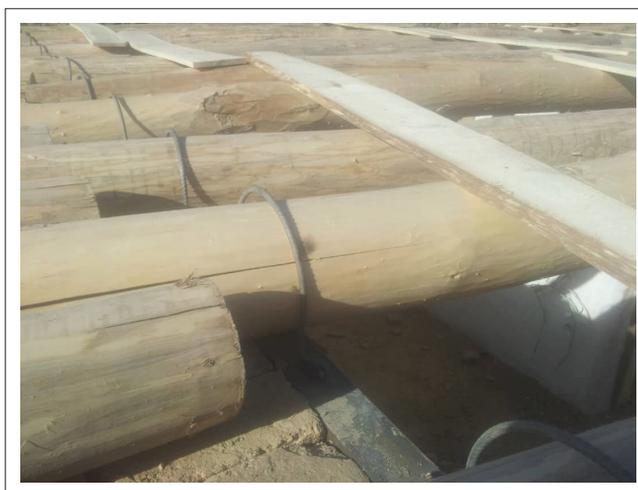
FIGURE 9: New roof cover and its connection with horizontal ties.

cases, steel profile ST37 IPE or UPE140 was applied. The connection between the new steel joist and steel horizontal tie was welded together through a $L100 \times 100 \times 10$ angle. In cases where the horizontal tie was RCC, new steel joists were placed inside the RCC horizontal tie reinforcement before concrete in order to provide a connection between these elements. In addition, the distance between the stirrups around the connection point of the steel joist to the RCC horizontal tie was reduced to 10 cm at a length of 50 cm. Wooden joists used for the ceiling cover were 15 cm in diameter, straight and without any visible cracks. Good connection between the wooden joist and the steel horizontal tie, as shown in Figure 9, was ensured through the use of U-shaped D8 steel bars placed on the wooden joists and welded to the horizontal tie. To prevent termites, both sides of the wooden joists were covered with a layer of bitumen before installation.

X bracing with a D12 steel bar on the top of wooden joists was implemented to ensure its resistance and integrity to lateral loads. These steel bar bracings were tightened at both ends of the frame. Implementing a small trench on the wooden joist where the X bracing steel bar passes make the

wooden plate installation easy. The steel bar was fastened to a wooden joist using dowels. A new wooden plate (2.5 cm thick) was used on top of the wooden joists together with a plastic sheet and 8 cm RCC on top of it. To prevent moisture in the ceiling, an isogam cover on the surface of the concrete roof was applied after 14 days.

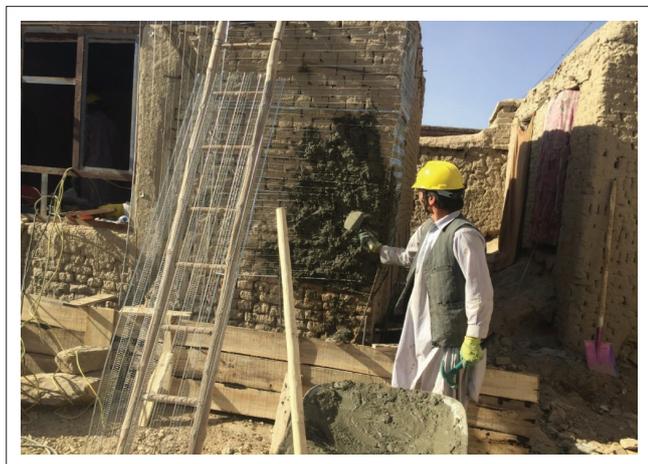
To overcome this deficiency, a layer of steel wire mesh (1 mm – 2 mm diameter) and plaster was used on the wall surface (as indicated in Figure 10). Firstly, it was necessary to remove the existing plaster on the wall. In addition, small 1 m trenches at 45° were made in the corners of the openings. Inside each trench, two 1 m long D8 steel bars were placed and fixed to the wall with dowels. Similarly, 2 m long trenches (1 m at each side) on the outside corner of the walls were made at 60 cm intervals. Inside each of these trenches, two 2 m long D8 steel bars (1 m on each side) were inserted and fixed to the wall with dowels. The surface of the wall was wettened with water in order to prevent water absorption from the plaster. The wire mesh was installed on the wall surface using L-shaped dowels made from 30 cm long D6 steel bars at 50 cm intervals. Finally, a 3-cm thick cement plaster (consisting of one part cement, four parts sand and water) was applied on the wall surface.

FIGURE 10: Wall mesh and plaster.

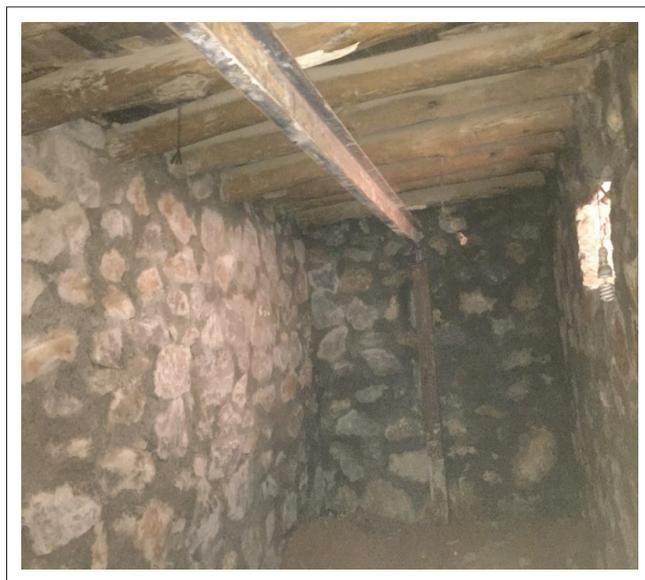
wall with cement mortar was added as support and buttress of the basement wall, as shown in Figure 11. Additionally, boxed 140 × 140 columns were also used for this purpose and the beam profile was UNP160 and IPE160.

FIGURE 11: Additional stone masonry for basement improvement.

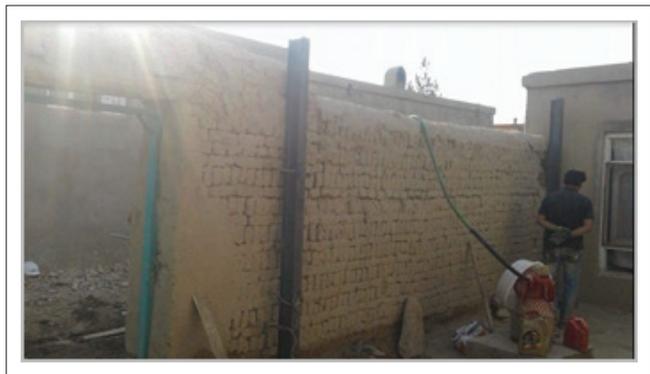
FIGURE 12: Installing buttress for surrounding wall.

indicated in Figure 12) was considered. These IPE140 ties were installed at 5 m intervals behind the existing boundary walls and in an 50 cm × 50 cm RCC foundation located at a depth of 40 cm. For a good connection between the steel column and concrete in the foundation, additional steel bars were welded at the bottom of the column. In addition, the vertical ties were adhered to the wall using steel straps at 50 cm intervals.

To ensure the overall stability of the wall, two diagonal D8 or D10 bars between the columns (vertical ties) and a horizontal D8 or D10 bar placed near the top of the wall were attached at 1 m intervals using straps. This included: creating T-sections with the bars on the earth, making holes in the wall thickness across the diagonals and horizontal bars, bending the bar on the main diagonal or horizontal bar and providing a connection with them using small welds or proper steel ties.

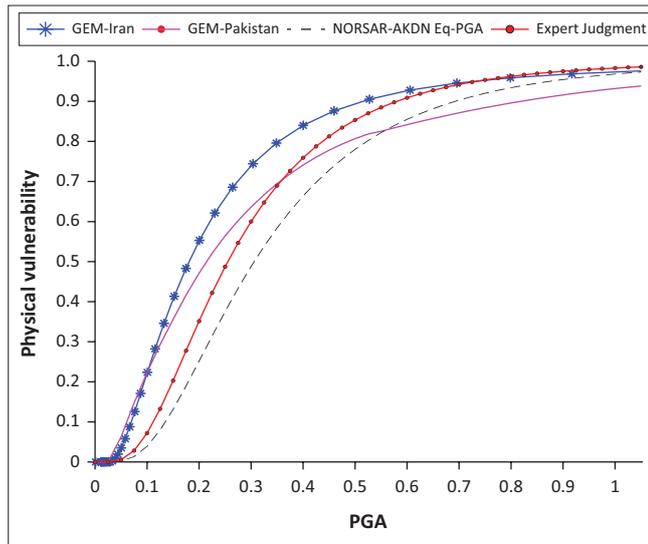
FIGURE 13: Comparison of developed vulnerability function for adobe structures.

Afghanistan office in 2019. Figure 13 shows the vulnerability curve for adobe buildings, which were derived via numerical analysis and site visits of mud brick adobe houses in districts 13 and 16 of Kabul City, and it has been compared with similar previous related works conducted by the Global Earthquake Model (GEM) Iran, GEM Pakistan and Norsar Akha Khan foundation. According to the developed vulnerability curves, existing adobe buildings in Kabul City will experience 60% damage at 0.3 g PGA and more than 90% damage at a PGA of 0.6 g and higher. The vulnerability function in Figure 13 was developed with a vulnerability index of 0.817 for sun-dried clay brick adobe buildings in Afghanistan. It is also remarkable that vulnerability functions for building typologies in Afghanistan have been developed using central damage factor values based on the HAZUS methodology with the incorporation of values suggested by EMS-98 (Ashtiany et al. 2019).

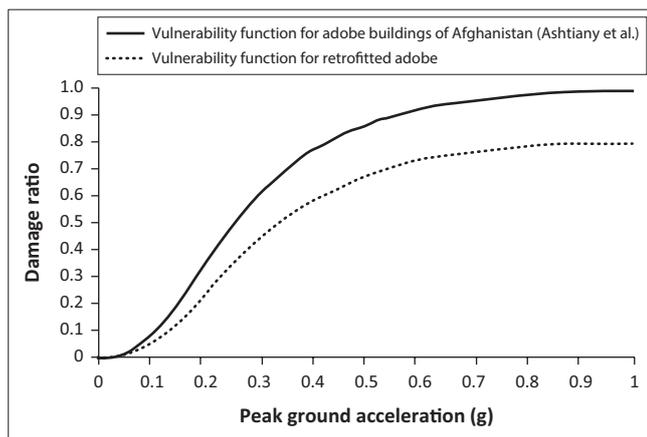
FIGURE 14: Effect of retrofitting on vulnerability reduction.

The overall score for retrofitting intervention in the PCR for the case of Kabul City was estimated at -0.0566. This score, which represents the behaviour modifier factor in retrofitted buildings, changes the vulnerability index from 0.817 in the

original vulnerability function of adobe buildings by Ashtiany et al. (2019) to 0.761. Accordingly, a vulnerability curve for retrofitted buildings has been developed. Figure 14 shows a comparison of the vulnerability curves for sun-dried clay brick adobe buildings before and after retrofitting. According to the figure, the damage ratio of adobe buildings has been reduced by 15%, at PGA 0.3 g and maximum 20% for higher ground motion. This level of damage reduction will give residents enough time to evacuate and save their lives in the event of an earthquake.

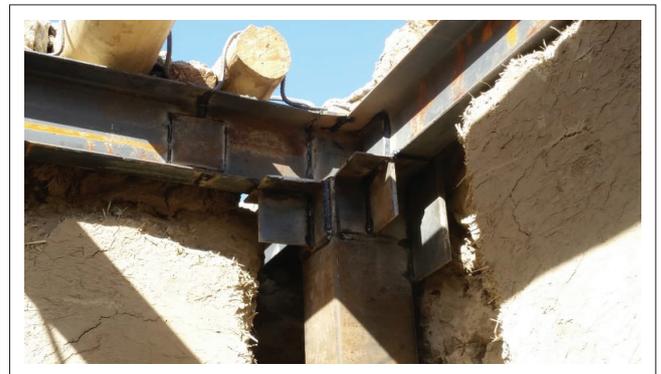
FIGURE 15: Splice in beam.

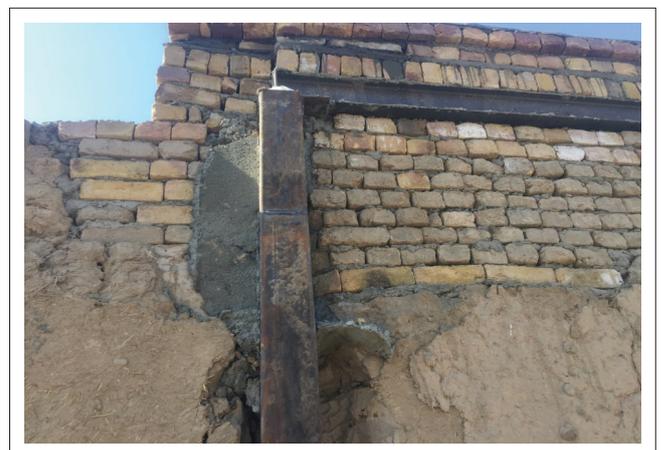
FIGURE 16: Splice in column.
