# Mechanistic modelling of weak interlayers in flexible and semi-flexible road pavements: Part 2

M de Beer, J W Maina, F Netterberg

This paper (Part 2 of a two-part set of papers) discusses models and illustrates the adverse effects of weak layers, interlayers, laminations and/or weak interfaces in flexible and semi-flexible pavements, also incorporating lightly cemented layers. The modelling is based on mechanistic analyses for pavement design and evaluation. In Part 1, the effects of these relatively weak layers, interlayers, laminations and/or weak interfaces were discussed. It was shown that methodologies are available to detect and investigate the existence of these weak layers in cemented pavement layers. In Part 2, several cases of the above conditions for different road pavement types are discussed, with field examples. Mechanistic analyses were done on a typical hot mix asphalt (HMA), several cases of a cemented base pavement and a granular base pavement, with and without these weak layers and interface conditions to demonstrate their adverse effects. The analyses focus on the strain energy of distortion (SED) as a pavement response parameter to indicate the potential fo

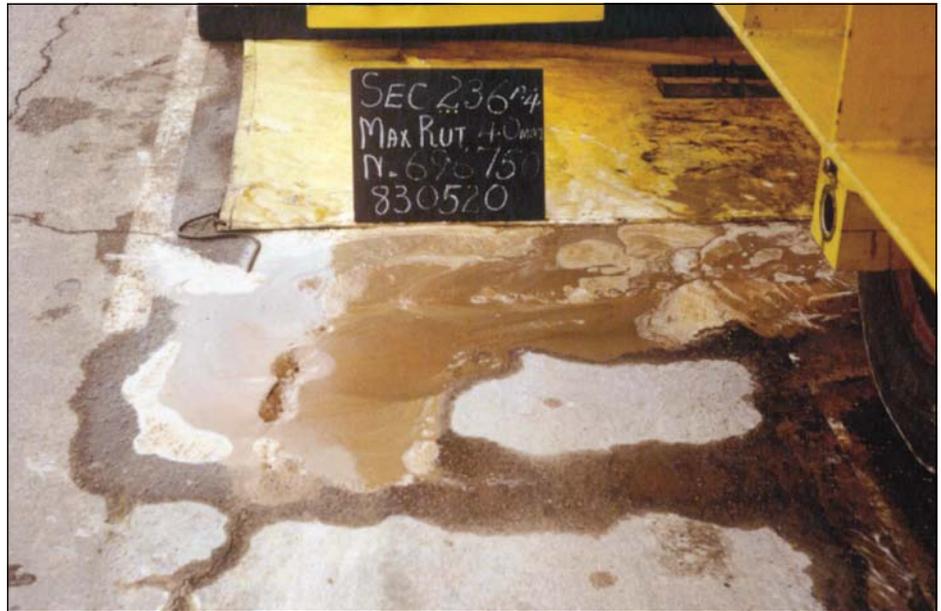
**Photo 16** Fine material pumping from HVS test from Road P30 at Hornsnek in 1985 (Opperman 1984)

Opperman (1984) and later Kleyn *et al* (1985) discussed the structural performance of a strongly cemented gravel base and subbase pavement (Road P30) at Hornsnek, outside of Pretoria. This pavement started pumping after six years in service, and an investigation in 1984 showed the presence of a weak interlayer, unbound and probably a result of poor construction according to Opperman (1984), and not a case of carbonation (for a definition of “deleterious” carbonation in cemented road layers, see Part 1). Photo 1 (see Part 1) indicates the pumping under normal trafficking at that time. In this case, there was a weak interlayer with a thickness of between 25 and 80 mm between the cemented base and subbase, 105 mm to 215 mm from the surface. Owing to its thickness, this weak interlayer was also identifiable with the dynamic cone penetrometer (DCP). During HVS testing in the wet state, severe pumping of fines occurred on the pavement surface from this weaker interlayer, as shown in Photo 16. The cemented base also “collapsed” on the cemented subbase after the weaker interlayer had been “removed” by pumping (Kleyn *et al* 1985, Figure 6). This created a “deeper” pavement structure, demonstrating a “re-balancing” of the pavement under the action of traffic loading, especially in the wetter state. However, this took place at the cost of a rougher pavement surface (maximum deformation > 20 mm within 750 000 standard 40 kN load repetitions in the wet state)

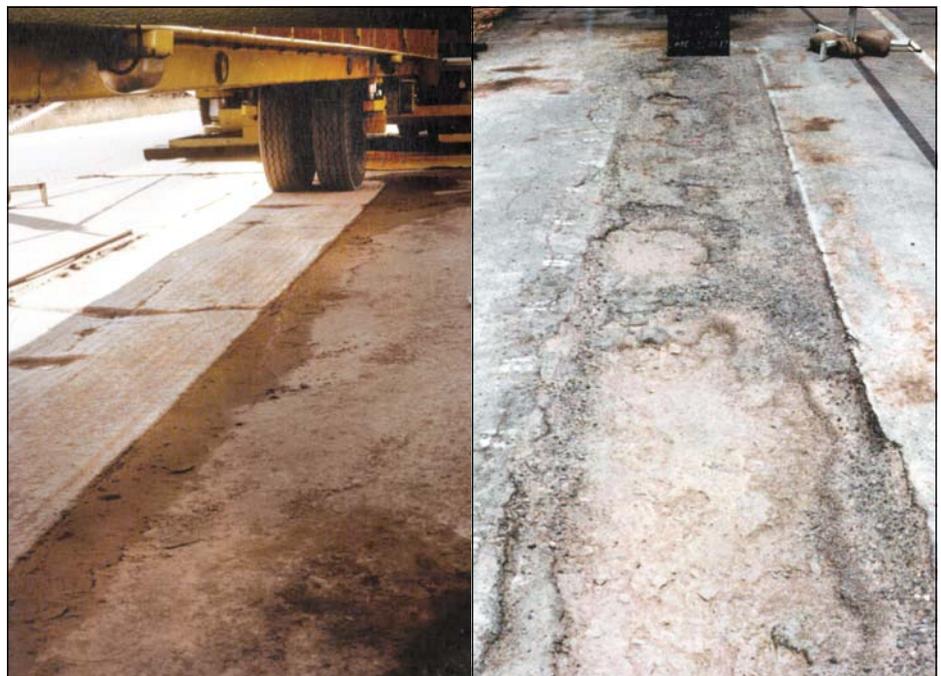
**Photo 17** Failed HVS test section of a cemented base pavement (with 25 mm weak layer at bottom of 80 mm cemented base) after wet test at Hornsnek, Road P30, in 1985 (Opperman 1984)

(Opperman 1984, Figure 8) with an associated lower functional riding quality as shown in Photo 17. *This situation could have been avoided if the weaker layer had not been present in the initial construction of this pavement.*

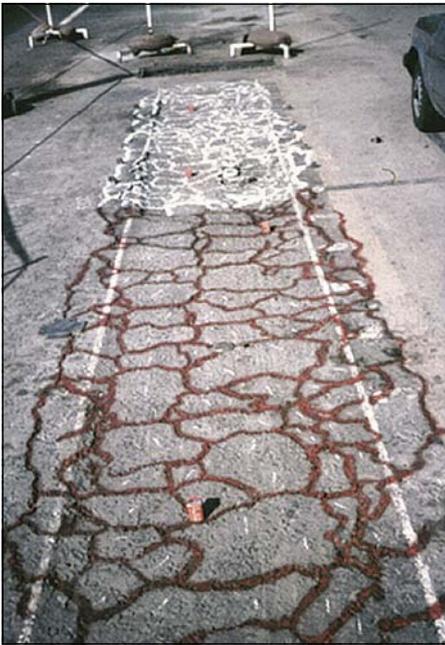
**Photo 18** Crack pattern on recycled asphalt base layer on Van Reenen's Pass during HVS testing in 1985 (De Beer 1985)

relatively weak and fully carbonated. This particular layer was constructed during snowfalls in 1981, which hampered the construction control on site. This caused a “sandwiched” type of pavement structure, in which this weaker layer dominated the structural fatigue failure of the rather stiff recycled asphalt base of this pavement, even in the dry state (see Photos 18 and 19). Again, this illustrates the adverse effect of a weak layer within the upper supporting pavement layers. In another study De Beer (1985) showed the effect of erosion in the wet state of a cemented Berea Red Sand upper subbase underneath an asphalt base. In this case, a weak layer was created outside the wheel path, between the upper subbase and the asphalt base. In order to avoid

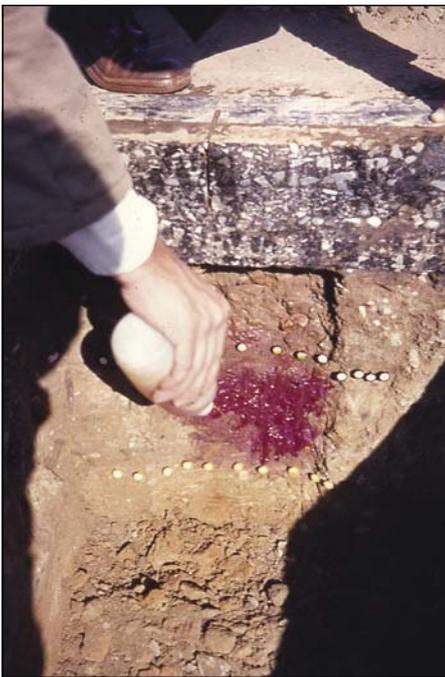
**Photo 19** Fully carbonated and relatively weak upper cementitious subbase layer directly underneath the recycled asphalt base layer, resulting in a "sandwich" structure of a weak upper subbase on the N3 at Van Reenen's Pass (De Beer 1985)

this condition, an erosion test device and associated erodibility criteria were proposed for material design in the laboratory *before* construction (De Beer & Visser 1989).

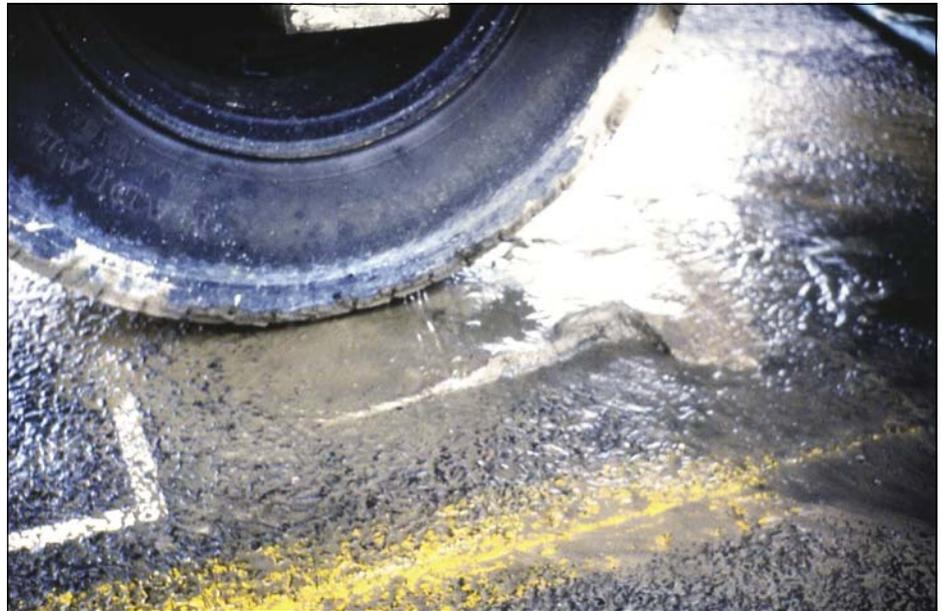
**Photo 20** Pumping of fines during HVS testing from a strongly cemented (C2) base pavement (Road MR27) (Rust 1987; Jordaan 1988)

Stellenbosch and Somerset West, Jordaan (1988) found that weak interlayers developed within the cemented base after traffic loading with the HVS, and also found a second weak interlayer just beneath the surfacing. In addition, crack activity measurements by Rust (1987) complemented the analysis of the traffic-associated failure of this pavement. Photo 20 indicates severe pumping during the HVS test on this road section in the wet condition. In addition, the adverse effect of moisture in the upper layers (i.e. wet state) was also demonstrated here, in that the bearing capacity of this pavement was reduced from 8 million standard axles in the dry state to a mere 1,6 million standard axles in the wet state (Rust 1987). *This is another illustration of the combined action of traffic loading and moisture on these pavements, with reported evidence of weak interlayers.*

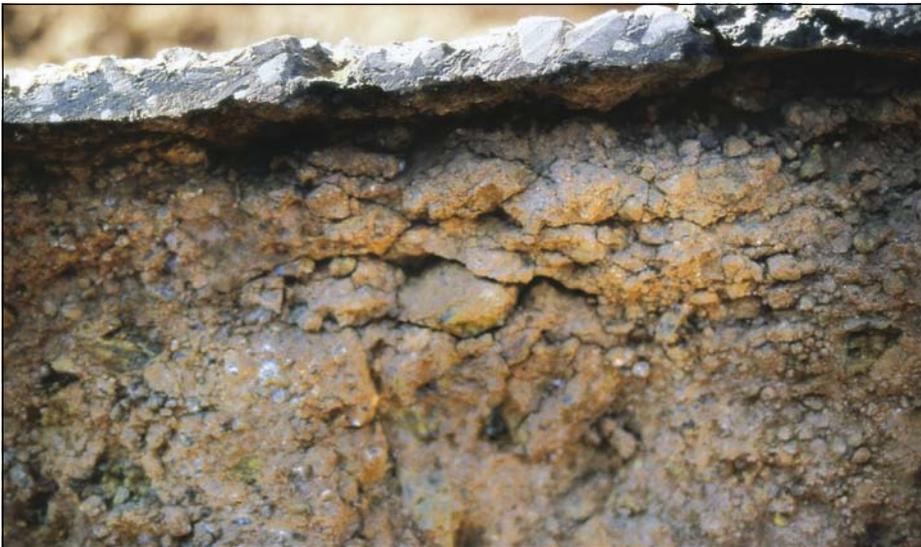
**Photo 21** Crushing (dry condition) of a lightly cemented base layer as a direct result of HVS trafficking (De Beer 1990)

For example, Figure 2 indicates that about one pass of a tyre resulting in an average vertical contact stress of  $\sigma_t = 1\,000$  kPa on a cemented base layer would immediately initiate the crushing mode of failure ( $N_{c_i}$ ) of the upper base (~ 50 to 75 mm) with a similar *in situ*  $UCS_{50}$  strength. Further, a  $UCS_{50}$  of about 3 MPa would be needed for 1 million contact stress repetitions before initiation of crushing failure in the upper 50 to 75 mm. The crushing (or compression) failure, even in the dry state, of a cemented base layer, as was observed under HVS testing, is illustrated in Photos 21, 22 and 23. The existing C3 base strength

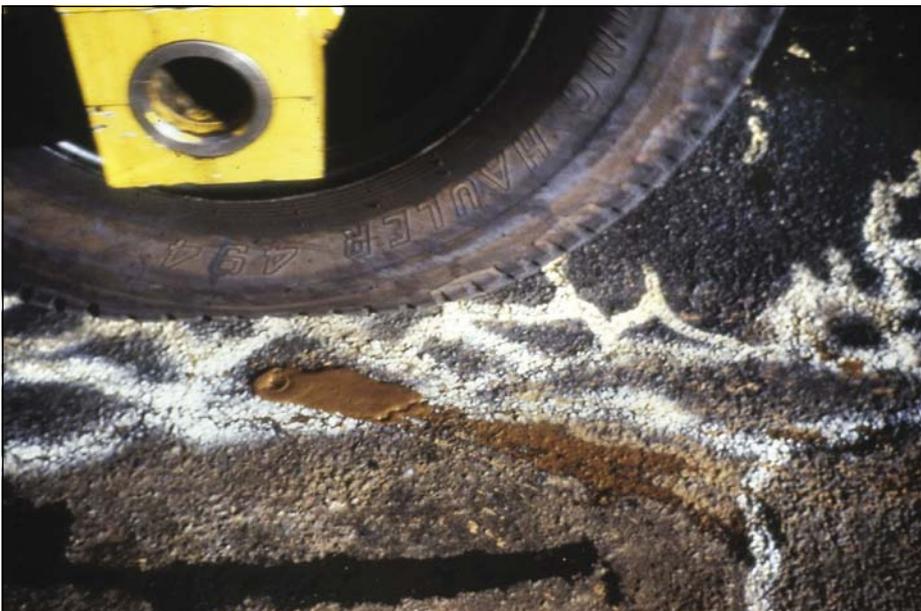
**Photo 22** Signs of pumping from the cementitious base layer during a wet HVS test, after crushing in the dry state (De Beer 1990)

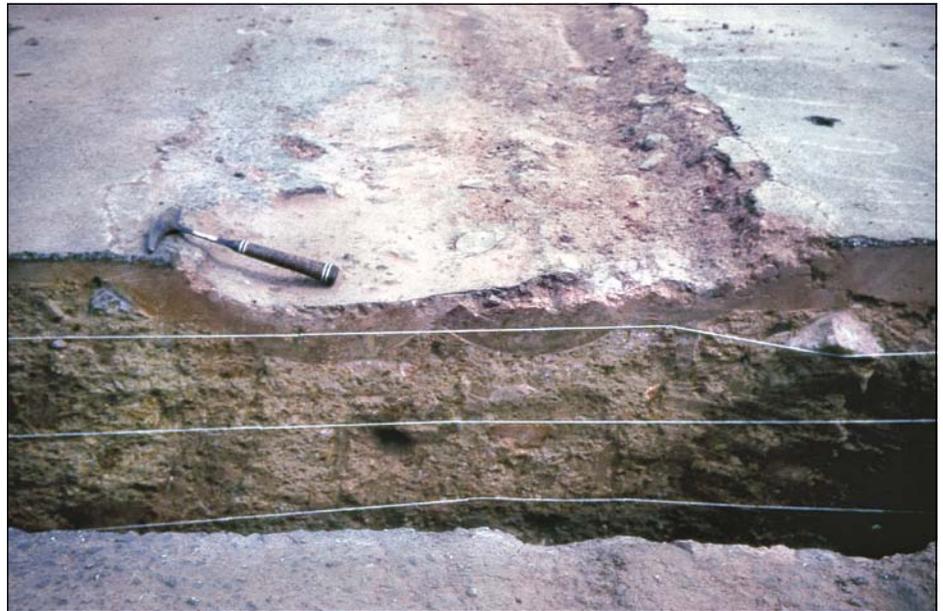
**Photo 23** Final state of the lightly cemented base layer after HVS testing and crushing, in the wet state (De Beer 1990). Note the amount of material lost from the wheel path in centre of photo

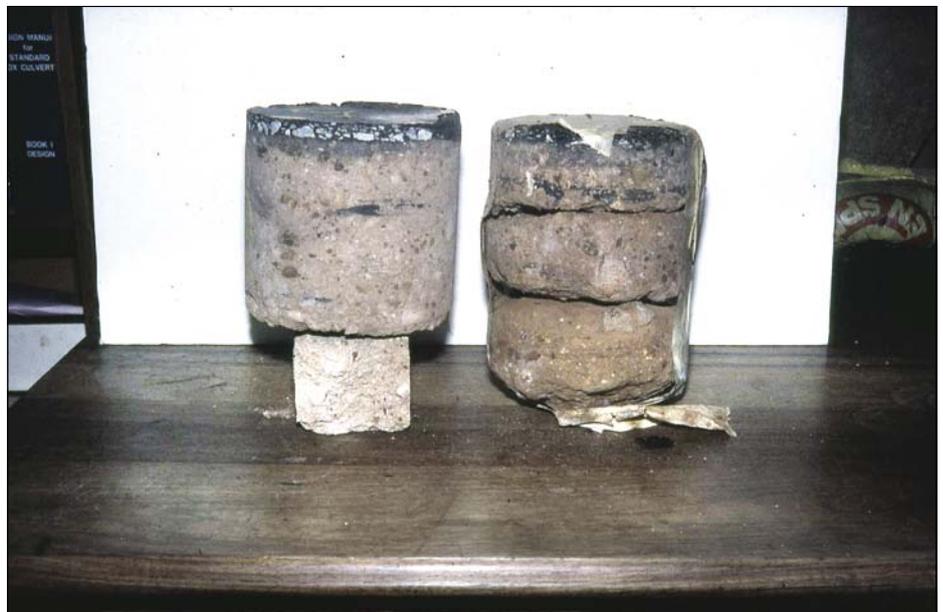
**Photo 24** Field cores from lightly cemented base layer – left core: solid; right core: weak interlayers

unfavourable condition should be avoided at all times, as it is postulated that it will lead directly to premature fatigue failure in the top part of the cemented base pavement. It is probably also associated with the crushing failure of the top  $\sim 50$  mm (discussed above) and hence with potholing in wet conditions. See Photos 3, 5, 6, 9, 11 and 15 in Part 1, and 21, 23, 24 and 25 in this paper (Part 2).

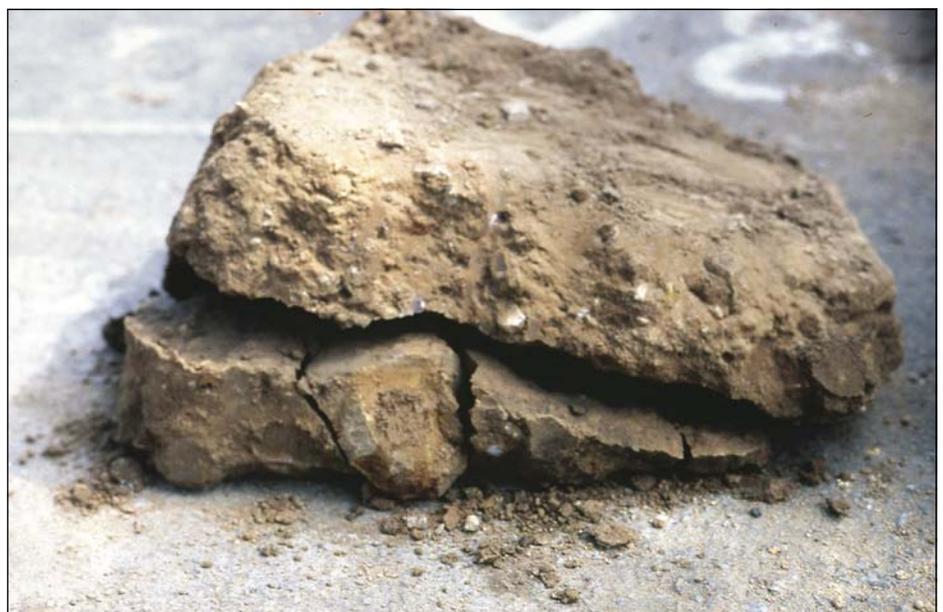
**Photo 25** Signs of delamination (possible construction plane) in a lightly cemented layer (De Beer 1990)

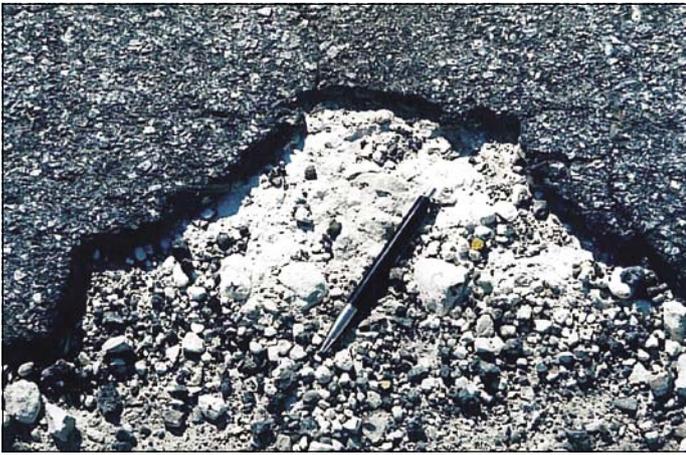
**Photo 26** Typical signs of crushing failure in a pothole in a cementitious base pavement

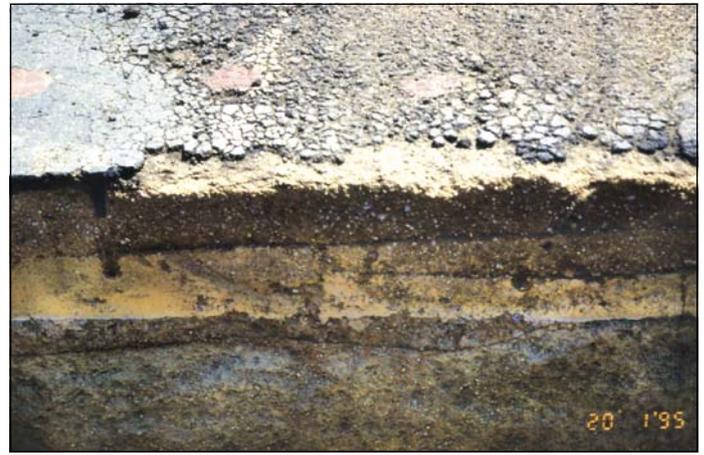
**Photo 27** Crushing failure of the top of a lightly cemented base layer – final state of the lightly cemented base layer after some HVS testing
