Coastal defences on the KwaZulu-Natal coast of South Africa: a review with particular reference to geotextiles

S Corbella, D D Stretch

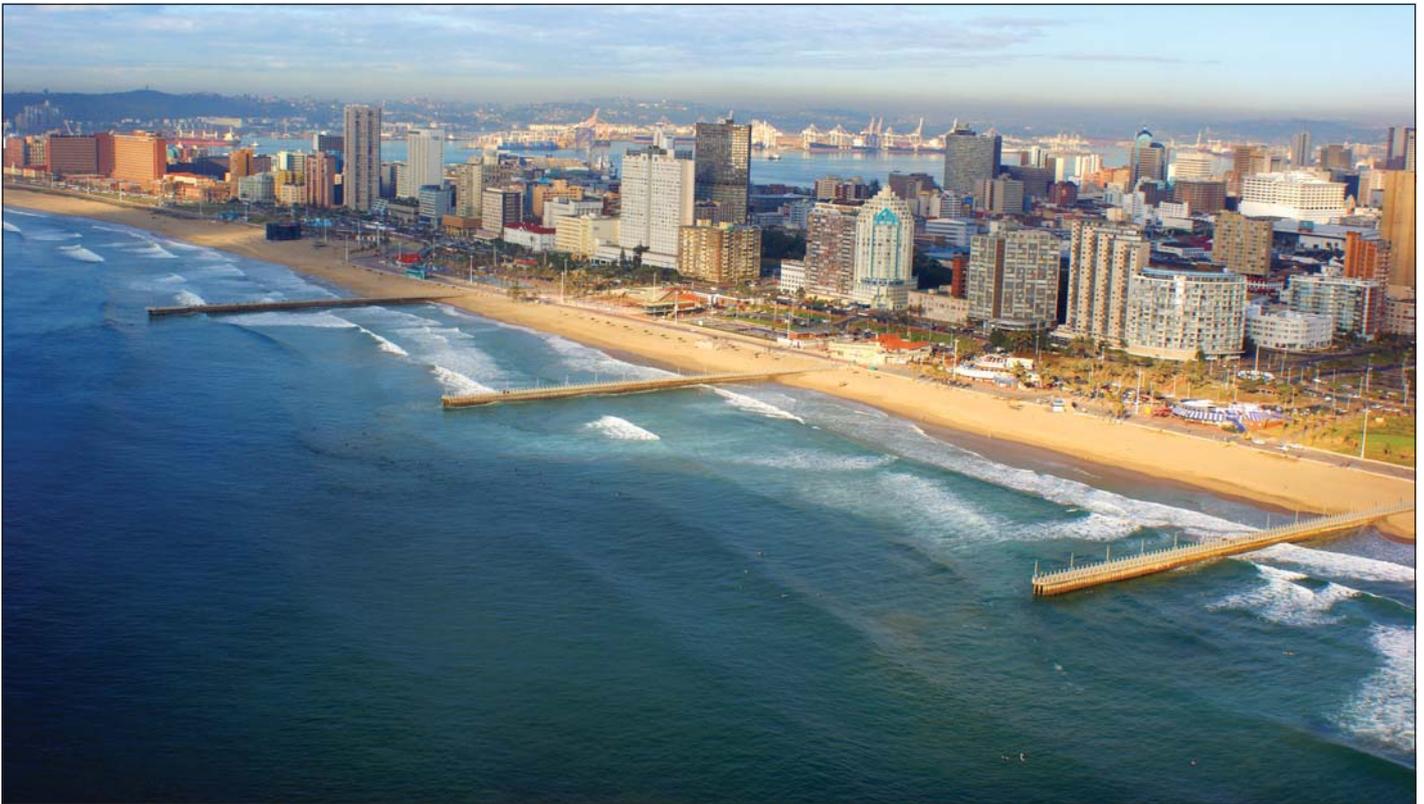
Figure 2 Photograph looking south-west across the main Durban beachfront showing the Bay of Plenty, North Beach and Dairy Beach Piers, from closest to furthest.

The long-standing sediment supply problem was eventually solved by the sand bypass scheme, completed in 1982, and the new groynes were completed in 1985. These groynes, called the Bay of Plenty and North Beach Piers (Figure 2), replaced the Paterson Groynes. In 1989 a third groyne, the Dairy Beach Pier (Figure 2), was constructed (Mather *et al* 2003). The sand bypass scheme

Durban's groyne field was constructed between 1985 and 1989 (Figure 2). This groyne field, in conjunction with the sand bypass scheme, has been successfully maintaining a stable beach over their existence. The groynes are semi-permeable rock groynes, making the beach width dependent on the rock elevation. The rock levels are monitored annually by the eThekweni Municipality and were adjusted to their design levels in 2009 with a combination of rock and geotextile sand bags.

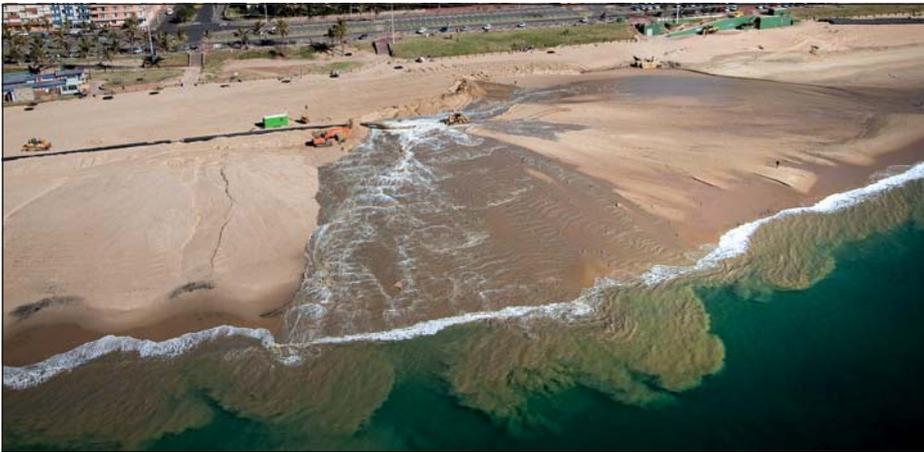
Figure 3 Beach nourishment at Addington Beach (Photo: Dredging International, June 2009)

A 900 mm diameter pipe was laid 1.4 km from the north breakwater of the harbour to Addington beach (Figure 3). An offshore borrow site that had previously been used to reclaim Berths D to G within the harbour was used. The site was surveyed and sediments sampled to ensure that the grading was suitable. Sediment grading is important, as fines produce plumes and increase the sediment's erosion susceptibility. At the same time the sediment cannot be too coarse

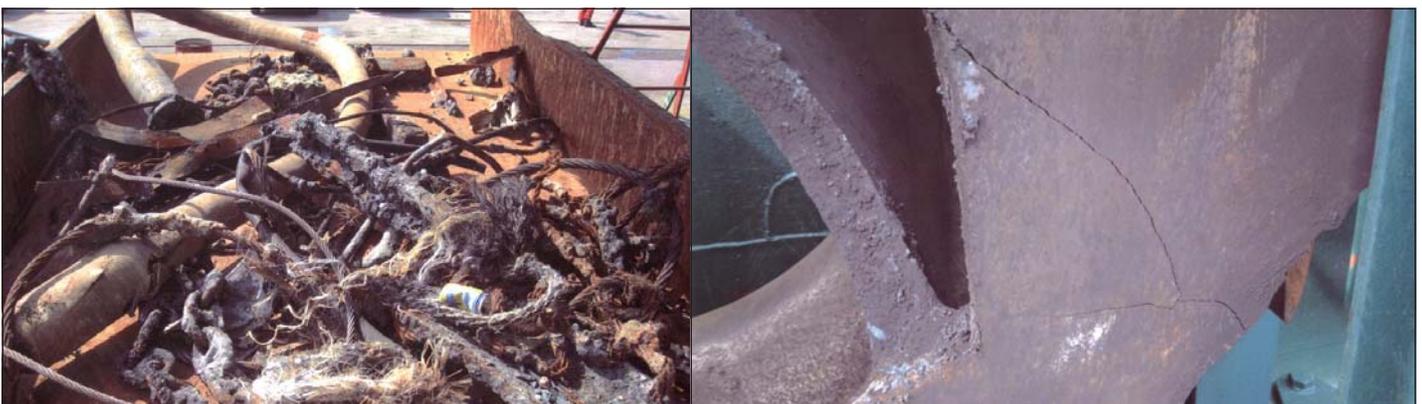
Figure 4 Dredged steel elements and cracked dredger impeller (Photo: Dredging International, April 2010)

The project was successful as it introduced new high-quality coarse sediment (about 500 000 m^3) into the system, aiding a correction in the sediment budget. The project was unfortunately not a complete success. The importance of creating a suitable beach profile was neglected in the first phase of pumping, largely due to time constraints. The resulting profile was quickly corrected to an equilibrium profile which produced unexpected earthworks costs to counteract the 3 m scarp that had formed. The borrow site was originally surveyed with a single scan sonar, as a higher-resolution multi-beam was considered an unnecessary expense since the site had been dredged extensively in the past. The initial dredging phase was without incident, except dredging of small ammunitions. The second dredging phase saw the dredging of steel elements (Figure 4) resulting in the cracking of the dredger impeller.

The cracking of the impeller was a major setback in the project and resulted in a large insurance claim. In hindsight an expensive multi-beam survey may have been more economical should the insurance not have covered the delays.

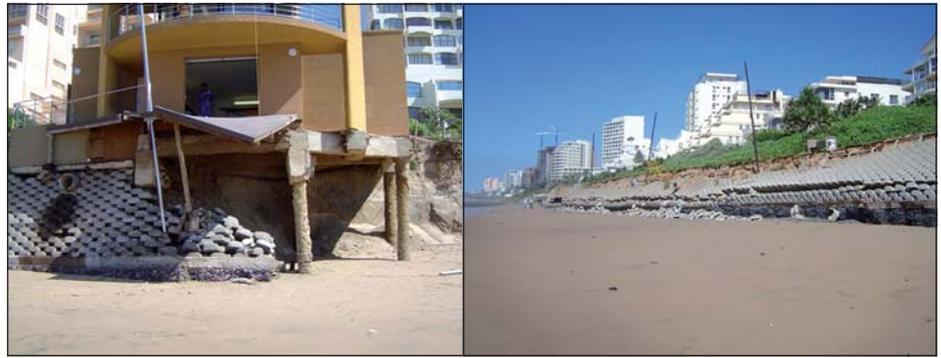
Figure 5 Failure of loffelstein seawall at Umhlanga main beach (eThekweni Municipality database, March 2007)

A large portion of these walls failed during the 2007 event. The failures were a result of water down-rush, and overtopping washing sediment out from behind the walls. This combination of sediment loss caused the walls to collapse (Figure 5). This failure mechanism highlights the need to have substantial drainage and filtration behind the walls. A geotextile filter layer ensures that water can drain from behind the wall while the filter retains the sediment. Some of the walls that had a geotextile filter parallel to the wall still failed, while none of the walls that had a filter parallel and perpendicular to the wall failed. It is felt that these perpendicular geotextile tiebacks (Figure 6) limit the likelihood of sediment escaping through gaps in the parallel filter. This was the only failure mechanism experienced during the event, as none of the walls were undermined. This was a consequence of the walls being either founded on rock or on a bed of gabion mattresses below the lowest scour profile.

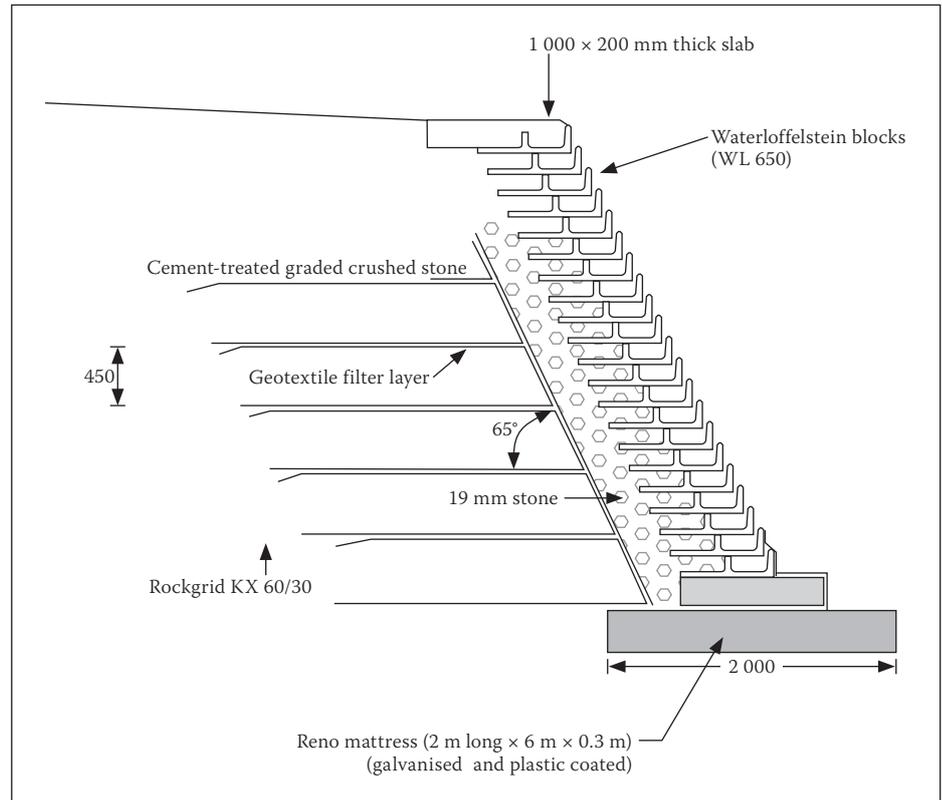
Figure 6: Typical section through loffelstein wall

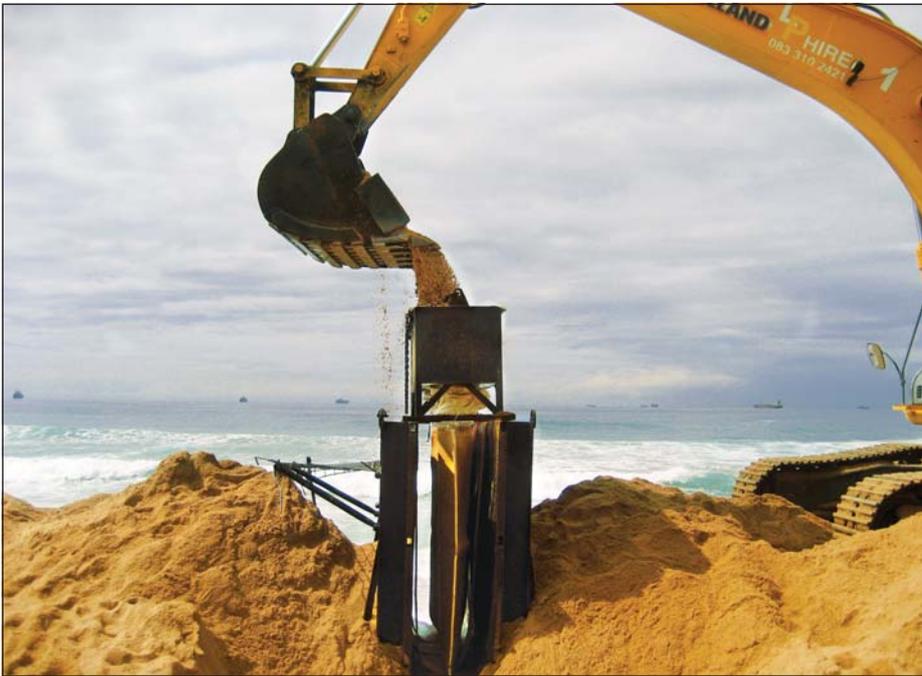
Figure 7 Filling of geotextile sand bags with frame (April 2007)

The filling of the bags required a steel frame (Figure 7). The manufacture of this frame should be governed by the geometry and layout of the bag. This proved to be an issue, as new bag manufacturers entered the market and the manufacture of the bag evolved. When the bag's chute diameter varied the frame's funnel diameter remained constant, and this necessitated the removal of some stitching to allow installation of the bag into the frame. This is problematic as the stitching has a tendency to run, potentially causing the bag to pull open.

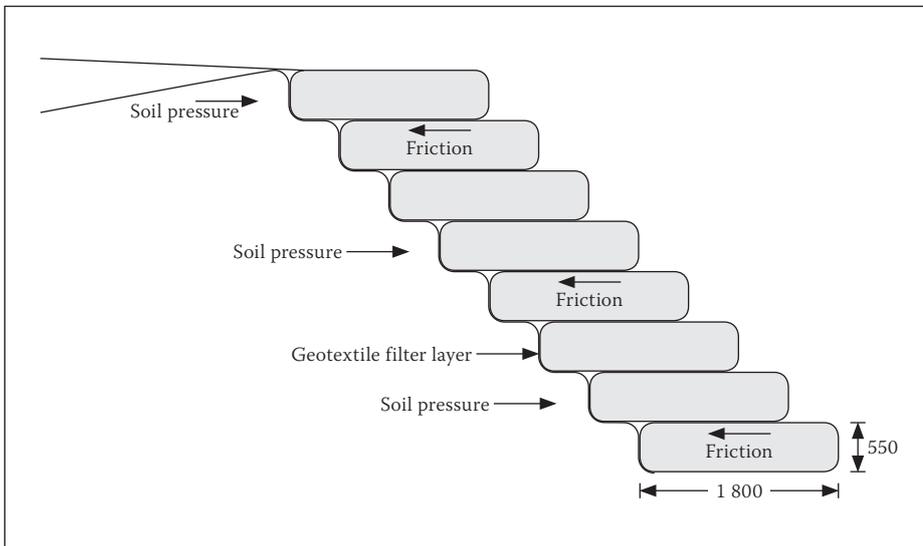
Figure 8 A typical section through a geotextile sand bag wall illustrating the soil pressure and bag friction

stability much more than assumed in past and present literature. In order for the bags to be stable this frictional force must be equal to or greater than the active soil force behind the bags (Figure 8). Therefore, although the friction increases as the bag wall approaches the vertical, so does the active soil pressure. A balance of these two forces was used to calculate an optimum bag slope. Figure 9 shows the number of stable bags through a range of slopes. The calculation includes a safety factor used on the soil properties. For comparativeness, results shown ignore cohesion, place the water table below the bag wall, and use a constant soil weight of 18 kN/m^3 and a friction angle of 30° . Active pressures were calculated using Coulomb's active earth pressure coefficient. The bag dimensions and weight are as previously stated.

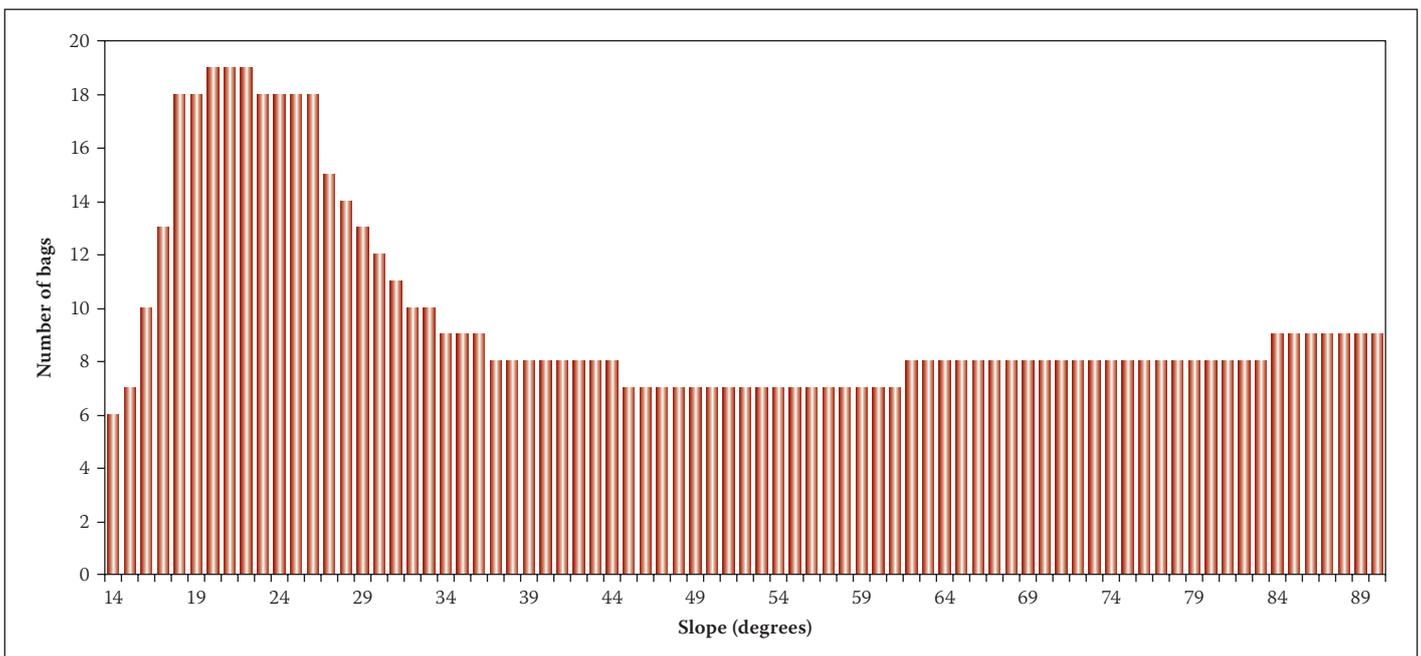
Figure 9 The number of stable retaining bags per wall inclination

Figure 9 illustrates that the angle range of $18^\circ - 26^\circ$ can retain the most soil – the flatter the slope of the wall, the less the wave loading, but the greater the wave run-up. This simple calculation does not consider the hydraulic stability of the bags, and because the sand is displaced to the bags' front face by the lifting and dropping of the exposed portion, it is thought that the less bag length that can be lifted the more stable the bags would be. It is felt that the increased restriction of this movement is what makes the bags more stable at steeper slopes (Hornsey *et al* 2011) and not the increased friction.

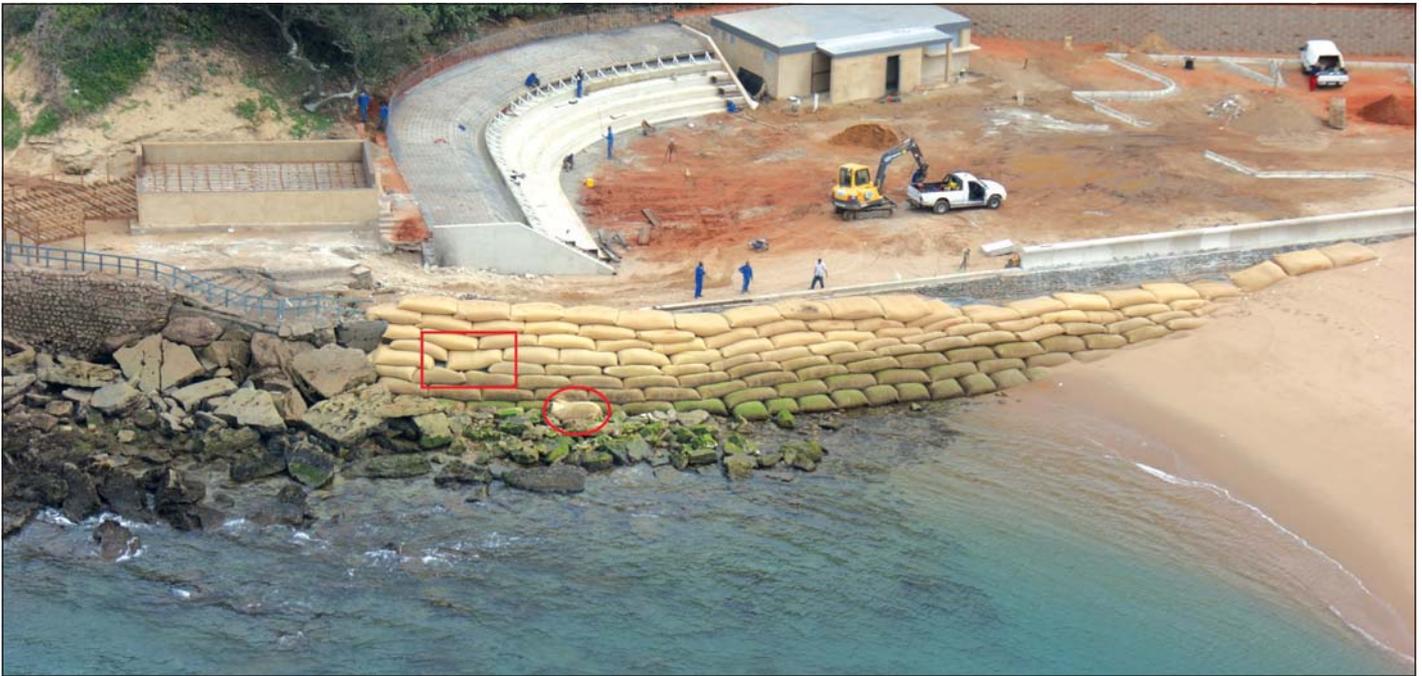
Figure 10 A geotextile bag wall failure at Isipingo (July 2011). The red rectangle highlights where a bag was removed from the wall and the red circle identifies the removed bag

The bags endured their first substantial test on 26 July 2011 from a significant wave height of 5 m, and all the issues identified in the literature were realised. Vandalised bags leaked sand and created weak spots in the walls. The lower layers of bags shifted forward making the lower wall face steeper. This appears to be the combination of three factors: the bags not being filled sufficiently, the bags leaking sand and the bags' geotextile elongation. All these factors enable the sand to move to the bag's exposed face, lowering the friction forces and increasing the drag forces. In an extreme case a bag was completely removed from the lower portion of a wall (Figure 10). We propose that our local bags need some refinement in terms of elongation and that stringent quality controls are required during installation. The significance of bag deformation is perhaps more evidence that the Australian method of filling the bags to capacity and using a 45° slope is more appropriate.

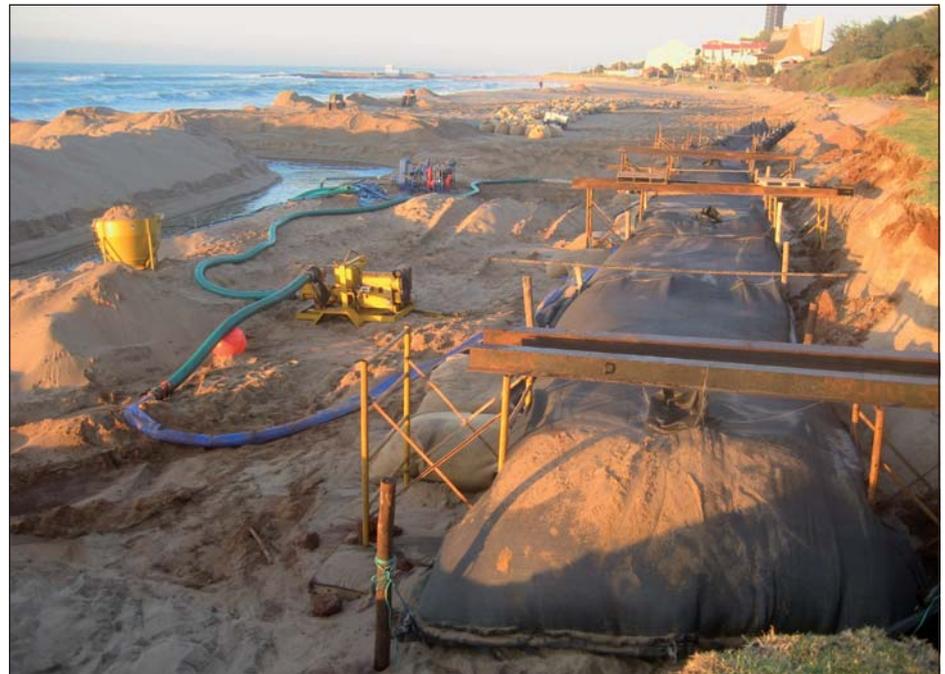
Figure 11 Geotextile tube installation at Amanzimtoti (April 2008)

structurally sound than using geotextile sand bags. The theory was that the 1.4 m diameter by 25 m tube could be laid in position and then pumped full of sand (Figure 11). This, however, was not as simple in practice.

Pumping slurry into the tube caused air to be trapped in the tube which had limited venting points. The slurry was also pumped at a ratio of about 30% sand to 70% water. The geotextile drained slowly, causing the tube to fill with water and air faster than it could expel them, resulting in the slurry discharge pipe being forced out the tube inlet. This issue was overcome by having scuba divers inside the tube directing the pump discharge. The tube also had to be braced every 5 m.
