Evaluation of rock types for concrete aggregate suitability for the construction of a gravimeter vault and access road at the Matjiesfontein Geodesy Observatory site near Matjiesfontein, South Africa

P R van Wyk, L Croukamp

Keywords: Matjiesfontein, concrete, durability, gravimeter, vault

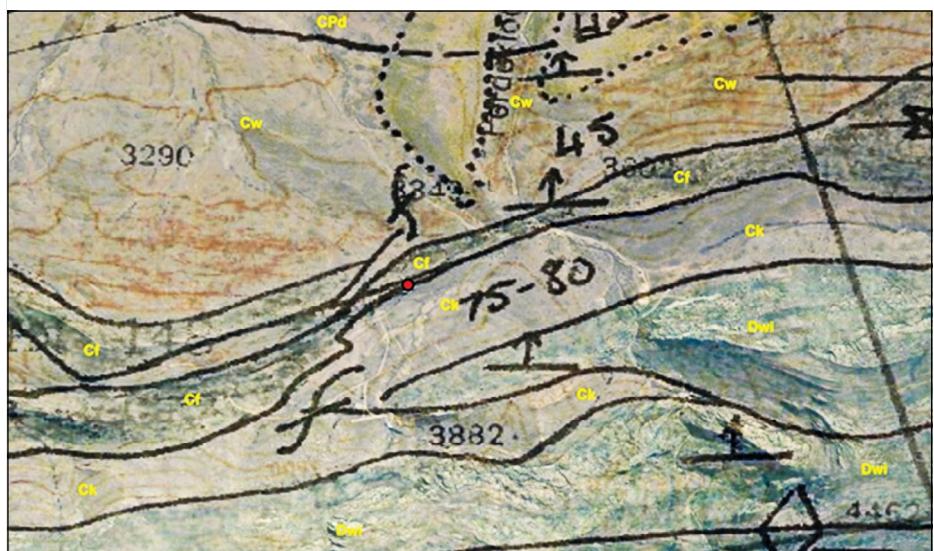
Figure 2 1:50 000 Field geology (courtesy Council for Geoscience)

The site of the MGO is located in a small depression at the foot of the Witteberg mountain range, about five kilometres south of Matjiesfontein village in the Western Cape (South Africa) on the boundary between the Cape and Karoo Supergroups (Figure 1). The typical rock types are mainly quartzite (Table Mountain Group), sandstone (Table Mountain Group), tillite (Dwyka formation) and shale (Karoo Supergroup). A portion of the 1:50 000 geology field map, obtained from the Council for Geoscience, is shown in Figure 2, where CPd is the Dwyka formation, Cw the Witpoort formation, Cf the Floriskraal formation, Ck the Kweekvlei formation and Dwi the Witpoort formation. These rock types all exhibit their own characteristics and potential risks when used for construction purposes. Although quartzitic sandstone of the Cape Supergroup (Peninsula and Skurweberg formations) is good when used as concrete aggregate and is extensively used in the George, Bredasdorp and Knysna regions (Cole 2011), quartzite, when strained, does pose a risk for alkali–silicate reactivity (Alkali–silica reaction in concrete, n.d.) when used as aggregate in concrete.

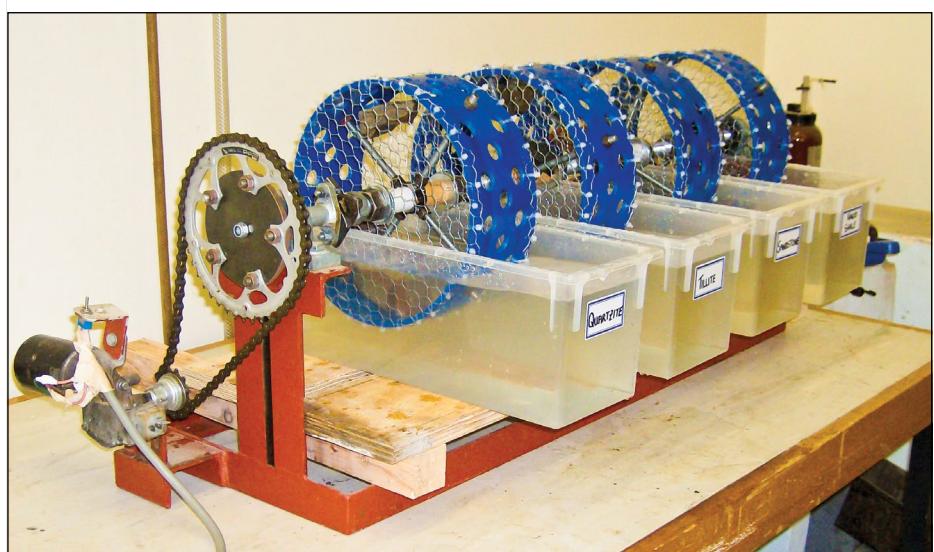
Figure 3 Apparatus used for the slake durability test – from left to right in consecutive containers: quartzite, tillite, sandstone and shale

The test apparatus consisted of four bins, each with a width of 100 mm and a diameter of 250 mm (Figure 3). The circumference of the bin consisted of Polyvinyl Chloride (PVC) pipe (250 mm diameter), with a matrix of 20 mm diameter holes, and closed on the sides with 13 mm mesh. Each bin was positioned on an axle and rotated at five rotations per minute by a motor.

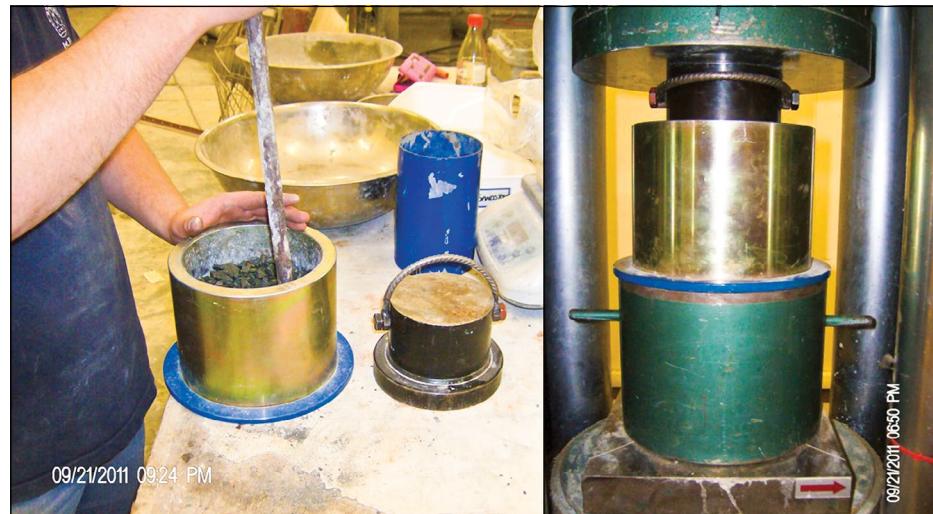
Figure 4 Left: tamping the aggregate lightly, plunger, base plate, steel cylinder and measure
Right: assembly in compression testing machine

mass) in a dry and wet condition. The way in which the test was done, was to crush 9.5 mm aggregate in a steel cylinder (in the compression testing machine) to yield a percentage fines between 7.5% and 12.5% and record the force required to produce this percentage (Figure 4). The force obtained for wet and dry conditions was then expressed as a percentage (wet-to-dry ratio). The general necessary wet-to-dry ratio for the present 10%FACT specification for road aggregates is a minimum of 75% (Thothela *et al* 2011).

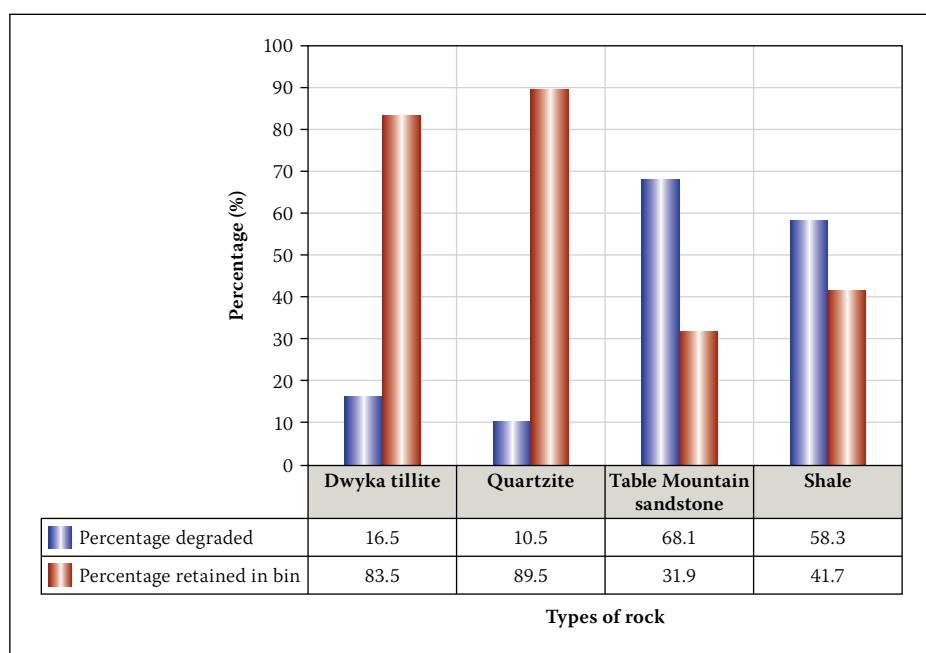
Figure 5 Slake durability test results of the percentage at which the different rock types degraded and the percentage of the initial mass retained in the bins after test completion

The slake durability test revealed that quartzite and tillite were the most durable materials, losing only 10.5% and 16.5% of their initial sample mass respectively. As illustrated on the graph in Figure 5, sandstone and shale proved considerably less durable than quartzite and tillite, losing over half their initial mass during the five wet/dry cycles.

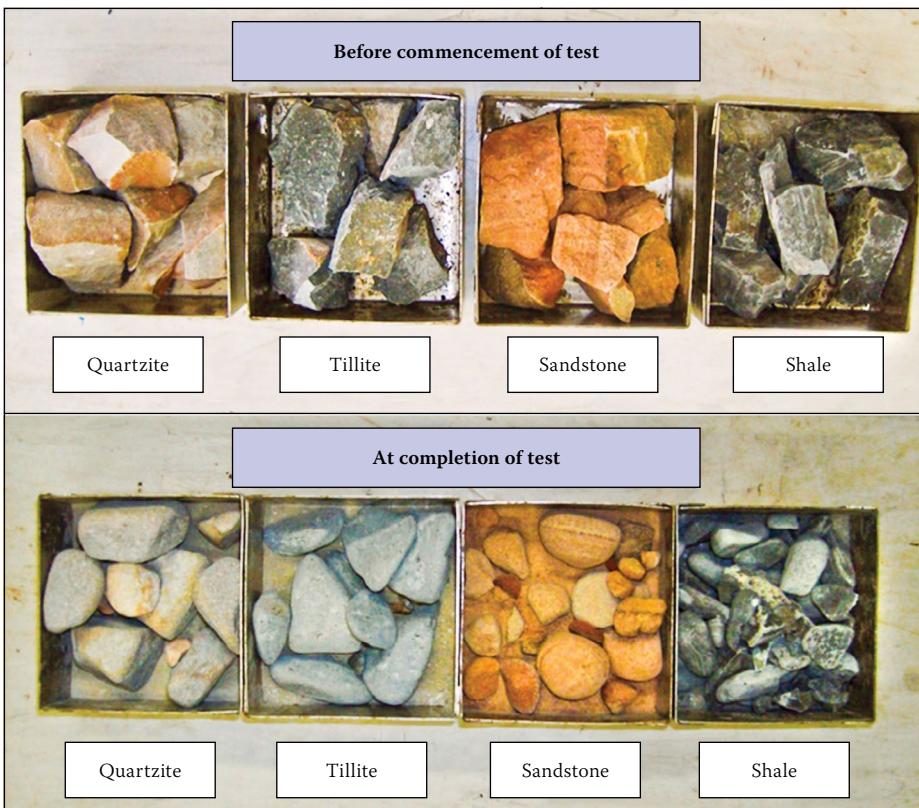
Figure 6 Images of the different rock types prior to the slake durability test and after

Figure 6 shows what the samples looked like before and after the test. Quartzite showed little breakdown and weathering,

and much of the material collected in the container underneath the basket throughout the test was in the form of silt-size particles similar to dust that had degraded through mechanical interaction with the surfaces of the apparatus and other lumps of rock. The quartzite lumps generally remained in an angular form, but were rounded at the edges.

Like quartzite, tillite showed little breakdown, and the material recovered in the container under the tillite bin consisted of tiny flaky pieces of rock material with a "powderish"

appearance. The tillite lumps also remained angular and rounded at the lump edges.

Sandstone showed the most weathering. Of the material collected under the sandstone bin, most was in the form of sand particles. The sandstone lumps progressed from being angular in appearance to rounded small-to-medium size lumps, many of which were small enough to fall out of the bin into the container.

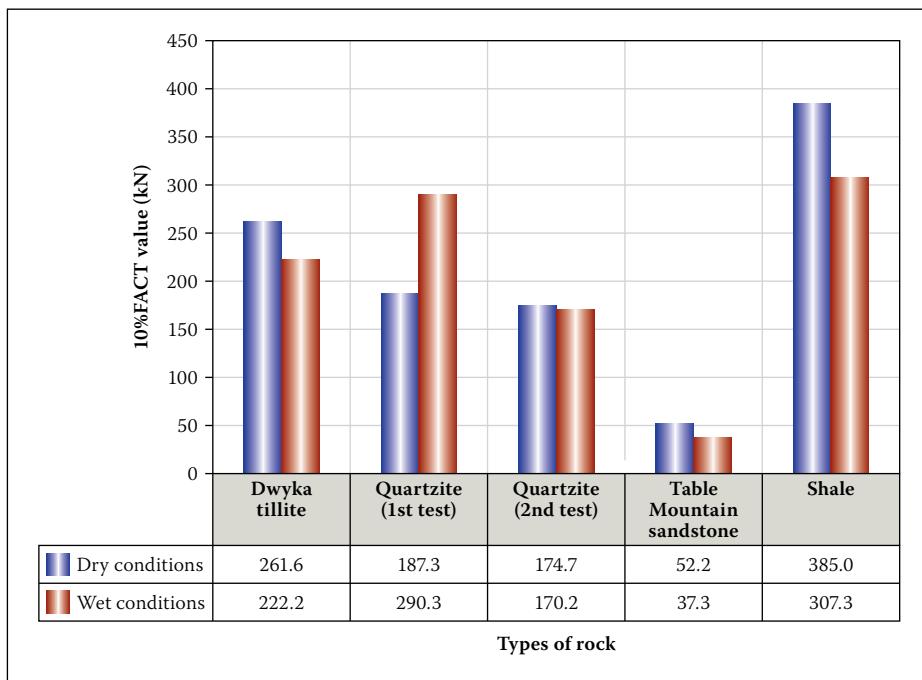
Figure 7 10%FACT results showing the 10%FACT value for each rock type in the wet and dry condition

Figure 7 shows the 10%FACT value for each rock type in wet and dry conditions. All of the rock types, except for the first test for

quartzite, had a larger 10%FACT value in the dry condition than under wet circumstances.

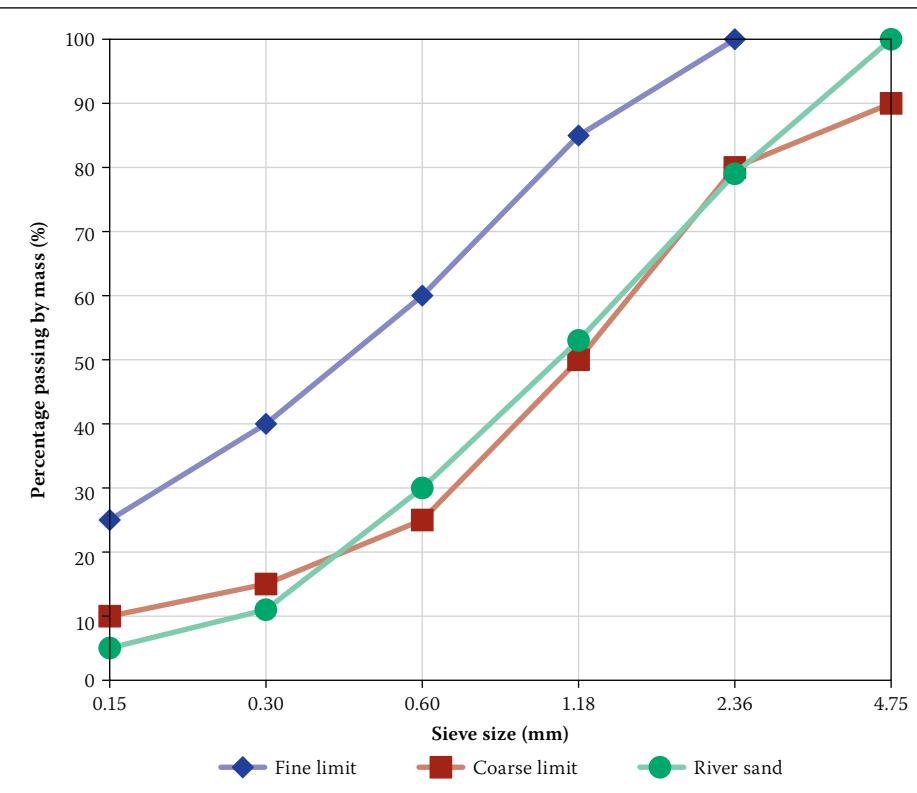
Figure 8 Sieve analysis of local river sand from Matjiesfontein; as can be seen the grading does not fall completely in the coarse/fine limits, indicating that river sand is very coarse (fine/coarse limits from Addis 1998: 88)

can be seen in Figure 8, the local river sand is very coarse, making the mixture abrasive and affecting its workability. As indicated in Addis (1998: 86–87), river sand on the banks of rivers (as the local river sand tested) often contains particles of roughly the same size. This is not conducive to workability, because materials have a large deficiency or excess of a certain size fraction. A possibility to remedy this situation may be to design and test a concrete mixture that contains a superplasticiser, or another admixture, to increase fluidity in the concrete (Illston & Domone 2001).
