Keywords: Mapungubwe Interpretation Centre, cracking, earthen shells, design considerations

Three lessons from the Mapungubwe shells

R A Bradley, M Gohnert

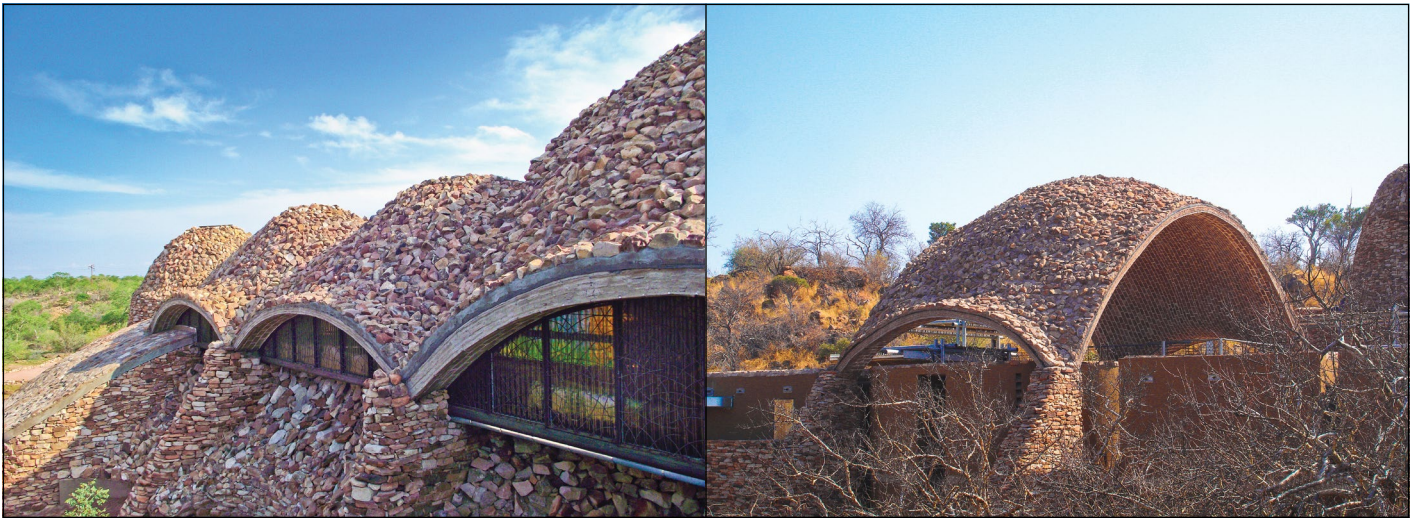
Figure 1 The Mapungubwe shells

The Mapungubwe Interpretation Centre is composed of multiple shell forms, which are striking and beautiful in appearance. The Interpretation Centre is located at the confluence of the Limpopo and Shashe rivers, where three countries meet – South Africa, Zimbabwe and Botswana – and is set deep into the *bushveld*, a local term used to describe a natural African bush environment. The magnificence of the shells (see Figure 1) earned them the 2009 World Building of the Year award at the World Architecture Festival – a fitting accolade for such magnificence (Mapungubwe Interpretation Centre 2009).

The form of the shell is based on a natural shape, comprising a series of catenary forms. The objective of the design is to achieve a purely compressive structure, without bending moments, shears and tensions. The material used in the construction of the shells is earthen tile, comprising seven layers for an average total thickness of 200 mm. The construction method was patterned after the celebrated architect Rafael Guastavino, who was made famous by his unique style of timber vaulting (Milkovich 1992).

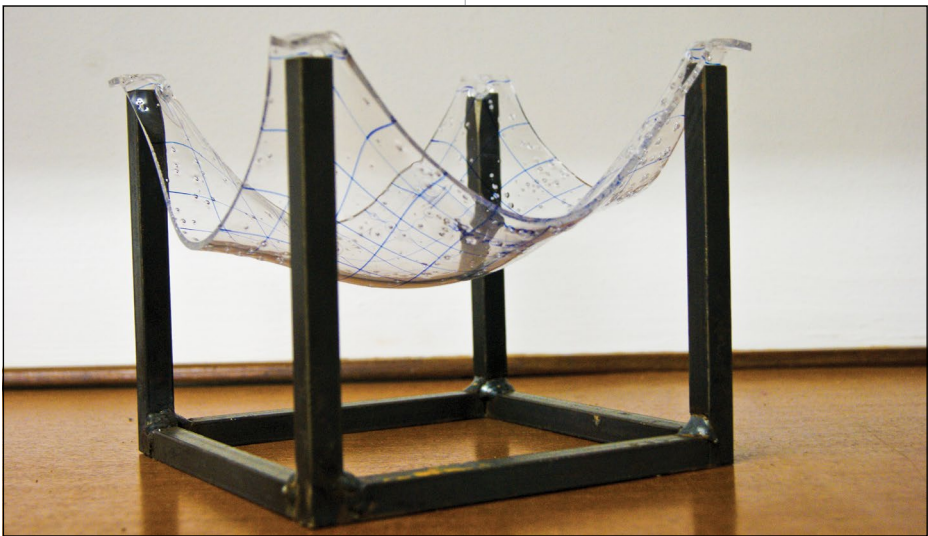
Figure 2 Hanging model using acrylic plates

The Mapungubwe shell has significant cracking in the regions of the lips. The crack is located at the change in curvature, i.e. where the lip begins. It is mooted that cracks form because of the disparity in stress between the stressed and unstressed regions of the shell, i.e. between the catenary dome and the lips. It has been found that the lips carry only a minor proportion of the shell load, contrary to what was previously thought. The shape of the lip is also catenary, and is resistant to the downward deflection of the catenary dome. A shearing force is created at the interface, resulting in cracking, and often a separation of the two structural elements. To substantiate the claim, a handkerchief model was formed by heating a 200 mm × 200 mm × 3 mm acrylic sheet [Poly(methyl methacrylate)] to 150°C. The sheet is attached to a frame, which only offers support in the corners, and is then

heated by placing the sheet in an oven, with an even distribution of temperature. After about 2.5 hours, a shell forms, in the shape of a catenary vault (see Figure 2).

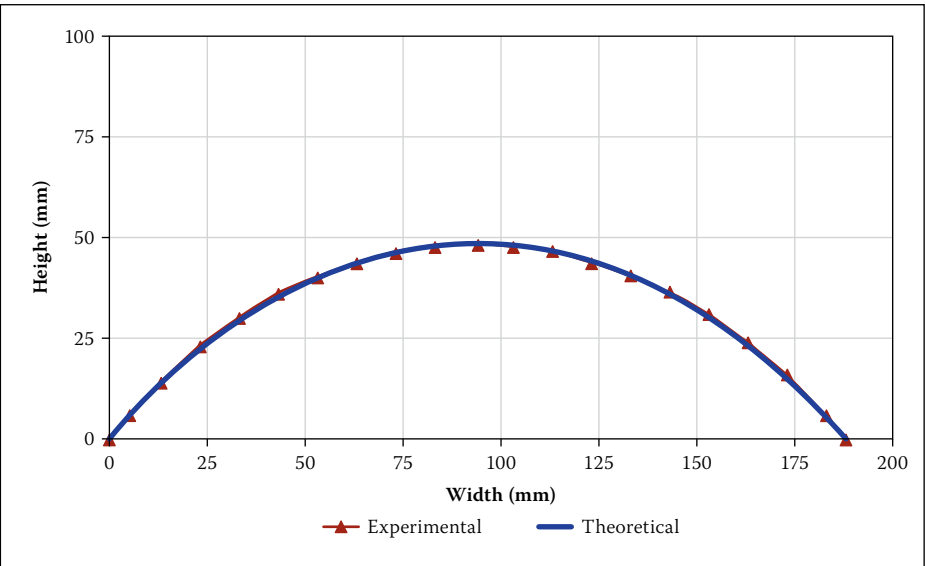
Figure 3 Experimental and theoretical catenary vault profiles

The experimental profile of the catenary shape is in good agreement with that of the theoretical profile, as shown in Figure 3.

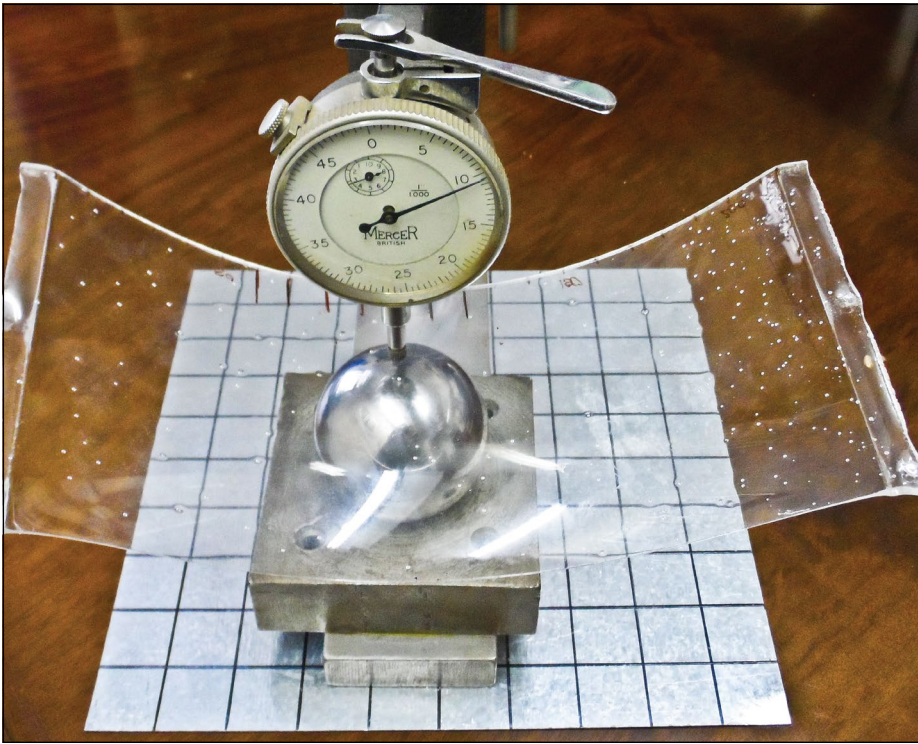
Figure 4 Thickness measurement apparatus

The profiles of the acrylic vaults, and those of the more complex catenary domes, were measured using a deflection gauge. In order to establish areas in which a stress disparity may be apparent, the material thickness was measured using a deflection gauge and steel ball to allow for variation in model curvature, as shown in Figure 4. The flow of stress within the model shell is proportional to the thickness of the shell – the greater the tension stress, the thinner the shell. This is demonstrated in Figure 5, which shows plots of the theoretical stress distribution along the arc length, from support to apex, and the measured change in thickness of the acrylic model. These initial tests demonstrated that the approach is adequate in describing the stress pattern within these structures.

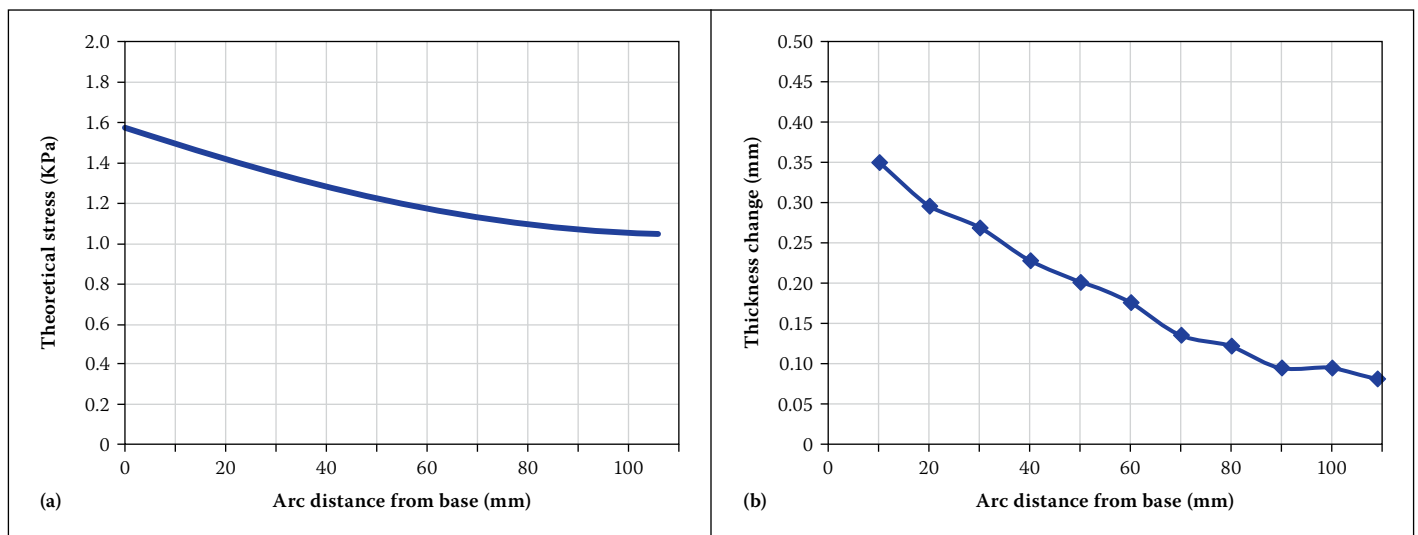
Figure 5 (a) Theoretical stress distribution, (b) Experimental: change in vault thickness

Initially a series of tests were conducted to assess the accuracy of the thermoforming process and testing apparatus. Two parameters were measured after the acrylic models had been removed from the oven and allowed to harden, namely the geometric profile and the thickness. The catenary shape, corresponding to an arch or vault, may be explained by considering a chain, which, when suspended from its two ends, will hang in pure tension. Catenary shapes were selected for the assessment of the modelling accuracy, primarily as tools to describe an ideal shape for a vault under self-weight, and because the theoretical profile and stresses are easily obtained through thrust-line analysis procedures (Heyman 1995).

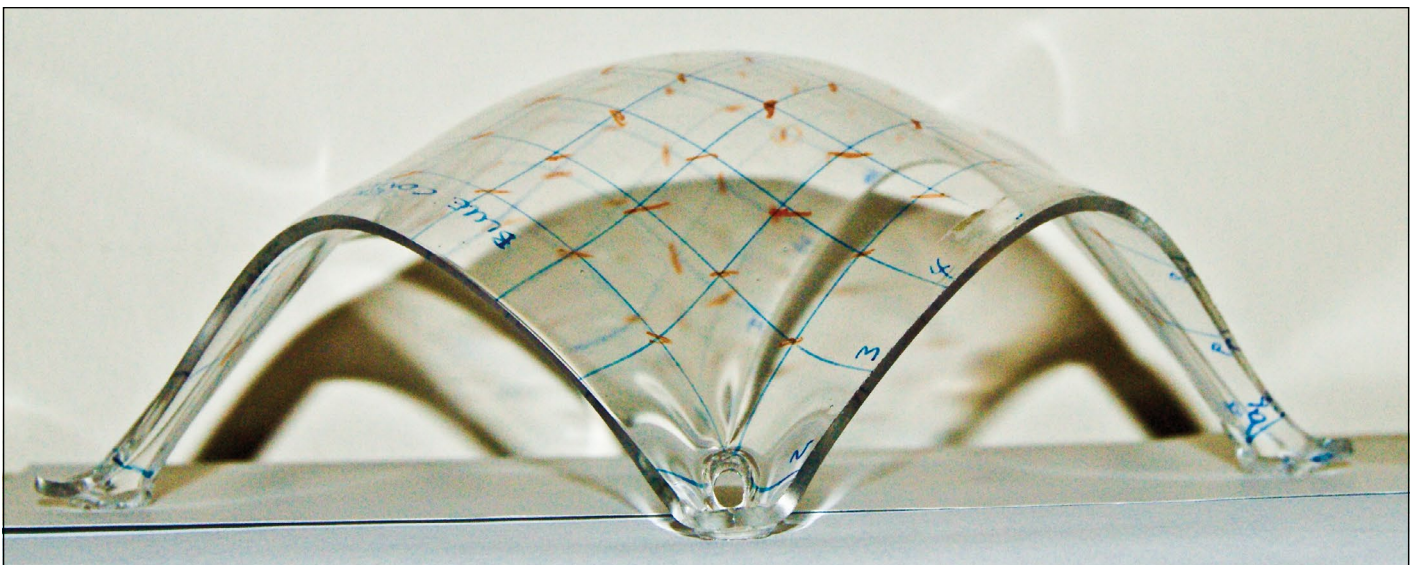
Figure 6 Acrylic model used to determine the flow of stress in a 'handkerchief' shape

At a temperature of 150°C, the acrylic material is in a semi-fluid state, which causes the material to sag and form a natural structure, or rather a catenary dome (see Figure 6). The stress in the shell will not be even, but will flow and concentrate at the supports. The shell thickness was measured at 81 locations, and a contour colour scale denotes the thickness contraction in millimetres.

The boundary, which separates the catenary dome from the edge lips, is the inflection point (see Figure 6), which is easily discernible in the model. The flow of stress in the handkerchief shape is as illustrated in Figure 8. As observed, the stress flows around the free edges (lips) and converges at the supports. It is incorrect to assume that the lips provide structural resistance to loads. In Figure 2, the lip regions of the acrylic model are unstressed and hang limply, forming the so-called lips. These regions may be cut away or omitted without compromising or altering the structural capacity of the shell.

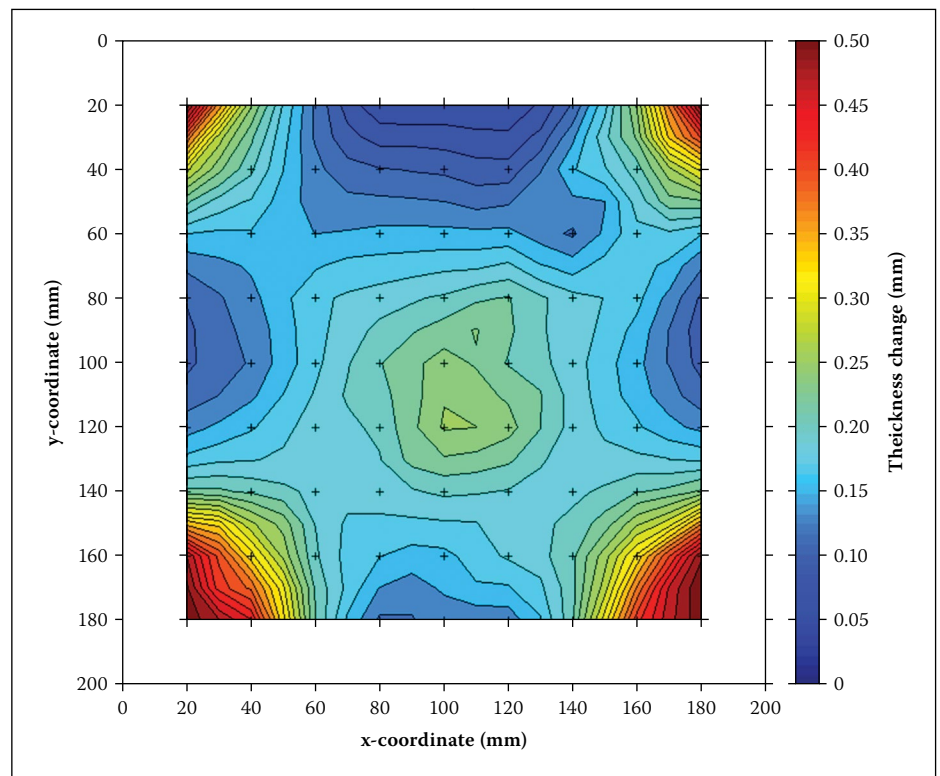
Figure 7 Contour plot of the stress pattern in the acrylic model

In Figure 7 the dark blue regions along the edges indicate very little change in thickness, and therefore minimal flow of stress. Measurements of the shell in the lip regions indicate that the thickness of the shell only contracts at most about 3%. However, at the supports and towards the centre of the shell the stresses are far more substantial. The greatest stress occurs at the supports, as one would predict. Since the lips resist very little stress, this region is structurally redundant and may be removed without infringing on the structural capacity of the shell.

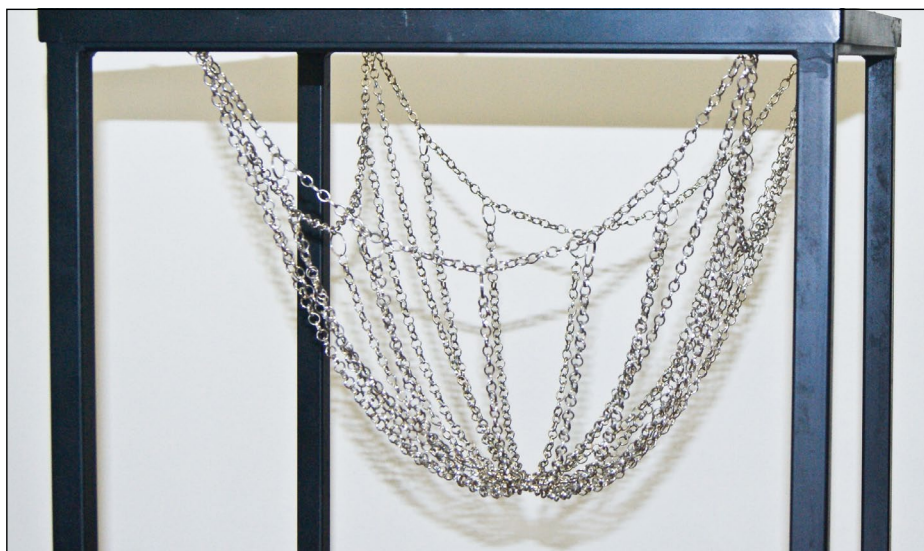
Figure 9 Chain model of a hanging structure supported at the corners

radially from a central point, which is the apex of the dome. This method was used in preference to cloth models, since the weave interferes with the forming of the shape. For this reason, cross-chains, forming rings, are not placed in the model. In Figure 9 the shape is similar to the handkerchief, which is supported at the corners, and openings are located along the four edges. The technique of modelling with chains requires one to constantly adjust the length of the radial chains until a catenary dome is attained, i.e. when a smooth curve forms at the apex.

Never at any stage in the construction of the chain model did eyebrows or lips form along the edges – lips only appear in cloth models. If the lips of the acrylic model are cut away, the resulting shape is identical to the chain model. Both shapes exhibit similar characteristics – the openings along the edges are catenary and the edge of the openings lean into the shape; thus, a side view displays a catenary profile.

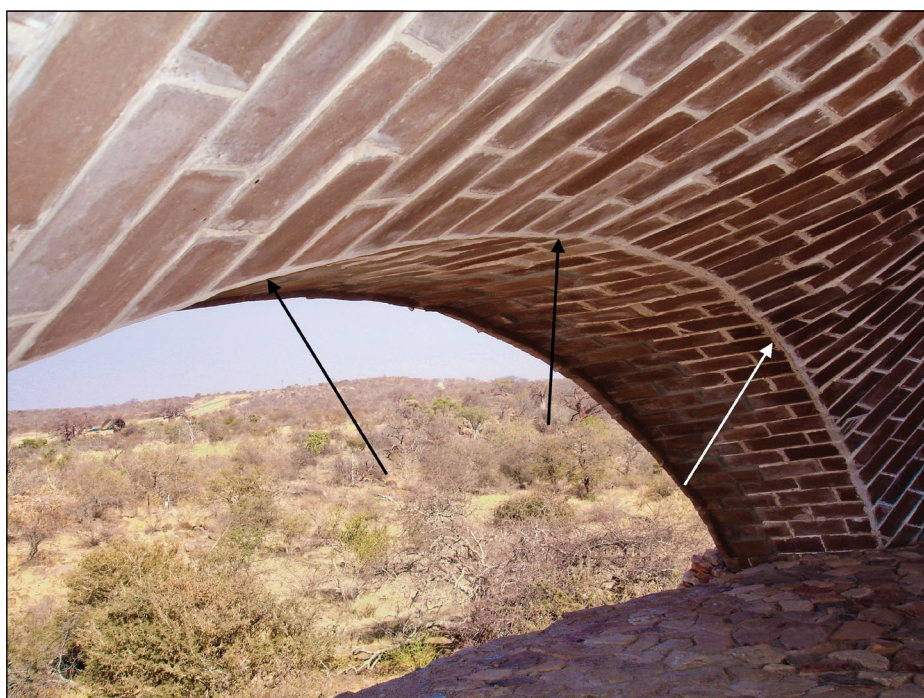
Figure 10 Repaired cracking near the inflection line of the lips

catenary dome will cause the shell to deflect downwards. The lips, or eyebrows, do not carry the shell load (other than its own self-weight) and therefore the deflection of the lip will be significantly less; for this reason, cracking is often observed where the lips are attached to the catenary dome. The Mapungubwe shells are no exception – significant cracking was observed in the region of the lip’s point of inflection, where the lips are attached to the catenary dome. The crack was repaired on several occasions, identified as a continuous white line at the interface in Figure 10.

- **First lesson:** Lips and eyebrows are redundant elements of the shell and should be avoided. Incompatibilities and the disparity of stresses between the lips and the catenary dome cause cracking along the interface.
- **Second lesson:** Shells should be unrestrained against expansion and contraction. This would require that windows, suspended slabs and walls are constructed independently and allow free movement of the shell. The upper region of the shell is more susceptible to cracking, where compressive loads due to self-weight are typically the lowest.
- **Third lesson:** Openings at the base of shells must be geometrically correct and

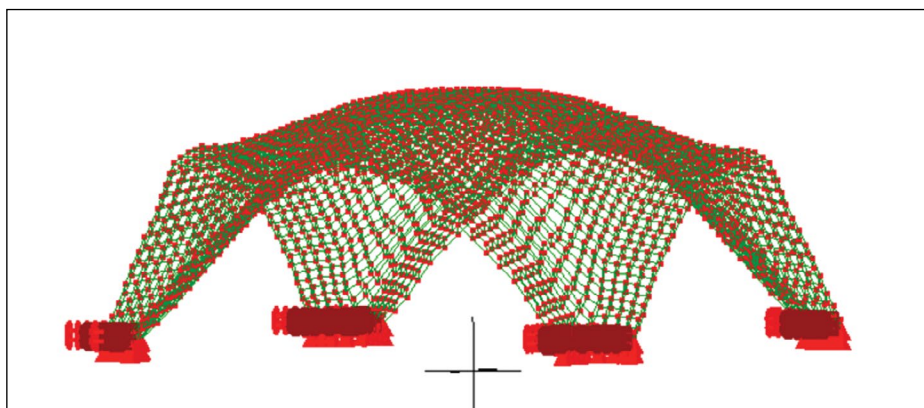
Figure 11 Finite element model of the catenary dome

The disparity of stresses at the inflection point is further substantiated by a linear finite element analysis. The analysis was conducted using FEM software LISA v7.6 (LISA). The spatial coordinates were physically measured from the acrylic model and used to create the finite element model (see Figure 11). For simplicity, a single quadrant was entered into the FEA software; this was then mirrored and rotated to achieve a full shell. A uniform gravitational load was applied to the structure to simulate the weight of the acrylic material. The properties of the FE model are given in Table 1. The corresponding major principal stress contour plots are shown in Figure 12. It should be noted that some localised bending was evident in the FE model due to the lack of “smoothness” of the input data. However, the overall principal stress pattern is strikingly similar to the acrylic model measurements, confirming the redundant nature of lips located along the free edges.

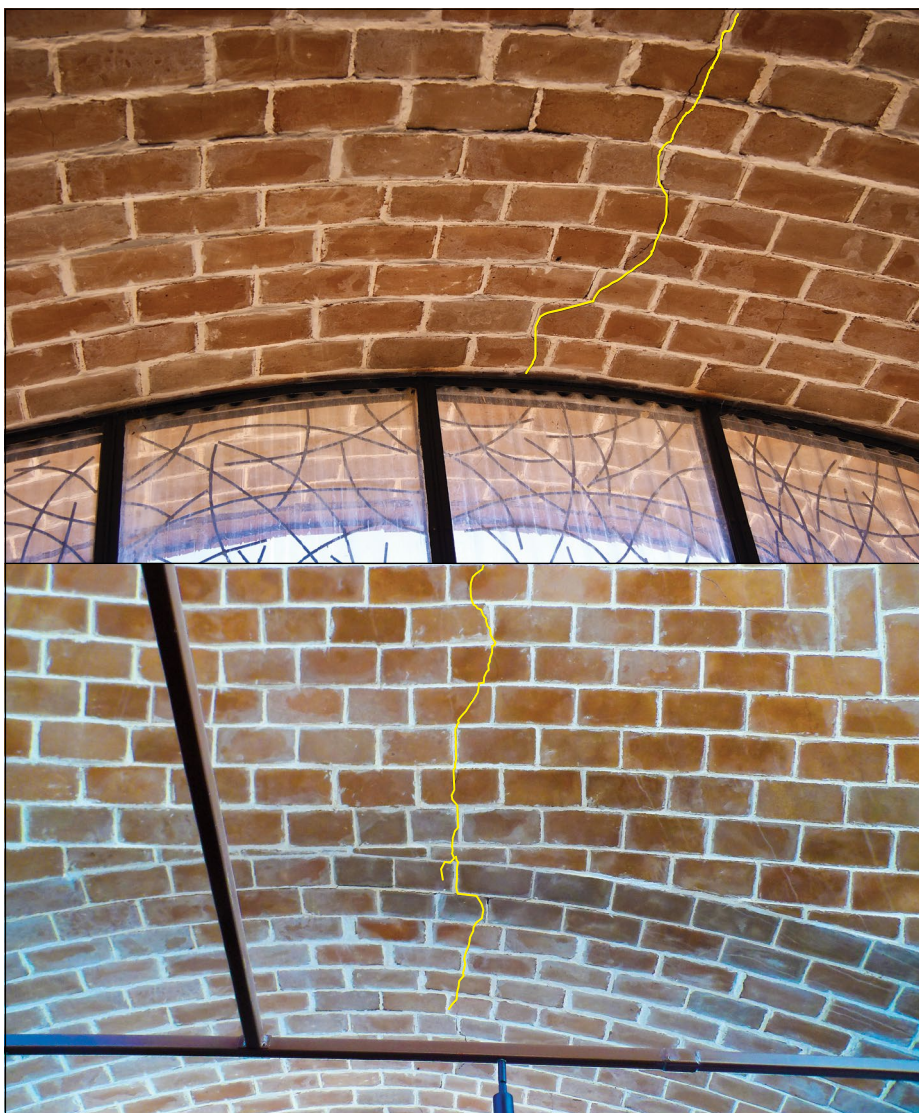
Figure 13 Cracking at the apex of two window openings at Mapungubwe (the cracks are traced in yellow for clarity)

Shell structures are like a living lung – the shell will expand and contract according to the thermal exposure. If the materials used in the construction of the shell have similar coefficients of thermal expansion, cracking should not occur (especially in thin shells which have a small thermal gradient through the thickness). The only critical region is usually at the supports, where the shell is most likely restrained – always in translation, but sometimes in rotation. Many shell structures include openings for doors and windows. Some shell structures, such as barrel vaults, are closed at the ends with vertical walls. These elements in the structure tend to be problematic and cause cracking if they restrain the thermal movement of the shell. In Figure 13 cracking in two window openings is discernible. The crack pattern is similar at the location of all of the windows at Mapungubwe, and is consistently at the

highest point in the opening. The cause of cracking is the steel window frame, which is fastened solidly against the shell structure. In the region of the windows, the shell is unable to expand or contract, resulting in cracking. Another example is the Bapong shells, also located in South Africa (see Figure 14). Similar to the Mapungubwe shells, cracking in the Bapong shells also occurred at the high point where the end-wall meets the shell. The end-walls are connected solidly against the shell, preventing thermal expansion and contraction.

potential for cracking is at the greatest, i.e. where the apex of the shell has minimal compressive strains due to gravity loads. To avoid cracking, an expansion joint should be placed above all window frames, doors and end-walls. The authors have used a 25 mm expansion joint in other structures, which has prevented comparable problems. A similar problem is also observed in shells that are constructed using formwork. However, the shell is only susceptible to this type of cracking after the final bricks have been laid. The contraction is due to shrinkage of the mortar, which is resisted by the rigid nature of the formwork. Thus, the formwork must be removed just after the initial set of the mortar to prevent cracking.

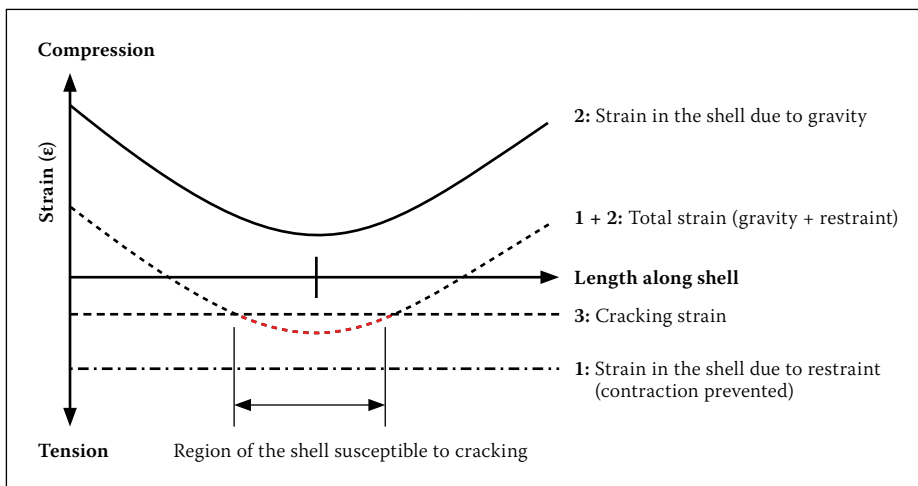
Figure 15 Strains in a shell due to gravity and restraint

In Figure 15 a simple strain plot is proposed to illustrate the region of cracking observed in the masonry shells. The solid line (i.e. line 2) in Figure 15 represents compressive strains in the shell due to gravity loads. If the shell is evenly restrained against contraction, the shell will be subjected to tension strains (see line 1). The mid-point of the plot corresponds to the strains at the apex of the shell, and the left and right boundaries are the shell supports. If line 1 and line 2 are combined, the resulting total strains are illustrated by the dotted line, labelled as 1+2. If the tensile strains are greater than the cracking strain of the shell material, the high point of the shell is the location where cracking is most likely to occur. The strains in Figure 15 correlate with what is observed above the window frames in the Mapungubwe shells and above the end-wall of the Bapong shells.

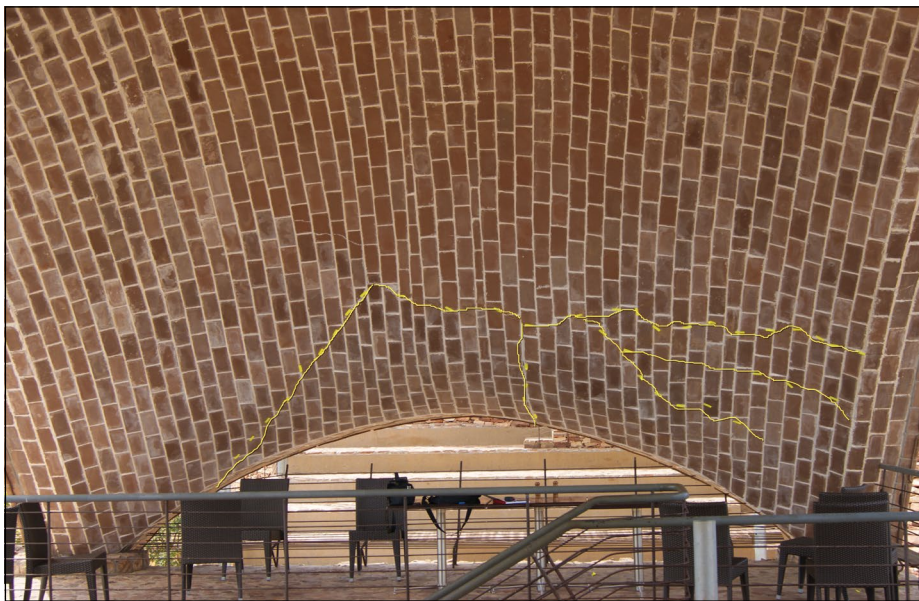
Figure 16 Cracking above a catenary opening at Mapungubwe (the crack is traced in yellow for clarity)

Substantial cracking in the vicinity of an opening is observed in the large open vault at Mapungubwe. The cracks are visible just above the catenary-shaped opening, as shown in Figure 16. In essence, stresses will

should ideally be a catenary arch to match the flow pattern of compressive stresses. The inherent weakness of earthen materials necessitates that the shape of the opening is of the correct proportions to prevent a tension zone, which may result in cracking.

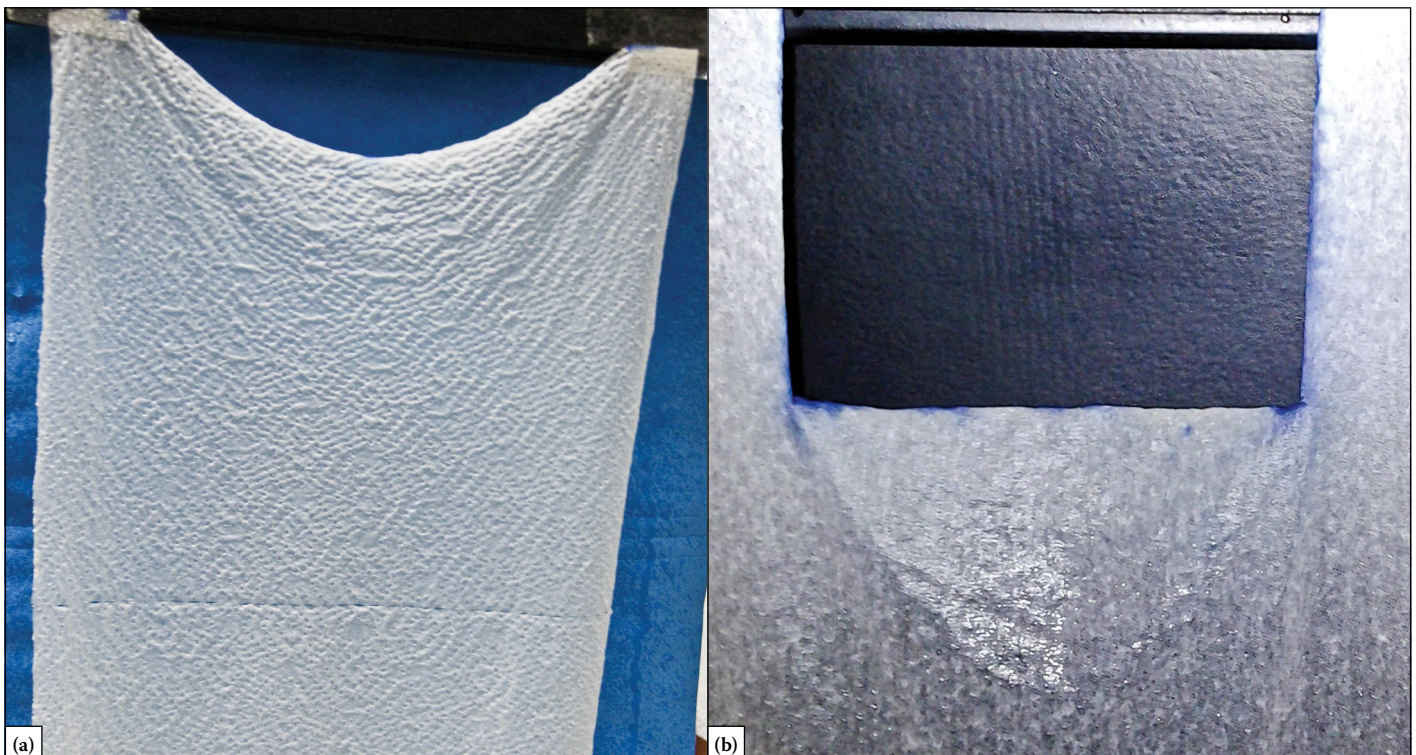
Figure 17 Paper models: (a) catenary opening, (b) rectangular opening

A series of simple tests were conducted to ascertain the reason why cracking occurred above the openings, which consistently happened at several locations in the Mapungubwe shells. The flow of stress was studied by observing the sagging patterns of water-absorbent paper. Openings were first cut into the paper and then the paper was hung vertically. The paper was then sprayed lightly with water to apply a uniform load and to allow the paper to distort, uninhibited by the material properties. These models are principally in tension (identified by taut paper), but localised compressive stress, or no stress, is also evident (and identified by sagging paper). Numerous tests were conducted on both rectangular and catenary openings to assess the flow of tensile stress around the openings. Two of these models, and the corresponding sag zones, are shown in Figure 17. As observed, the stresses follow a catenary-shaped path to the supports.

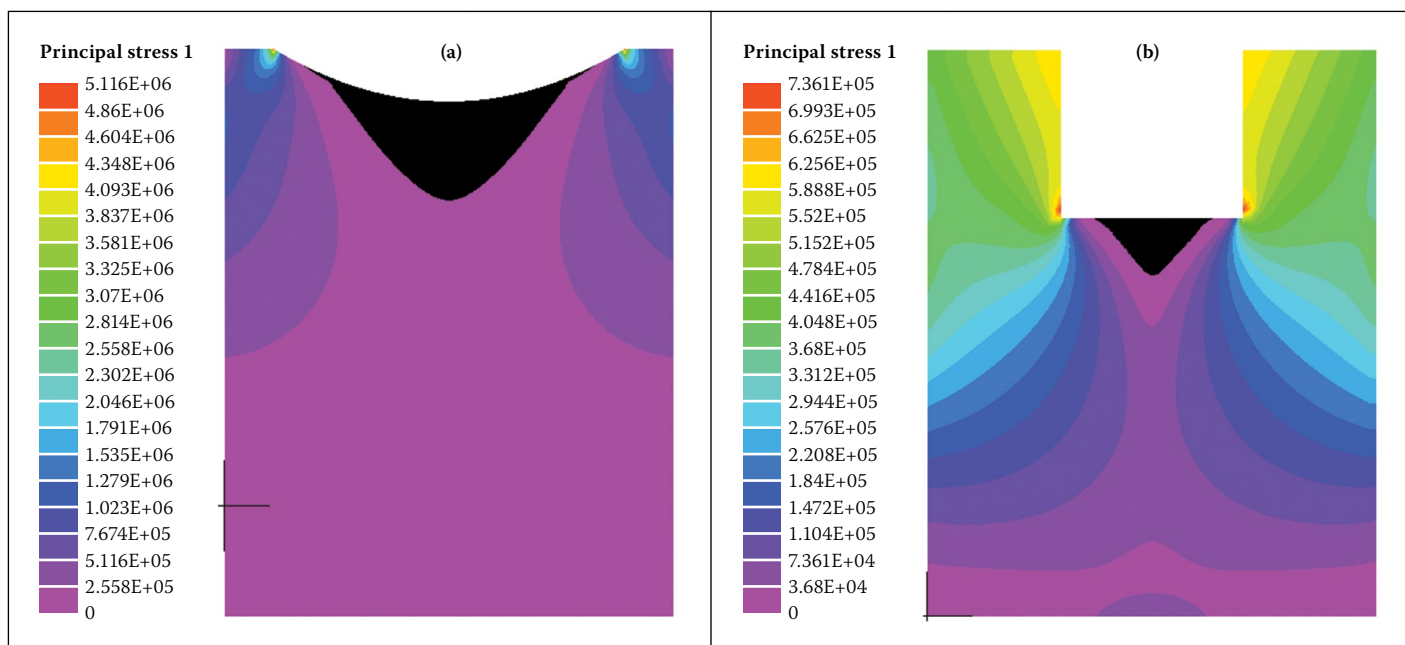
Figure 18 Finite element models: partial fixity – (a) catenary, (b) rectangular

Finite element (FE) models were also produced to substantiate the trends observed in the paper models. Triangular and quadrilateral elements were adopted in the study. A uniform gravity load, comparable boundary conditions (only vertical restraint was provided at the nodes) and material isotropy were applied to the FE model to simulate the paper models. The FE parameters for these models are given in Table 2. The results of two of these analyses are shown in Figure 18. The zones marked in black, observed directly

below the openings, indicate compressive stress. Consequently, tensile stress must flow around this 'dead' zone to the supports.

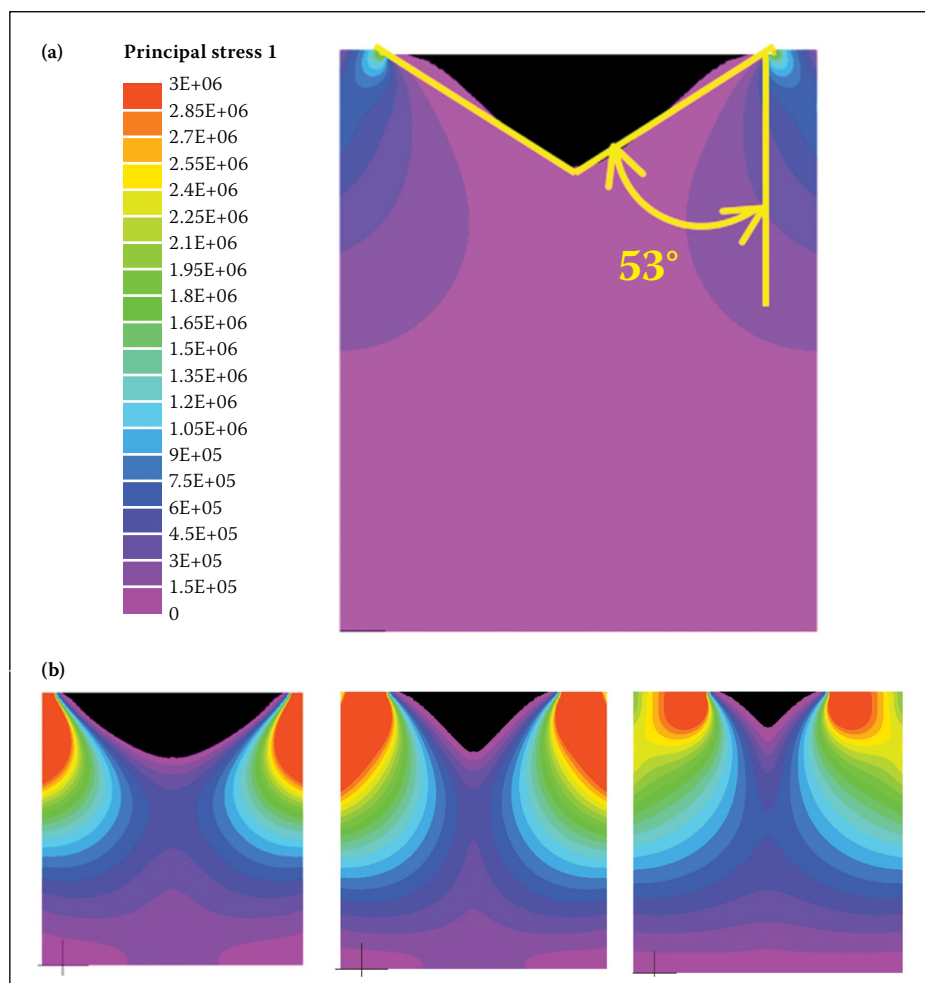
Figure 19 (a) Finite element model with narrow supports at ends, (b) Finite element model with different support widths: partial fixity

To better understand the nature of these 'dead' zones, a stress flow study was undertaken on a plate configuration without an opening, just supported at either end of the FE model (see Figure 19a). If a triangle is inscribed on the plot, the angle measured from the triangle diagonally to the vertical is approximately 53°. This concept was further extended to a single-curvature catenary vault, primarily in compression (see Figure 20). Despite switching to a compression stress study (the paper models are tension flow studies), the flow of stress was found to be similar to the tension studies; the compressive stresses flow to the supports forming a catenary arch and the dead zone is of similar proportions. In this model, the inscribed triangle forms an angle with the

vertical of approximately 52°. The flow of stress to the supports is therefore similar in planar and curved configurations, as well as tension and compression studies. If the support width of the plate shown in Figure 19a is increased (or decreased) the angle increases above 53°, resulting in a smaller compression zone. Consequently, the angle of 52°–53° defines the lower limit for the adopted configurations and boundary conditions.

Three illustrations corresponding to different support widths are shown in Figure 19b. For a very narrow support width, the compression zone looks strikingly similar to the shape of a catenary. However, for broader support widths the dead zone resembles a triangle. Thus, the extent of fixity at the supports alters the shape of the

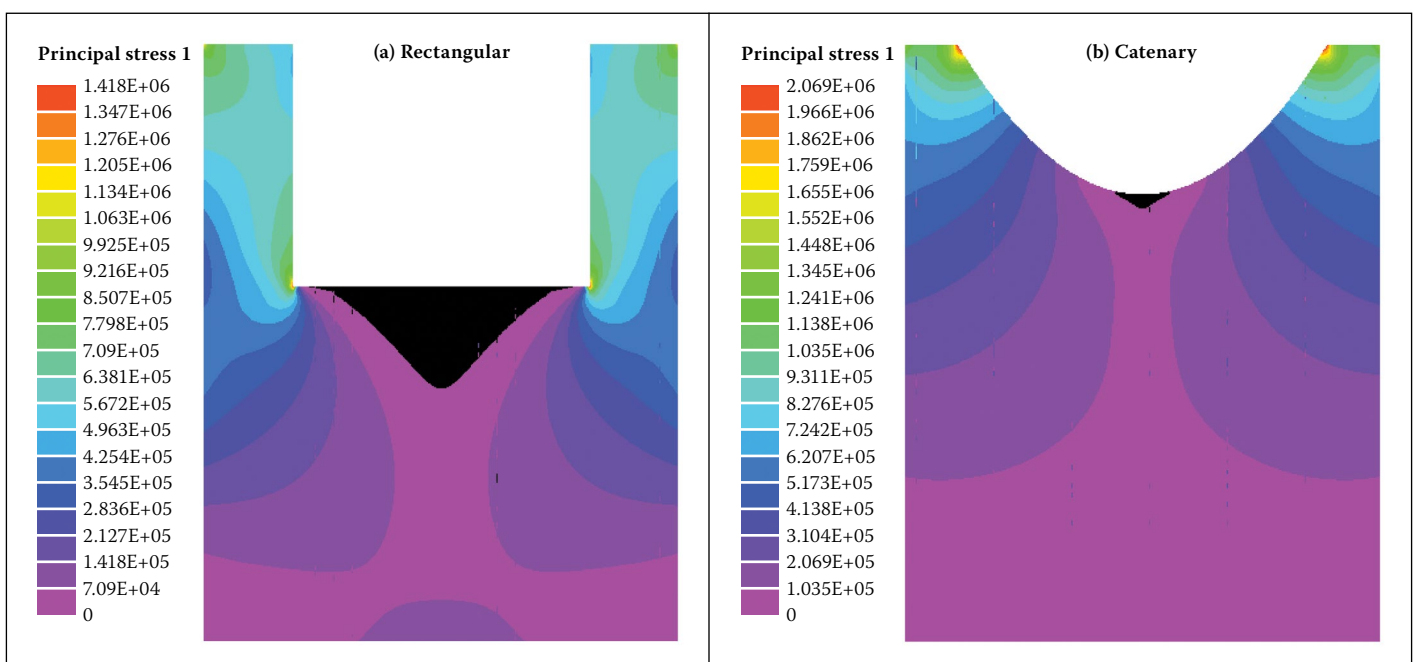
Figure 21 Finite element models: pinned supports – (a) rectangular, (b) catenary

The extent of the compression zone decreases noticeably when lateral support is added to the base of the finite element models. (These support conditions most likely match the actual situation more closely). The major principle stress plots for a catenary and a rectangular opening, assuming pinned supports, are shown in Figure 21. It is apparent that a relatively large compression zone arises below the rectangular opening, when compared with that for the catenary opening (for which the zone has decreased substantially). This result demonstrates the advantage associated with a suitably proportioned catenary opening.

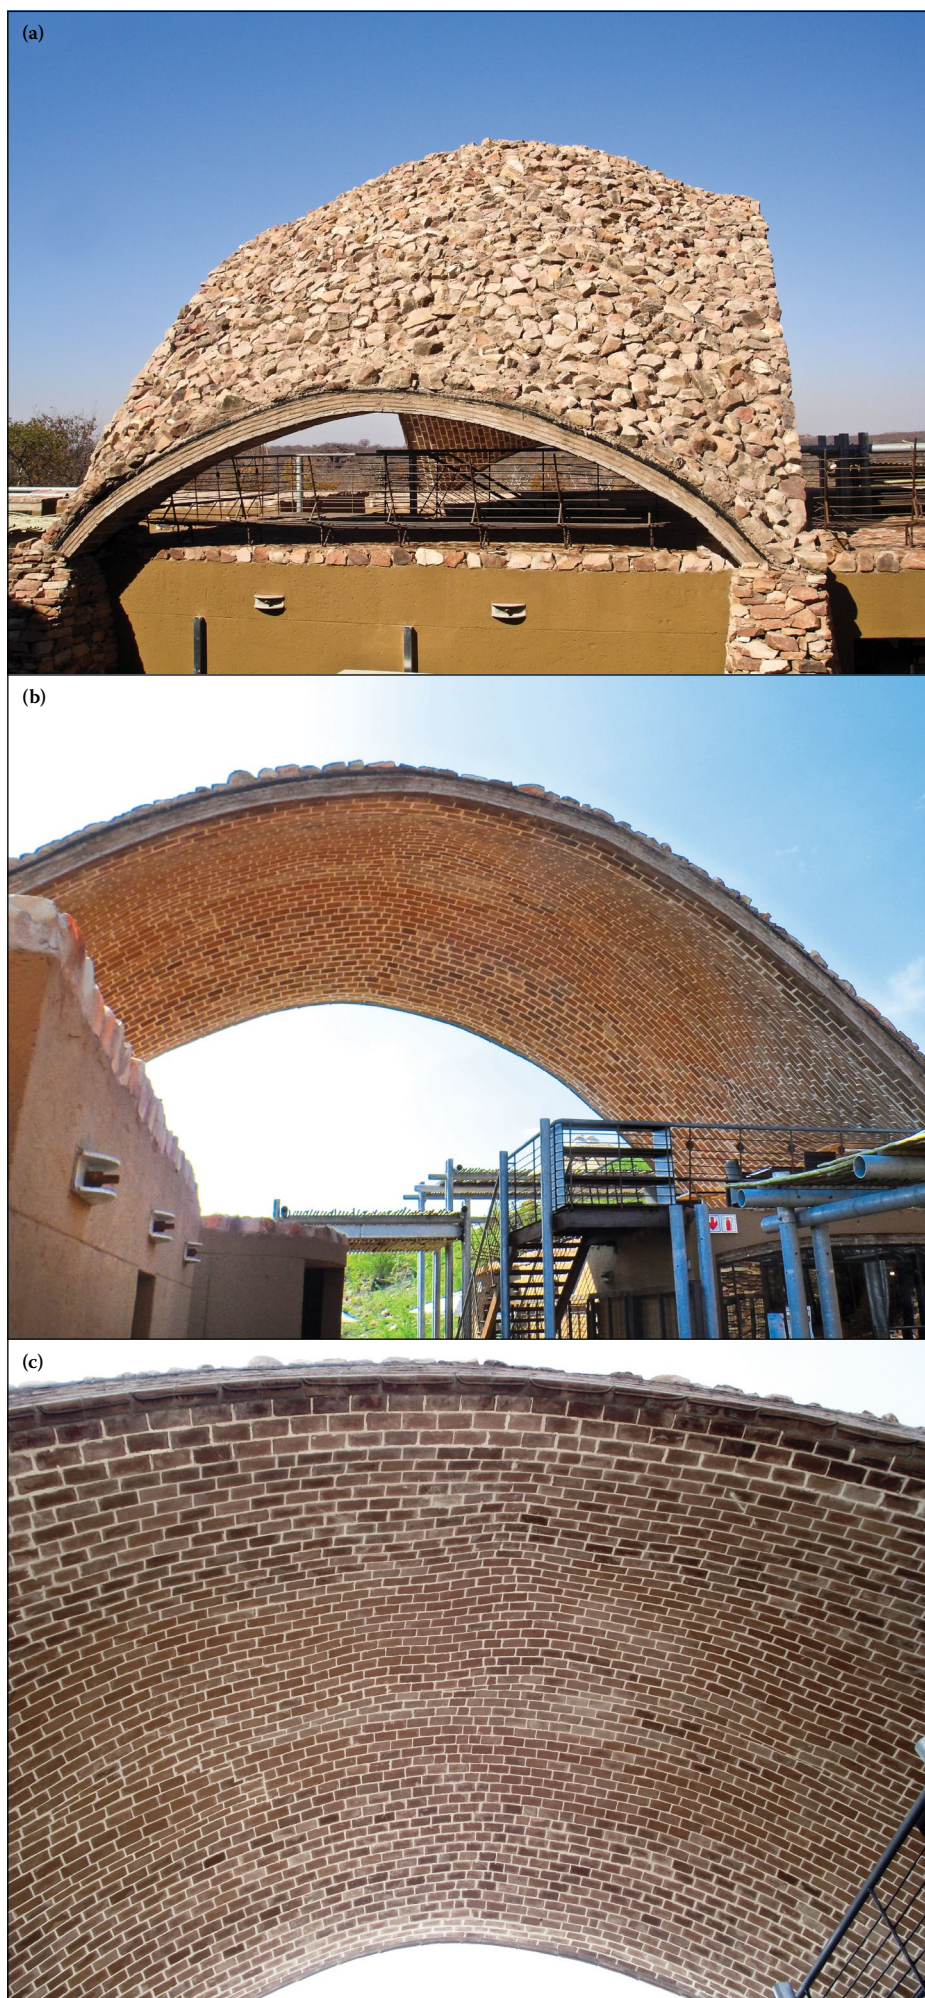
Figure 22 Examples of construction issues in the Mapungubwe shells

Referring back to the Mapungubwe shells (see Figure 22), a postulate for the observed cracking is due to the incorrect proportioning of the opening. Although the shell was designed using well understood techniques (i.e. two-dimensional graphic statics), it was built free-hand using reusable guide work (instead of continuous formwork) to save costs. This approach, however, has resulted in a degree of inconsistency in the constructions as shown in Figure 22(a)(b)(c) – kinks (or undulations), particularly in the upper extent of the shell, are evident. The shell is relatively thick and has a layer of stones on the outer face as an architectural feature. It appears, due to the lack of any cracking in the upper section of the shell, that this additional compressive load has sufficiently countered any localised bending (or tensions) associated with the sudden changes in geometry. In the lower sections, shape deviations at the base may have caused tension cracking above the opening. However, the crack pattern resembles a catenary curve, and the proportions match the FE and paper studies for partial fixity.

It should be noted that the Mapungubwe vaults are more complex than those modelled in the present study. However, a great deal of similarity was observed when comparing the crack patterns in the shell to the models (paper models and FE analysis). This leads to the deduction that the shape and proportions of the openings in masonry shells are vital to prevent tension zones and cracking along the interface of the catenary stress pattern.
