Fire tests of South African cross-laminated timber wall panels: fire ratings, charring rates, and delamination

S van der Westhuyzen, R Walls, N de Koker

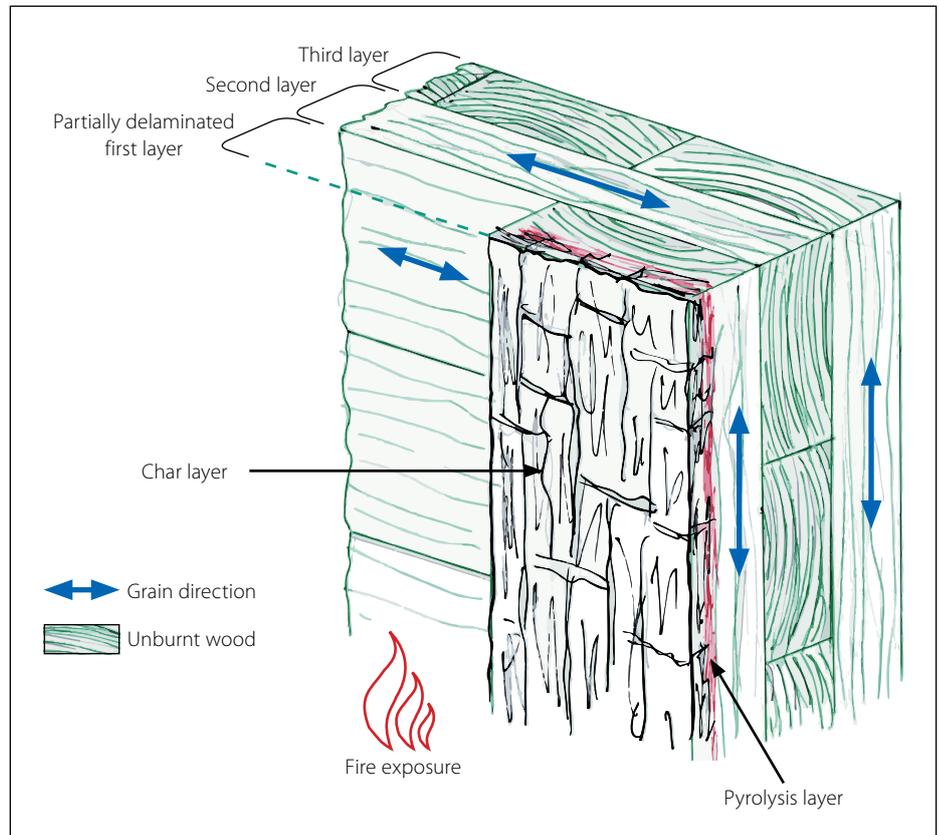
Figure 1 Cross-laminated timber wall panel exposed to fire (adapted from Buchanan (2002))

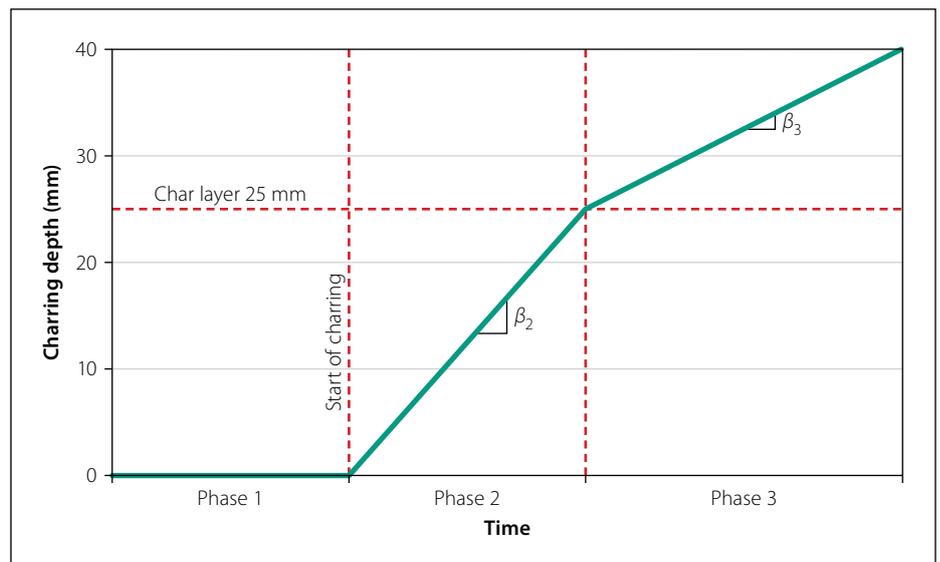
Figure 2 Charring rate model for timber proposed by Kippel and Schmid (2018)

Based on these conclusions, Klippel and Schmid (2018) proposed a charring model similar to that adopted by EN 1995 for charring of timber with a protective layer in place (Figure 2). According to this model, charring occurs in three main phases. During Phase 1 the timber is below 300°C (due to outer laminae or a retardant layer), and no charring occurs (charring rate is zero). Phase 2 begins once the timber starts charring, and is characterised by a charring rate of β_2 . Phase 3 begins when the charring layer has accumulated a sufficient thickness to slow the charring of the remaining timber to a rate of β_3 . EN 1995 indicates that a char thickness of 25 mm provides enough insulation to reduce the charring rate by 50%, signalling the transition from Phase 2 into Phase 3.

The notably higher observed charring rates compared to the values for solid timber (Klippel *et al* 2014) can be understood in terms of the model (Klippel & Schmid 2018) discussed in the introduction (Figure 2), which predicts that the charring rate should be notably higher in the presence of delamination. The model requires a 25 mm thick insulation layer to form I in order to reach the lower charring rate of solid timber. In the case of this work, such a layer never forms, so that the CLT charring front always remained in Phase 2, where charring is accelerated.

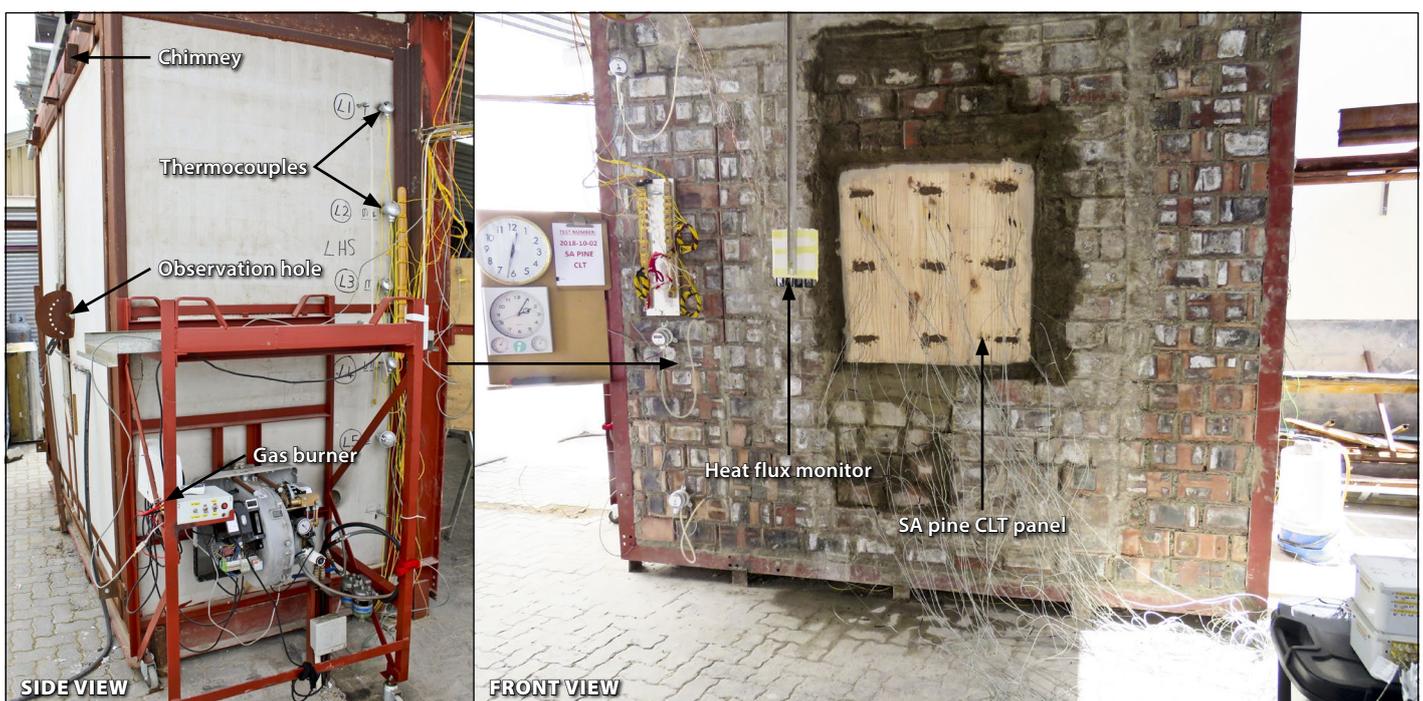
The two fire tests were conducted at the facilities of Ignis Fire Testing, using a furnace conforming to SANS 10177-2 (SANS 2005) (Figure 3). The temperature inside the furnace was regulated using a modulating gas burner to follow the standard ISO 834 fire curve, within the tolerance limits allowed by SANS 10177-2 (Figure 4). The average temperature within the furnace was measured with ten Type K thermocouples placed at different heights in the furnace.

Figure 3 Ignis Fire Testing Furnace

Observation of the progress of the test through the observation hole (Figure 3) served as the primary means of determining whether delamination had occurred. An oxygen measurement approach can also be used, although this proved ineffective due to the relative sizes of the furnace and CLT panel. A smaller furnace or a larger CLT panel may have rendered oxygen measurement more effective (Johansson & Svenningsson 2018).

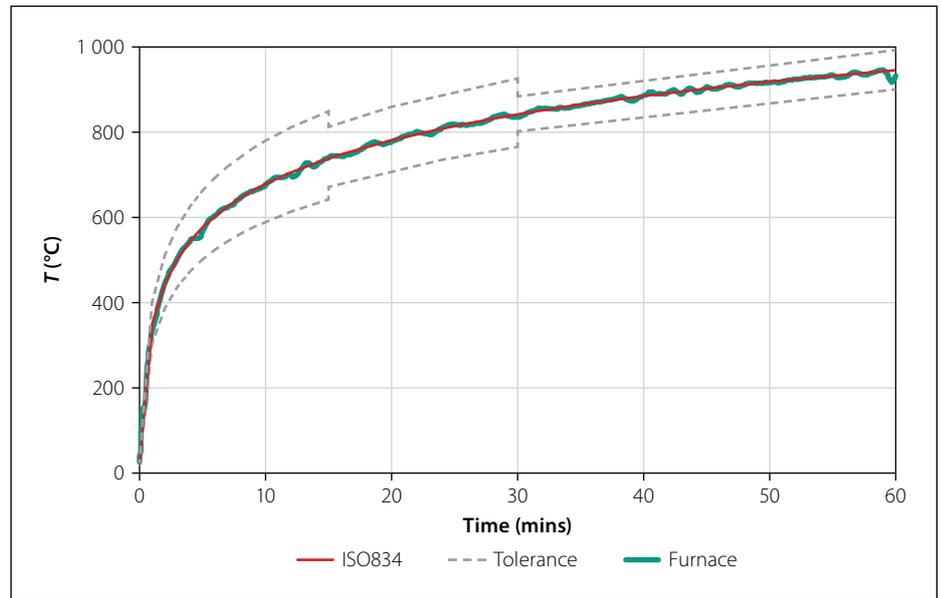
Figure 4 ISO 834 time-temperature curve for SA pine furnace test

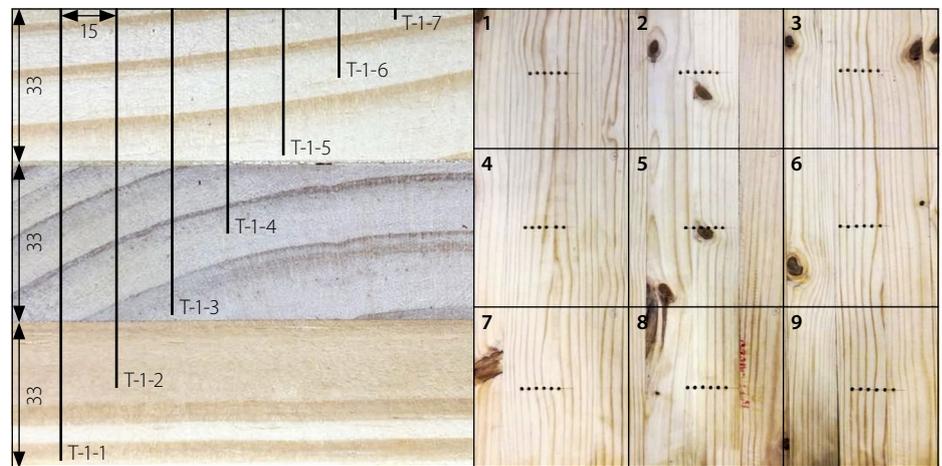
shallower depths (Figure 5), by identifying the progress of the reference charring temperature, 300°C in this case (Johansson & Svenningsson 2018). Nine sets of seven Type K thermocouples with a 2 mm diameter were cemented into the CLT samples at consecutive 16.5 mm depths, as shown in Figure 5. These depths were chosen to measure the time it takes for the charring front to reach the bond line and middle of each layer.

Figure 5 Cross-section of the layout of one set of thermocouples in the CLT panel (left), and thermocouple layout (right)

The progress of the charring front into the CLT panels is summarised in Figures 7 and 8. The process of inferring the progress of the charring front and determining the charring rate is illustrated in Figure 7 for point 5 and point 7 on the SA pine and eucalyptus samples, respectively (sample position numbers are as shown on

Figure 5). A temperature of 300°C was used as the reference temperature for charring, and the time that elapsed between the start of the test and each thermocouple reaching 300°C was recorded.

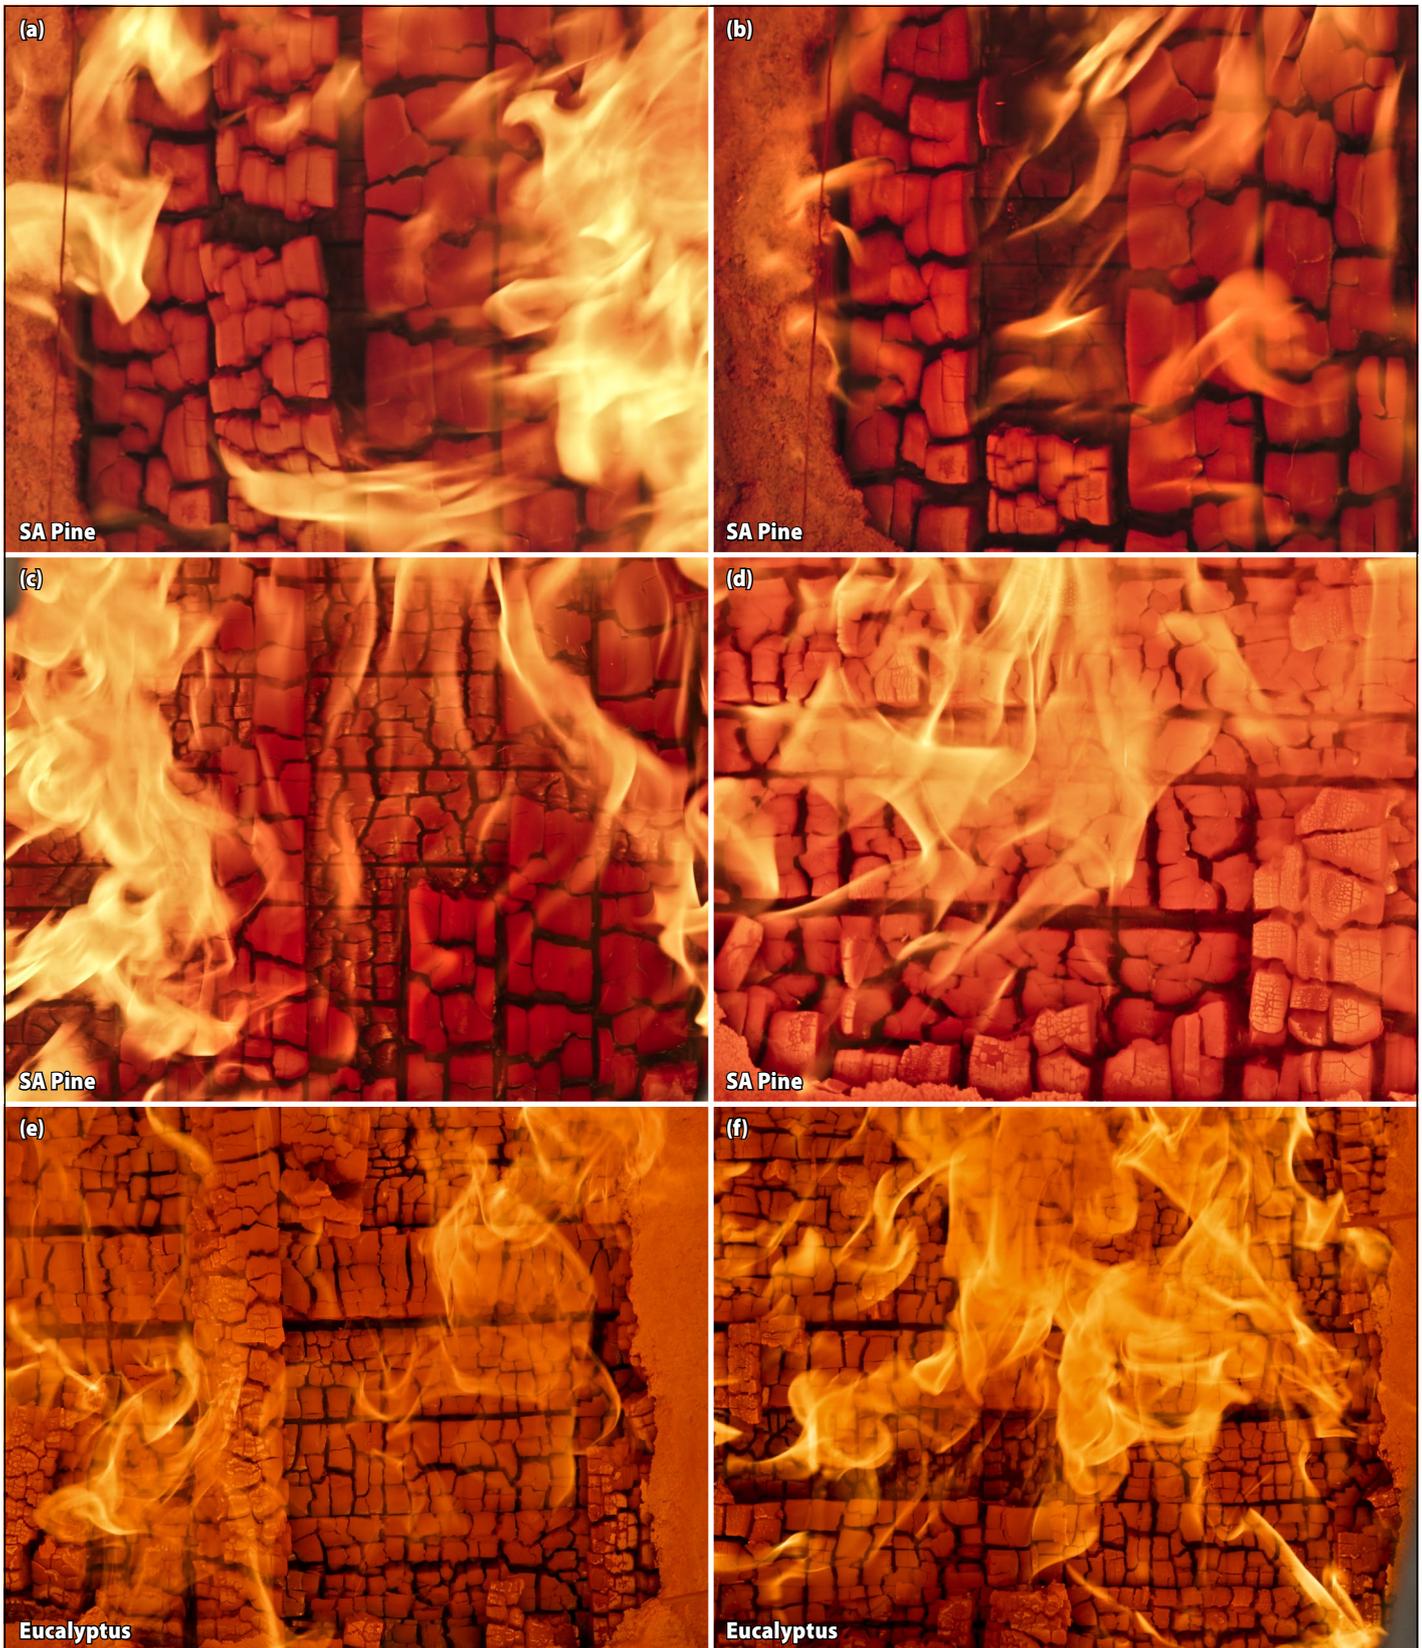
For the test of the SA pine sample, images (a) and (b) of Figure 6 clearly show how the charred remains of a timber plank had

fallen off the burning surface of the panel, thus exposing the second layer of planks to the fire. Within 35 minutes of the test the second layer of the CLT became clearly visible as a result of the widening of the vertical gaps between the planks. Images (c) and (d) of Figure 6 further illustrate how the first layer delaminated. After a period of 40 minutes, more than 50% of the first layer was seen to have delaminated, with near-complete delamination of this layer observed 50 minutes into the test.

The eucalyptus sample also showed clear signs of delamination of the first and the second layer, as shown in images (e) and (f) of Figure 6. Interestingly, when comparing the two timber species, delamination occurred much later in the test for the eucalyptus, consistent with the observed lower charring rate (see below). At approximately 48 min the second layer became clearly

Figure 6 Images of the pine and eucalyptus samples in the furnace during the fire test, illustrating how delamination occurred

Integrity failure times were 66 minutes and 105 minutes for the SA pine CLT and eucalyptus CLT panels, respectively. The eucalyptus CLT therefore performed significantly better than the SA pine CLT. The eucalyptus was observed to burn differently compared to the SA pine. The SA pine burned quite uniformly without any ‘popping’ of the timber. The eucalyptus, on the other hand, burned aggressively with small pieces of timber popping off and making significantly more noise. Additionally, the crocodile/map cracking pattern (Figure 6) of the eucalyptus was much finer than the large block cracks of the SA pine.

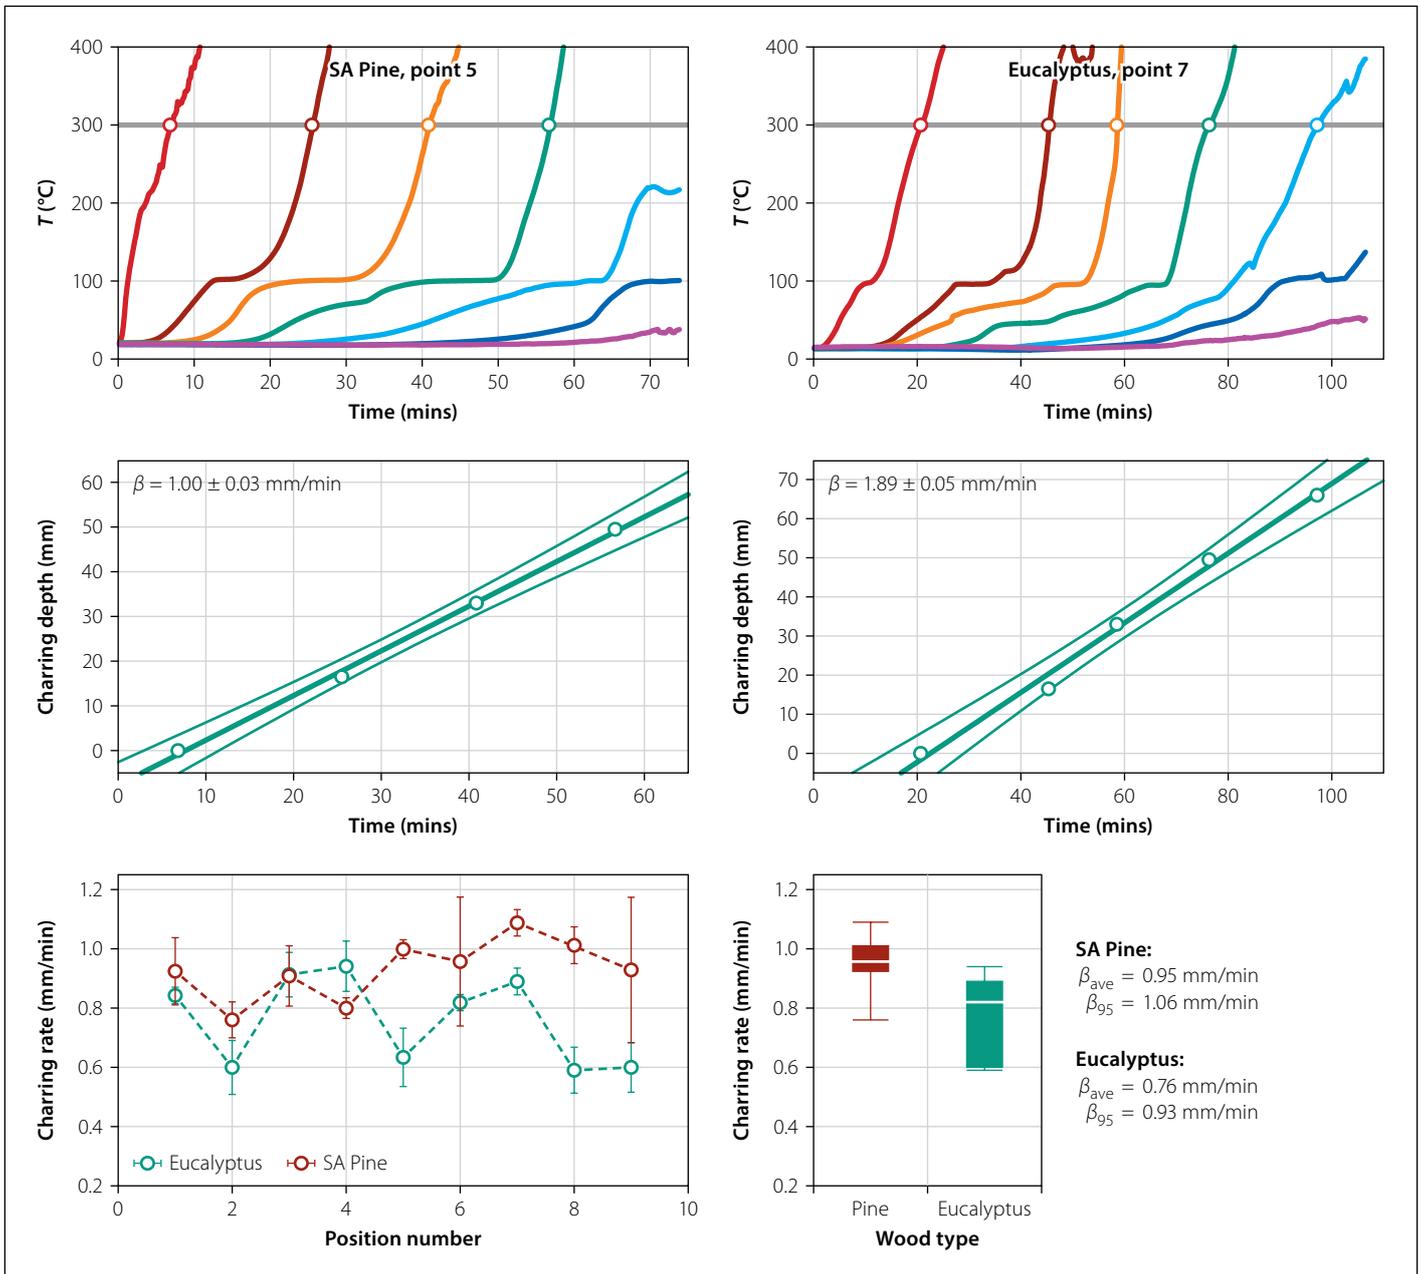
Figure 7 Eucalyptus CLT sample 7 and SA pine CLT sample 5 thermocouple readings

The choice of 300°C as the charring reference temperature may appear somewhat arbitrary. However, using a reference temperature of 260°C yielded almost identical average charring rates for both CLT panels. This finding is not surprising, given the rapid rise in temperature seen at any given thermocouple between 200°C and 350°C (Figure 7).

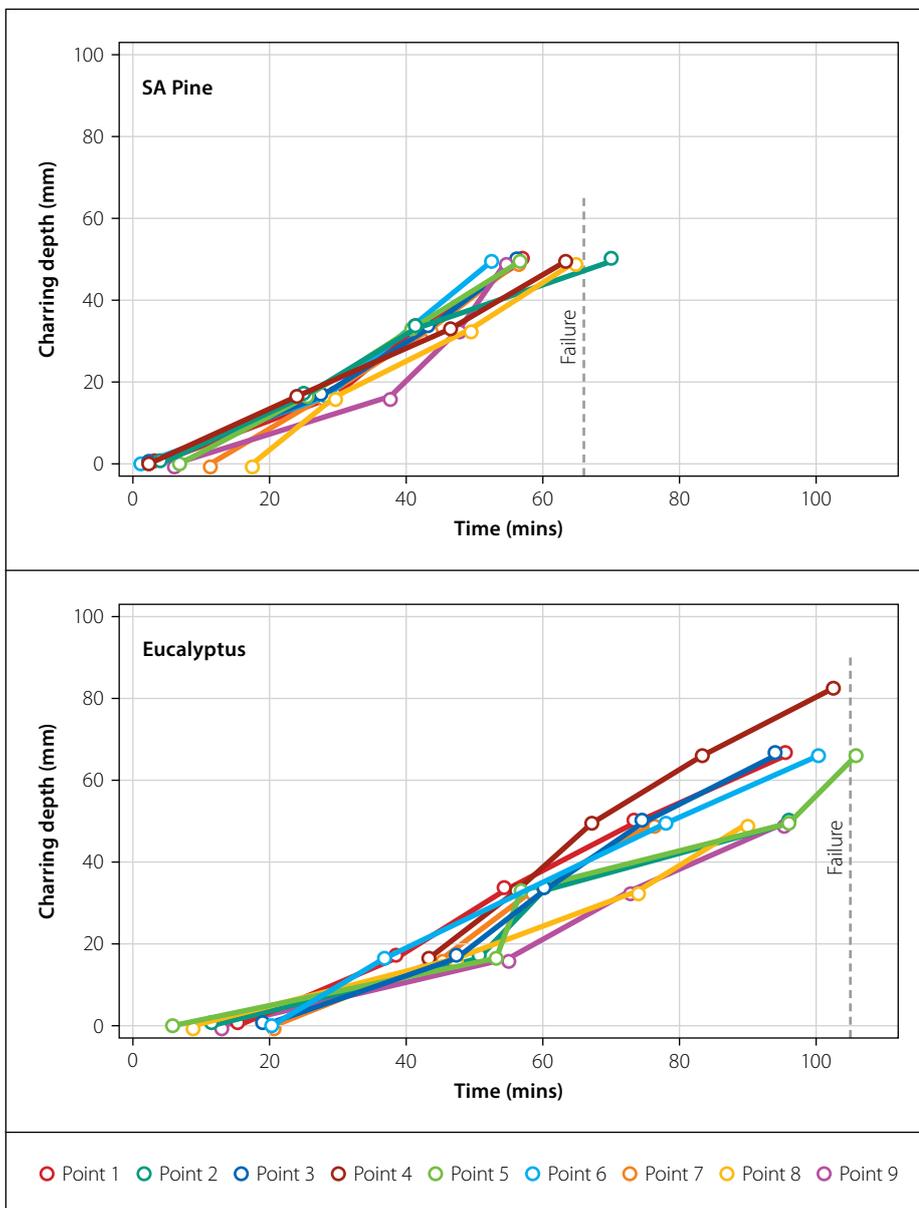
points on a given sample. Following this process for all nine points on each of the two panels (Figure 8), a summary of charring rates is given in the bottom two panels of Figure 7. Note also the horizontal sections of the time-temperature curves at 100°C in Figure 7, which are due to the latent heat of moisture evaporating in the timber. While the charring rate is unaffected by this phenomenon, the time to initial charring will be affected by moisture content.

Figure 8 Charring depth versus time for the nine pine (top) and nine eucalyptus (bottom) CLT samples at 300°C reference temperature

As seen in Figure 8, most of the surface of each CLT panel charred at an approximately uniform rate. Integrity failure nonetheless occurred notably earlier than

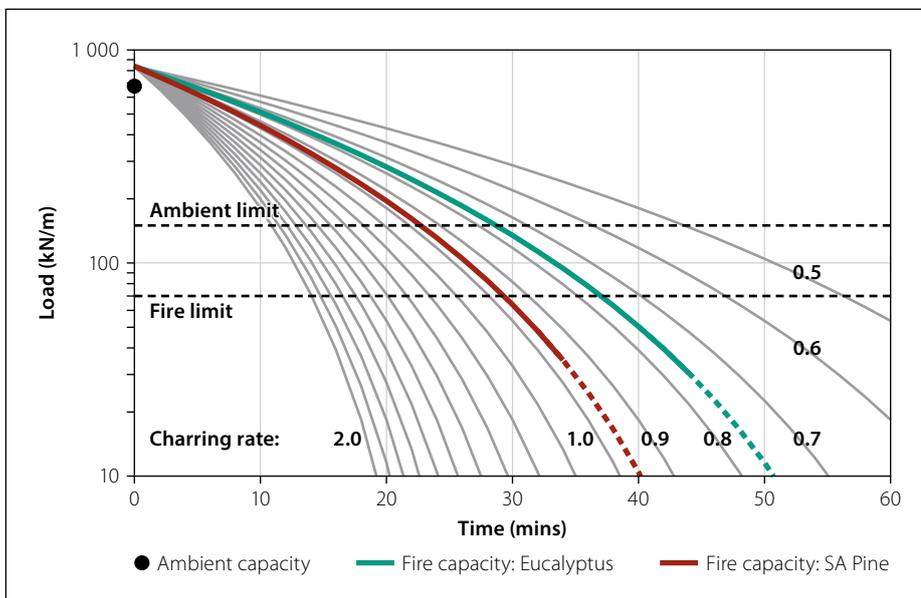
Figure 9 is provided to illustrate the process for the determination of rational structural resistance times for a vertically loaded 2.4 m high and 100 mm thick wall panel. The thickness of the wall panel is taken to correspond to that considered in the preceding sections, although cross-lamination is substituted with a longitudinal lamination arrangement (LLT). For a characteristic load of 100 kN/m, the ambient design load is 150 kN/m while the fire limit state design load is 70 kN/m (computed using partial and combination factors specified in EN 1995). Ignoring eccentricity effects, a simple structural capacity check using one-dimensional Euler buckling (un-conservative) illustrates the loss of structural capacity (Figure 9). For charring rates corresponding to those determined in the preceding section, structural resistance times of only 29 mins

Figure 9 Deterioration of structural resistance capacity of load-bearing LLT wall panel with time

and 36 mins are obtained, notably smaller than the integrity fire ratings reported above. These resistance times will decrease further if the effect of eccentricity and of locally accelerated charring in laminated timber is taken into account (EN 1995).
