An assessment of a practical implementation of the deemed-to-satisfy durability design and specification approach in the Swakopmund–Walvis Bay Freeway upgrade project in Namibia

M Otieno, K Walter

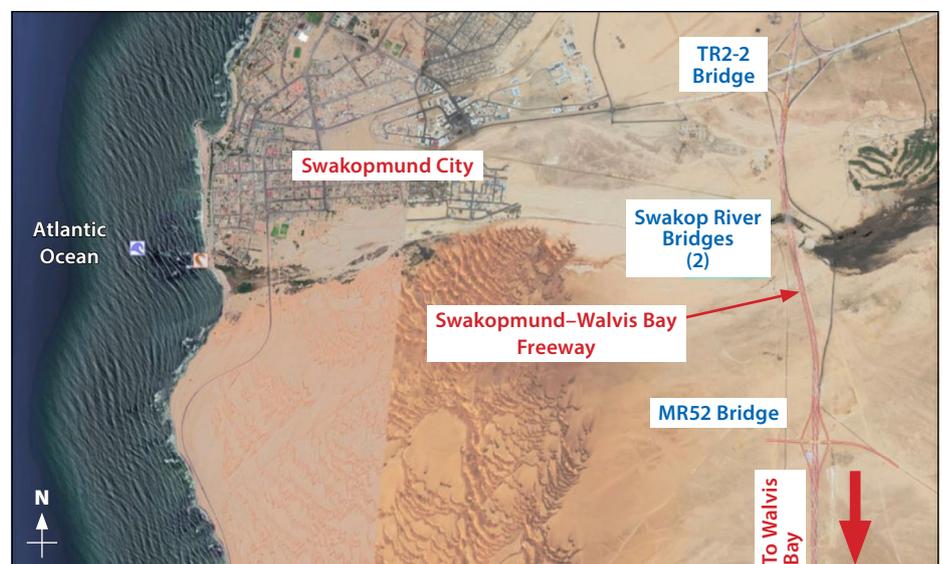
Figure 1 Schematic layout of the RC bridges in the Swakopmund–Walvis Bay freeway upgrade project

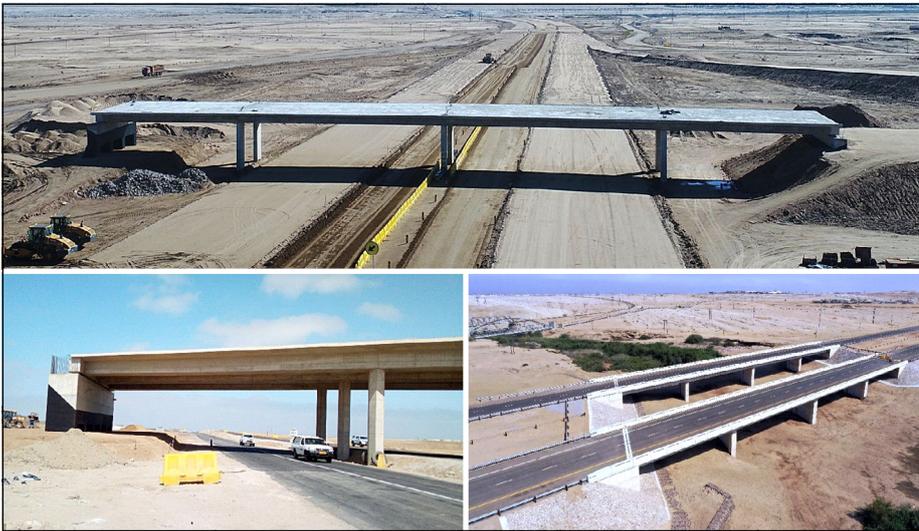
Figure 2 Photographs of some of the bridges in the Swakopmund–Walvis Bay freeway upgrade project during construction

Trans-Zambezi highways. The project is expected to increase the movement (including import and export) of goods considerably along these corridors. The project was funded by the Namibian government (the client) under the Roads Authority of Namibia, to a total estimated cost of circa 950 million Namibian dollars (1 ZAR = 1 Namibian dollar). The project consisted of constructing four post-tensioned RC bridges with overall deck lengths ranging between 56 m and 109 m. Two of the bridges spanning the Swakop River were each constructed using more than 2 500 m³ of concrete, while an excess of 1 700 m³ of concrete was used in the remaining two bridges (see Figure 2).

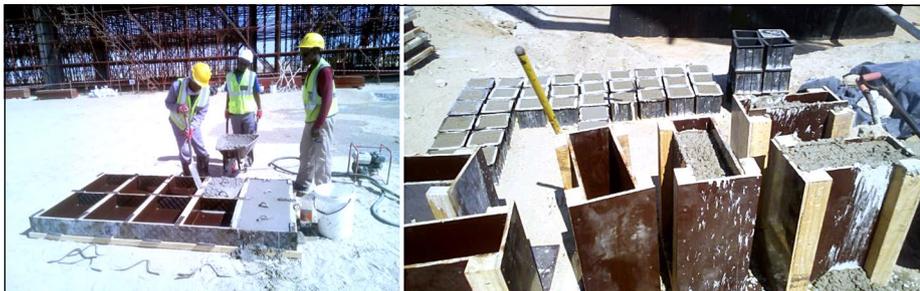
**Figure 3 Casting of horizontal and vertical test panels on site**

Companion disc specimens for DI testing were obtained from either 150 mm cubes or 600 × 400 × 150 mm test panels – see Table 2 for a summary of the sample size, and Figure 3 for photographs of the test panels from which DI test scores were taken. The test panels were cast to match the direction of casting of the bridge element of interest. All the specimens for durability testing were made using the concrete used to cast selected bridge elements (piers, abutments and decks). More test panels were cast compared to the cube specimens to cater for the expected inherent variability in the as-built concretes in the various bridge elements. The cube specimens were cured

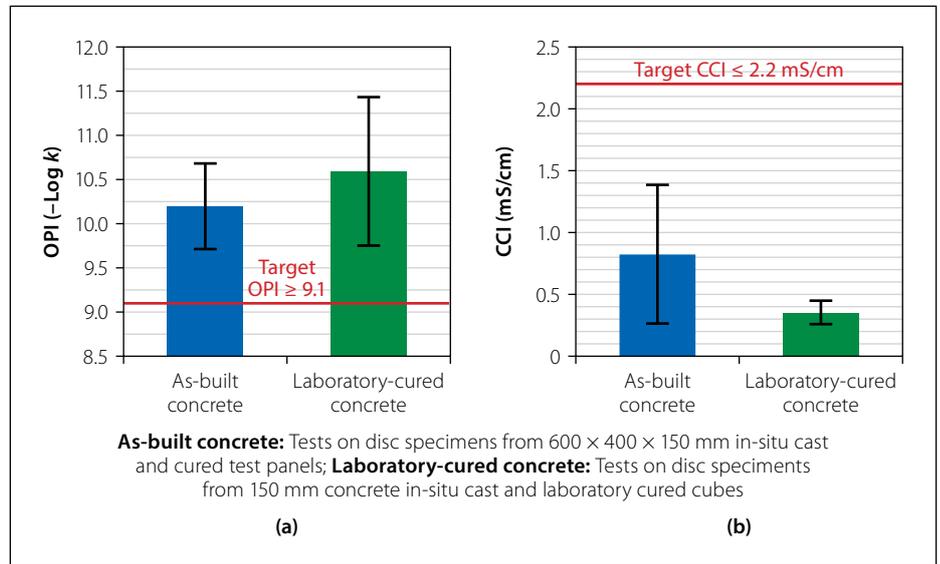
Figure 4 Oxygen permeability and chloride conductivity test results for the as-built and laboratory-cured concretes (error bars at 95% confidence interval)

Outliers were manually removed from the test results (based on the coefficient of variability values) and not considered in the subsequent analyses. A summary of the DI results is presented in Figures 4 and 5. As expected, the results show that the laboratory-cured concretes had better durability potential than the as-built concretes, i.e. higher OPI, lower CCI and lower WSI (Beushausen *et al* 2021). The results also corroborate those of previous similar projects that showed that there is generally higher variability in the on-site DI values (Nganga *et al* 2017). It is also clear that the target OPI, WSI and CCI values were met,

a trend that can be attributed mainly to good quality control on site, i.e. adequate compaction and curing.

(Otieno 2017) that highlight the importance of concrete quality (i.e. penetrability) in minimising the risk of steel corrosion in RC structures; in the project, the target penetrability, especially with respect to chloride ingress, was exceeded (see Figures 4 and 5).

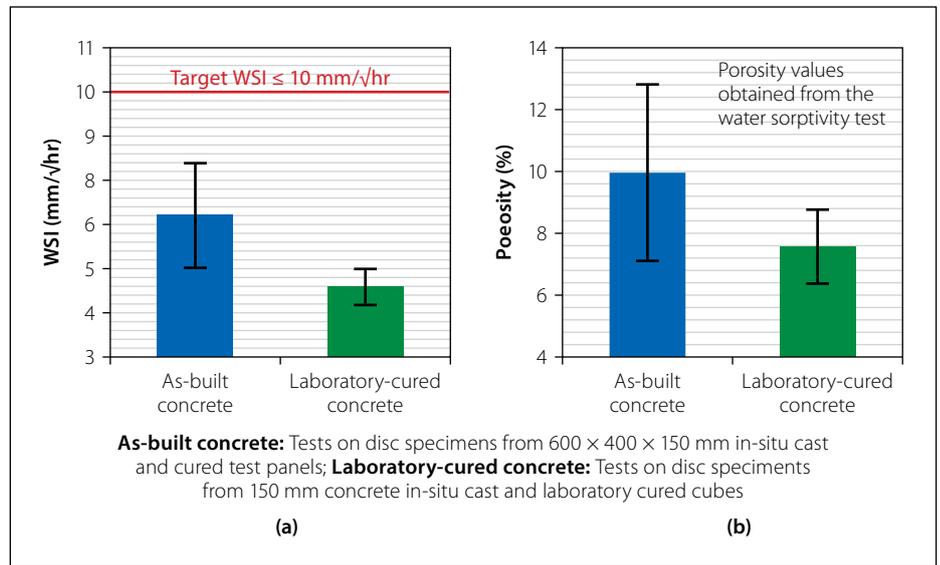
Figure 5 Water sorptivity and porosity test results for the as-built and laboratory-cured concretes (error bars at 95% confidence interval)

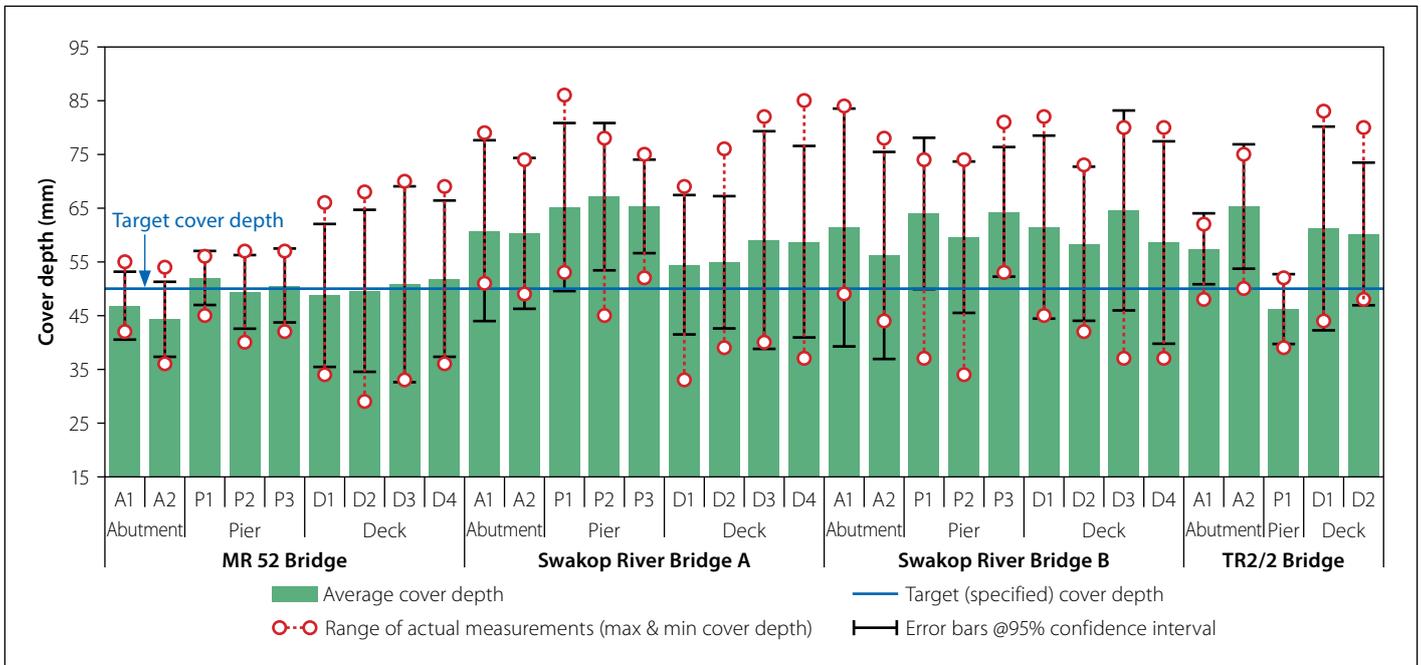
Figure 6 Cover depth measurement results

Figure 6 shows the results of the cover depth measurements, while Figure 7 shows a lognormal distribution curve fitted using MATLAB® to the histogram of the as-built cover depth measurements. Up to 30% of the cover depth readings fell below the target cover depth of 50 mm.

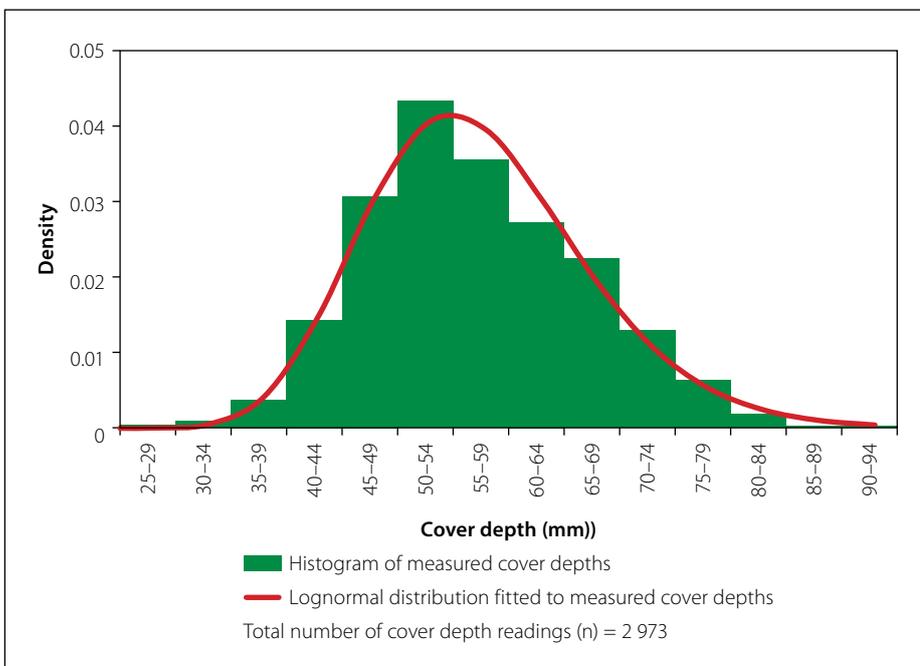
Figure 7 Distribution of as-built cover depth measurements

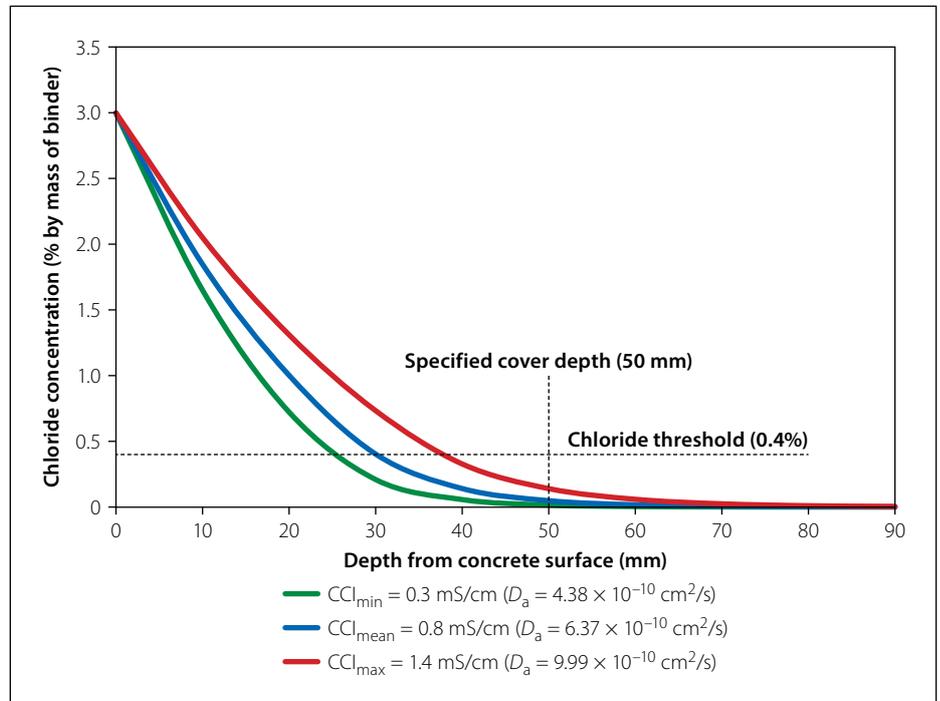
Figure 8 Chloride profile predictions for 100-year service life based on measured concrete quality

Figure 8 shows the chloride profiles determined using the aforementioned model input parameters. From this figure, two observations can be made. First, it is clear that if the specified cover depth of 50 mm

was achieved in all the RC bridge elements, the desired 100-year service life would be surpassed, i.e. the chloride concentration at the steel level would be less than the chloride threshold value after 100 years' exposure. Secondly, it is also clear that even in instances where the specified cover depth of 50 mm was not achieved (see Figure 6), the 100-year service life would still be achieved as a result of increased concrete quality. This necessitated a careful look at the analyses results presented in Figure 8 to determine the minimum cover depths for the various concrete qualities (quantified using chloride conductivity index) required to achieve the desired 100-year service life. These are presented in Figure 9, which shows that even though the specified concrete cover of 50 mm may not have been achieved in some instances during construction of the various RC bridge elements, the expected loss in service life (Beushausen *et al* 2021) is compensated by the relatively high concrete quality achieved on site.

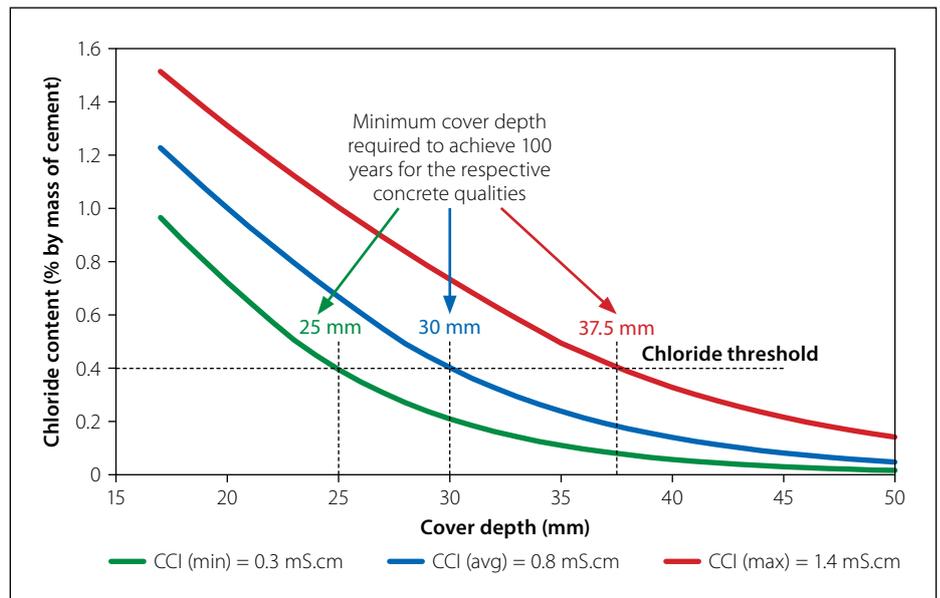
Figure 9 Minimum cover depths required for the various in-situ concrete qualities

The determination of the minimum cover depths for the various concrete qualities shifts the focus to cases where the minimum cover depth (25, 30 or 37.5 mm) was not achieved. Effectively, considering the high concrete quality of the in-situ concrete achieved during the construction of the bridges, the prescriptive design cover depth of 50 mm can be viewed as an 'over-specification'. From a steel corrosion risk standpoint, two combinations of cover depth and concrete quality with the highest risk of steel corrosion were then identified, namely (i) 25 mm and 0.3 mS/cm, and (ii) 37.5 mm and 1.4 mS/cm. An analysis was therefore carried out to determine the expected loss in service life considering the corrosion risk posed by a combination of inadequate cover depth (< 37.5 mm) and concrete quality (< 1.4 mS/cm). The results are summarised in Figure 10 and Table 4.

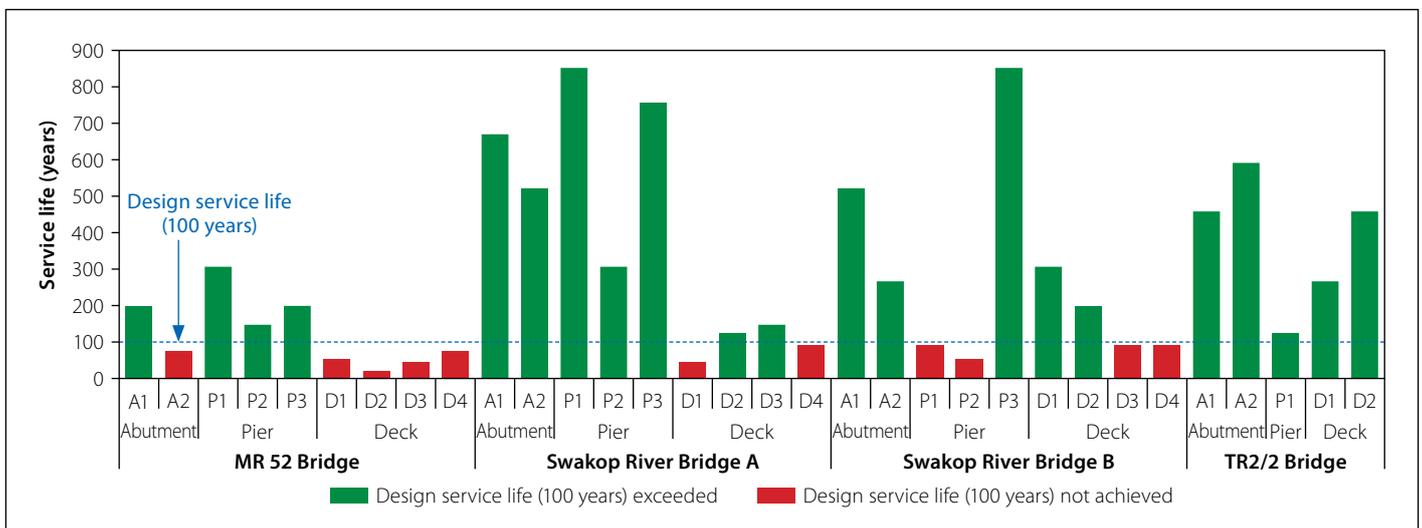
Figure 10 Expected service life performance of the various bridge elements

c 100-year service life exceeded (i.e. cover depth > 37.5 mm) – see Figure 10
