Alleviating the problem of cracking of masonry buildings on expansive clay by building flexibility into the masonry

P R Stott, Z Smith, E Theron

Stott PR, Smith Z, Theron E. Alleviating the problem of cracking of masonry buildings on expansive clay by building flexibility into the masonry. *J. S. Afr. Inst. Civ. Eng.* 2023;65(1), Art. #1455, 12 pages. <http://dx.doi.org/10.17159/2309-8775/2023/v65n1a2>

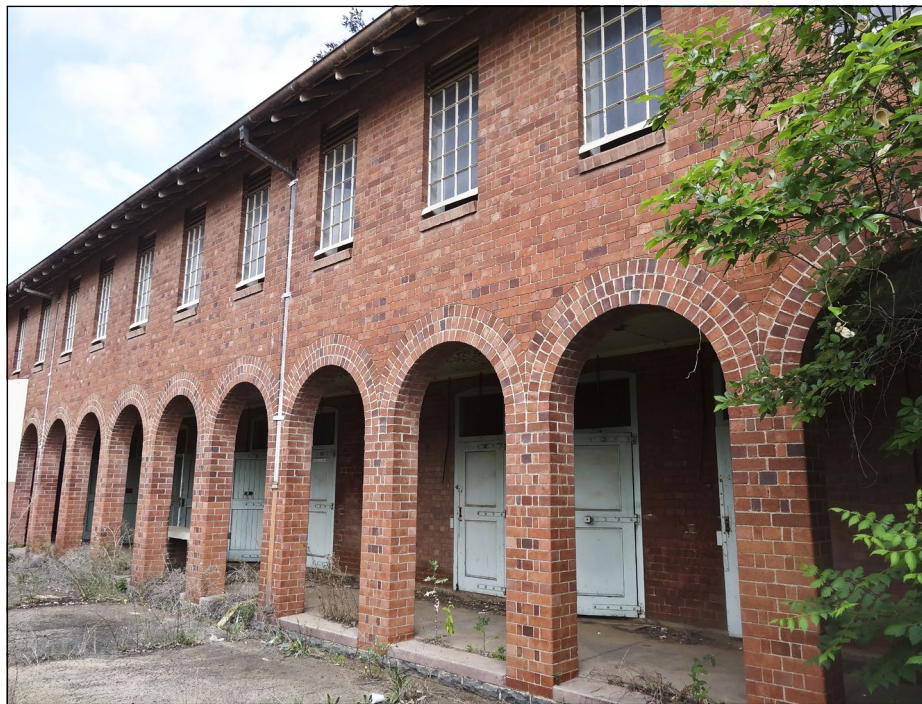
Figure 1 One of the abandoned buildings at the former Oranje Hospital

Buildings at the former Oranje Hospital (now the Free State Psychiatric Complex) in Bloemfontein provide a very good illustration of the performance of mortar that meets these criteria. The one- and two-storey buildings were built in the late 19th and early 20th centuries. Construction is of baked clay bricks and lime mortar. The underlying foundation material is expansive. These buildings have largely been abandoned, though one or two are still used for storage. The reason for abandonment is failure to meet current standards for hospitals (size of rooms, number, and positioning of ablu-tion facilities, etc). No aprons around the buildings or movement joints in the walls were provided. No maintenance has been performed for several decades, yet the condition of the masonry remains excellent. Despite the length of the building shown in Figure 1, there are no visible cracks or evidence of distress, even though there are no movement joints.

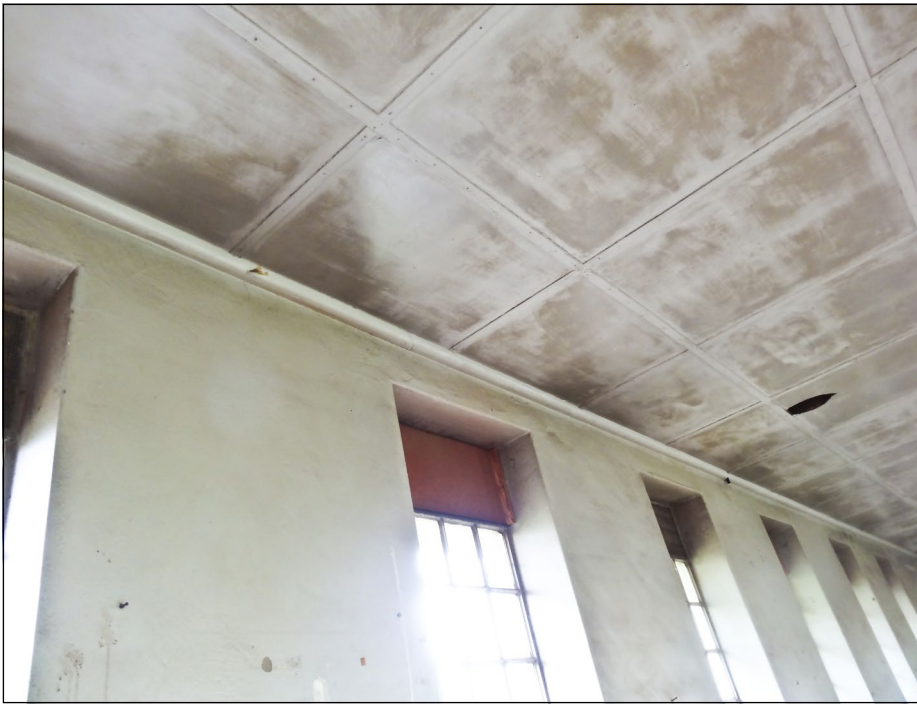
Figure 2 The interior of one of the abandoned buildings illustrating no cracks

The interior of this abandoned building is shown in Figure 2. It does not show any evidence of cracks forming at the top of the windows or anywhere on the walls after many decades of abandonment and neglect.

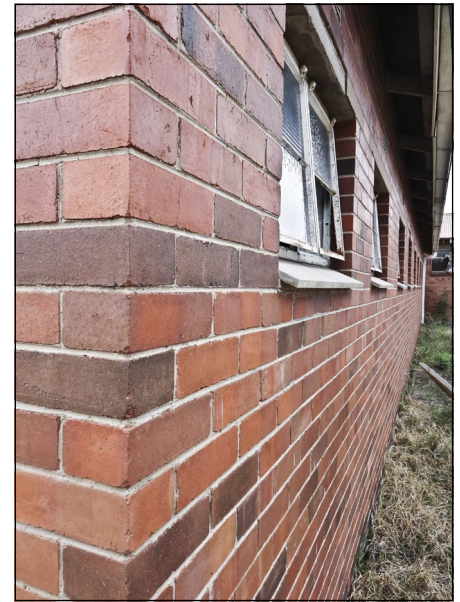
Figure 3 Closer view of the outside wall of one of the abandoned buildings

A closer look at the outside wall of one of the abandoned buildings in Figure 3 illustrates that there is no evidence of

distress found in the mortar and no gaps between the bricks and mortar.

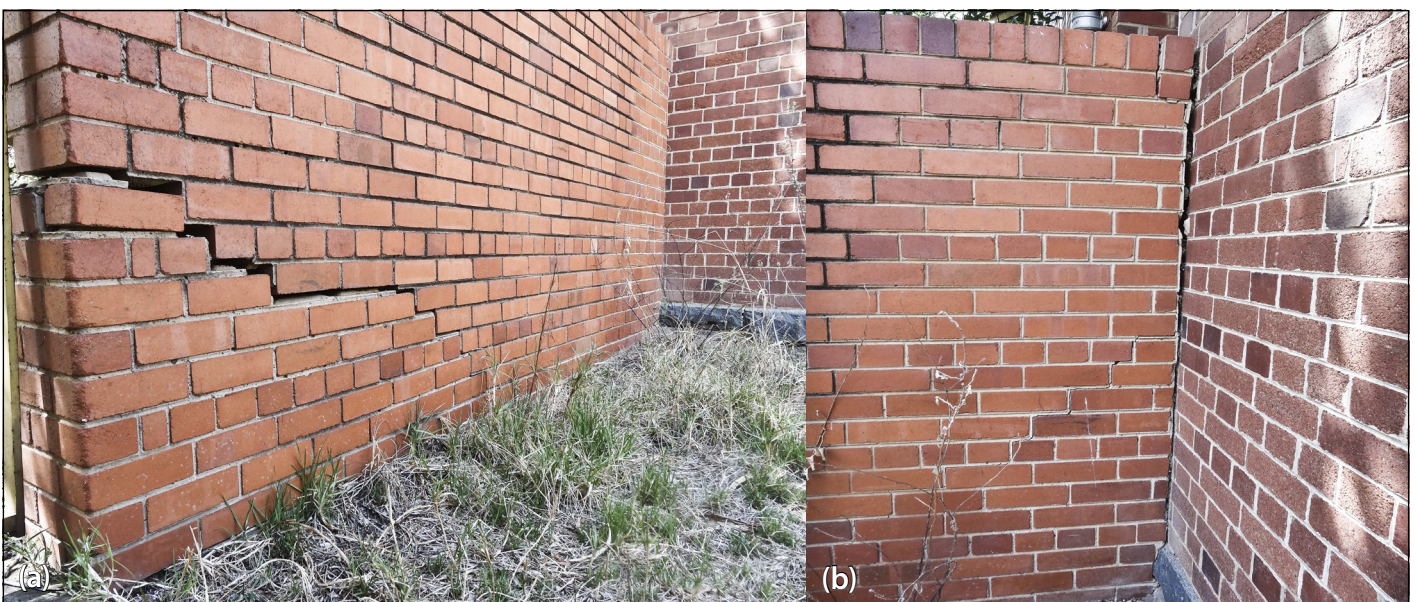
Figure 4 A later additional wall showing typical damage due to soil movement

A much later addition of a wall to an abandoned building, to close a gap between two buildings and restrict access to a locked gate, shows typical damage due to soil movement (Figure 4). The new, cement mortar wall, is leaning away from the original wall and typical cracks at the mortar-brick interface are evident. At the end farthest from the old building, severe cracking along mortar joints has taken place. The new wall shows staining and degradation of the mortar, while the old wall shows very little degradation. The original lime mortar allowed the buildings to flex under the action of expansive clay,

whereas the later additions do not have the required flexibility to do so.

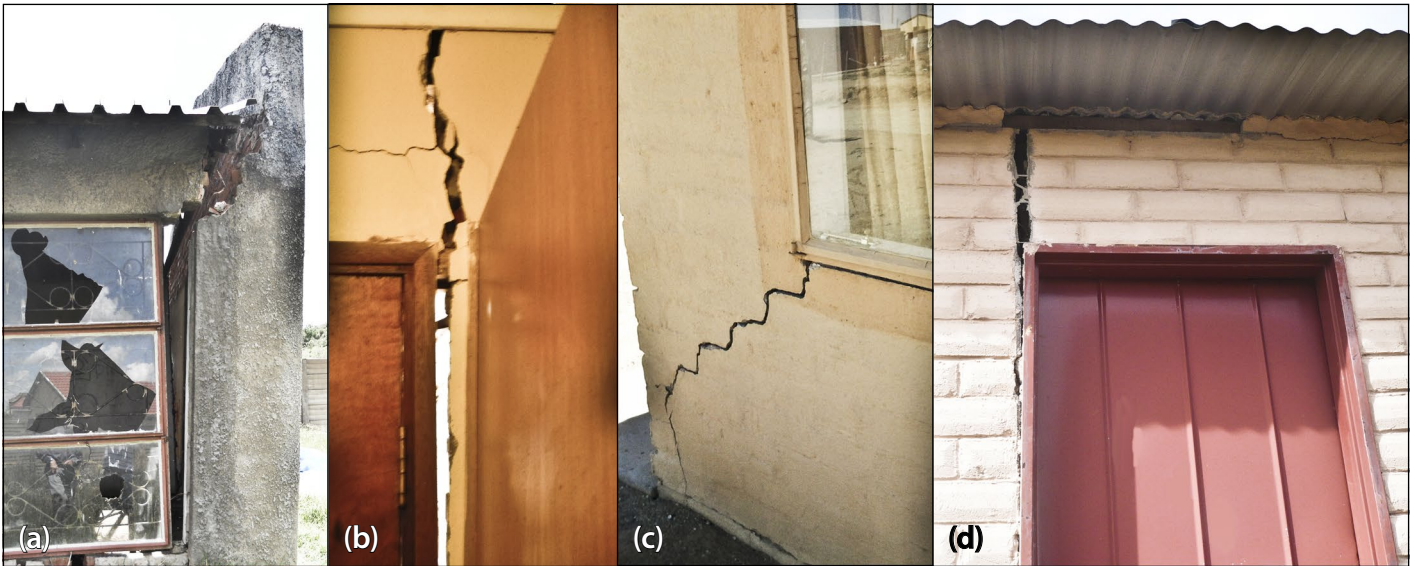
Figure 5 Four single-storey masonry houses failing within a few years after construction

In contrast to these buildings, which have remained intact on unfavourable foundation conditions for about a century, many of the light structures now being built in South Africa have failed to last even five years without severe damage. Figure 5 illustrates four light, single-storey houses that failed within a few years after construction. Picture (a) shows a small light structure in an “emerging middle class” development that became too dangerous to complete before receiving its first coat of paint. The second picture (b) is of a single-storey masonry house in another “emerging middle class” development that

lost its structural integrity less than four years after construction. The third picture (c) is of an RDP (Reconstruction and Development Programme) development where almost every house showed evidence of cracks on this scale within five years of construction. In picture (d) the RDP house failed soon after receiving its first coat of paint.

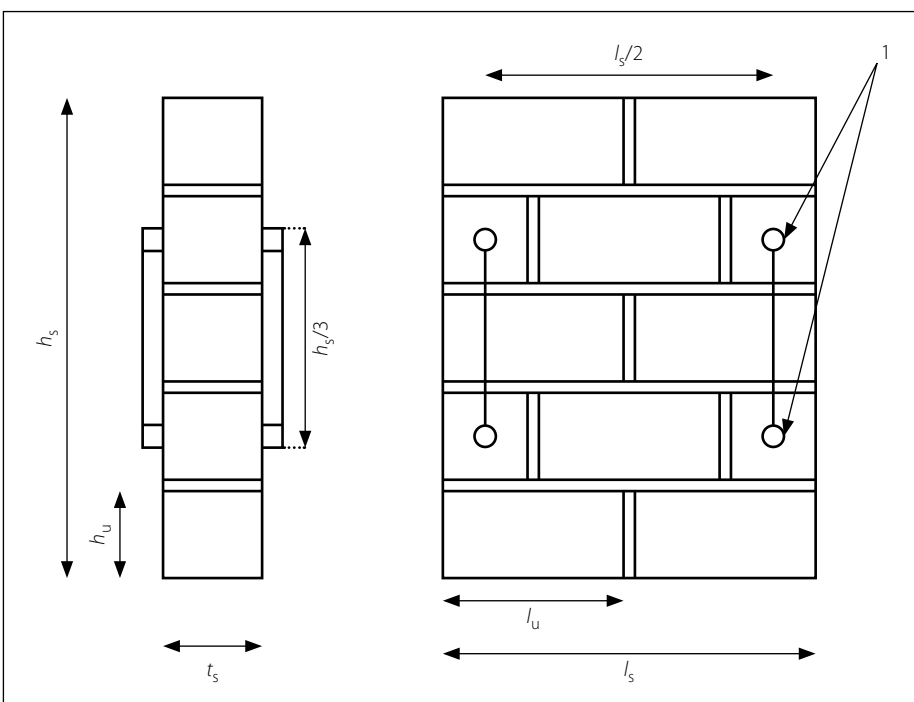
Figure 6 Test panels of two bricks wide and five bricks high (European Standard 1999)

panels two bricks wide by five bricks high as in EN1052-1 (European Standard 1999) shown in Figure 6. This may have relevance to medium-rise masonry construction, where failure may be due to high structural loading. It may be unhelpful for light structures, such as low-cost housing, where distress in brickwork is usually due to distortion caused by foundation movement rather than by high structural loading.

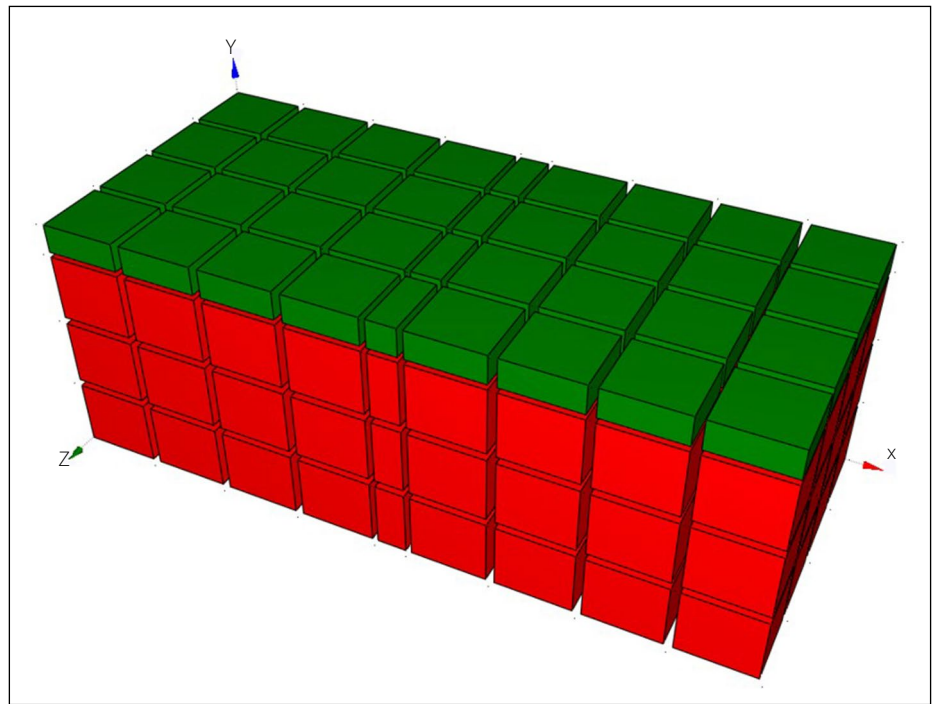
Figure 7 Accepted mesh refinement in a brick solid element and mortar solid element

The arrangement of elements was subject to the mesh refinement procedure, until further refinement showed less than 1% influence on stresses within the wall shown in Figure 8. Figure 7 illustrates the accepted mesh refinement in a single brick solid element (red) with a single layer of mortar (green). The standard PROKON conventions for directions, shown in Figure 7, are used throughout. All analyses used PROKON's second order setting for convergence. This setting repeatedly analyses the structure until further increases in deformation are negligible. None of the analyses required more than five iterations.

The mesh refinement shown in Figure 7 was applied to a wall panel of eight bricks by ten courses. Figure 8a provides a view of the wall panel designed using PROKON. The wall panel was restrained using restraining conditions $XYZxyz$ (restrained from movement in the XYZ directions and from rotation about XYZ axes) at the first three nodes in line in the Z-direction of the bottom brick solid element. Thereafter, the remaining bottom nodes of the brick and mortar solid elements were restrained in the Y-direction to follow a simulated heave dome. AutoCAD was used to obtain an appropriate heave dome and the displacements were read from the simulated dome. The values presented in Figure 8b show that the maximum displacement was 100, which was converted to 1 mm maximum displacement in the wall. The rest of the dimensions were also divided by 100 and entered in the appropriate displacement table in PROKON. Because the wall panel is symmetrical, a preview of half of the dome is provided ranging from zero displacement found at the corners of the wall panel, to the full 1 mm displacement at the centre of the wall panel.

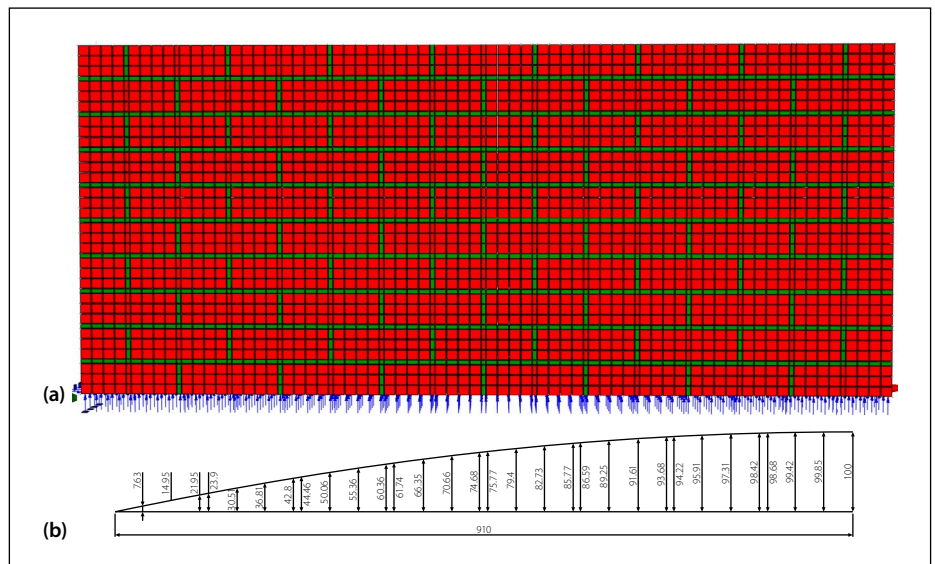
Figure 8 (a) Masonry wall panel of eight bricks by ten courses with accepted mesh refinement, (b) displacement values simulating one half of a heave dome

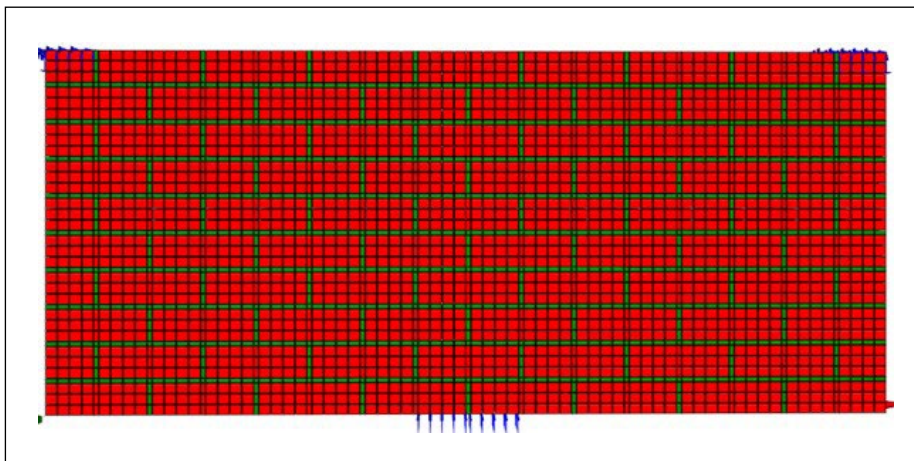
Figure 10 Restrained finite element model

The finite element program PROKON was used to model restrained experimental test panels using the mortar parameters of Costigan *et al* (2015). This is shown in Figure 10. The restraints at the top corners are linear restraints in the conventional Y and Z directions, while restraints at the bottom corners are linear restraints in the Z direction (see Figure 7). Deformation is applied upwards to the central brick of the bottom of the panel.

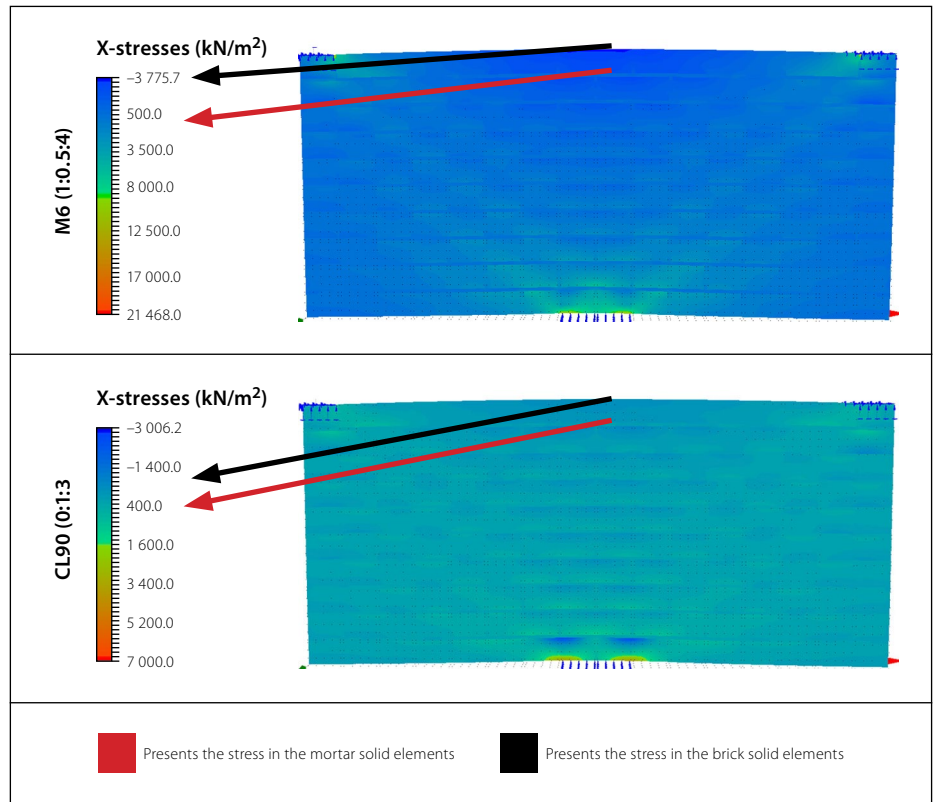
Figure 11 Results of finite element wall panels with applied restraints and displacements

Results showed the same trends as found in the preliminary investigation. Stronger mortar (M6 – cement plus hydrated lime) produced less flexible panels. Figure 11 shows the results of the finite

The applied displacements (1 mm) resulted in very different stresses in panels made with a strong, stiff mortar compared to a weaker, more flexible mortar. As can be seen in Figures 9 and 11, stresses throughout the masonry panels decreased considerably as mortar strength decreased and flexibility increased.

In Figure 11 the wall with M6 mortar (cement plus hydrated lime) shows tensile stresses at the upper centre of about 3 MPa and differential stress between bricks and mortar approaching 5 MPa. The wall with CL90 mortar (hydraulic lime) shows tensile stresses at the same location of about 800 kPa and stress difference between bricks and mortar of about 600 kPa. These trends are quite similar to the heave mound results.

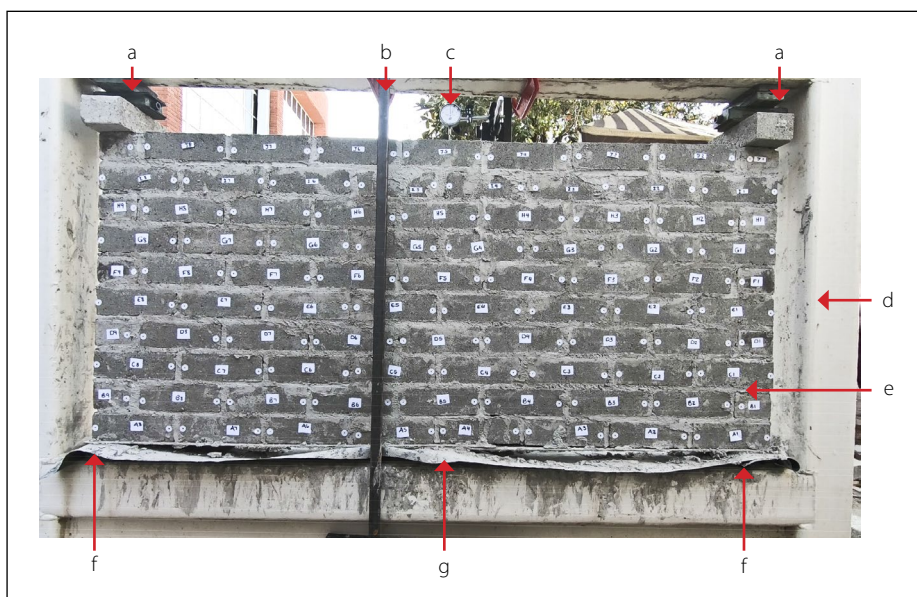
Figure 12 Test frame with masonry wall panel

A steel test frame to accommodate an experimental masonry wall panel was used to conduct displacement tests on such panels. To maintain stability, and to provide references for displacements, restraints were applied to prevent vertical and lateral movement of the corners of the panels. A 3 mm steel plate was placed across seven evenly spaced industrial levelling jacks on the lower beam of the test frame. The panel – approximately 1 830 mm × 760 mm, consisting of ten courses of eight standard cement bricks (220 × 98 × 70 mm, 14 MPa) in stretcher bond with mortar thickness 10 mm – was built on top of the steel plate, covered with plastic sheeting, and left to cure for seven days. Figure 12 shows the test frame and an experimental masonry panel ready for testing. Two industrial levelling jacks were placed at the top corners of the experimental wall panel at positions (a) to provide restraint and stability. Safety bars (b) were clamped to the frame and a dial gauge (c) was mounted to the safety bar on the opposite side. The

test frame is shown at (d) and the experimental masonry wall panel at (e). The two bottom industrial levelling jacks at the two bottom corners are illustrated at (f) with the fifth levelling jack at (g).

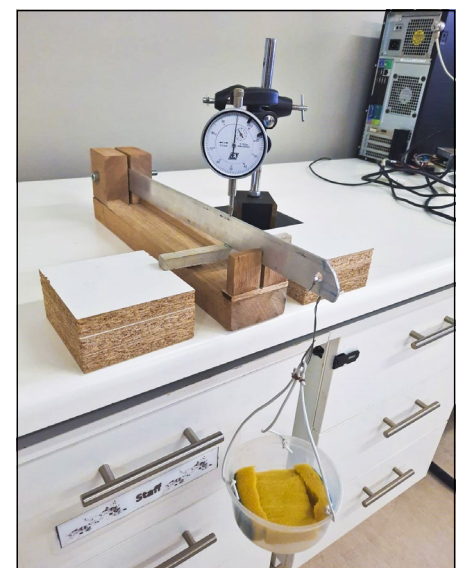
Figure 13 Apparatus used for Young's modulus test
