# Durban Harbour tunnel—first use of a slurry tunnel boring machine in South Africa

by J.A. Hindmarch\*, A.L. Griffiths†, A.K. Officer†, and G. Wittneben‡

## Synopsis

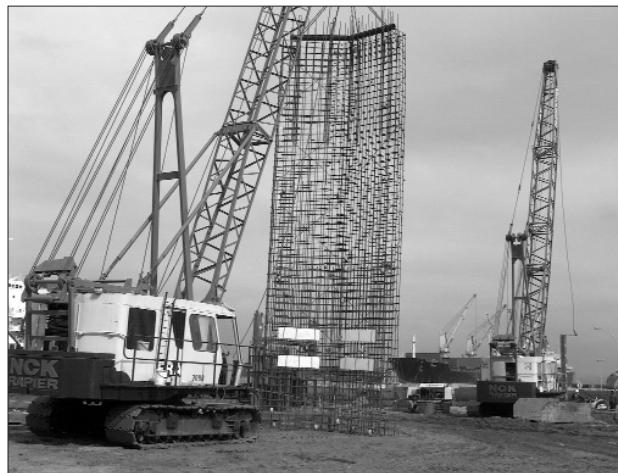
Figure 8—Shaft diaphragm wall reinforcing panel being lifted into position

- Steel stop-ends were installed at each end of the primary panel.
- Reinforcing cages were then lowered into the slot, incorporating 75 mm roller blocks to ensure the correct cover and to allow the cage to move freely down the slot (see Figure 8).

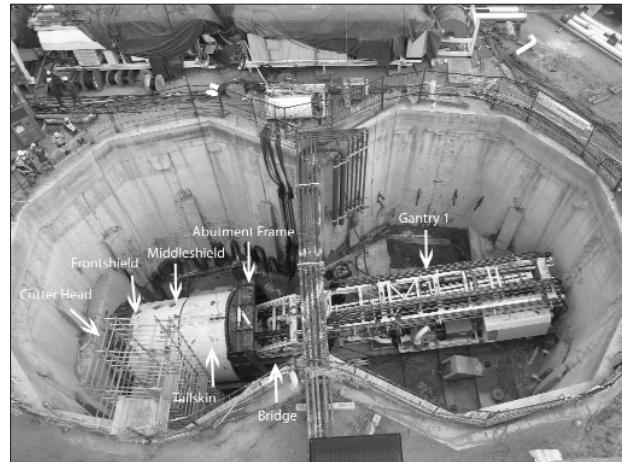
Figure 9—TBM established in the north shaft prior to launch

Following completion of the North Shaft and construction of the TBM support works, the TBM was established at the base of the shaft (see Figure 9).

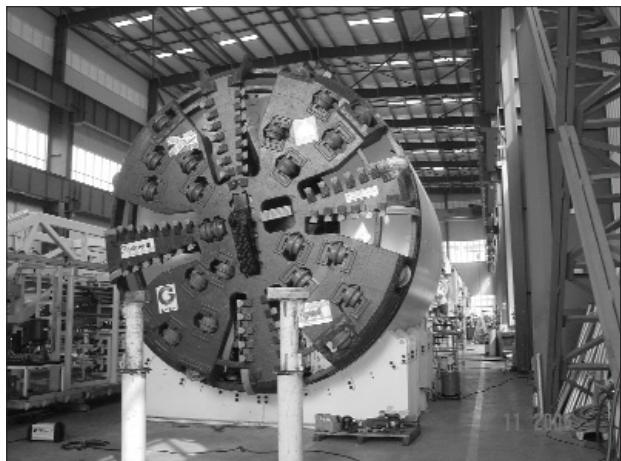
Figure 10—TBM cutterhead

The cutterhead consisted of 50 scrapers for the sand and clays and 24 disc cutters capable of excavating through the sandstone on the south side of the harbour (See Figure 10).

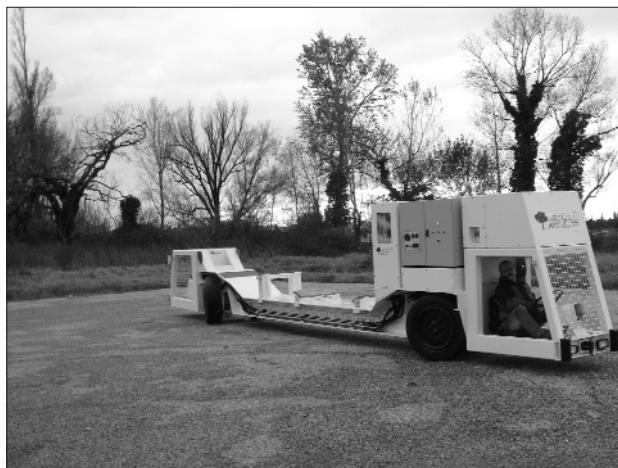
Figure 11—Multi-service vehicle

Due to the steep 20% decline and inclines in the tunnel, a trackless system of transport was developed for the operation of the TBM that was specially designed to carry the tunnel segments and grout mix and fit under the backup sledges. This multi-service vehicle was specially designed and fabricated by Techni Métal Systèmes (TMS) in France for the project, and tested using simulated conditions for full load operations on a 20% slope (see Figure 11).

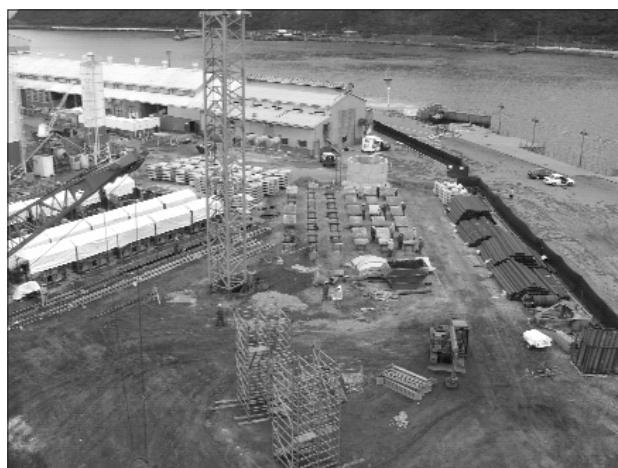
Figure 13—View along tunnel alignment showing segment production area

The manufacture of the lining segments took place on site close to the North Shaft (see Figure 13). With the limited production requirement for the short length of tunnel, and the generally favourable weather in Durban, the use of an indoor production facility was not felt to be warranted. However, portable screens were provided to protect the molds from sun, wind and rain. The molds were retrofitted with form vibrators to assist with compaction of the concrete.

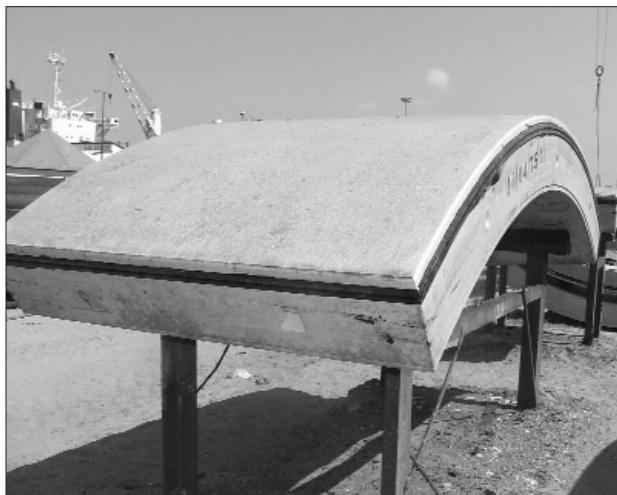
Figure 14—Typical segment in finishing yard

Segments were demolded at approximately 18 hours using a vacuum lifting device, and removed to a finishing yard where they were stored on specially fabricated steel frames (see Figure 14). At this stage minor repairs and crack sealing were carried out, and the EPDM Phoenix gasket was fitted. The segments were then moved to a storage area, and stacked in complete rings. Each segment was also given a
