Support system performance under different corrosion conditions

by J. Hadjigeorgiou*, J.F. Dorion* and E. Ghali*

Synopsis

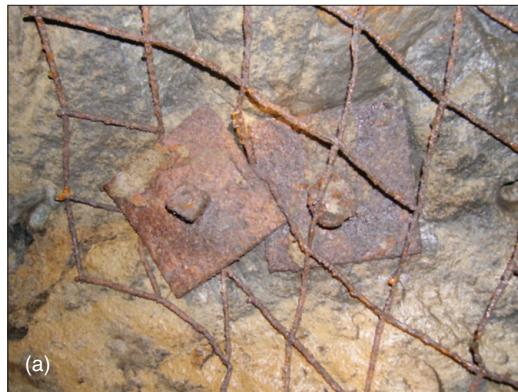
(a)

Figure 4—(a) Corroded plates with deteriorating screen; (b) corroded split set ring

An example of atmospheric corrosion is illustrated in Figure 4a where surface corrosion is observed on the elements of the support system. A second example of atmospheric corrosion is presented in Figure 4b, clearly illustrating the damage to the ring of the split set. In this particular location the rock mass was weak and the excavation had converged significantly. At both sites the relative humidity of the atmosphere was 100%.

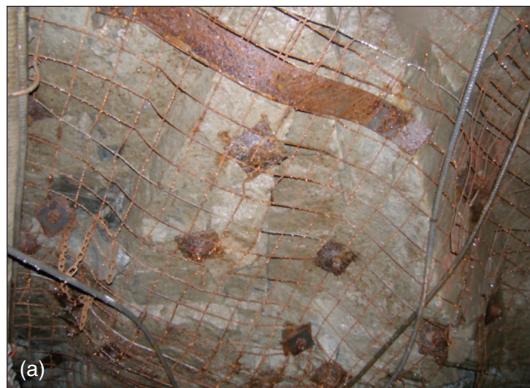
(a)

An example of heavily corroded support system is shown in Figure 5a. This was attributed to both the very high humidity but also to the presence of water infiltration in the back of the excavation. A closer inspection of the photograph shows the water droplets on the support as well as resulting metal laminations, Figure 5b). The analysis of the water samples, flowing through the rock fractures at this location, revealed a concentration of 1938 ppm of Cl⁻. In this particular location the screen crumbled when squeezed by the fingers.

Figure 5—(a) Surface corrosion of support; (b) corroded screen
