# Investigations into the residual strength of a 2.5 m wide Bushveld Merensky Reef crush pillar

by B.P. Watson\*, S.M. Mosomane\*, J.S. Kuijpers\*, and D.P. Roberts\*

## Synopsis

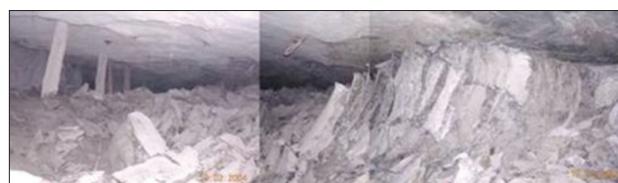
Figure 2—Panoramic view showing the up-dip end of a burst pillar. Note the gully is full of rock fragments from the pillar burst

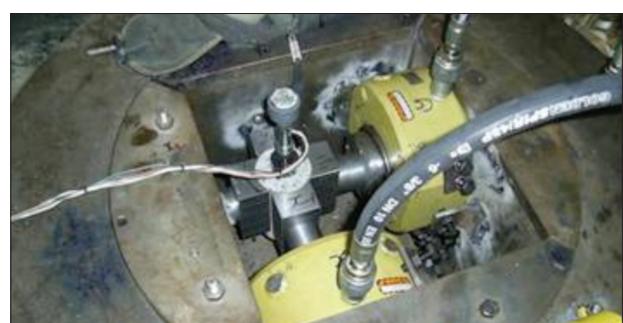
Figure 9—Mechanical biaxial test apparatus for doorstoppers

Further analysis and microscope work established that the behaviour was influenced by open micro-cracks. Thus, in theory, once the cracks are closed the material should behave in a normal, linear elastic manner. However, in the case of the UCS tests, the onset of failure occurred before the cracks were fully closed. The doorstoppers were, therefore, evaluated using a biaxial test, performed on specially prepared doorstopper samples, as shown in Figure 9 and Figure 10 respectively.

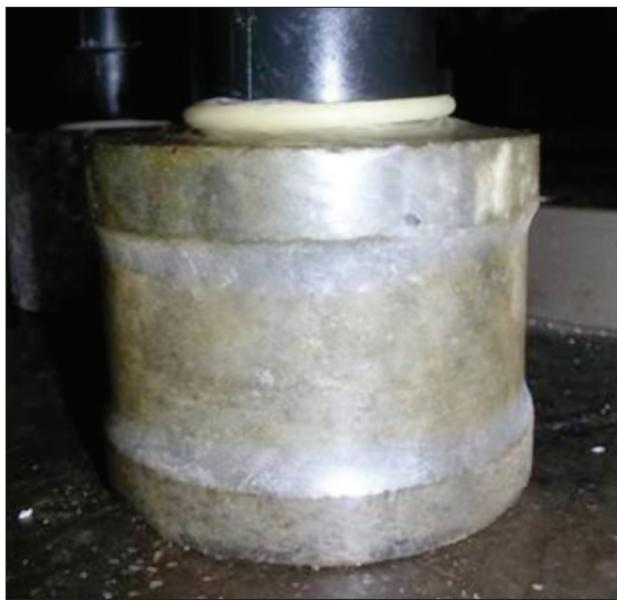
Figure 10—Specially prepared doorstopper sample

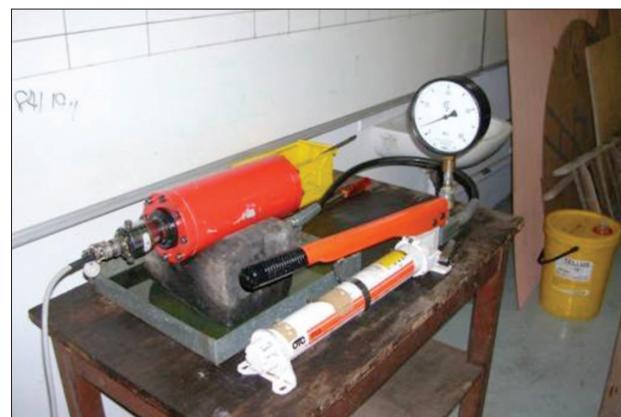
Figure 11—Test apparatus for loading triaxial cells

The triaxial cells were evaluated using the biaxial test apparatus shown in Figure 11. The stress concentrations on the inside of the hollow cylinder used in the tests meant that the radial and axial strains had to be evaluated separately for the non-linear material. A list of all the stress results is shown in Table I. The triaxial cell results are in bold.

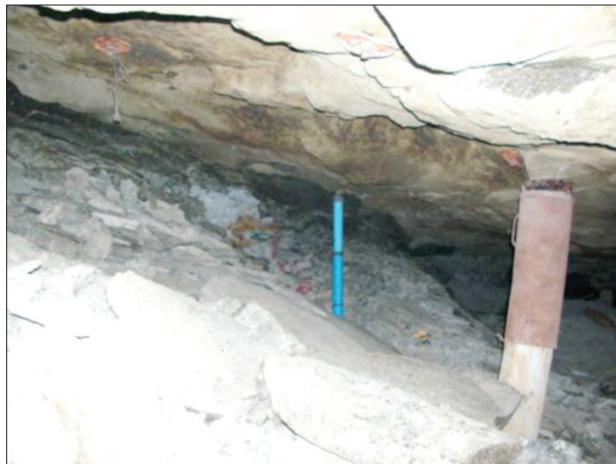
Figure 13—Down-dip side of the instrumented pillar. View away from face

The reference point used for the evaluation of the stress measurements was the centre of the down-dip edge of the pillar (the bottom edge in Figure 12). The matrix inversion of the 'adjusted' stresses provides the estimated stress distribution across the pillar. While other measurements made around the pillar showed that it had failed, the Boussinesq evaluations suggest that the central core of the pillar is still carrying 2 100 MPa. This high stress is unlikely as the physical conditions surrounding the pillar suggested a reasonably low stress environment after failure, with a stable hangingwall adjacent to the pillar (Figure 13).

However, stress change was measured on the evaluated pillar from before pillar failure. The stress had dropped to the measured value 12 months prior to the profile measurements and remained unchanged while further mining took place. In addition, the observed pillar condition (Figure 13), the stable hangingwall adjacent to the pillar and the significant closure measured up-dip and down-dip of the pillar show that the pillar is in an advanced stage of failure. It is therefore concluded that the pillar is in or very close to the residual condition. The location of the pillar when the siding was cut and good blasting appears to have resulted in an unfractured siding. This solid siding may have contributed to the unexpectedly high residual strength of the pillar.

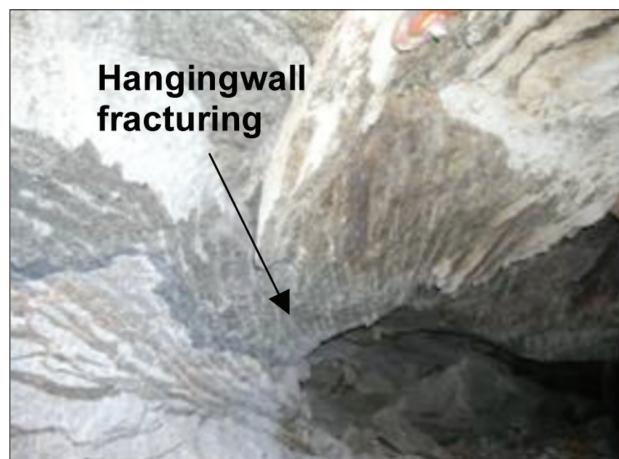
Figure 16—Up-dip side of the instrumented pillar. View towards face

Both the peak and APS stresses are high for a failed pillar of width:height ratio 2.1:1. However, the pillar height was less than 0.5 m high in places on the up-dip side (Figure 4), which may have caused the pillar to carry a higher load on this side (Figure 16). The low height of the 2.5 m wide siding may have affected the effective width:height ratio, thus accounting for the high residual strength. The high density of fracturing in the hangingwall suggests that the pillar was carrying a high stress, probably at some stage before the siding was cut. Similar fracturing was observed on the down-dip side where the fractured sidewall of the pillar had fallen away.
