Mine-wide panel stability monitoring at Anglo Platinum Union JV

Synopsis

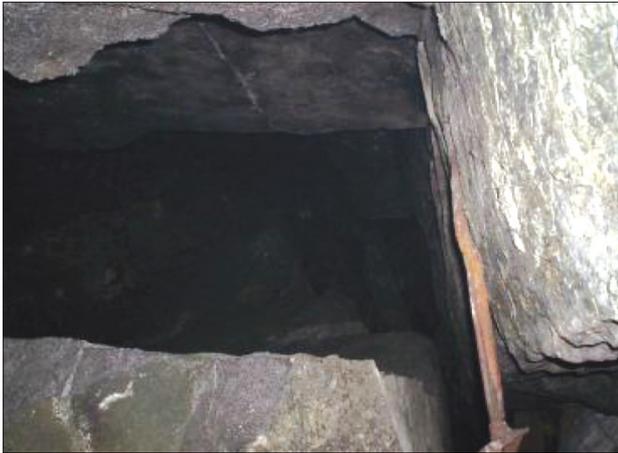
Figure 1—Planar nature of the steep dipping joints as exposed by a large fall in Panel 15S, 4S decline

structures. Massive collapses occurred if blocks of certain critical dimensions delineated by these joints were exposed. An example of one of these planar joints and the fallout caused by this are shown in Figure 1.

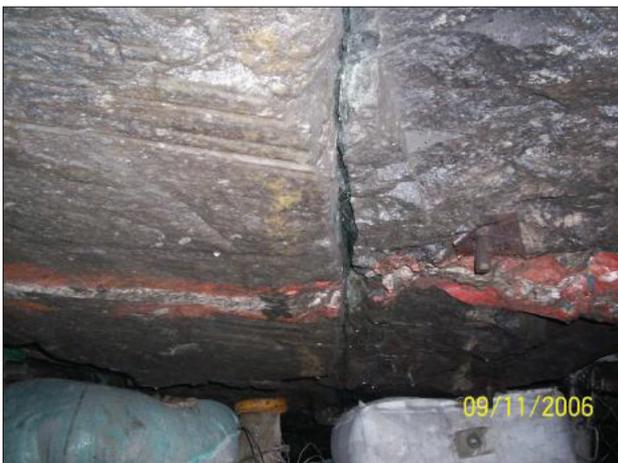
Figure 3—Opening of a discontinuity in one of the ASDs at the Declines Section

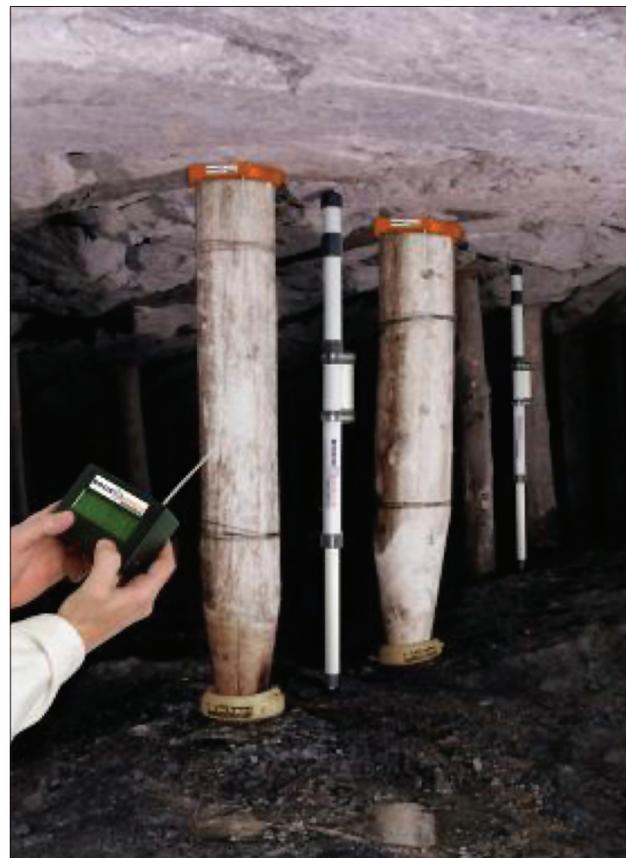
Figure 4—Continuous closure logger used to measure panel closure (hand-held radio communication unit also shown)

To overcome these monitoring problems, Groundwork Consulting (Pty) Ltd initiated the development of a far more robust and mine-worthy electronic closure logger. An example of the closure logger is shown in Figure 4. The closure is typically recorded at 5 minutes intervals. The data are stored for up to 30 days using an onboard logger and

they are then downloaded via a radio communications link to a handheld unit (also shown in Figure 4). As a battery life exceeding nine months is currently achieved, the units are designed to be discarded after this period. An important safety feature of these devices is the ability to download the data remotely. This enables these devices to be installed in areas that might become hazardous in future, allowing the operator to download the data from a safe area. Although very low power transmitters are used, underground communication distances (line of sight) of up to 30 m have been obtained.

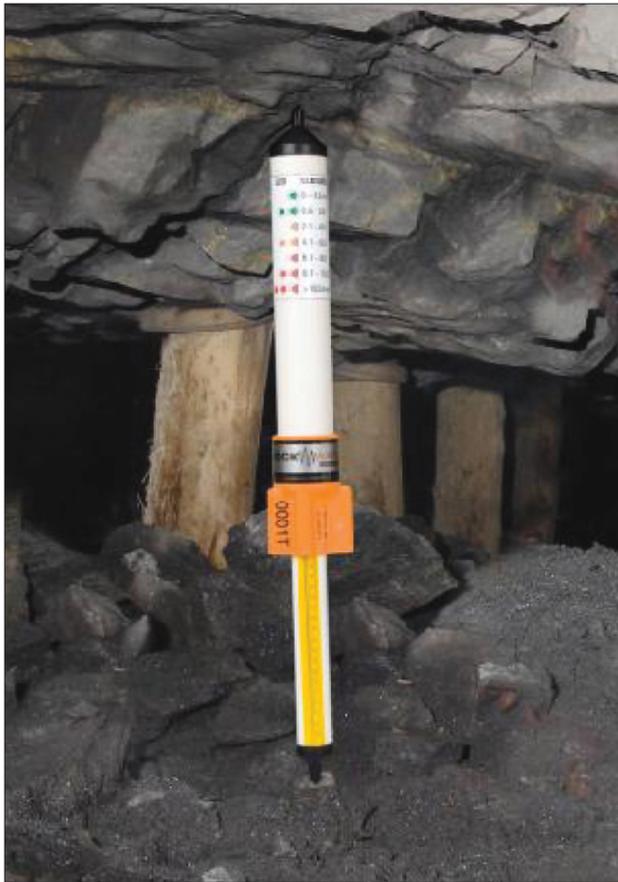
Figure 11—A photograph of the Closure Telltale

The Closure Telltale is illustrated in Figure 11. The Telltale consists of two springloaded telescopic plastic tubes to hold the instrument in place and a central sleeve containing the movement sensor and other electronics. Relative movement

between the hangingwall and footwall is detected by the sensor and converted to a visible traffic light signal transmitted by two LED lights situated on either side of the sensor sleeve. The sensor is able to detect movement of less than 0.25 mm. Other features include the ability to compensate for unnatural extension of the Telltale, an anti-tampering device, various battery conservation methods, and the ability to program alarm levels. The Closure Telltale translates rock movement into green, amber or red LED ‘traffic light’ signals, which can be easily seen and interpreted by panel workers. This immediate information enables the workers to be more aware of potential rock hazards which would not be seen or detected by normal methods. Based on the database of continuous closure information, it was decided to use 10 mm as the maximum alert level. This resulted in the sequence of LEDs being activated as shown in Figure 12.
