Magnesia refractory dryout—managing the risk of hydration

Synopsis

In 2002 the commissioning of an ilmenite smelter on the North Coast of South Africa was extended by three months due to the failure and subsequent replacement of the magnesia-based refractory lining. The lining failed due to the hydration of magnesia caused by an unexpected source of water. The incident resulted in significant financial losses and a prolonged insurance claim which was settled in 2009. As magnesia-based refractories are used extensively in both ferrous and non-ferrous applications, the authors of the paper want to share the experience gained from this incident with others. The paper reviews the literature available on furnace start-up practices and explains the hydration of magnesia using available sources. The incident is studied in more detail, both technically and economically, and the costs incurred are quantified in terms of the cost of the original lining. The paper concludes with lessons learned and recommendations made for future work. The intention of the paper is to stimulate open debate regarding best practices in preheating of furnaces lined primarily with magnesia.

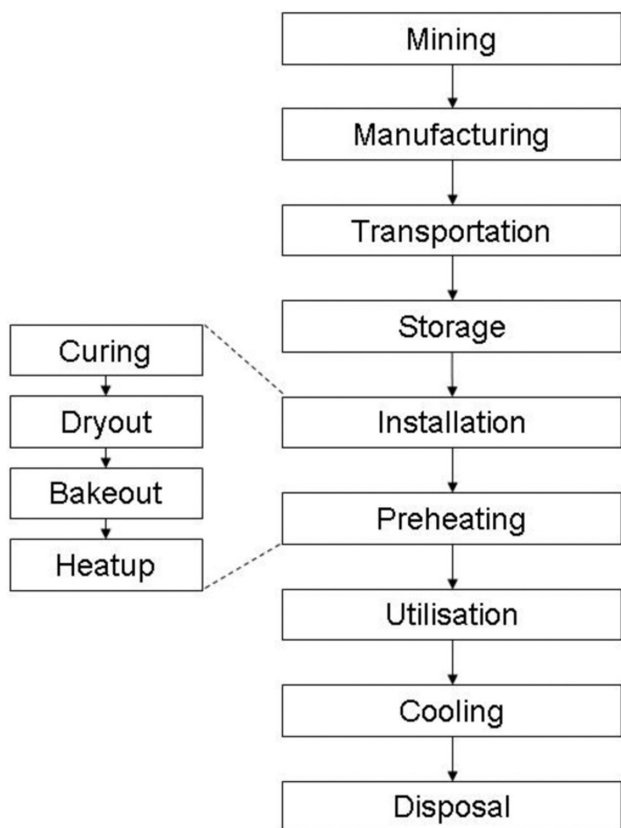
Figure 1 depicts the life cycle of a typical magnesia refractory brick. Hydration of the magnesia refractory brick can occur during any of the stages after manufacturing, but the installation and preheating (dryout specifically) stages are high risk stages⁴.

Figure 1—Typical life-cycle of a magnesia refractory brick

During the installation and preheating stages the brick undergoes several changes²⁰. Curing is the formation of hydraulic bonds. Curing follows the placement of the material and is limited to wet installations of magnesia refractory bricks. In wet installations, mortar is utilized as a bonding agent between the bricks. The hydraulic bond forms at ambient temperature within 24 hours of placement i.e. during installation. Dryout is the removal of moisture to render the lining safe to start the process at a later stage. Bakeout is the formation of chemical bonds at elevated temperatures. Heatup is the continuation of the dryout or bakeout stages to the point where the furnace can be put into operation.

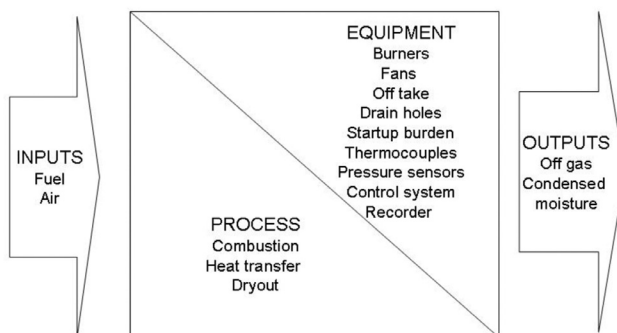
Figure 2 summarizes the inputs, process steps, outputs, and equipment involved in a dryout process where measures are put in place to prevent magnesia refractory from hydration by moisture condensing from the off-gas and by moisture condensing against the furnace shell.

Figure 2—Analysis of the dryout process

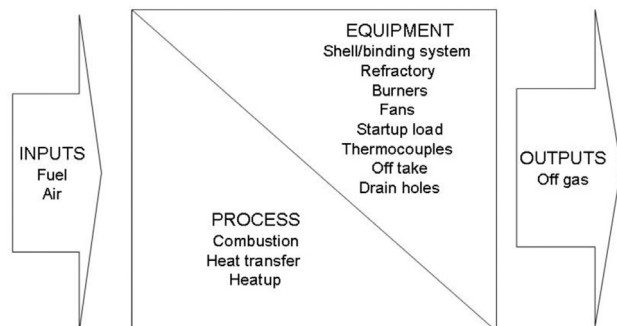
The layout and placement of the burners and fans are designed in such a manner that the heat transferred from the hot, dry air to the refractory material is homogenous⁹. If start-up burden is installed prior to preheating, its layout is designed to ensure homogenous heat transfer from the hot, dry air to the refractory lining, but the burden is preferably introduced when the heatup process reached operating temperatures⁵ (Figure 3).

Figure 3—Analysis of the heatup process

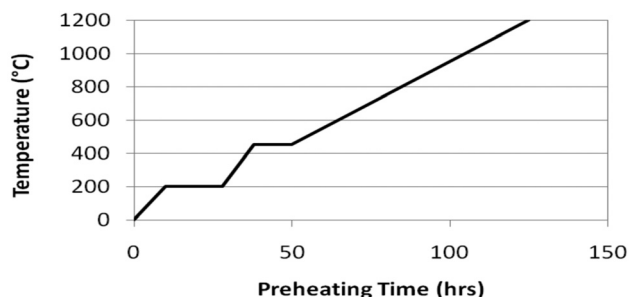
Figure 4—Refractory heatup curve as prescribed by the supplier

- The thermal input into the furnace had to be controlled according to the preheating rate prescribed in Figure 4 to prevent excessive temperature gradients within the bricks

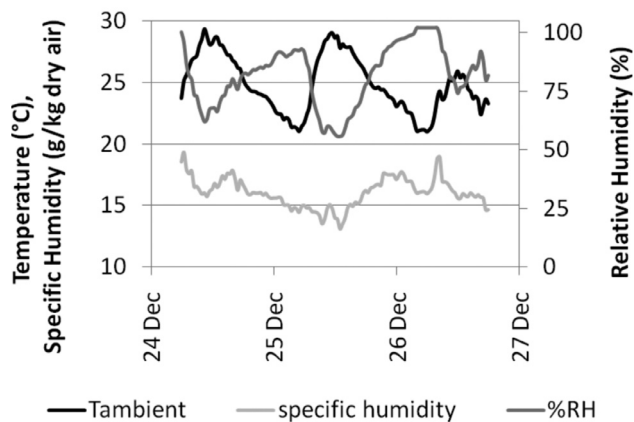
Approximately 36 hours after commencing with the preheat, the process was halted due to excessive water damage to the magnesia refractories. The water originated from the humid air utilized for combustion and its subsequent condensation within the water cooled duct (the contribution from the combustion products of the Sasol gas was, in this instance, negligible).

Humidity and temperature readings for the days over which preheating were conducted are given in Figure 5. Temperatures ranged in the high twenties, while humidities were close or equal to 100% over the period. This combination results in a humidity load to the internal furnace above 15 g/kg dry air over the last few hours of the hold at 200°C and the subsequent initial increase in internal furnace temperature. At the typical air consumption rates of 10 000–12 000 m³/h, this results in 170 200 kg of water per hour. While present as vapour within the heated furnace volume, a major part of this water condensed along the inside of the water-cooled off-gas duct, which was kept cool for the reasons as given above.

Figure 5—Ambient temperatures, humidities and dew point inside the furnace during the preheating period. The latter takes into account the increasing volume flow through the furnace with increasing temperature
