Magnesia refractory dryout—managing the risk of hydration

Synopsis

Case study

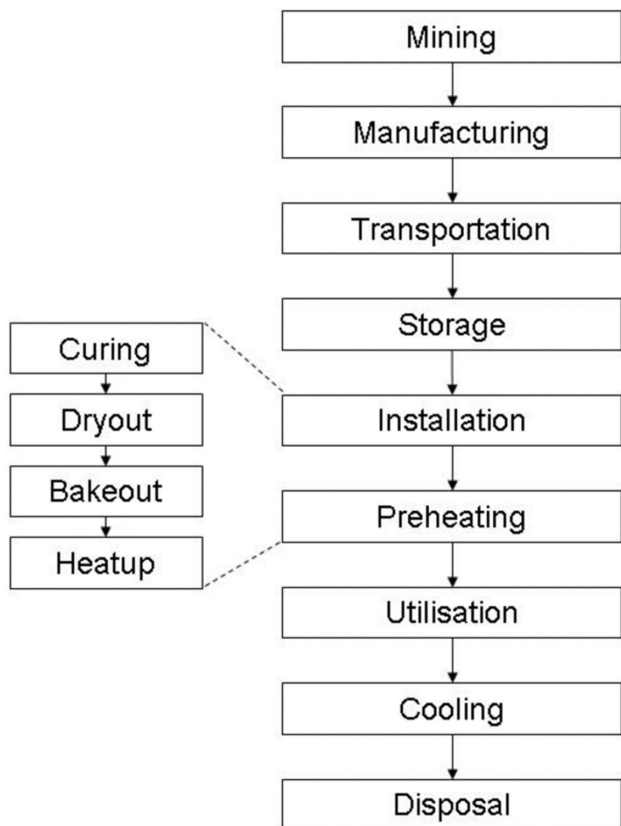
Figure 1—Typical life-cycle of a magnesia refractory brick

Figure 1 depicts the life cycle of a typical magnesia refractory brick. Hydration of the magnesia refractory brick can occur during any of the stages after manufacturing, but the installation and preheating (dryout specifically) stages are high risk stages⁴.

During the installation and preheating stages the brick undergoes several changes²⁰. Curing is the formation of hydraulic bonds. Curing follows the placement of the material and is limited to wet installations of magnesia refractory bricks. In wet installations, mortar is utilized as a bonding agent between the bricks. The hydraulic bond forms at ambient temperature within 24 hours of placement i.e. during installation. Dryout is the removal of moisture to render the lining safe to start the process at a later stage. Bakeout is the formation of chemical bonds at elevated temperatures. Heatup is the continuation of the dryout or bakeout stages to the point where the furnace can be put into operation.

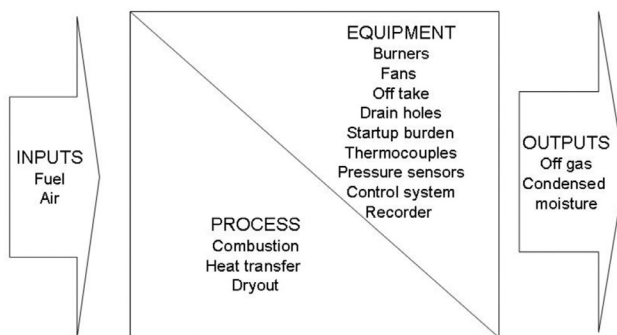
Figure 2—Analysis of the dryout process

Figure 2 summarizes the inputs, process steps, outputs, and equipment involved in a dryout process where measures are put in place to prevent magnesia refractory from hydration by moisture condensing from the off-gas and by moisture condensing against the furnace shell.

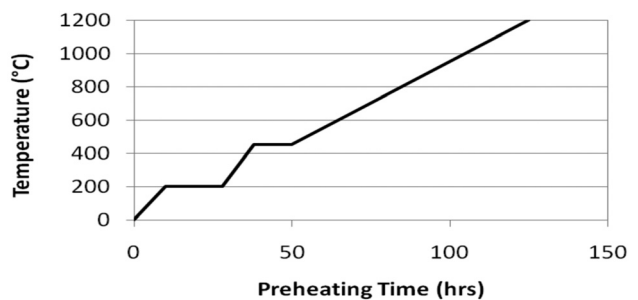
Figure 4—Refractory heatup curve as prescribed by the supplier

- The thermal input into the furnace had to be controlled according to the preheating rate prescribed in Figure 4 to prevent excessive temperature gradients within the bricks

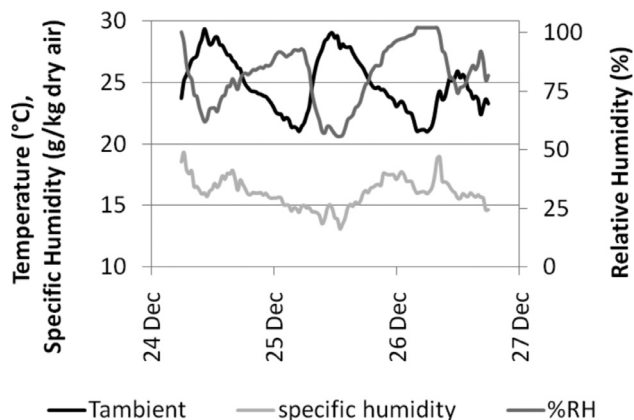
Figure 5—Ambient temperatures, humidities and dew point inside the furnace during the preheating period. The latter takes into account the increasing volume flow through the furnace with increasing temperature

Humidity and temperature readings for the days over which preheating were conducted are given in Figure 5. Temperatures ranged in the high twenties, while humidities were close or equal to 100% over the period. This combination results in a humidity load to the internal furnace above 15 g/kg dry air over the last few hours of the hold at 200°C and the subsequent initial increase in internal furnace temperature. At the typical air consumption rates of 10 000–12 000 m³/h, this results in 170–200 kg of water per hour. While present as vapour within the heated furnace volume, a major part of this water condensed along the inside of the water-cooled off-gas duct, which was kept cool for the reasons as given above.

Approximately 36 hours after commencing with the preheat, the process was halted due to excessive water damage to the magnesia refractories. The water originated from the humid air utilized for combustion and its subsequent condensation within the water cooled duct (the contribution from the combustion products of the Sasol gas was, in this instance, negligible).
