Qualitative and quantitative determination of inclusions in high-carbon steel alloy (Class B) for rail wheel application by SEM/EDS analysis

by J.S. Moema*, S.M. Semenyat†, and C. Jones‡

Synopsis

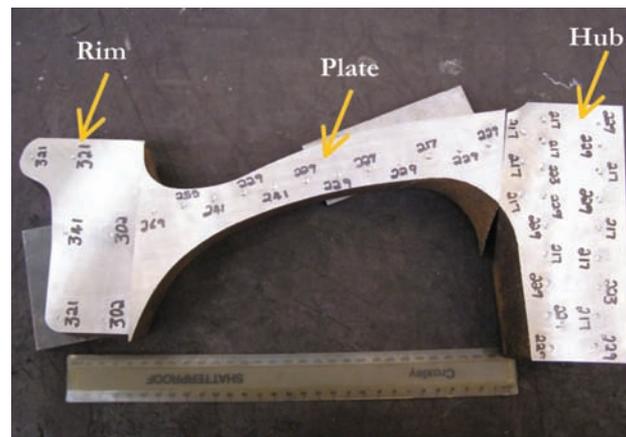
Figure 1—Photograph showing a section of a railroad freight wagon wheel (rim, plate, and hub)

additions of chromium and molybdenum (up to 0.20 per cent and 0.05 per cent, respectively) would be beneficial to achieve the minimum (specified) hardness of 321 BHN at the condemning diameter (on the rim)⁵, see Figure 1.

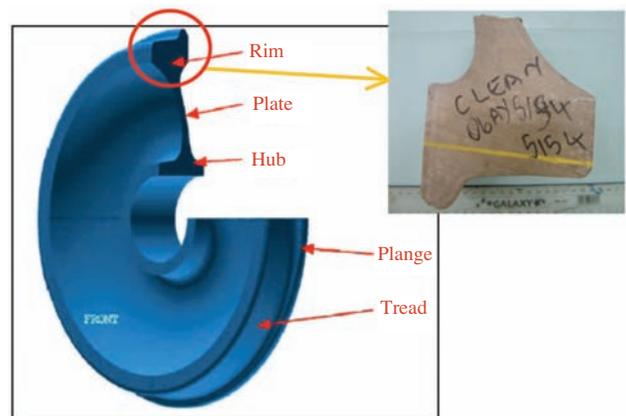
Figure 2—Photograph showing a section of the wagon wheel (rim) removed from good batch

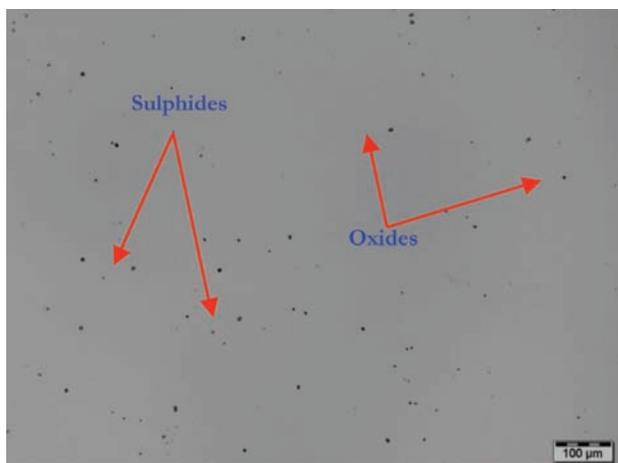
Figure 3—Micrograph of a clean sample showing lower amount of inclusions such as oxides (black dots) and sulphides (grey)

present). Figures 3 and 4 show the as-polished micrographs of the clean and rejected samples respectively. The clean sample has fewer inclusions which are homogeneously distributed throughout the cross-section as compared to the rejected sample. The oxide inclusions are globular in shape; this morphology is preferable since their effect on mechanical properties is moderate. Figure 3 shows the micrograph of the rejected sample, which reveals inclusions such as oxides (black dots) and some sulphides (grey). It contains a high amount of inclusions compared to the clean sample.

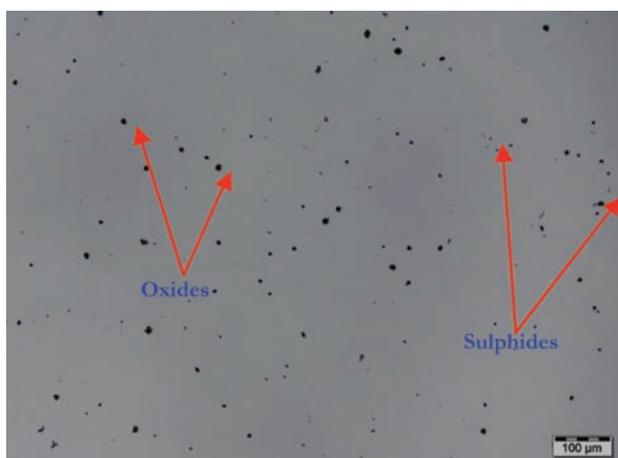
Figure 4—Micrograph of a rejected sample showing high amount of inclusions such as oxides (black dots) and sulphides (grey)

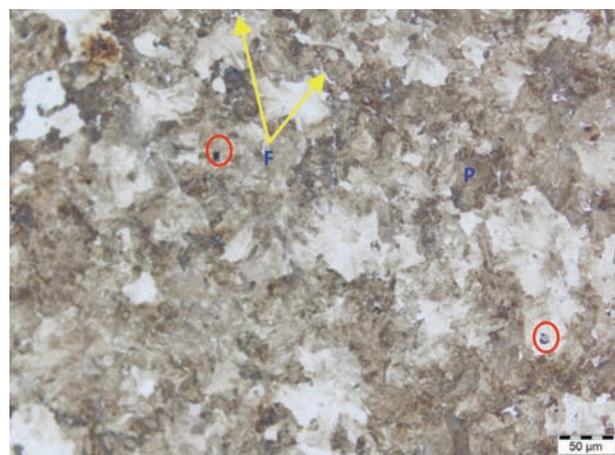
Figure 5—The microstructure of a clean sample (Class B alloy) on the rim showing fine grains of pearlite (P), ferrite (F – white phase), and low amount of inclusion (black spots)

Figures 5 and 7 shows the presence of pearlite with traces of hypo-eutectoid ferrite along the grain boundaries. The reason for this combination of phases in the microstructure is to have the advantage of the well-known high wear resistance of pearlite and to prevent the formation of pro-eutectoid cementite along the grain boundaries. This may increase fracture toughness and reduce cracking propensity along the grain boundaries, and (ideally) shelling.

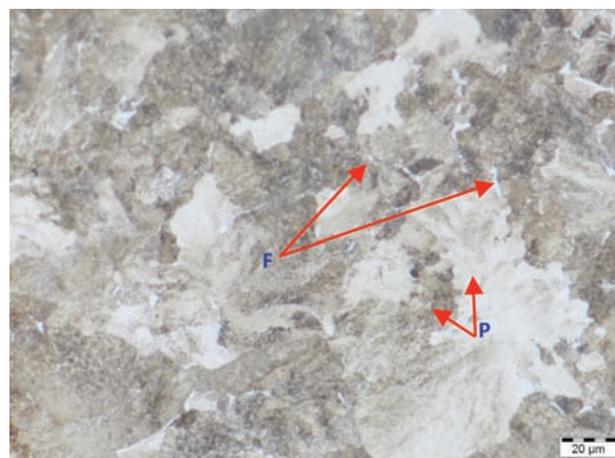
Figure 6—The microstructure of a clean sample (Class B alloy) on the rim at a higher magnification than Figure 4, showing pearlite (P) and ferrite (F – white phase)

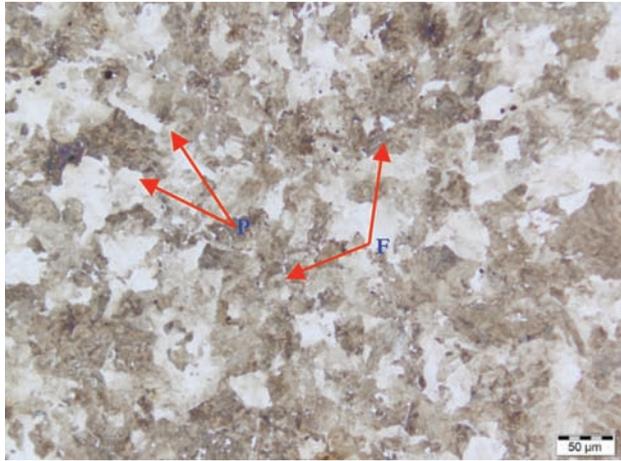
Figure 7—The microstructure of a rejected sample (Class B alloy) on the rim showing fine grains of pearlite (P) and ferrite (F – white phase)

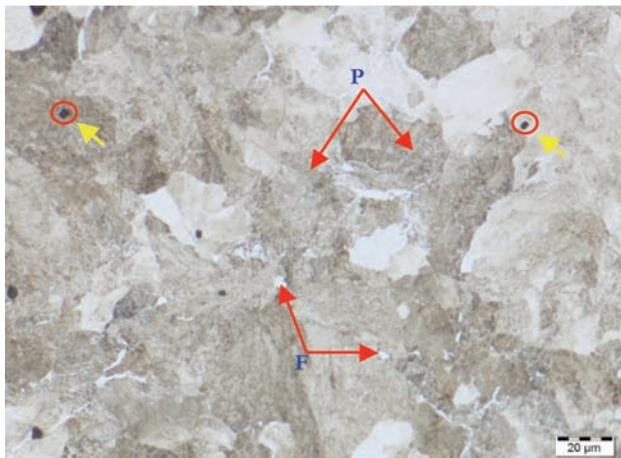
Figure 8—The microstructure of a rejected sample (Class B alloy) on the rim at a higher magnification than Figure 7 showing pearlite (P), ferrite (F – white phase), and inclusions (black spots indicated by the arrows)

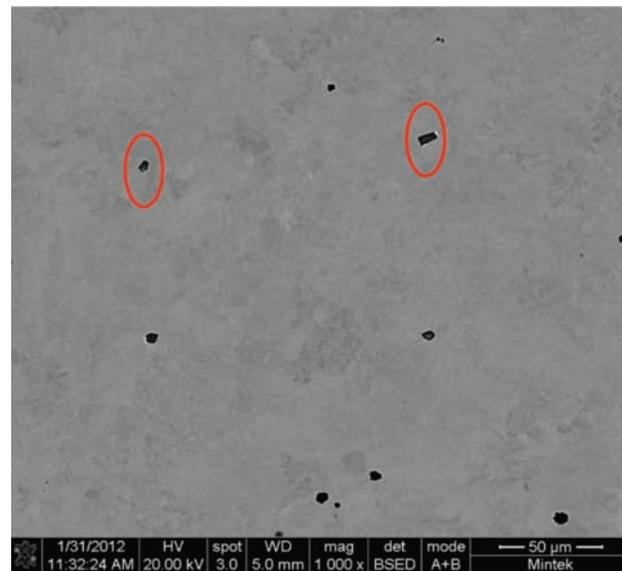
Figure 9—SEM micrograph of a clean sample on the rim showing distribution of inclusions (dark particles)

shape, and composition of each inclusion particle. Manganese, alumina, common spinel, sulphide, and oxisulphide inclusions could be identified as the dominant inclusion types in the supplied steel. Figures 9 to 12 depict the SEM microstructures and EDS spectra of the clean and dirty/rejected samples, showing the shape, size, and type of inclusions.

The EDS spectrum of the clean sample shows sulphur and manganese and traces of calcium, possibly from deoxidizer during steelmaking. The EDS spectrum of the rejected sample shows major sulphur, manganese, and oxygen contents and traces of aluminium and silicon, again possibly from the deoxidizer during steelmaking. Some inclusions are observed on the polished surfaces of the specimens, and EDS analysis has shown that these inclusions are some kind of sulphur compound. The defects or inclusions analysed are manganese sulphides. Aluminium is required for killing the molten steel, but excess quantities of aluminium produce alumina inclusions which are very hard and deleterious to the steel's mechanical properties.

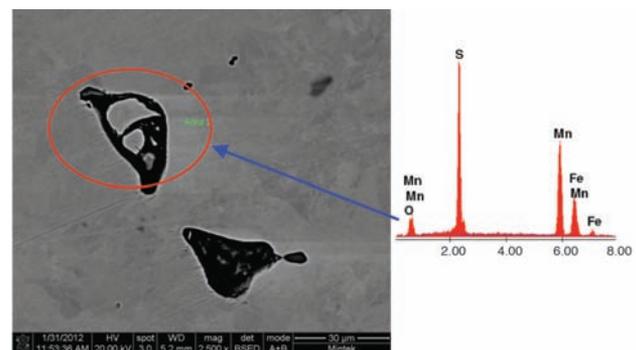
Figure 10—SEM micrograph of a clean sample from the rim at a higher magnification than Figure 9, showing the shape, size, and type of inclusions (dark phase)

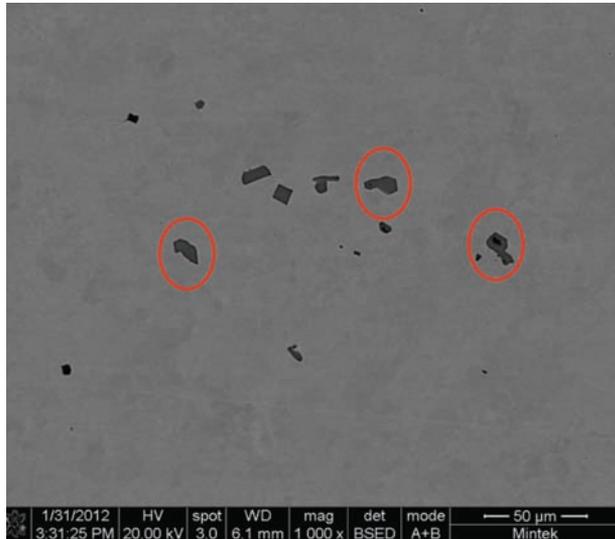
Figure 11—SEM micrograph of a rejected sample on the rim showing distribution of inclusions (dark phase)

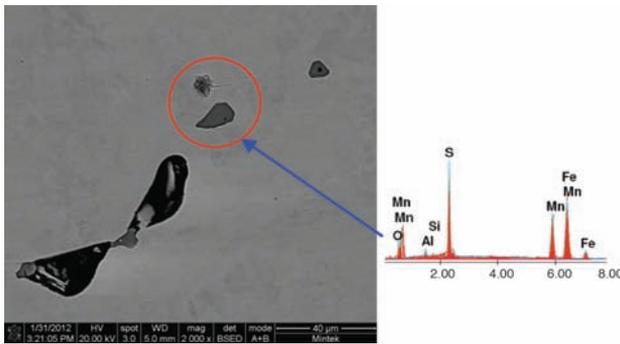
Figure 12—SEM micrograph of a rejected sample on the rim at a high magnification than Figure 11, showing the shape, size, and type of inclusions (dark phase)

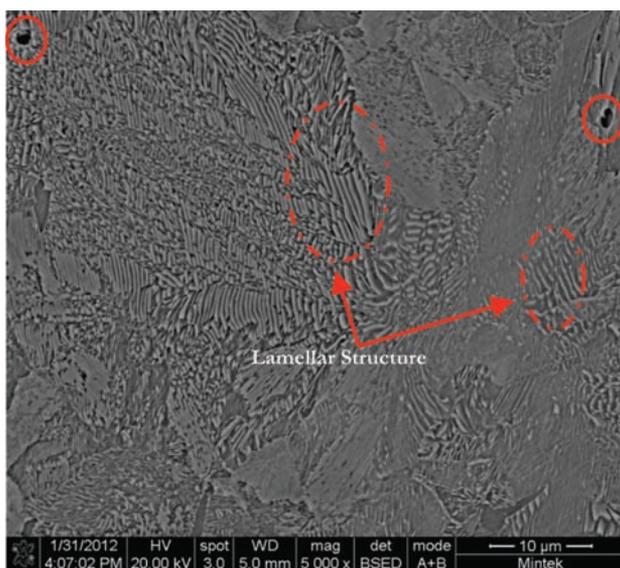
Figure 13—SEM micrograph of a clean sample machined from the wheel rim showing the pearlite structure (lamellar structure comprising ferrite and cementite) and inclusions

The microstructure of the etched clean sample was studied using SEM. Figures 13 and 14 show the lamellar morphology of the pearlite. As well as the significant higher pearlite content of the wheel steel, the ferrite areas and cementite lamellae spacing could be clearly identified.

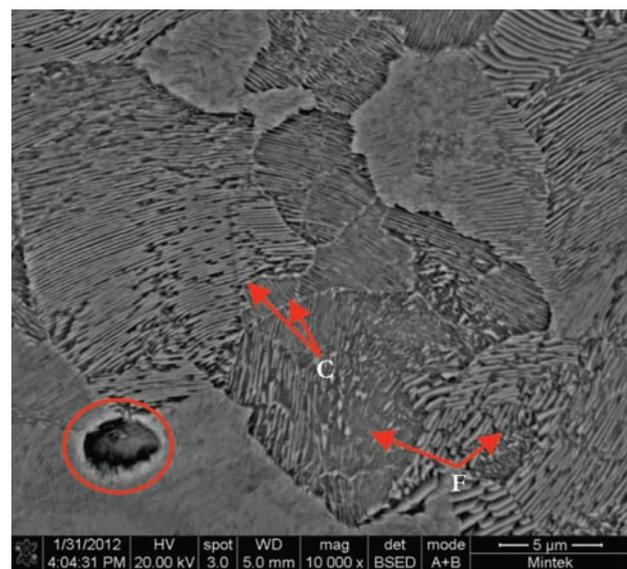
Figure 14 – SEM micrograph of a clean sample machined from the wheel rim showing the pearlite structure (lamellar structure comprising ferrite (F) and cementite (C)), and an inclusion

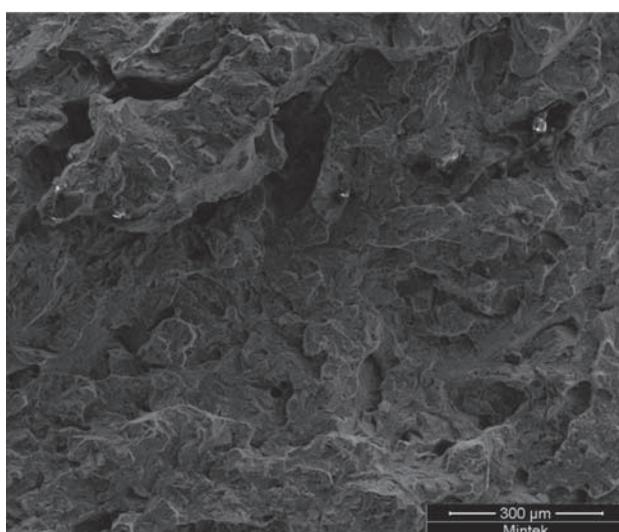
Figure 15—SEM fracture topography of a clean sample showing the fracture surface that consists essentially of transgranular cleavage fracture

The fracture surfaces of the clean sample after impact testing are characterized essentially by typical transgranular cleavage, without any evidence of the presence of striation marks (compare microfractographic results in Figures 15 to 17). An additional microfractographic feature is the presence of a stepped fracture topography, due to the delamination of the lamellar microstructure (ferrite/cementite interface). This indicates that the material is brittle. These observations clearly indicate that the resulting fracture topography of a pearlitic microstructure depends on the relationship between the orientation of the pearlitic colony and the load direction. As consequence, adjacent pearlitic colonies may display distinct fractographic features.

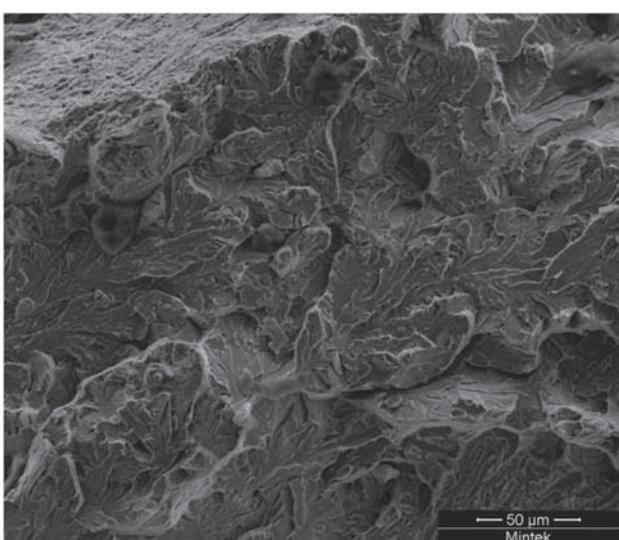
Figure 16—SEM fracture topography of a clean sample at a higher magnification than Figure 14, showing transgranular cleavage fracture

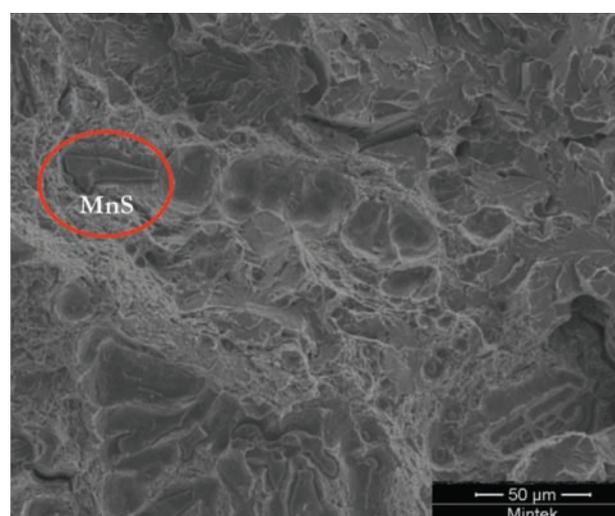
Figure 17—SEM fracture topography of a rejected sample at a higher magnification, showing transgranular cleavage fracture and manganese sulphide inclusions
