# Challenges and solutions in PGM furnace operation: high matte temperature and copper cooler corrosion

by A. Shaw\*, L.P.vS. de Villiers†, R.J. Hundermark†, J. Ndlovu†, L.R. Nelson†, B. Pieterse†, R. Sullivan\*, N. Voermann\*, C. Walker\*, F. Stober\*, and A.D. McKenzie‡

## Synopsis

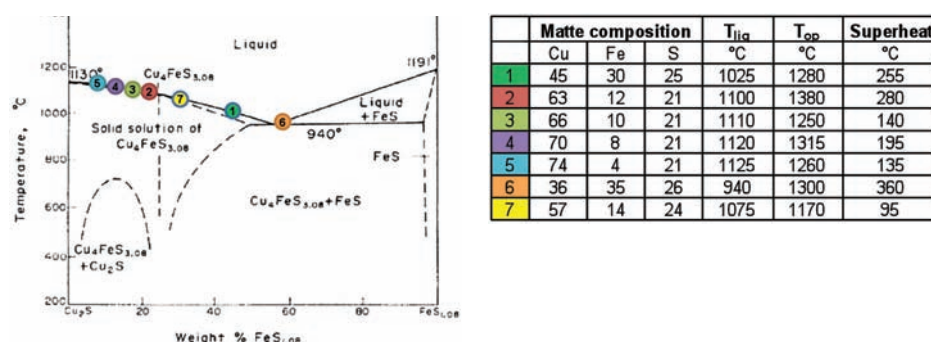
Figure 1—Copper primary matte liquidus temperatures (diagram after Schlegel and Schüller, 1952; matte composition information after Kapusta, 2004)

When one considers the copper matte formed in these furnaces, the matte liquidus temperatures range from around 940°C to around 1125°C, and a maximum difference of 360°C between the operating temperature and the matte liquidus temperature is observed (Figure 1).

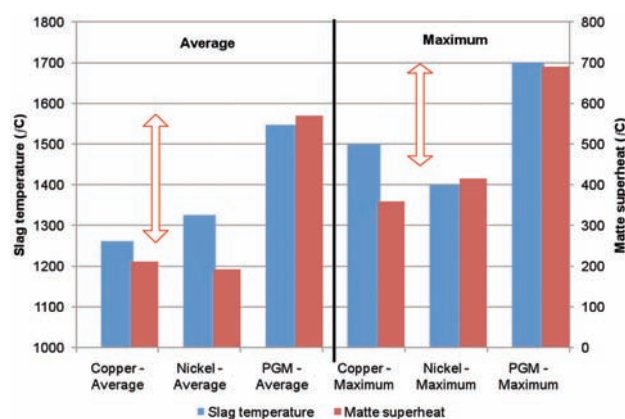
Figure 2—Comparison of operating temperatures and matte superheats across the copper, nickel, and PGM smelting industries

The average and maximum slag temperatures and matte superheats in the primary furnaces of the copper, nickel, and PGM smelting industries were calculated based on the information available in the aforementioned reviews and are shown in Figure 2. The step change increases in slag, and therefore operating, temperatures and most significantly matte superheats are evident for the PGM industry.

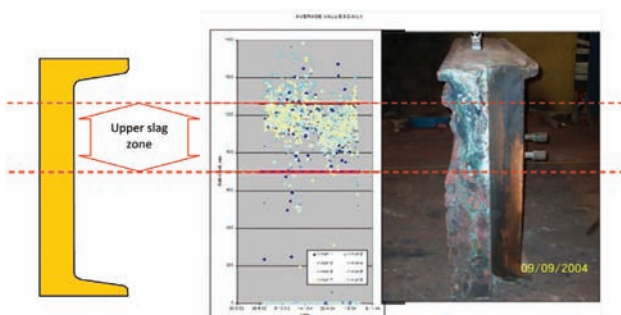
Figure 3—Location of maximum copper wear around slag-concentrate interface

In contrast to most other copper and nickel sulphide smelting operations, concentrate fed into PGM furnaces is not roasted. Corrosive species that are normally removed during concentrate roasting are instead released through heating and thermal decomposition of the concentrate in transit to and at the hot slag interface inside the furnace. These species tend to migrate and accumulate at the slag-concentrate interface near the walls, leading to pronounced wear of the coolers in this region (Figure 3).

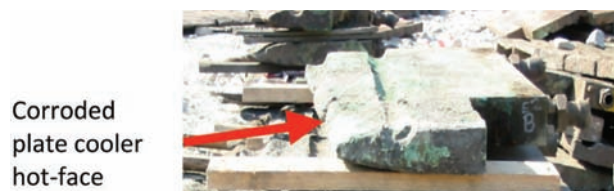
Figure 4—Severe upper plate cooler corrosion at Waterval Smelter. Note increased corrosion of upper plate cooler located in the furnace nearest the top of slag and concentrate interface

Corrosion is also not limited to waffle coolers. Given time, copper plate coolers in PGM furnaces are corroded to a short sharp edge (Figure 4), barely protruding into the furnace wall, and so reducing their cooling effect and upper wall stability. The corrosion is pervasive and continues to some extent throughout the furnace, not being limited to attack of copper, but also of basic magnesia-based refractories where magnesium sulphates (often resulting from sulphidation of

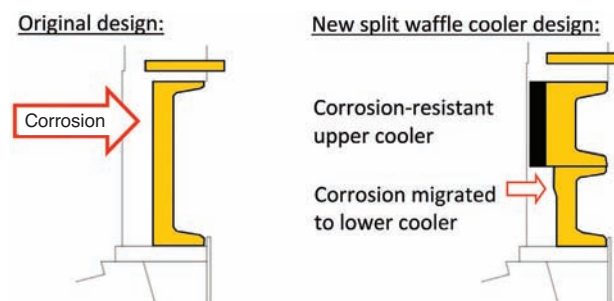
Figure 5—Initial copper loss in slag-concentrate interface zone. Following splitting of the coolers and protecting the upper block, copper corrosion migrated to the unprotected lower block

As part of the comprehensive plan to address corrosion, which is described later, the coolers were split horizontally into upper and lower blocks. After an effective corrosion-resistant barrier was applied to the hot face of the upper waffle coolers, the corrosion problem on these blocks significantly abated; however, the corrosion migrated to the 'deliberately' unprotected lower waffle coolers (Figure 5), though at a reduced rate.

It was possible to reduce the replacement cost of the waffle coolers by splitting them horizontally into upper and lower blocks because the most severe corrosion occurred mainly in the upper portion of the waffle coolers near the slag-concentrate interface (Figure 17). By doing this, the corrosion-prone upper waffle coolers could be replaced independently of the lower waffle coolers. One advantage of this arrangement is that the slag bath needs to be only

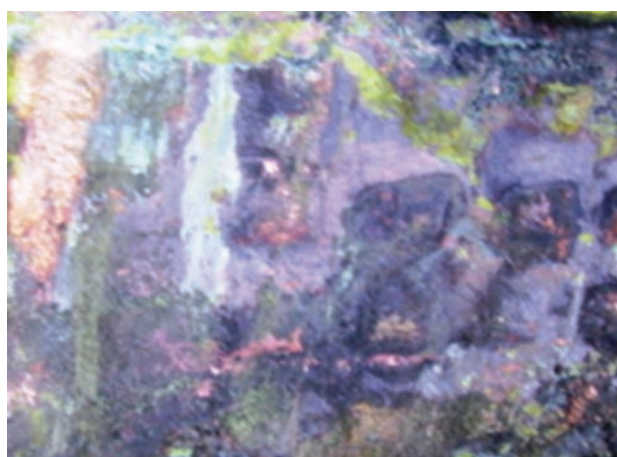
Figure 7—Severely corroded, unprotected copper block. Black copper sulphide pervasive. Increasing evidence of green copper hydroxy-chloride in close proximity to copper

In an attempt to simulate the presence of the thin copper chloride layer observed on most operational coolers (e.g., failed unprotected lower waffle cooler – Figure 7) a test was devised where the copper was first subjected to 1 day of exposure to 5 per cent HCl(g) by volume, followed by standard sulphidation with sulphur vapour. At a temperature of 90°C, after the initial exposure to HCl for 1 day, corrosion was not measurable.

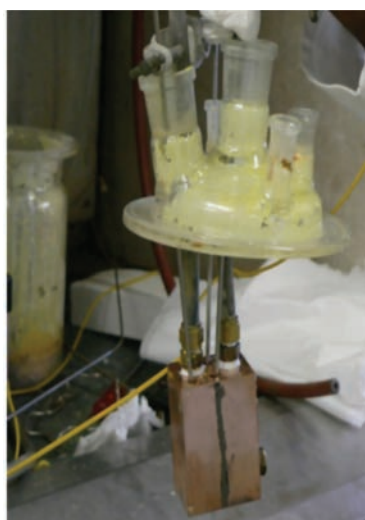
Figure 10—Suspended water-cooled copper test piece before insertion into test rig

To investigate this discrepancy, a special test rig was devised in an attempt to simulate copper cooler corrosion conditions. This comprised suspending water-cooled copper test blocks above a heated bath of sulphur, so exposing cooled copper to sulphur vapour (Figures 10–13). The results demonstrated that some direct sulphidation of water-cooled

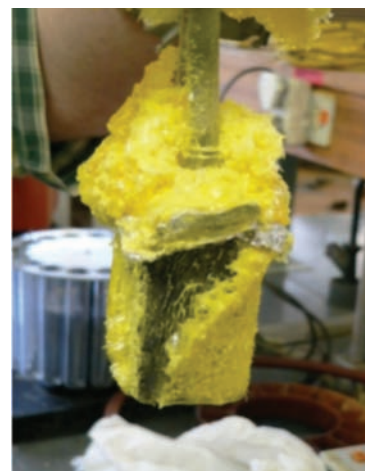
Figure 12—Water-cooled copper specimen coated with sulphur after testing

copper was indeed feasible even at a temperature as low as 25°C (0.2 mm over 14 days or 5.2 mm/a). As the copper temperature is raised to 90°C the corrosion rate increases to 16 mm/a. At a copper temperature of 125°C, the rate is

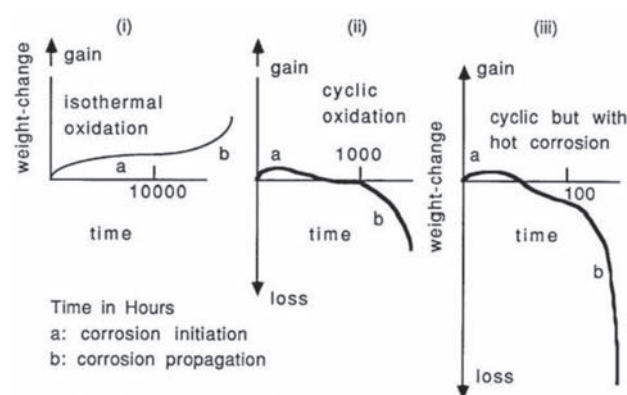
Figure 14—Corrosion mode typical of hot corrosion systems (after Hocking *et al.*, 1989)

The rate of 'hot corrosion' (by definition, corrosion in the presence of sulphur species) is inherently highly non-linear with respect to time (Figure 14). Coupled with the specific cooler conditions described above, this will further contribute

to a greatly accelerated rate of copper wear with cooler operating time. This is consistent with the great difficulty experienced in attempting to use condition-monitoring of copper thickness to predict the timing for safe replacement of the coolers before failure. In one instance of lower waffle cooler failure, involving detection through the automated water-pressure leak detection system of cooler water leaks into the Polokwane furnace, the mean rate of copper wear in front of the cast monel water pipes increased by over an order of magnitude in under a year, from 1.4 mm/a to 40.3 mm/a.

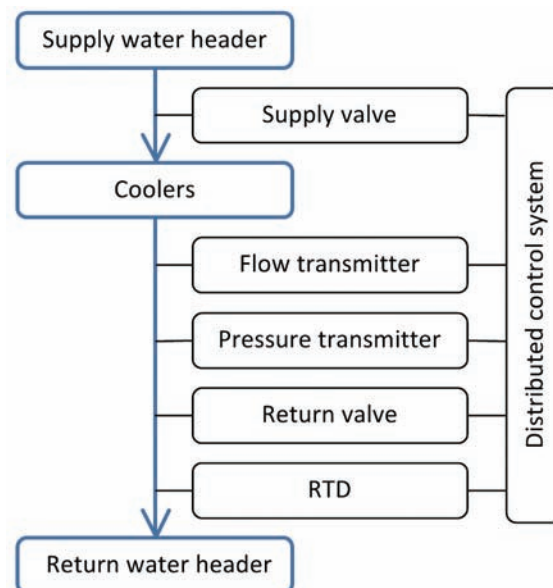
Figure 15—Schematic showing the automated pressure testing system components

An automatic water leak detection system was developed and installed on the cooler water circuits to detect pinhole leaks based on pressure (Figure 15). This system momentarily stops the flow of water on a circuit using valves at the inlet and outlet. A pressure transmitter then checks for a decrease in static pressure. The system is very sensitive, and leaks as small as a few drops per minute can be detected (Figure 16). Once detected, a leaking water circuit can be isolated because the cooler is designed with dual redundant water-cooling circuits. Consequently, a faulty cooler or piping can be replaced without further risk of refractory hydration or an explosion. This is not a continuous leak detection method, but it is automatically run at regular intervals selectable to as little as 4-hourly. This is the most direct and valuable monitoring system of the cooler condition available to operators.

The one drawback of the system is that it is not operated continuously. Therefore water leaks associated with rapid failure of copper blocks, due to exposure to superheated matte or water hoses blowing off, will not be detected as soon as they happen (the latter being detected by a continuous, but less sensitive, leak detection system based on inlet and outlet flow meters).

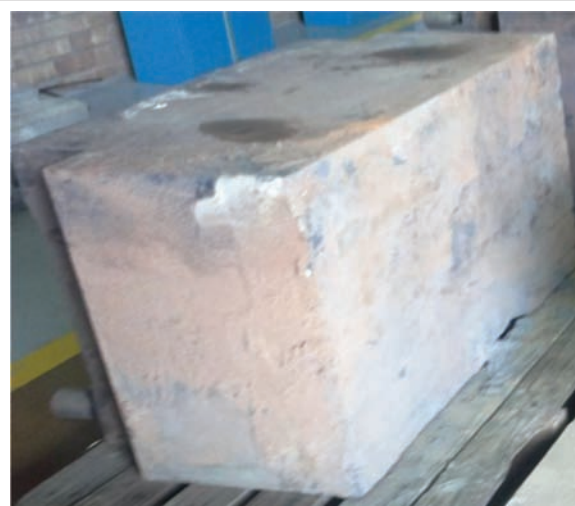
Figure 18—Upper cooler copper and graphite in pristine condition after being installed in the furnace for 12 months

Two consecutive planned annual inspections of the latest generation of graphite-protected copper coolers revealed the graphite to be in near pristine condition after 12 months' service. Given that the life of the original coolers was approximately one year, these results are very positive.

Instead, a number of methods of protecting the coolers from corrosion were developed and tested. Of these, the installation of a graphite barrier on the hot face of the copper coolers has proven to be the preferred option. For the graphite to survive in the furnace, good thermal contact is required between it and the copper cooler behind it. If this contact is not maintained, the graphite will overheat in contact with the slag bath, leading to rapid graphite oxidization, CO bubble-induced stirring, and very high convective heat fluxes. To avoid this loss of thermal contact, stresses induced in the graphite due to differential thermal expansion and movement of the surrounding furnace refractory were minimized in the design of the graphite-protected cooler system.
