Review of mud rush mitigation on Kimberley's old scraper drift block caves

Synopsis

The November 2011 mud push at Dutoitspan

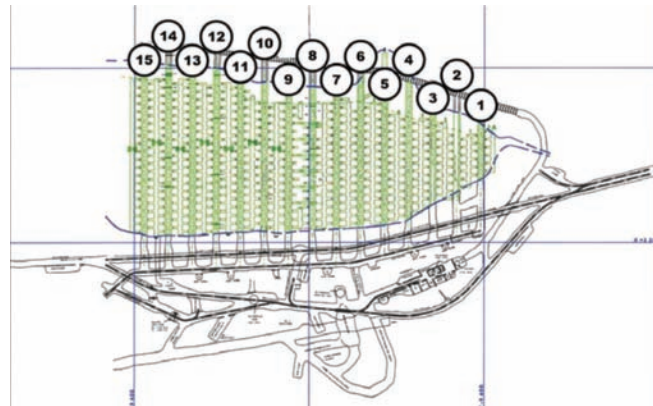
Figure 1—870 m level scraper drift block cave layout at Dutoitspan

The production footprint of the Dutoitspan 870 Lvl scraper drift block cave is shown in

Figure 1, with scraper drift numbers indicated for ease of reference. The block cave was historically drawn as two separate caves, with production from the East Cave (Drifts 1 to 7) far exceeding that from the West Cave (Drifts 8 to 15), see Figures 2 and 3.

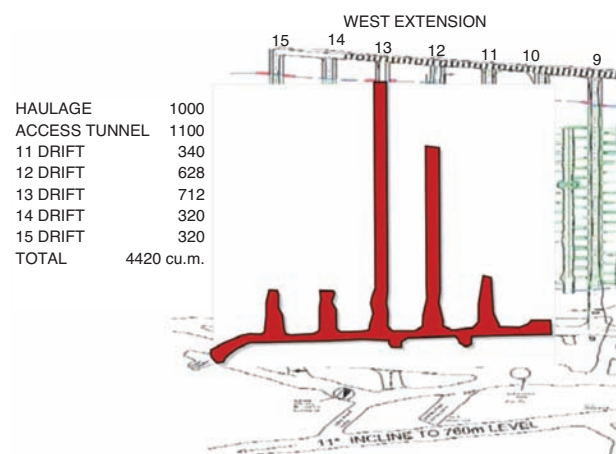
Figure 4—Extent of mud inundation, Dutoitspan 870 Lvl

The extent of mud inundation in the West Cave is shown in Figure 4 after an estimated 4 420 m³ of mud entered 870 Lvl; also see the photos in Figure 5 (a) to (e). Mud flooded

the whole of Drift 13, almost all the way up to the RAW, and two-thirds of Drift 12. It pushed into the rim tunnel on the south side, flooding the whole rim tunnel from Drift 10 in the east, past Drift 15 in the west and down the access ramp via which the Drift 13 crew escaped. The winches and ground transfer boxes (i.e. 'chinamen') at the entrances to Drifts 11 to 15 were also flooded, with mud spilling through the open transfer boxes and flooding the haulage directly below. The extent to which mud pushed towards the back of Drift 12 suggests that mud entering Drift 12 through a drawpoint rather than pushing in through the front of the drift. In other words, the mud push entered the production level via both Drifts 12 and 13.

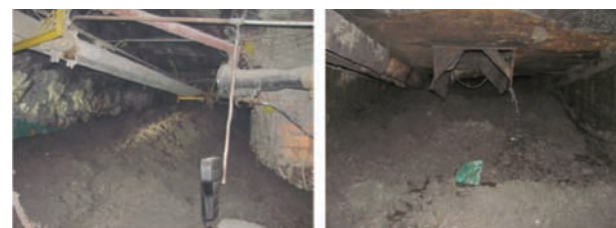
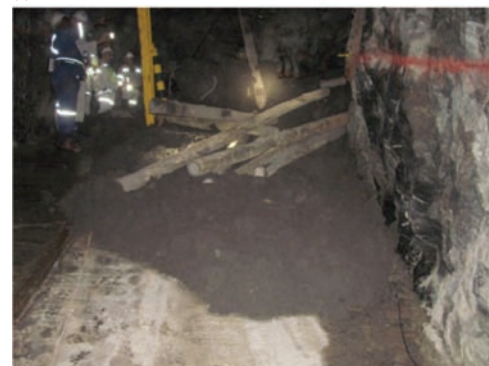
Figure 5—Photos of mud on 870 Lvl

(a) Mud in rim tunnel at Drift 10

(b) Haulage below Drift 10 transfer box

(c) Mud in access ramp into western end at Drift 15

(d) Mud in back of Drift 12

(e) Mud in back of Drift 13 near RAW

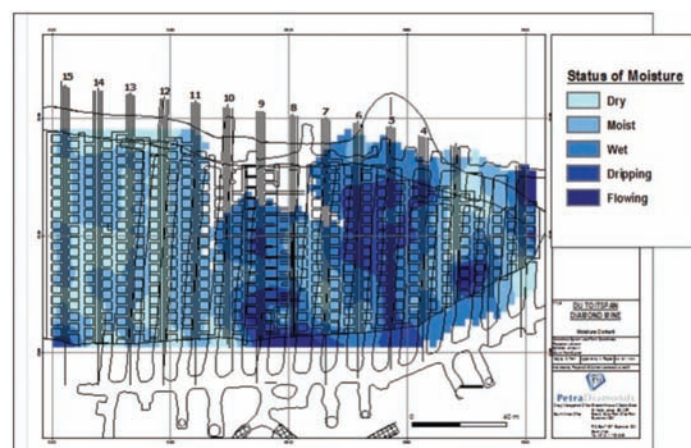
Figure 6—Moisture conditions on 870 Lvl, October 2011

Despite these sources of water ingress, the October 2011 moisture condition plot for 870 Lvl in Figure 6 shows that the West Cave was relatively dry compared to the East Cave, except for water inflows at the host rock/pipe contact in the front of Drift 15.

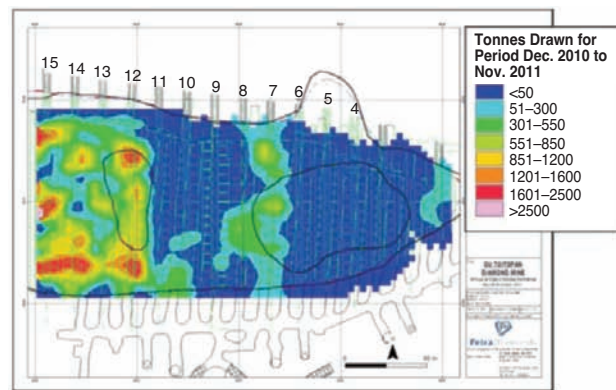
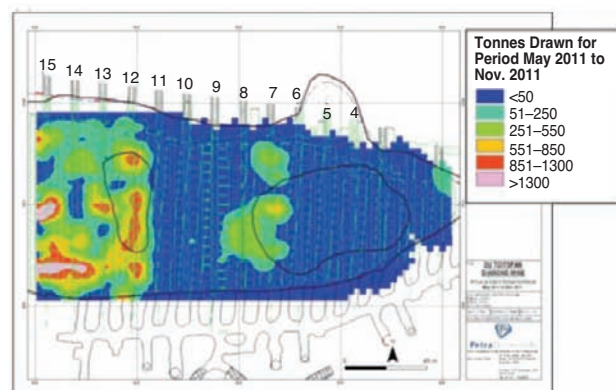
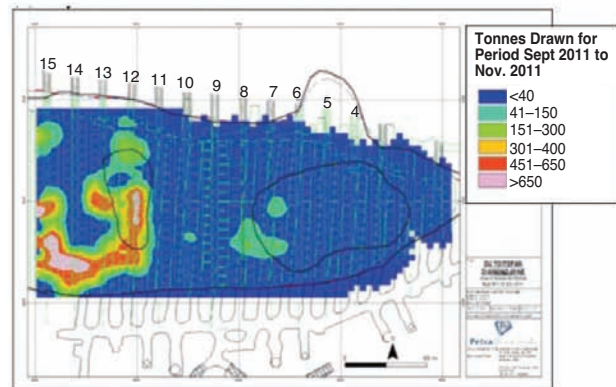
Figure 7 – Tons drawn from 870 Lvl

Cave drawdown patterns in the months prior to the November 2011 mud push were reviewed by producing plots of tons drawn for the year (Figure 7a), 6 months (Figure 7b),

and 3 months (Figure 7c) preceding the mud push. The plots clearly show is that although cave drawdown over the year preceding the mud push was more or less evenly spread over the footprint of the West Cave, draw patterns shifted in the latter part of this period, with most of the draw between September and November 2011 coming from the front of the West Cave in Drifts 13 to 15 and the central portion of Drift 12.

(a) December 2010 to November 2011

(b) May to November 2011

(c) September to November 2011

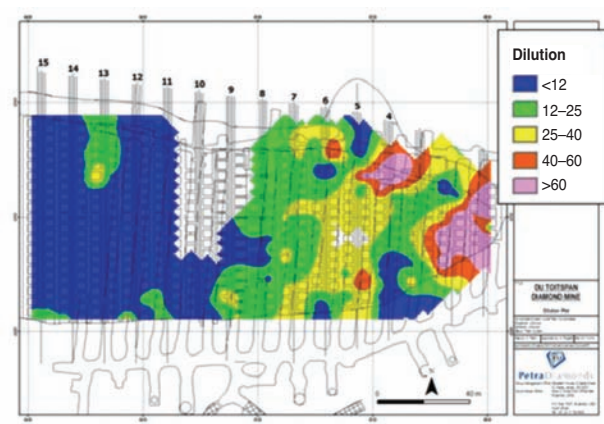
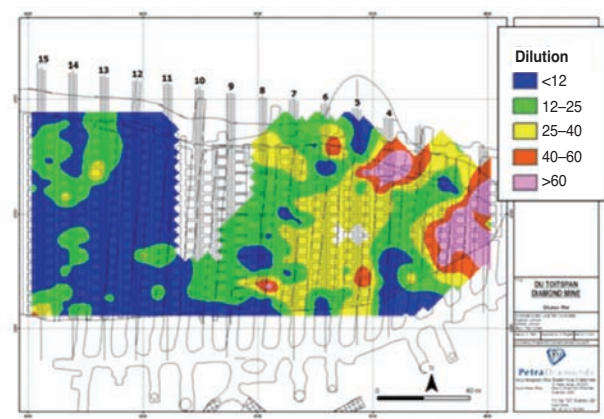
Figure 8—Waste dilution in months preceding the November 2011 mud push

numbered drifts being constructed ahead of the undercut while the even-numbered drifts were constructed later, in the de-stressed zone below the undercut. Figure 8(a) shows that some waste was reporting to drawpoints in the back of Drift 13 during March 2011, whereas by November 2011, waste started reporting across various parts of the West Cave footprint as shown in Figure 8(b).

(a) Waste entry (%) during March 2011, Dutoitspan 870 Lvl

(b) Waste entry (%) during November 2011, Dutoitspan 870 Lvl

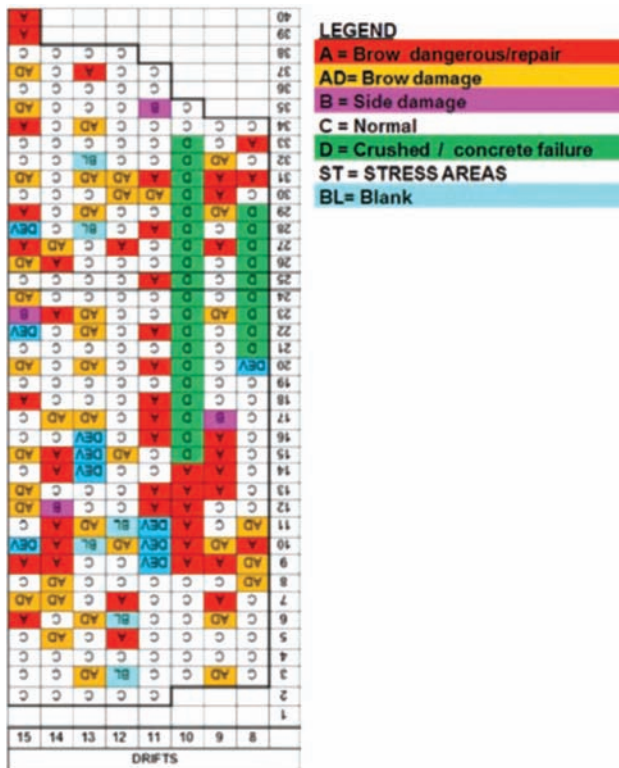
Figure 9—Structural condition of West Cave drawpoints by November 2011

The structural condition of drawpoints in the West Cave in November 2011 is schematically presented in Figure 9. This plot shows why draw shifted towards the front of the cave in the latter half of 2011, with badly damaged drawpoints (A-class drawpoints) in Drifts 11, 14, and 15 making it impossible to draw the central and back portions of these drifts. This resulted in severe isolated draw from the front of the cave and from Drifts 12 and 13, which were still in reasonably good condition compared to the other drifts in the West Cave.

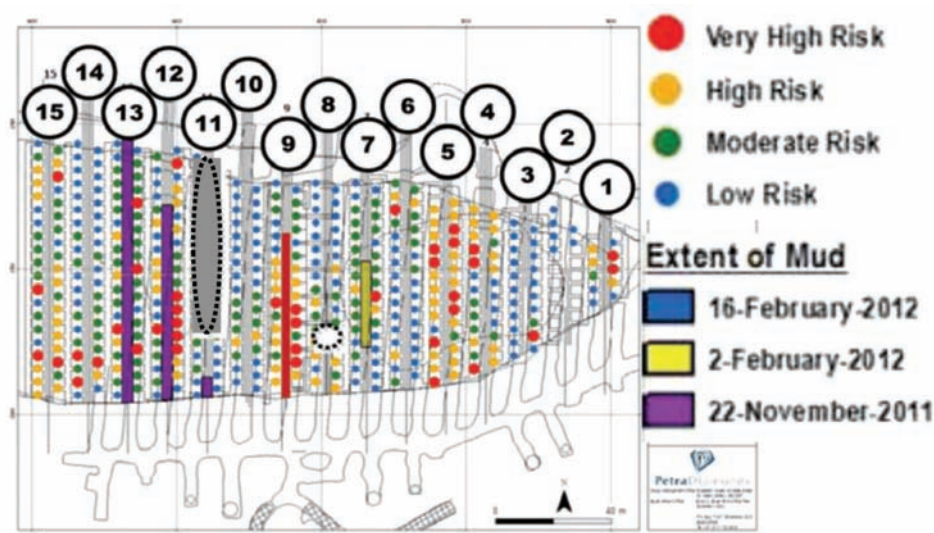
Figure 10—Mud rush risk plot for Dutoitspan 870 Lvl

were reverse-engineered (or 'calibrated') to give a relatively good correlation with mud push and mud rush incidents that have occurred at Dutoitspan mine over the last 5 to 10 years. Figure 10 shows the 3-month moving average plot as an example of a typical result obtained).

Figure 10 shows very high mud rush risk potential in the front part of the West Cave as well as in Drifts 12 and 13 where the November 2011 mud push occurred, in Drift 9 where the 2005 mud rush occurred, and in Drifts 1, 4, and 5 as well as in the back of Drift 6 in the East Cave where mud rushes and pushes have occurred in the past. It furthermore indicates a very high mud rush risk potential in the central portion of Drift 7, which is where a small mud push developed in early February 2012, about 3 months after the November 2011 mud push in the West Cave. A smaller mud

push, which occurred mid-February 2012 in Drift 8, however, was not 'predicted'.

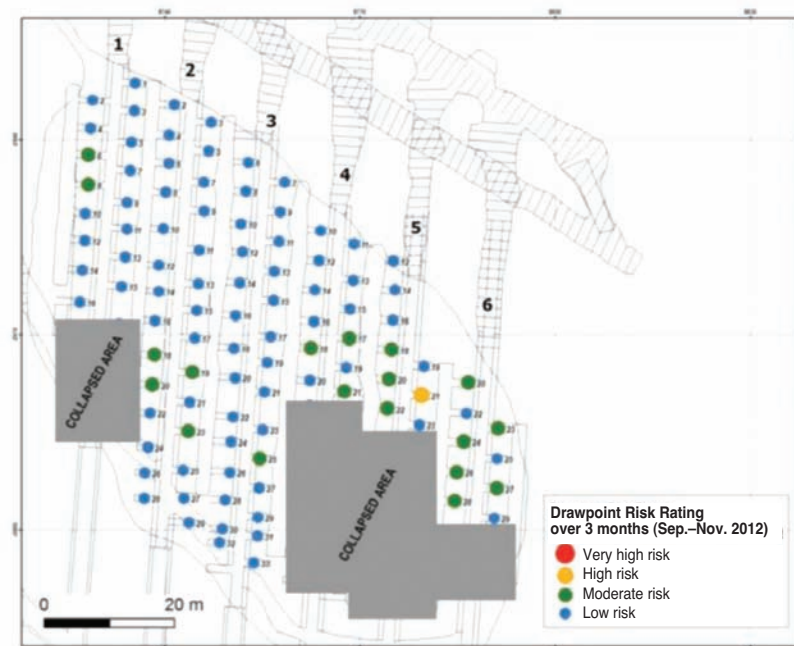
Figure 11 – November 2012 mud rush risk plot for Bultfontein 845 Lvl

As an example, Figure 11 gives the 3-month moving average mud rush risk scores for Bultfontein 845 Lvl for November 2012. The plot indicated a high risk score at Drawpoint 21 in Drift 5. A review of the draw control data showed that this was a badly damaged drawpoint (or A-class drawpoint) from which more than 300 scoops of material was drawn during November 2012, which equated to a relatively high rate of draw compared with draw from many other drawpoints in the cave. A draw control decision was therefore made to repair Drawpoint 21 and to limit draw from this area to reduce the risk score for this drawpoint to a more acceptable level.
