A potential method of containing rockburst damage and enhancing safety using a sacrificial layer

by T.R. Stacey* and E. Rojas†

Synopsis

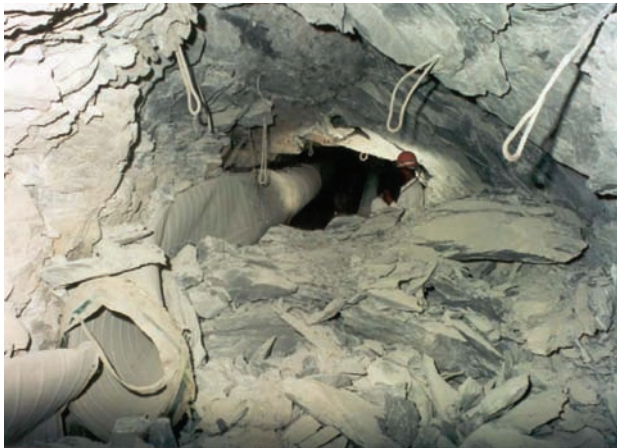
Figure 1—Rockburst damage and fragmentation (photograph W.D. Ortlepp)

Rockbursts are very violent events that are a great safety hazard and often leave excavations severely damaged. The manifestation of a rockburst is usually rock ejected from the walls of the excavation. The ejected rock is commonly fairly finely fragmented, as illustrated in Figure 1. If concrete is involved in the construction of the excavation, this may be massively moved, as illustrated in Figure 2. Failure of rock support elements is often observed, with containment support (wire mesh, shotcrete) often pulling over tendon supports, leaving them exposed and protruding out of the rock walls, as shown in Figure 3.

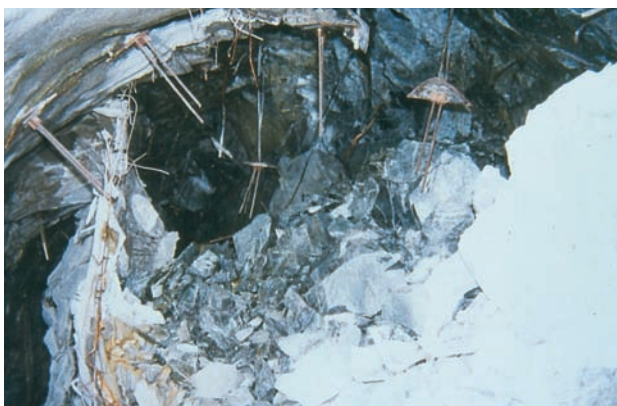
Figure 3—Rockburst damage showing protruding and failed support elements (photograph W.D. Ortlepp)

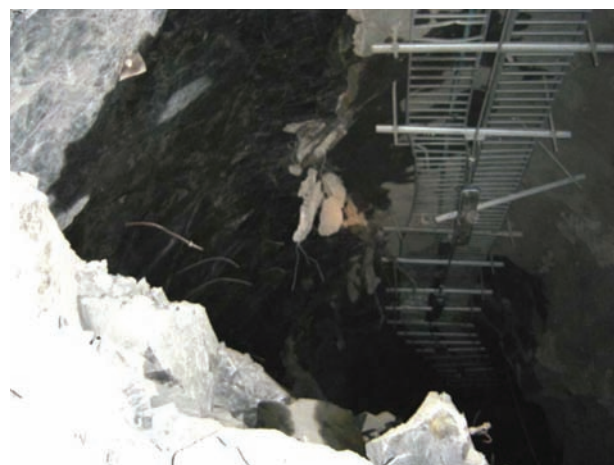
Figure 4—Upwards ejection of sidewall rock to impact service tray (photograph T.R. Stacey)

Another interesting case is illustrated in Figures 4 and 5, showing upwards ejection of rock from the sidewall of a 4 m high tunnel.

Simple back-analysis of the ejection velocity of this rock gives a value of near 8 m/s. Owing to the 'bent' geometry of the rockbolts, they are likely to have enhanced the deceleration, and hence the actual ejection velocity could have been about 10 m/s.

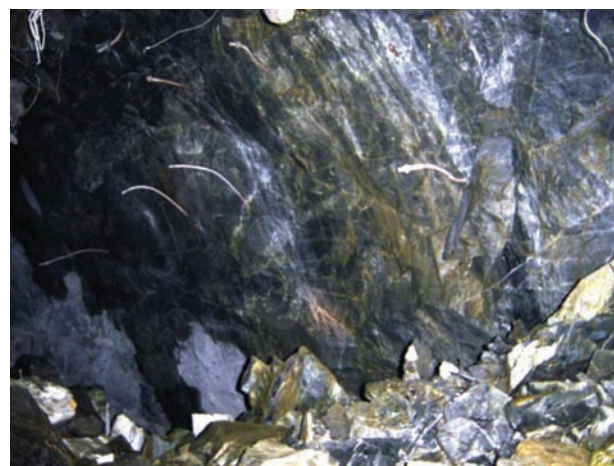
Figure 5—Rockbolts indicating upwards direction of ejection (photograph T.R. Stacey)

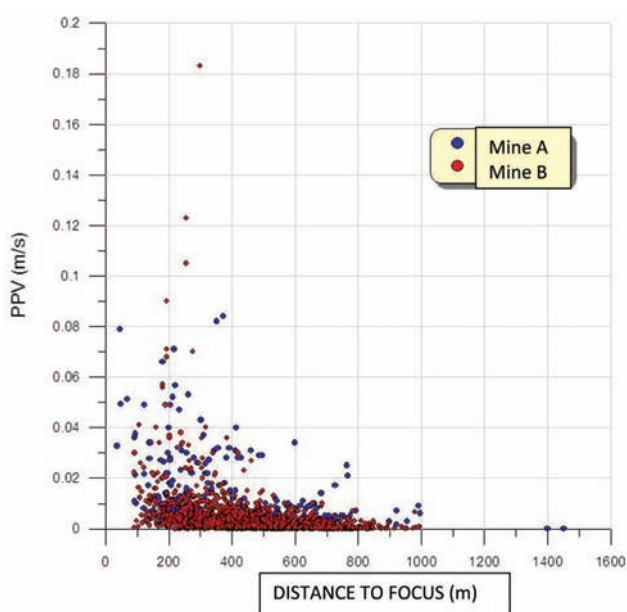
Figure 6—PPV vs distance to focus for rockburst events over a 12 year period (Bacco, 2010)

material and the distance of throw. The information for these evaluations was contained in documented reports on each rockburst event. Source locations and PPV data were provided by experienced seismologists, based on records from an ISS seismic monitoring system. Figure 6 shows this PPV data, all associated with rockburst damage, for seismic events with a magnitude greater than 1.5. Amplification factors determined for six selected events ranged between 8 and 52, with an average value of 32.

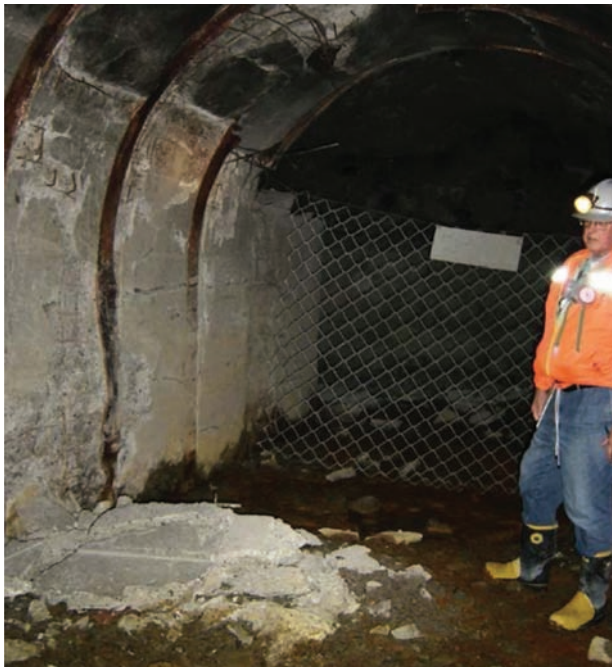
Figure 7—Rockburst damage caused by floor heave (photograph T.R. Stacey)

In Figure 7 an area of clean concrete can be seen in the floor. During the rockburst event, this concrete was clearly heaved upwards, causing significant loading on the steel arch. The thrust along the arch has caused it to fail in the roof, with associated damage to the concrete in the roof. However, in the photograph it can be seen that neither of the adjacent arches show any signs of distress. They are each about 1 m from the damaged arch, and their bases are surrounded by mud and water, not clean concrete.

Figure 12 illustrates the propagation of a seismic compressive shock wave from its source location towards a rock surface covered with a layer of concrete. The wave passes through the rock/concrete contact (with possible minor reflection at this interface, as shown, owing to the stiffness difference) and then reflects at the concrete/air interface, since air cannot sustain the passage of compressive waves. On reflection, the compressive wave is converted into a tensile wave, which then travels back down to the concrete/rock contact. Since this contact has no tensile strength, the tensile wave is trapped in the concrete layer and the concrete is ejected as indicated in Figure 13. This leaves the rock surface undamaged. However, much damage would be observed in the excavation owing to the heaved concrete. This behaviour is manifested in the rockburst damage illustrated in Figures 2, 7, 9, and 11.

The absence of rockburst damage where the floor was covered with mud in Figure 7, and in Figure 8 where the central floor area was under water, could be explained by this behaviour.

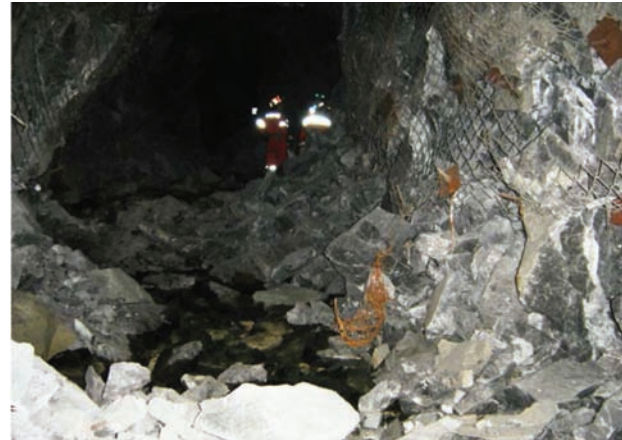
Figure 8—Rockburst damage in lower sidewalls of tunnel (photograph T.R. Stacey)

In Figure 8, significant ejection of rock from both lower sidewalls of the tunnel can be seen, and this ejection has caused damage to the installed rockbolt and wire mesh support. In the central floor of the tunnel, however, where water is present, the behaviour has apparently been different, since there appears to have been no heave, nor ejection of rock.

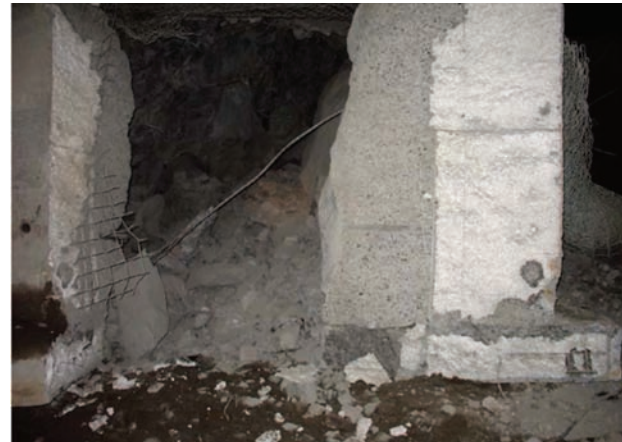
Figure 9—Lateral movement of concrete wall (photograph T.R. Stacey)

The photograph in Figure 9 shows a concrete wall some 1 m thick that was moved laterally by about 3 m during a rockburst event. The wall was constructed by casting concrete against the rock sidewall and it was 'tied' to the rock by rockbolts and cables. Rockbolts and cables were broken during the event, as can be seen in Figure 10. However, the rock surface was undamaged, as can also be seen in this photograph.

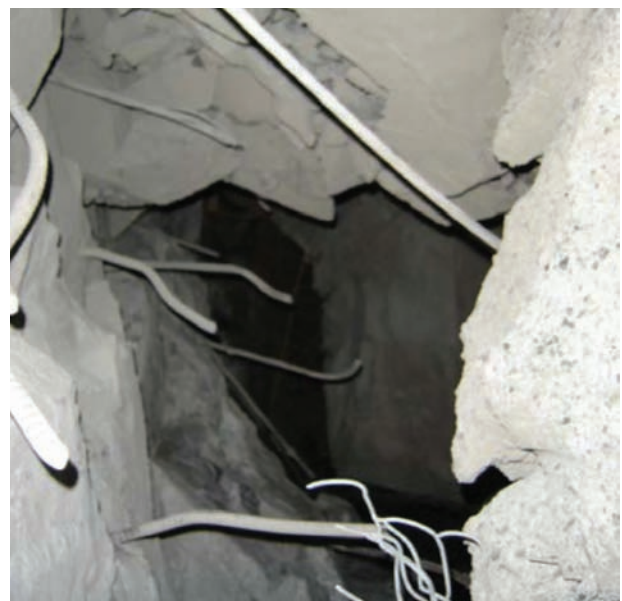
Figure 10—Broken rockbolts and cables behind concrete wall (photograph T.R. Stacey)

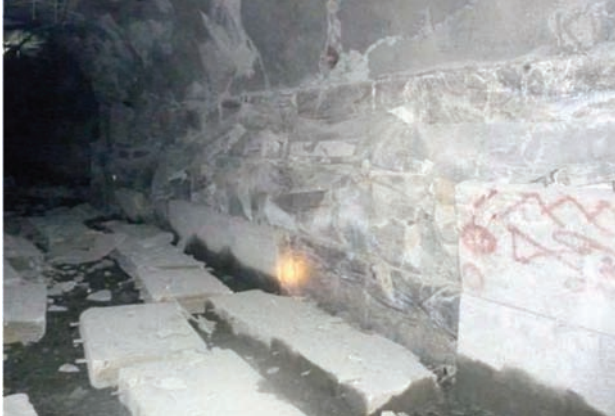
Figure 11—Concrete support panels ejected during a rockburst event (photograph Y. Potvin)

The tunnel support system shown in Figure 11 consists of concrete panels, each panel being retained against the rock surface by fully-grouted cables. After a rockburst it was

found that panels had been ejected from the sidewalls, an example of which can be seen in the photograph, causing significant damage to the support system. However, the rock surfaces that were behind the failed panels were not displaced and appeared undamaged.

The concrete panel support shown in Figure 11, a satisfactory design in static conditions, could be considered to be an inappropriate support system for dynamic, rockburst conditions. Concrete panels retained by fully-grouted cables represent a rigid support system. Such a rigid system is contrary to the commonly understood rockburst design requirement of compliant, yielding support systems that can absorb energy during deformation, but at the same time maintain their load-carrying capability. However, what may be considered an inappropriate rockburst support design has provided a rock support method that may be considered a most elegant solution to counter the rockburst problem and contain the associated damage. It has provided an excellent opportunity not only to observe the behaviour (ejection of the concrete panels), but also to observe the implementation of a remedial solution. This remedial solution had to be implemented at short notice to ensure safe, stable working areas. The solution was to install steel wire ropes, wrapping over the panels, with the ends of the ropes being grouted into boreholes drilled through the panels. This remedial support design is illustrated in Figure 16. The photograph shows the support prior to its being sprayed with shotcrete to provide protection against damage by mechanized equipment. Owing to the geometry of the remedial support ropes, they are colloquially referred to as 'staples'. Such staples provide the containment support to the panels, preventing them from being 'thrown off' in a rockburst event. They need to be loose enough to perform in a secondary mode – to catch the ejected panels, but not to be part of the primary support system.

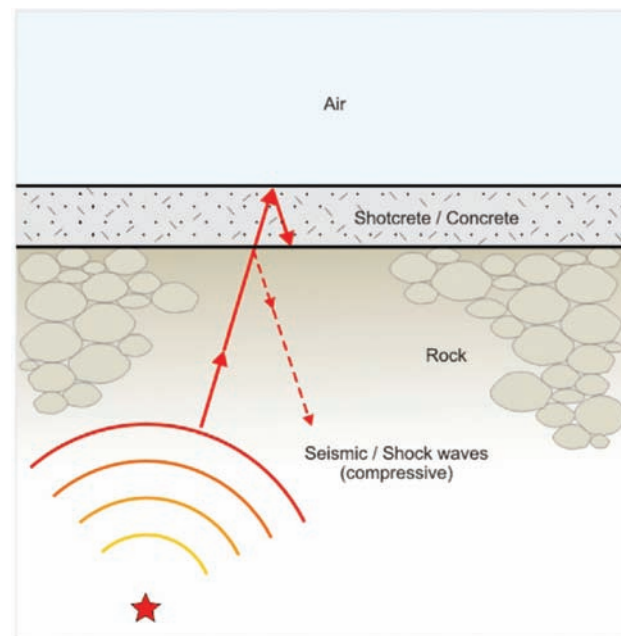
Figure 12—Passage of a compressive shock wave and its reflection at the concrete/air interface to become a tensile wave

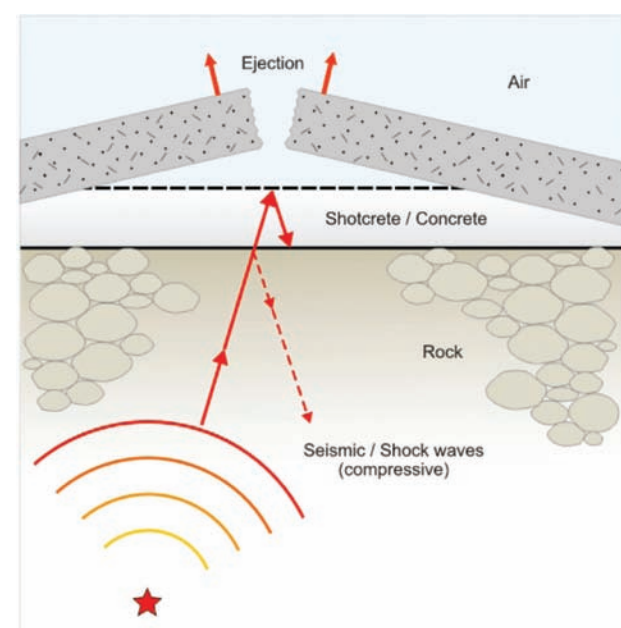
Figure 13—Ejection of the concrete due to the trapped tensile wave

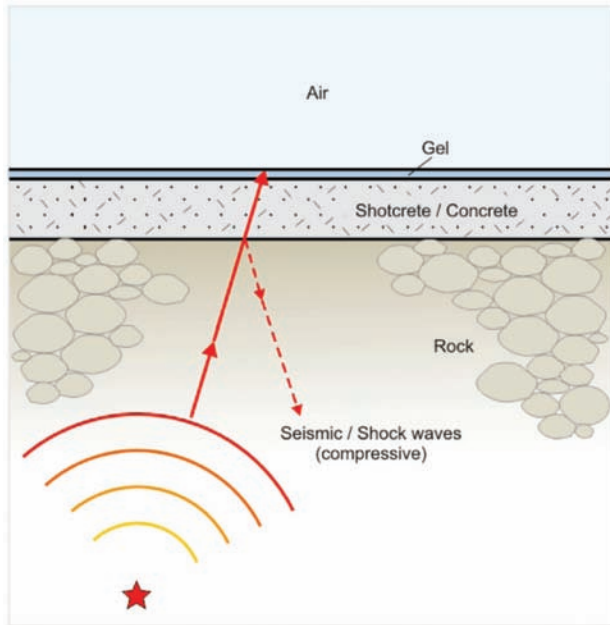
Figure 14—Propagation of a compressive shock wave through rock, concrete, and water/mud

Similar wave trapping could occur when mud and water are present – this situation is represented in Figures 14 and 15. The compressive wave travels through the rock, concrete, and water/mud (indicated as 'gel'), all of which materials can sustain the propagation of such compressive waves. At the interface between the air and the water/mud, the wave is reflected, becoming tensile, and, since water/mud cannot sustain tensile stresses, the wave is trapped and dissipated as a spray of water and mud, leaving the concrete and rock undamaged.

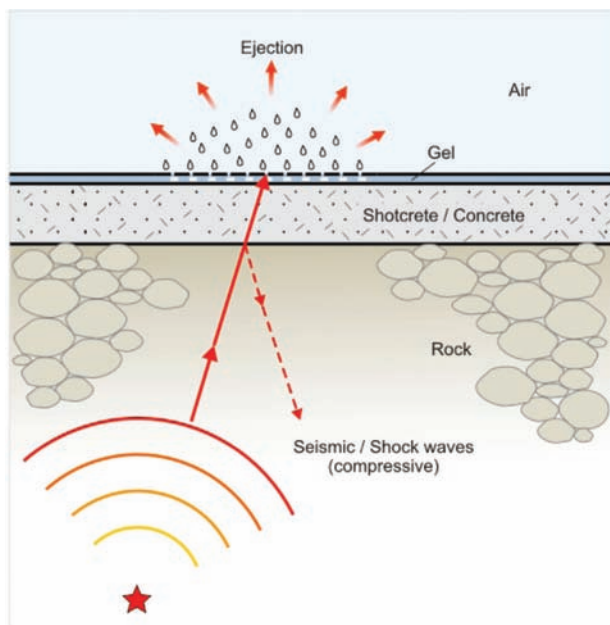
Figure 15—Reflection of a compressive shock wave at the interface between the air and the water/mud

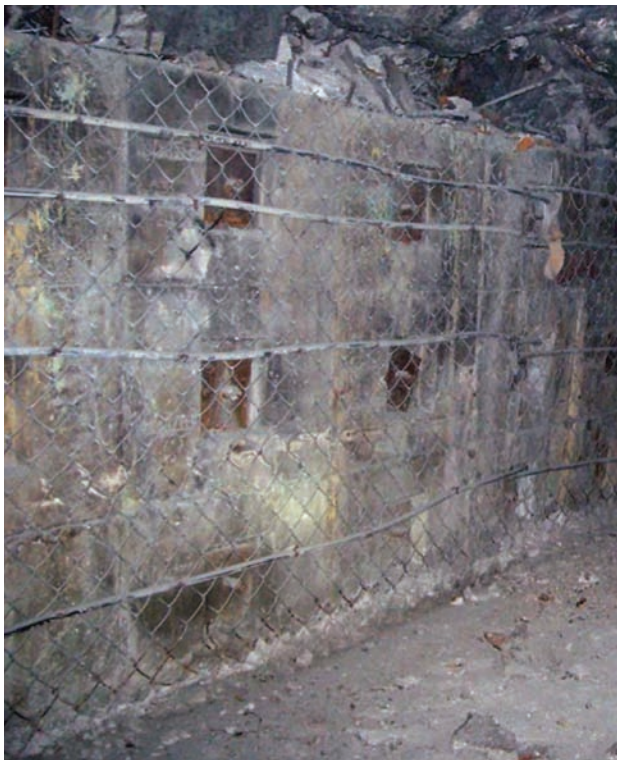
Figure 16—Remedial 'staple' support with wire ropes (photograph Y. Potvin)

The performance of this new, remedied, support system under rockburst loading has already been tested in practice, since such support has been subjected to actual rockbursts in the mine. Under such conditions it has proven to be capable of preventing ejection of the concrete panels, hence proving itself as a successful support system for rockburst conditions. The panels represent sacrificial support components, and their ejection, which would be the observable rockburst damage, is prevented by the staples in their secondary support capacity. Most importantly, the rock is left apparently undamaged, therefore ensuring that the rock mass retains its coherence and that the excavation maintains its stable state. The magnitudes of seismic events to which this support system have been exposed are in the same range as the events that caused the ejection of panels prior to the remedial support.
