# In situ monitoring of primary roofbolts at underground coal mines in the USA

by A.J.S. Spearing\* and A. Hyett†

## Synopsis

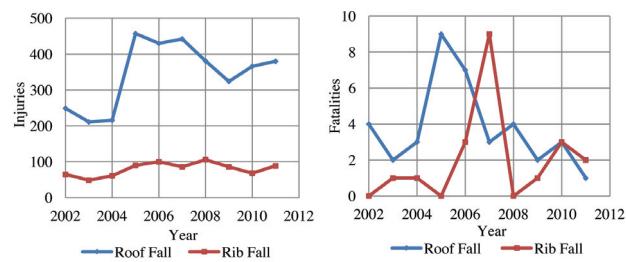
Figure 1—Fall-of-ground injuries in US underground coal mines (Mine Safety and Health Administration, 2010, 2011; Reisterer, 2011)

Primary roof support represents the first line of defence against rock-related falls of ground in underground mines, and improper utilization and/or understanding of primary supports applicability and behaviour can be costly and adversely affect rock-related safety. This is a major concern for underground mines, as roof support is the single most costly expense from a mining operations perspective and is the production bottleneck. This is further backed by the evidence that, in the USA, fatalities and hundreds of injuries still occur each year because of rib, roof, and massive roof falls, as shown in Figure 1 (Mark, Pappas, and Barczak, 2009).

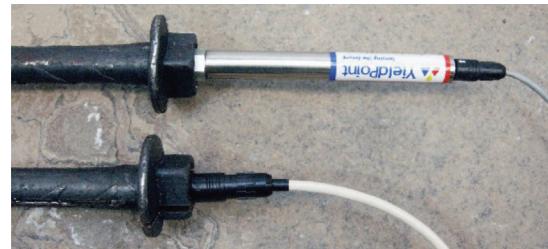
Figure 4—Instrumented roofbolt with an extended-length head (top) and shallow head (bottom) (Kostecki, 2013)

The electronics of the sensors were housed in an extended steel head at the end of the rockbolt. When data logging began, Mine A and Mine C utilized the extended bolt head shown in Figure 4. This bolt head protruded some length below the hangingwall; eventually, due to moving machinery at the face, mainly the continuous miner holing through the crosscuts, several instruments were knocked out and destroyed. Therefore a more adaptive shallow head (shown at the bottom of Figure 4) was used later at Mine B to eliminate this problem.

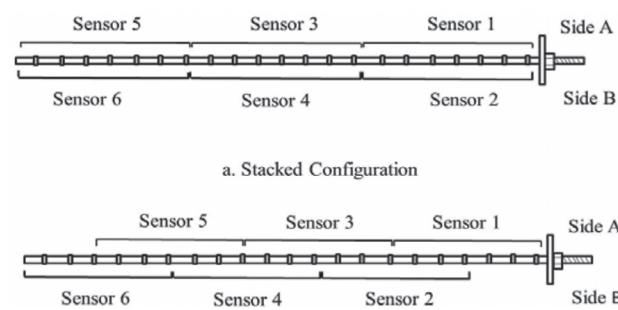
Figure 5—Representation of the stacked gauge orientation (a) used at Mine B and Mine C, and the staggered orientation (b) used at Mine A (Spearing, *et al.*, 2012)

The sensors on the bolts were arranged in two configurations. Mines B and C utilized a stacked configuration shown in Figure 5a and Mine A utilized a staggered configuration shown in Figure 5b. For the stacked configuration the sensors are placed in a diametrically opposed pattern in the machined slots, and for the staggered configuration the sensors are offset by half the baselength of the sensor. It was felt that the stacked configuration could miss some of the localized shearing loads that could occur between the

sensors, and a staggered arrangement was therefore considered for comparison purposes.

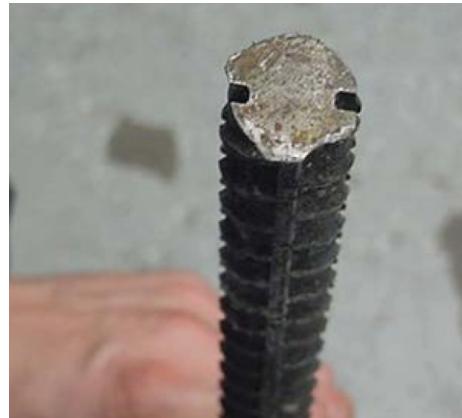
Figure 3—Slotted rebar for sensor placement (Kostecki, 2013)

Once the bolt type, capacity, and technology had been determined, the bolts were machined by slotting along their length for placement of the sensors (Figure 3). YieldPoint Inc. was chosen as the manufacturer because of their competitive costs, their willingness to be present during instrumentation installation at the mine sites, and because they were able to develop all of the rockbolt instrumentation, as well as closure meters, extensometer, tilt meters, and data loggers.

The bolts were slotted to a depth of 3.2 mm (0.126 inch) for placement of six 45.7 cm (18 inch) displacement sensors (three on each side). Six sensors per bolt were chosen to mitigate the total cost per bolt while still obtaining a comprehensive coverage of the bolt. The sensors were placed in an end-to-end arrangement within the machined slots and were held in place by epoxy.

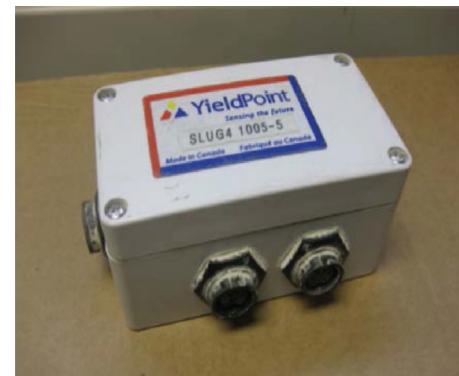
Figure 6—d<sup>4</sup> logger data-log box by YieldPoint Inc. (Kostecki, 2013)

The data was collected using data loggers, shown in Figure 6. Each data box could store over 30 000 readings and was equipped with four channels (one per rockbolt) that were wired to the instruments. The data loggers were manually set to take readings every hour, which could then be retrieved via a USB connection and custom software also developed by YieldPoint. Routine visits to the instrumentation site were scheduled to download the data. The data, which was recorded in microstrain, was then manipulated to obtain axial load, axial strain, and axial stretch. A conversion factor of 153  $\mu$ -strain per ton was used, based upon the cross-sectional area of the machined rebar and the elastic modulus of the bolt steel.

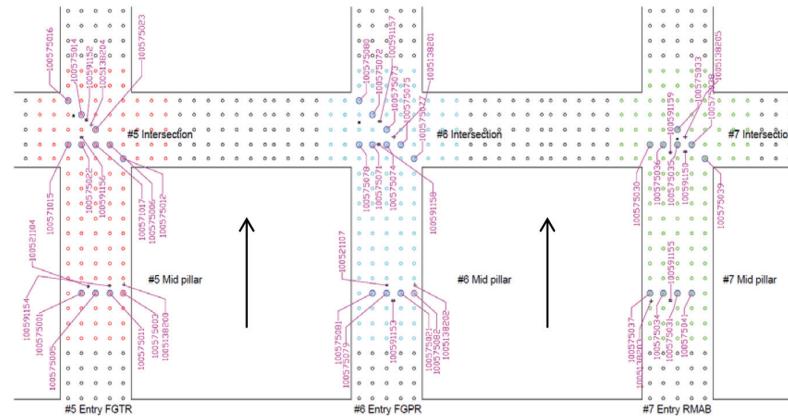
Figure 7—Instrumentation layout at Mine A, comprising instrumented bolts: multi-point extensometers (#), shear meters, (+) and closure meters (\*). Mine A: (o) – normal primary bolts used by mine, (o) – [FGTR], (o) – [FGPR] and (o) – [RMAB] (Spearing, *et al.*, 2011)

Instruments at Mine A were installed as primary support on-cycle. Figure 7 shows the instrumentation sites. From left to right in Figure 7 the entries were numbered 5, 6, and 7. These entries were chosen for several reasons. First, instruments were placed in three adjacent entries so that the geology was as similar as possible. Next, the adjacent entry to no. 5 was a belt entry and the adjacent entry to no. 7 was a return-air entry blocked off by a stopping. Finally, because monitoring of the instruments was to last several months, these entries were located in an area such that production would not be hindered over the entire monitoring period.

Instrumented roofbolts were installed in the intersections and mid-pillar regions of each entry. The arrows in Figure 7 show the direction in which the face was advancing during instrument installation, and therefore the mid-pillar was mined first and the mid-pillar instruments were installed a few days prior to the intersection instruments. The patterns at each site were identical. The diagonal pattern shown across the intersections was of particular importance as this represents the longest span, and therefore would offer the greatest chance of capturing the highest displacements and loadings over time. The FGTR instrumented bolts were installed in entry 5, FGPR in entry 6, and RMAB in entry 7. The non-instrumented support surrounding each test site, shown in Figure 7, was of the same type as the instrumented support in each area. Most importantly, each instrumented bolt was zeroed prior to instrumentation using a d-READER instrument reader provided by YieldPoint Inc. The entries were 6.1 m (20 ft) wide with 24.3 × 24.3 m (80 × 80 ft) centre-to-centre pillars (Spearing, *et al.*, 2011).

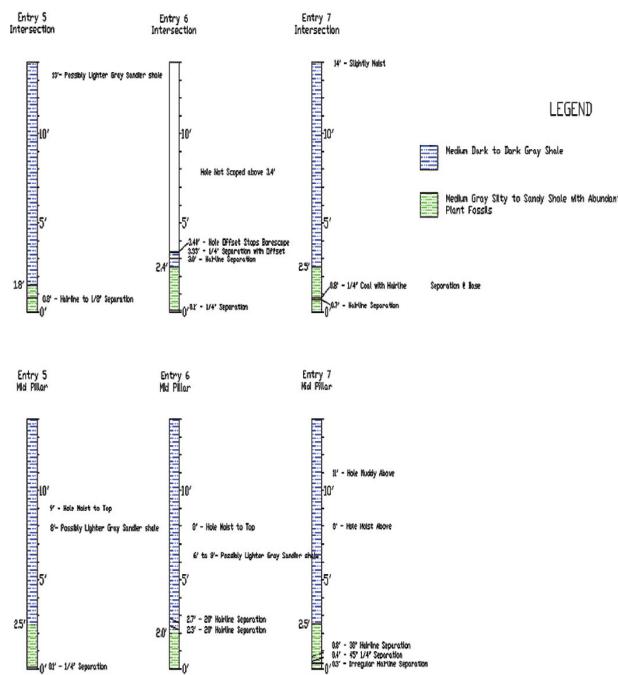
Figure 8—Borescope logs for Mine A (Spearing and Gadde, 2011)

Mine A is located in southwestern Indiana and exploits the Danville No. 7 seam of the Dugger Formation. Borescopes to 4.27 m (14 ft) above the coal seam were taken at each instrument site and the roof lithology is shown in Figure 8. In the immediate roof, the first 0.7 m (2.3 ft) on average was a medium-grey silty shale. This was overlain by a medium dark gray shale to the top of the 4.26 m (14 ft) borescope. Hairline separations were present in the bottom 0.3 m (1 ft) of the immediate roof in entries no. 5 and no. 7, with the most discernible separation in the no. 7 mid-pillar, where a 6.35 mm (0.25 inch) -45° hairline separation existed. Within the no. 6 entry, hairline separations existed from the 0.61–0.91 m (2–3 ft) level. The immediate floor was a soft medium-grey claystone common to Illinois Basin Mines. The coal seam thickness was 1.34 m (4.4 ft), on average, and was relatively flat-lying. The average mine height was 2.29 m (7.5 ft) with an overburden of 97.5 m (320 ft).

The roof lithology (Figure 8) and the floor lithology for Mine A were generated into a global grid, shown in Figure 20. This represented a portion of an entire panel at Mine A. The objective was to simulate the mining-induced loadings generated in the bolts as the panel progressed to two points in time – when the first readings were acquired and the readings at the beginning of the next month. These two points and times correspond to the relative face positions shown in Figure 21. Also shown in Figure 21 are the locations of the no. 5, 6, and 7 entries where the FGTR, FGPR, and RMAB were installed.

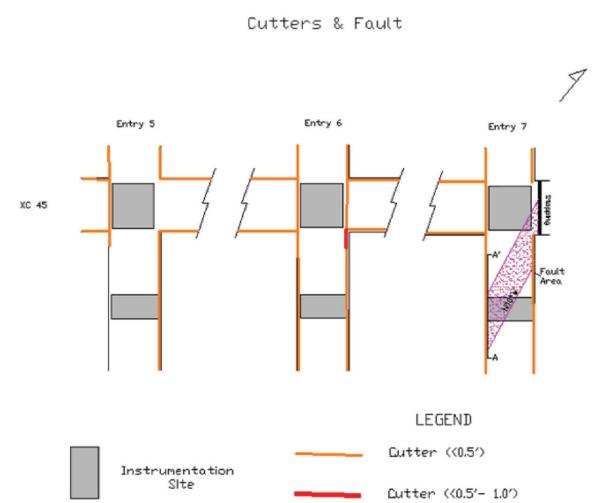
Figure 9—Cutter and fault mapping for Mine A (Spearing and Gadde, 2011)

Cutters existed throughout the mine site, shown in Figure 9, along most of the entries and crosscuts. The most significant was a 15.2–30.5 cm (0.5–1.0 ft) cutter at the eastern corner of the no. 6 intersection. A normal fault also existed in the no. 7 entry. This was not discovered until after the instruments had been installed and was not intended as part of the project design. The normal fault had a strike in the N10°W direction with a dip of 20° and a throw of 5 ft, which completely displaced the coal seam. A diagram of the normal fault is shown in Figure 10.

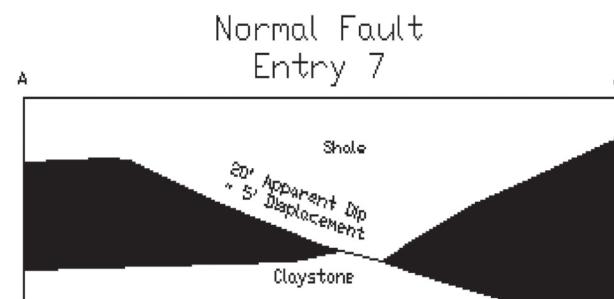
Figure 10—Mapping of fault located in the no. 7 entry of Mine A (Spearing and Gadde, 2011)

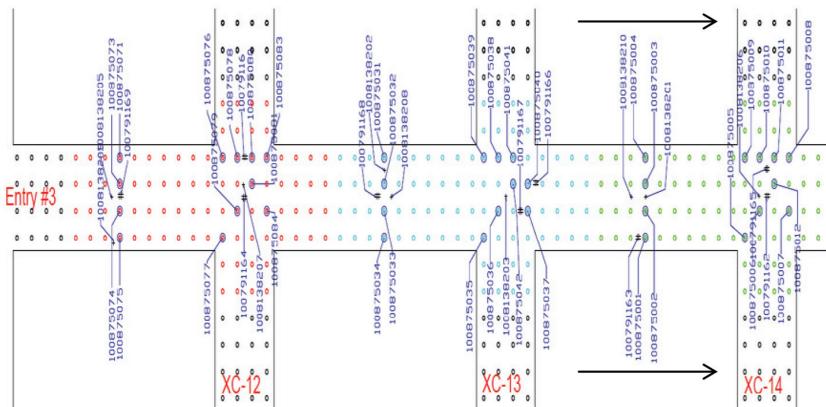
Figure 11—Instrumentation layout at Mine B, comprising instrumented bolts: multi-point extensometers (#), shear meters (+) and closure meters (\*). Mine B: (o) – normal primary bolts used by mine, (o) – [FGPR], (o) – [RMAB], and (o) – [FGTR] (Spearing, *et al.*, 2011)

Instruments at Mine B were installed as primary support on-cycle. The instruments were all installed in the same entry (*i.e.* entry 3 – Figure 11). This was mainly because of ventilation issues at the mine, and limited access to the adjacent entries at the time of installation. Parallel entries similar to Mine A were initially designed for.

Instrumented roofbolts were again installed in the intersections and mid-pillars regions. The arrows in Figure 11 show the direction in which the face was advancing during instrument installation. The FGPR instrumented bolts are denoted by the red circles up to crosscut 12 in Figure 11, RMAB are blue up to crosscut 13, and the FGTR are green up to crosscut 14. The non-instrumented support surrounding each test site was of the same type as the instrumented support, and each instrument was zeroed prior to instrumentation.

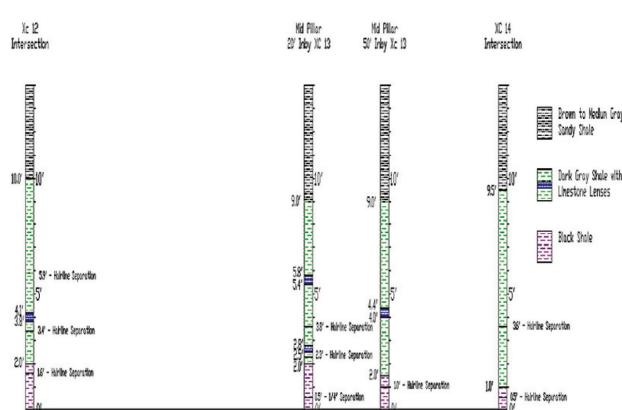
Figure 12—Roof lithology for Mine B instrumentation site (Spearing, *et al.*, 2011)

Mine B is also located in southwestern Indiana, and exploits the Springfield No. 5 coal seam of the Petersburg Formation. The depth to the instrument site was 106.7 m (350 ft) on average. Borescopes were taken at Mine B as at Mine A, although only four borescopes were obtained in total. The lithology for Mine B is shown in Figure 12.

The immediate roof comprised a black shale in the first 0.6 m (2 ft) overlain by a dark grey shale with limestone lenses up to 3.05 m (10 ft) in the most extreme case. This was overlain with a brown to medium grey sandy shale up to the top of the 4.27 m (14 ft) borescope. Hairline separations were found from 0.15 m (0.5 ft) up to almost 1.83 m (6 ft). The area was again underlain by weak underclay.

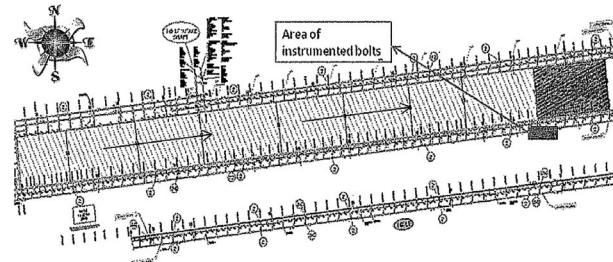
Figure 13—Instrumentation site at Mine C relative to advancing longwall. The arrows denote the direction of advance (Reisterer, 2011)

Instruments at Mine C were installed as supplemental support. Figures 13–17 show the instrumentation sites. The gate roads were already developed and had been supported with primary and secondary support. The instrumented supports were installed in the mid-pillar and intersections and were all located in the same entry. The FGPR bolts were installed in the no. 86 crosscut and mid-pillar, the FGTR bolts were installed in the no. 84 crosscut and mid-pillar, and RMAB bolts were installed in the no. 82 mid-pillar and crosscut. The direction of advance of the longwall is shown in Figure 13.

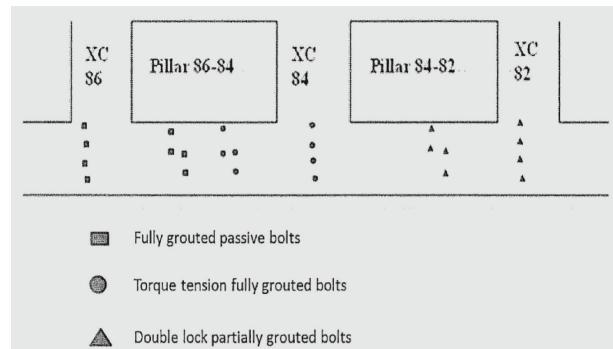
Figure 14—Generalized view of the instrumented bolt locations for Mine C (Reisterer, 2011)

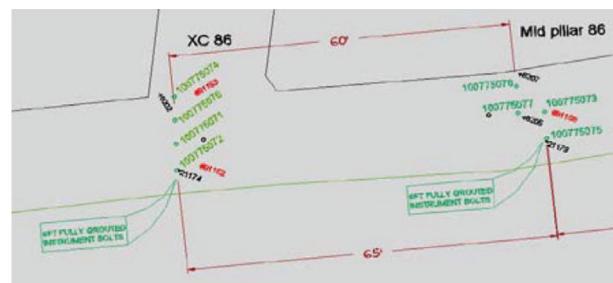
Figure 15—FGPR at mid-pillar and intersection, Mine C instrumentation site (crosscut 86) (Spearing, *et al.*, 2011)

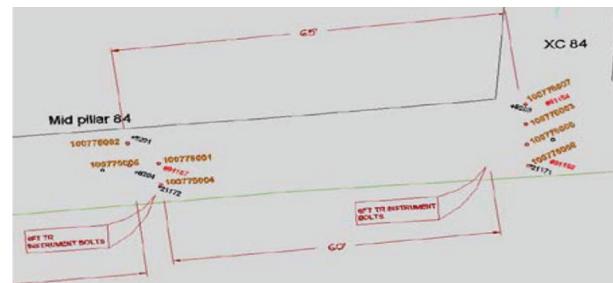
Figure 16—FGTR at mid-pillar and intersection, Mine C instrumentation site (crosscut 84) (Spearing, *et al.*, 2011)

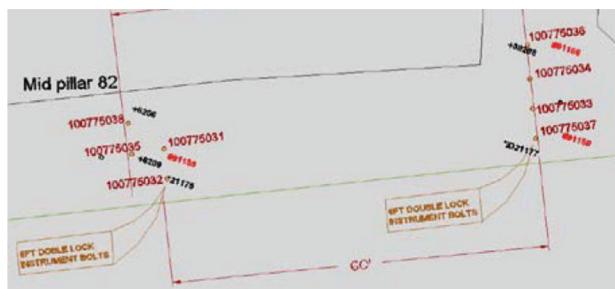
Figure 17—RMAB at mid-pillar and intersection, Mine C instrumentation site (crosscut 82) (Spearing, et al., 2011)

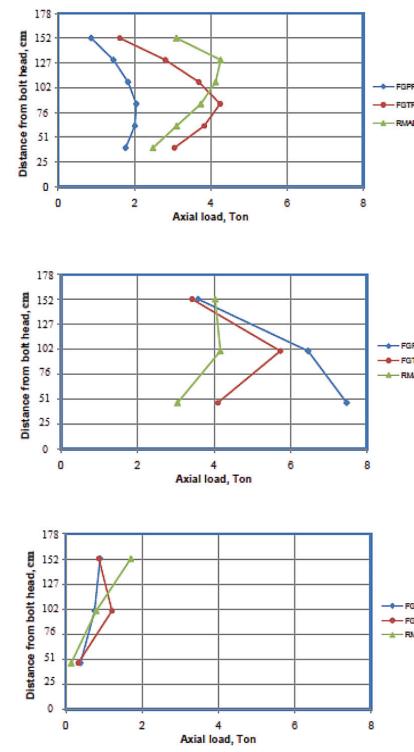
Figure 19—Initial bolt loads from mines A (top), B (middle), and C (bottom), as presented by Spearing, et al., (2011)

The earliest bolt readings are shown in Figure 19, which represents an average of all the initial bolt readings from each bolt type (FGPR, FGTR, and RMAB) from each mine (A, B, and C).

The initial assumption was that the active bolts would show a few tons more load on installation than the passive bolts, as they are tensioned on installation (4–5 t *versus* 1–2 t), especially since the roofbolter was set to 325 foot-pounds (441 Nm) torque (Kostecki, 2013). However, the results showed that the initial loads on the bolts were not significantly different. Although the results may be a poor representation of the initial loads at mines A and B, because of the delay in readings, the readings at Mine C were obtained soon after installation, and yet there was no significant difference in loadings.

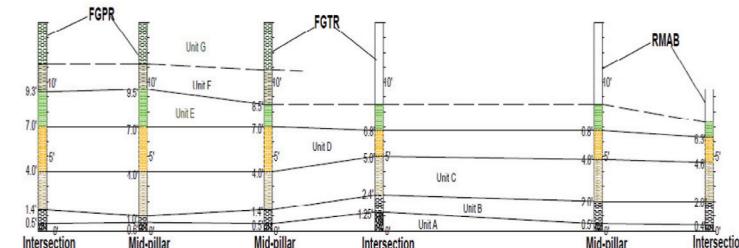
Figure 18—Roof lithology for Mine C instrumentation site (Spearing, et al., 2011)

Mine C is a longwall coal mine located in Colorado and exploits the Wadge coal seam. Borescopes were conducted at Mine C as at mines A and B. The lithology for Mine C is shown in Figure 18.

The immediate roof consisted of broken shale (Unit A) in the first 0.19 m (0.625 ft) on average. This was overlain by shale (Unit B) up to 0.52 m (1.7 ft) on average. Interbedded sandstone and shale (Unit C) overlaid the shale up to 1.52 m (5.0 ft) in the most extreme case. Sandstone with minor shale interbeds (Unit D) constituted the region 2.59–2.89 m (8.5–9.5 ft). Above this region were interbedded shale and sandstone (Unit E), sandstone and shale (Unit F), and shale (Unit G). Water ingress was also noticed within Unit F and Unit E during scoping (Figure 18).

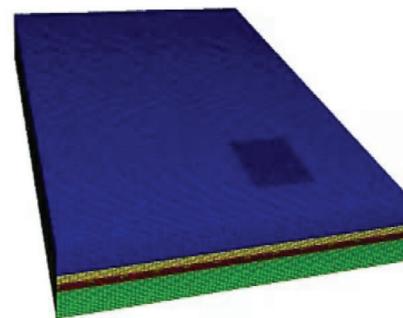
Figure 20—Global grid for Mine A

The panel was a large region, therefore to limit the model run-time, the zones were kept relatively large throughout (10 × 10 ft; 3.05 × 3.05 m), except in the area of interest. In this case the no. 6 mid-pillar and intersection were of interest because this was the location of the passive instrumented bolts. Therefore the zone sizes were 'densified' via a FISH subroutine, which broke the zones down into smaller 0.3 m × 0.3 m (1 × 1 ft) zones. An excavation sequence, which made a 12.2 m (40 ft) cut of coal and then placed a pattern of bolts, was then modelled. The excavation sequence progressed until the face positions were matched to those shown in Figure 21. At this point the loads on the instrumented bolts were extracted from the model and processed in a similar manner as the actual instrumented bolt data. Figure 22 shows the same global grid as in Figure 20 with the lithology above the coal pillars removed to show the excavations generated. In

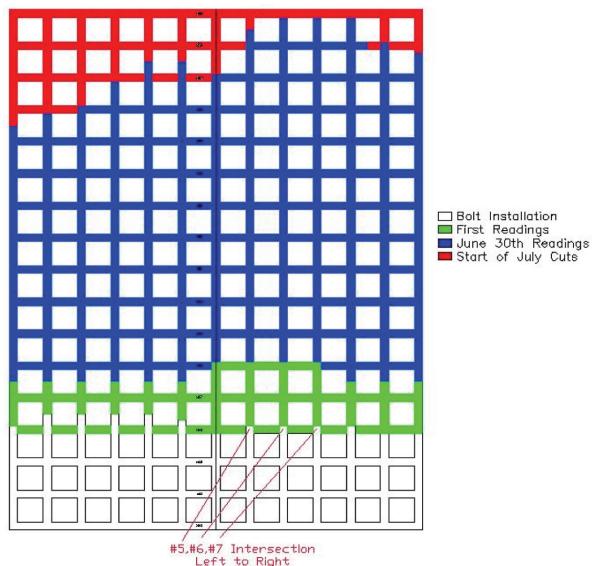
Figure 21—Map of the relative face positions for Mine A

the case of Figure 22, the face positions match the exact face position of the 'Start of July Cuts' shown in Figure 21. Also shown is the densified no. 6 mid-pillar and intersection where the FGPR bolts were located. The model was assumed to undergo elastic-perfectly plastic behaviour and followed the Mohr-Coulomb failure criteria.

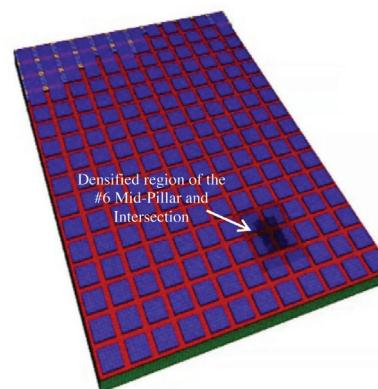
Figure 22—The global grid showing the excavation sequence and the densified region of the FGPR bolts

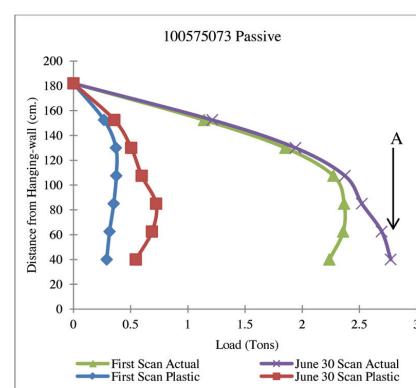
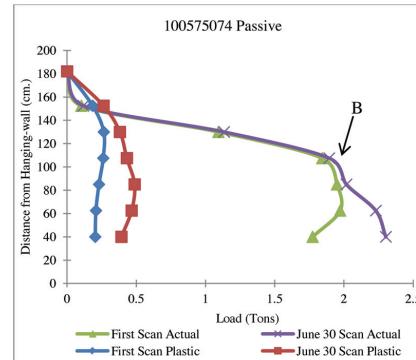
Figure 23—Actual and modelled elastic-perfectly plastic Mohr Coulomb (First Scan Plastic and June 30 Plastic) loadings for the 100575073 FGPR bolt (top) and the 100575074 FGPR bolt (bottom)

Bolts 100575073 and 100575074 were arbitrarily chosen for discussion because they best represent the challenges still remaining in the modelling portion of this study. The actual results from the instrumented bolts at two points in time (i.e. First Scan Actual and June 30 Actual) and the results of an elastic-perfectly plastic Mohr Coulomb model at two points during the excavation (*i.e.* First Scan Plastic and June 30 Plastic) are shown in Figure 23. The actual bolt loadings of the FGPR bolts tend to show peak loadings nearest to the excavation hangingwall, shown by point A in Figure 23. This was to be expected, as over time FGPR bolts are loaded by the downward movement of rock, which should transfer down the length of the rebar to the head of bolt. For the modelled bolts, the peak loadings tend to be somewhat near the head of the bolt but not nearly as distinctly as the actual loadings. Additionally, the modelled loads tend to be generally lower and less pronounced with no real peaks in loading, as is the case for bolt 100575074 (point B of Figure 23). In the actual bolts, the peaks are generated because of some discontinuity driving the loading at that point (*e.g.* dilation or shearing of the strata). For example, from point A in Figure 23, it is unclear what phenomena are driving this peak load, but these peak loadings were not re-created within the model.

It was therefore concluded that although the modelling shows potential to recreate the *in situ* loadings, challenges still remain. A particular challenge is replication of the bearing plate at the head of the bolt, which could be the reason behind the lack of peak modelled loads nearest to the hangingwall. Challenges also remain in modelling the geological structure on a local scale. For instance, dilation and shearing of the immediate roof over time could account for the absence of peak loadings shown by point B in Figure 23.
