Tap-hole monitoring technologies

Synopsis

This paper provides a progress update on three tap-block monitoring technologies that Hatch has been developing with our clients for non-ferrous smelting furnaces.

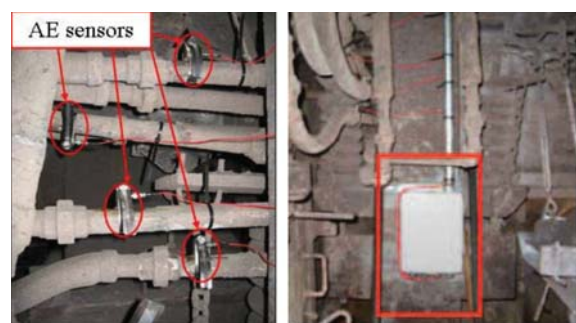
An example installation of selected TAM components is shown in Figure 1. The required number and the optimal type of sensors are determined individually for each tap-hole based on its design and through a calibration process. At KUC, four AE sensors were installed on the cooling pipes. The drilling and lancing activities cause acoustic emissions

Figure 1—AE sensors and preamplifiers installed near a tap-hole

The TAM software processes and displays data from a set of acoustic emission (AE) sensors installed around the tap-hole, typically on the cooling water pipes. Using these pipes as waveguides implies that the computed location of an AE event is always related to a specific position along the cooling coil. This is converted to a particular location in the nearest brick in the tapping channel. However, technically this is not a 3D source location algorithm. The 3D presentation of the results is added only to simplify the interpretation. A potential enhancement to this design would be the installation of specially designed waveguides to improve the sensitivity of the AE sensors. This would also allow use of the actual 3D source location algorithm for evaluating the damage in the tap-block. In either case, the AE signal is transferred from the sensors via preamplifiers to the processing unit.

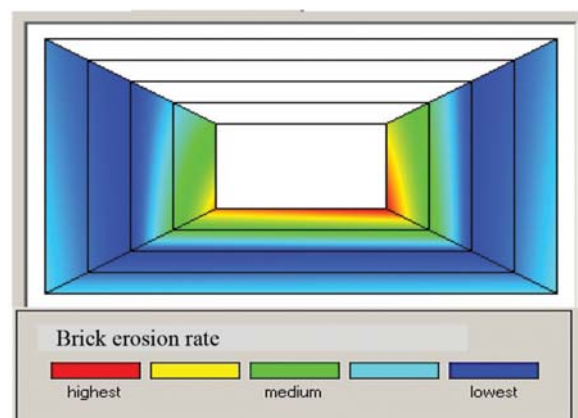
The image presented in Figure 2 shows a higher rate of brick erosion in the bottom right section of the block towards the hot face. This parameter is measured and updated on the screen frequently to show which area of the block is currently most affected, allowing lancing and drilling performance to be displayed in real time.

Figure 2—Brick erosion in the tapping channel (TAM screen capture)

Depending on the difference in time in arrival time at the four sensors, the source of the AE can be localized to one of the twelve zones. The operator screen gives a qualitative indication of the copper or brick erosion rate in the tapping channel, or indicates off-centre lancing or drilling based on the number and intensity of AE events detected in each zone.

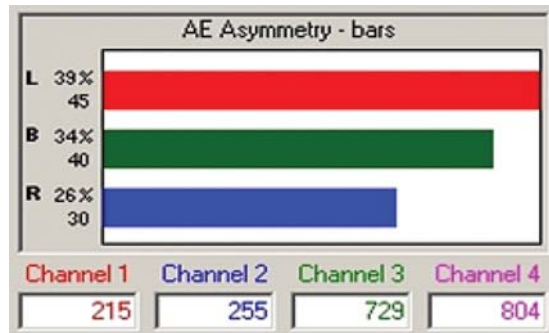
Figure 3—Orientation of drilling or lancing (skewed to the right (R) – the red bar) as indicated by the increase in AE activity

Optimal drilling should result in a uniform distribution of the AE signals detected in the left, right, and bottom sections of the block. Skewed drilling or lancing is detected by an unequal distribution of AE signals as shown in Figure 3, where the drilling and lancing activity is skewed to the right. These results displayed on the screen in the control room and

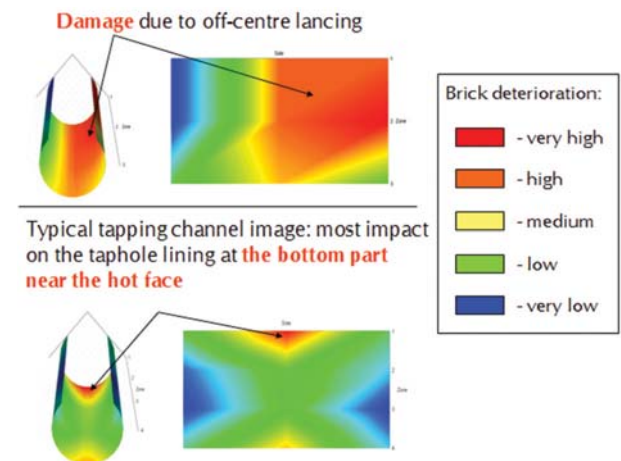
Figure 4—Brick deterioration measured by TAM. Left side shows the tapping channel and right side shows the developed view of the tapping channel

Due to off-centre lancing of a tap-hole, the refractory inserts were severely damaged. Towards the hot face, the hole was drilled approximately 7.6 cm (3 inches) lower than normal and oriented to the right side of the tap-hole. The opening was as close as 2.5 cm (1 inch) from the copper block. The reduction in refractory thickness resulted in less attenuation of the AE signals compared to normal. The locations of the high acoustic intensity zones identified by TAM within the tapping channel are shown in the top part of Figure 4. For comparison, the lower part of Figure 4 shows the acoustic intensity map during normal operation. Clearly, the off-centre lancing results in a cluster of high-intensity AE signals towards the right side of the tapping channel near the hot face. When the refractory inserts were removed, the inspection revealed erosion of the bricks in the area identified by TAM. The most damaged areas were found on the right and bottom of the tapping channel as shown in Figure 5.

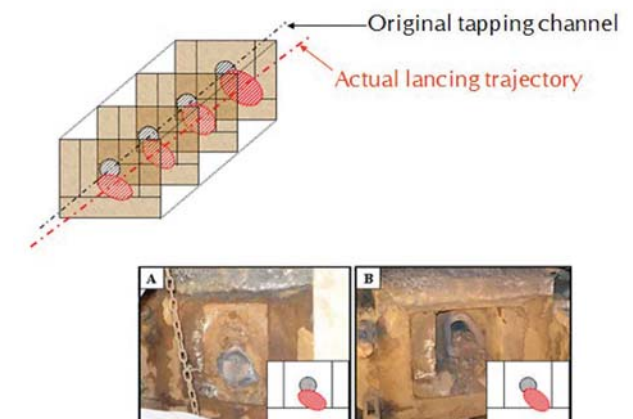
Figure 5—Actual brick damage in the tapping channel

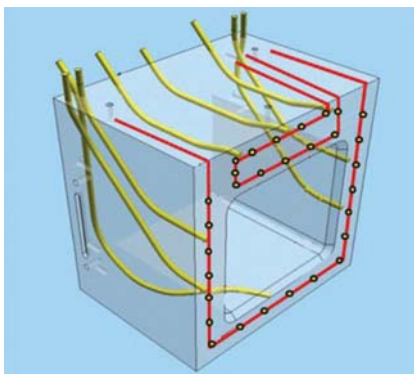
Figure 6—Tap-block showing location of thermowells and fibre optic cables

Prior to the use of fibre optics, the best practice to evaluate tap-block condition was a combination of thermocouples to monitor spot locations in the copper and resistive temperature devices (RTDs) and flow meter measurements to monitor the overall heat flux from changes in water temperature. The key benefits of the fibre optic temperature sensors are the small size of the fibre and the ability to install many sensors along a single fibre optic strand. In the case of the tap-block, the fibres are installed across the hot face, on or just below the surface of the copper. Figure 6 shows an example of an installation with two fibre optic strands (in red) on the copper surface. Sensors are typically spaced at 50–100 mm intervals over the regions of interest. A typical installation will involve the addition of 50 fibre optic sensors per tap-block. In contrast, the yellow tubes show a typical thermowell arrangement where this tap-block can accommodate only eight thermocouples.

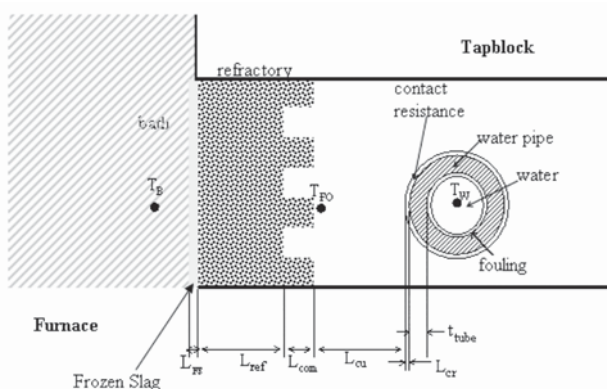
A basic cross-section through a tap-block is shown in Figure 7. Using knowledge of the properties of the materials and the temperature of the bath and water, it is possible to compute the expected measured temperature (TFO) using heat transfer relationships.

Figure 7—Heat transfer schematic

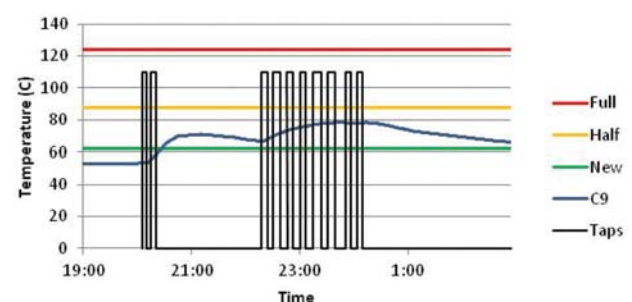
Figure 8 shows the measured temperature response of one of the fibre optic sensors to a sequence of tapping events. This sensor is physically located on the copper hot face above the tapping channel in the centre of the tap-block. The vertical black lines show the tapping events. The green, yellow, and red lines show the expected steady-state tapping temperatures for that sensor for a new, half worn, and fully worn refractory condition.

Figure 8—Thermal response of sensors to a tapping event

Several interesting observations can be made from the measured temperature data in Figure 8:

1. Installation of the sensor at the copper-refractory interface provides very good sensitivity to changes in refractory thickness. This expected temperature at this particular sensor covers a range of over 60°C as the refractory deteriorates from a new to fully worn condition. In contrast, thermocouples embedded in the copper may show only 2–3°C increase for the same change in refractory condition from new to fully worn. The increase in sensitivity provided by the surface-mounted sensor greatly enhances the ability to discern a change in the condition of the refractory and confidence in the results

2. The delayed response following the start of the tap is consistent with the refractory's low conductivity and the slow absorption of the energy from the molten material. It is also evident that the temperature continues to rise at the copper-refractory interface after tapping ceases as a result of the energy stored in the refractory (see times between 20:00 and 21:00 in Figure 8). The transient response of the temperature reading is directly related to the amount of refractory. Work is currently under way to develop a relationship between the transient temperature response and the refractory thickness. It is necessary to have an understanding of this relationship for smelting operations that tap occasionally and where the tap-block never reaches thermal equilibrium, as shown following the first two taps in Figure 8

3. Shortly after 23:00, it can be observed that with subsequent tapping there is no associated increase in the temperature above 80°C. This is defined as the steady-state condition for continuous tapping, where the heat load from exposure to the molten material is balanced by the cooling water. In this state, it is possible to evaluate the refractory condition on a consistent basis each time. Based on the wear reference lines (new, half worn, and fully worn) determined from the thermal model, it is expected that this tap-block is approaching a half-worn condition.

The pre-tapping temperature (about 53°C at 19:00 in Figure 8) of the tap-block depends on a number of parameters that cannot be measured and are related to variables such as the time since the last tap and clay plug position. The consequence is that condition assessment during the non-tapping period is very challenging. It has been found that the most reliable time to evaluate the

condition of the tap-block is during a period of continuous tapping (see 23:30 to 00:00 in Figure 8). In this state there are fewer unknown parameters that confound the assessment.

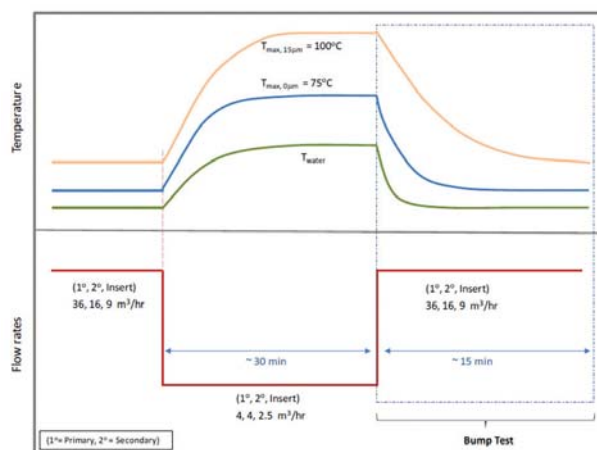
new bump test procedure was therefore designed that instead manipulates the cooling water flow rates to cause an abrupt decrease in tap-block temperature. A graphical representation of the procedure and the expected response is shown in Figure 9. The cooling water flow rate is first reduced to allow the temperature of the tap-block to increase. Once a sufficient temperature rise is obtained, the bump test is initiated by abruptly increasing the cooling water flow rate back to normal so that the tap-block temperature decreases. The actual thermocouple measurements are then analysed to estimate the tap-block thermal resistance.

Figure 9—Graphical representation of the new bump test procedure

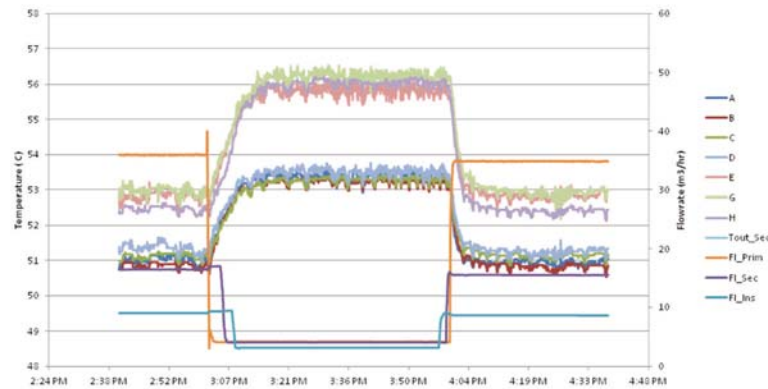
A bump test was recently performed on one of the tap-blocks at a client facility using the new procedure. During the test, as expected, the thermocouple temperatures increased upon lowering of the flow rates, reached a steady state, and finally decreased following a first-order response as shown in Figure 10.

Figure 10—Field bump test trends

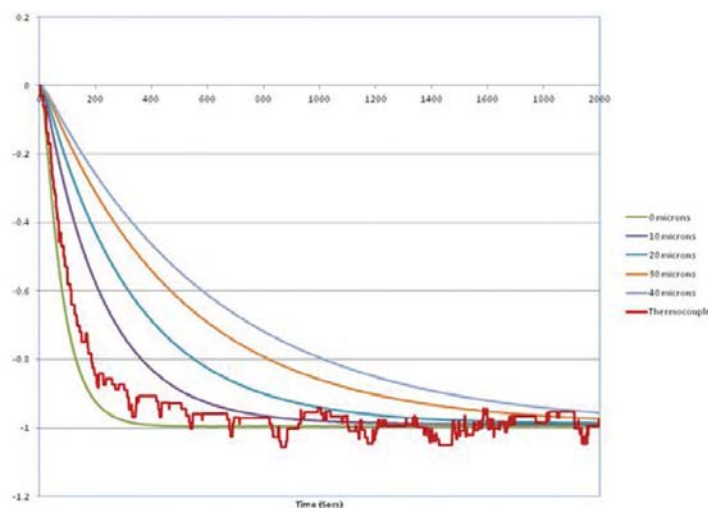
Figure 11 shows the normalized thermocouple data collected during the cooling portion of the bump test overlaid on the simulation data. The simulation curves are obtained at different block thermal resistances represented by 0, 10, 20, 30 and 40 μm gaps in the bonding between the copper block and water pipe. This range of gaps is taken as a generic way to represent any factor affecting the heat transfer through the copper block to the water pipe. Generally, there is no physical

Figure 11—Block thermal resistance estimation

gap at the boundary between the copper block and cooling water pipe. A zero gap represents perfect thermal bonding and results in the fastest thermocouple response, whereas a 40 μm gap results in a slower thermocouple response as the gap impedes the heat flow from the copper casting into the cooling water. Although this range of block resistance does not represent a problem with the tap-block cooling, the range of values has a significant impact on the interpretation of the temperature readings.

The sample data shown in Figure 11 clearly indicates that the block thermal resistance is between 0 and 10 μm and the diagnostic system has precisely calculated the values to be 4 μm . Similar analysis at different thermocouple locations indicated the tap-block thermal resistance is between 2 and 6 μm . These values are in the same range as those obtained for the Teck Cominco tap-blocks using the previous bump test procedure, and thus provide confidence in the new procedure.

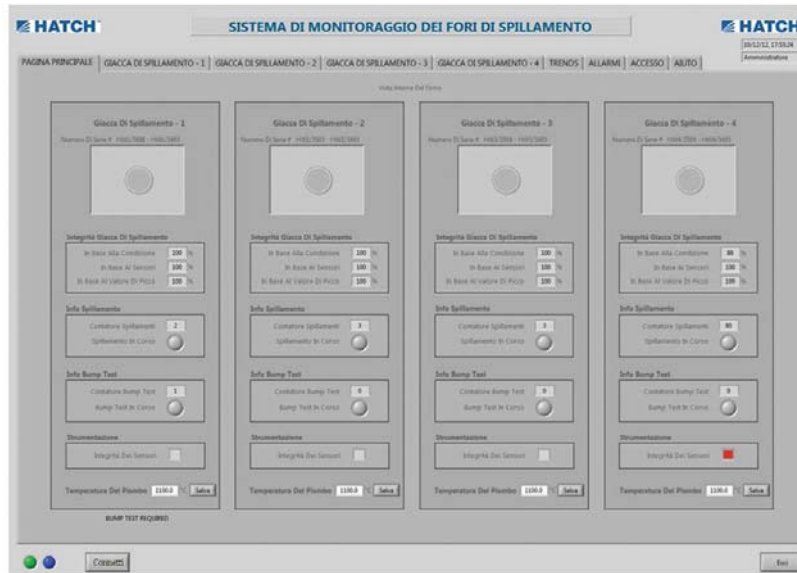
Figure 12—Overview screen of the Tapblock Diagnostic System at Portovesme s.r.l.

In general, the diagnostic system must be designed to present the results in a meaningful way to highlight significant events, and the HMI must quickly point out key conditions that require operator attention and provide the process engineer with insight into particular events of interest with a first-pass analysis. Figure 12 shows a sample operator display for the TDS screen with easy-to-interpret colour indicators (red/yellow/grey) that are used to alert operators to warnings ranging from instrument failure to tap-block
