Monitoring, repair, and safety practices for electric furnace matte tapping

by L. Thomson*

Synopsis

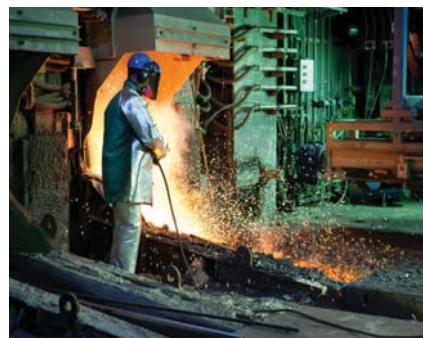
Figure 3—Matte tapping at Sudbury Integrated Nickel Operations smelter

There are three matte tapping channels on the furnace, and tapping (Figure 3) is rotated on a shift-by-shift schedule to allow time for cooling and lengthen the time between repairs.

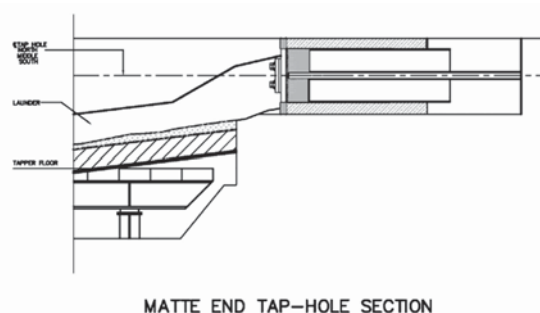
Figure 4—Matte end tap-hole section – side view

The deep copper coolers at the matte end (Figure 4) have either Monel or Cu/Ni alloy tubing and all connections for water piping are located outside the furnace wall. This set-up is the same for both the shallow- and the deep-cooled elements. Sand seals are in place above each matte end tap-hole covering the coolers and instrumentation cables. A moisture detection system that alarms back to the operating control system DCS is used to detect any leaks in these areas.

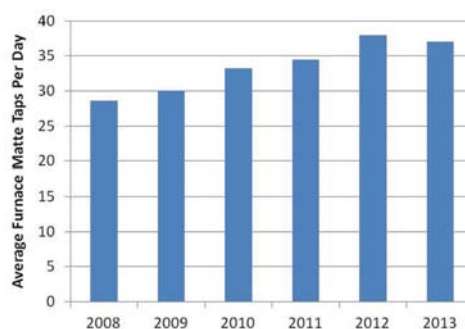
Figure 5—Furnace matte taps averaged on an annual basis for the last 5 years

With higher nickel production targets continuing to be achieved at similar smelter feed grades, a higher throughput is required in the two roasters and furnace. Given the single furnace operation and close tie-in to the converting aisle, the required matte tapping rates per shift have increased. To increase smelting rates, the matte temperatures and superheats have also been increased. Figure 5 summarizes the matte taps per day on an average annual basis since

2008. Average daily tapping rates for 2013 are 28% higher than in 2008.

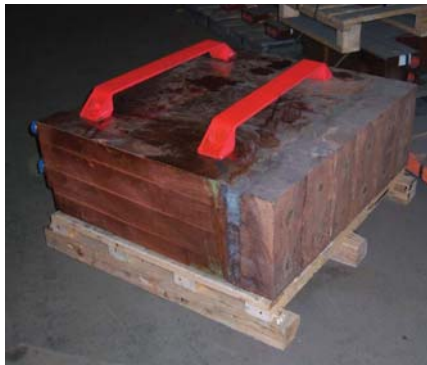
Figure 7—Refractory-lined copper deep lintel

The initial design for the deep lintel was for a larger copper cooler with refractory lining at the hot face to be inserted past the doghouse in order to push out the isotherm. This lintel (Figure 7) was installed on the middle tap-hole in the summer of 2011 and remained in service for two six-month campaigns. The deeper cooling above the tapping channel was found to be successful in protecting the doghouse from elevated temperatures. However, elevated temperatures that required closer management occurred near the end of the campaigns on the deep lintel cooler itself.

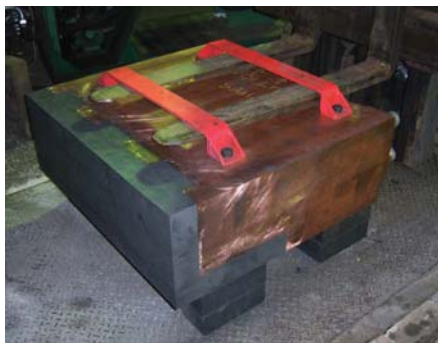
Figure 8—Graphite-lined copper deep lintel prior to installation

The second design (Figure 8) incorporated a graphite block at the hot face that was installed on the middle tap-hole in the summer of 2012. After two months' service, elevated temperatures were measured on this block. The tapping on

this tap-hole was reduced to manage the temperatures, and after one month the tap-hole was taken offline to complete a tap-hole repair and removal of the graphite-lined copper lintel. At this time, the refractory-lined copper lintel was put back in service.

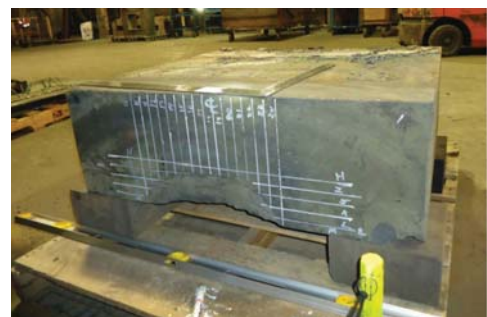
Figure 9—Graphite-lined copper deep lintel removed in September 2012

Upon removal and inspection, the graphite was found to be worn back in the bottom section (Figure 9), consistent with the location of the thermocouples where the highest temperatures were recorded. Further analysis showed that, given the elevation of the lintel cooler near the slag-matte interface, maintaining an adequate build-up layer was difficult. At the furnace re-start in June 2012 with the new cooler in place, the solid slag build-up in front of the cooler was present, but with time and tapping frequency, this build-up could not be maintained to provide an adequate protective layer in front of the cooler (Cerilli, 2012).
