Determination of stable spans in UG2 excavations

by B.P. Watson*, and R. Gerber†

Synopsis

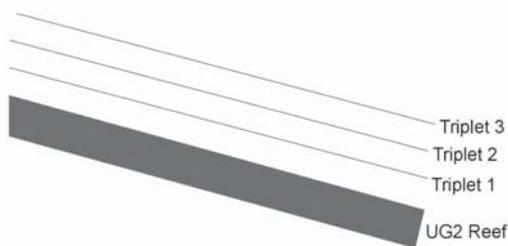
Figure 2—Typical UG2 Reef and the weakly cohesive chromitite stringers (triplets)

The UG2 Reef is widely mined in the South African Bushveld Complex (Figure 1). It is a tabular, gently dipping orebody as shown in Figure 2. The hangingwall of the UG2 Reef is characterized by stratification in the form of thin and weakly cohesive chromitite stringers (triplets) that can vary in number and height above a stope. Traditionally this reef has been extracted conventionally (Figure 3) using mine poles and packs as support. Increasingly it is extracted using mechanized (Figure 3) or partially mechanized mining methods, and these stopes or zones have to be supported on tendons.

For any given situation, the stability of a UG2 hangingwall depends upon the presence or absence of shallow-dipping thrust structures, height and spacing of the chromitite bands (triplets) above the reef (Figure 2), the stoping span, the rock mass rating, the support resistance, and depth of penetration (if tendons are used). The conditions for stability, incorporating all these variables and their interactions, have to be determined in order to develop a design methodology to determine stable spans for the mining of the UG2 Reef.

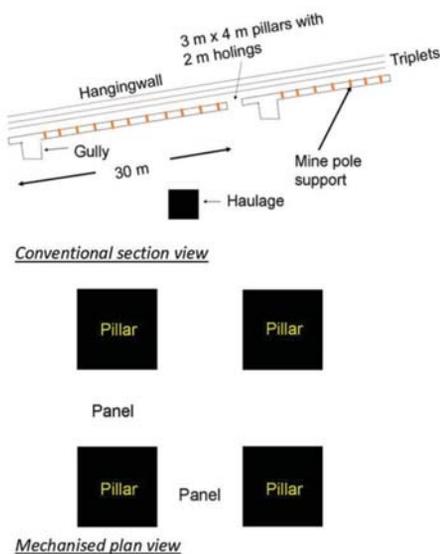
Figure 3—Typical conventional and mechanized mining layouts

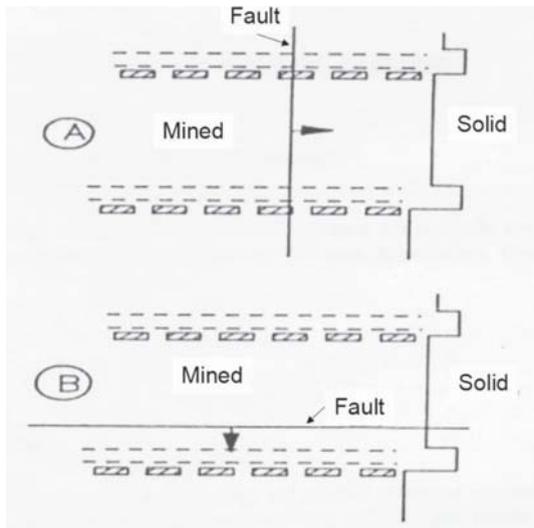
Figure 4—Favourable (A) and unfavourable (B) orientations of fault planes with respect to the yield pillar layouts (after Brummer, 1988)

- Discontinuity orientation. Brummer *et al.* (1988) suggested that faults or persistent joints striking parallel to pillar lines (Figure 4) are considerably less stable than those perpendicular to the pillar lines.

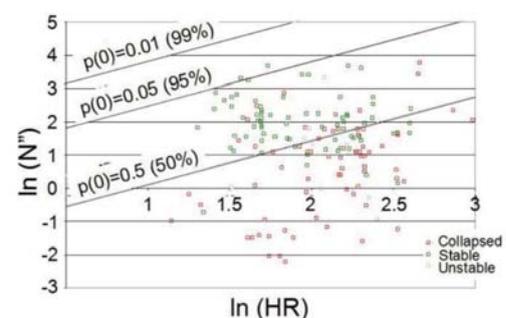
Figure 5—Design chart for N''

The angle of the shallow-dipping thrust fault was changed to 30° to the strata to determine if a slightly steeper angle would increase the height of instability at a particular span, and thus reduce the stable span for a given set of conditions. However, no discernible difference was observed. Hutchinson and Diederichs (1996) also show equal severity across the range of dip angles between 10° and 30° to the strata, and suggest that the worst discontinuity angles are within that range (Figure 5).

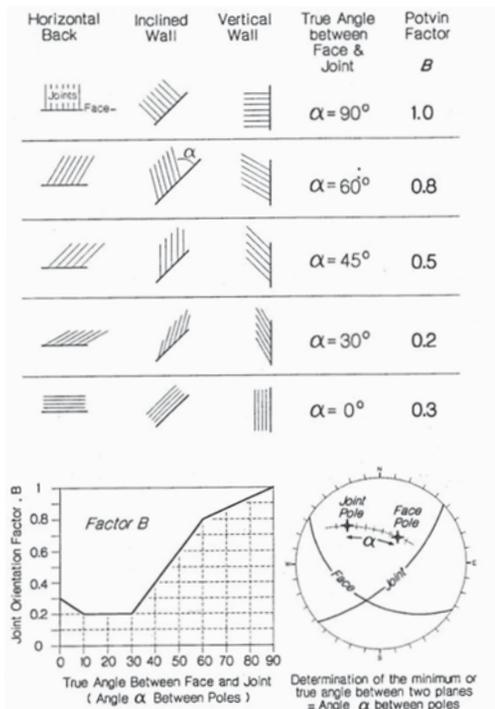
Figure 6—Factor for joint orientation 'B' (after Mathews *et al.*, 1981 and revised by Hutchinson and Diederichs, 1996)

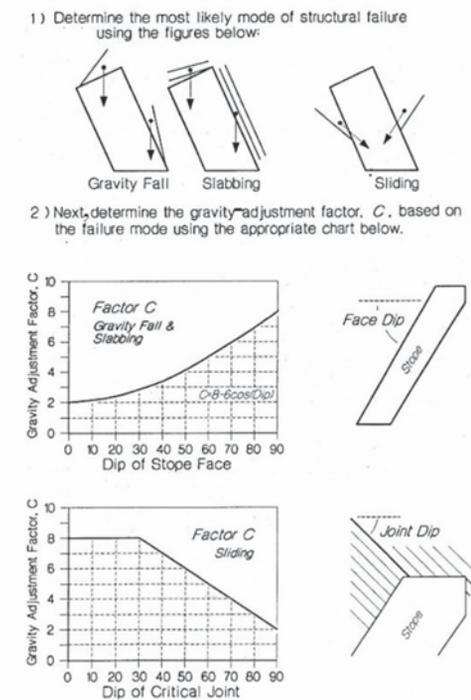
Figure 7—Gravity adjustment factor 'C' (after Mathews *et al.*, 1981 and revised by Hutchinson and Diederichs, 1996)

A statistical evaluation and reworking of the N'' equation (Equation [2]) was done to provide a best fit between collapsed and stable panels. A significantly better fit was found (confidence level: about 93 %) when Equation [5] ($N^{(3)}$) was compared to support resistance (SR) and a factor describing the joint filling. The analysis suggests that support resistance plays a more influential role than span for a given discontinuity condition, within the context of the spans in the database. Note that the dominant parameter in this equation is the B-value, which is a factor accounting for the dip orientation of the most influential discontinuity (Figure 6). The C-value (Equation [1]) accounts for the influence of gravity on the hangingwall blocks (Figure 7).

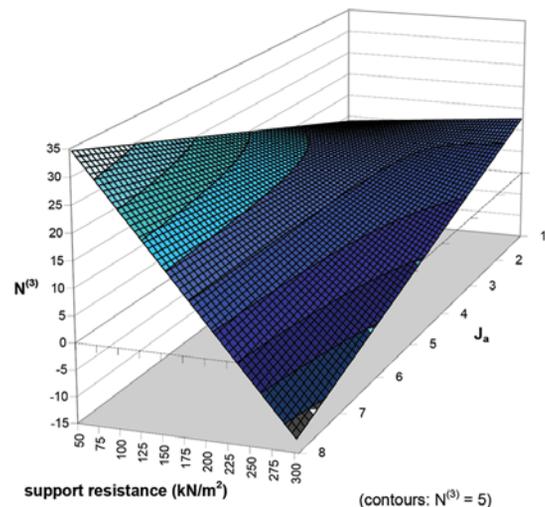
Figure 8—Surface showing a probability of a collapse at <5%

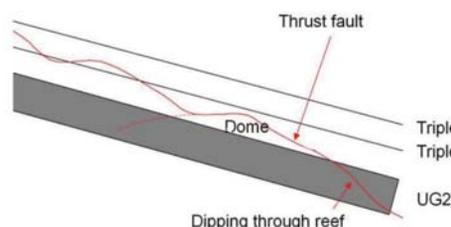
Figure 9—Diagram showing a section through an actual thrust structure

The statistical evaluation of the geotechnical data suggested that the most significant stability parameter is persistent, shallow-dipping or curved discontinuities. Generally, these features are associated with thrust fault structures, which appear to be endemic across the platinum-bearing orebodies of the Bushveld Complex. These discontinuities dip in and out of the reefs, resulting in the development of dome structures in the hangingwall during mining (Figure 9).

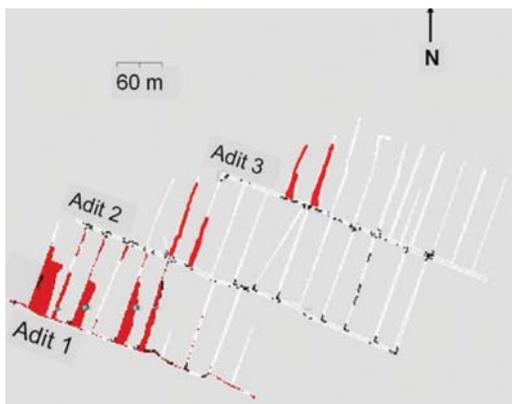
Figure 10—Plan view of the workings at the time of the 'mine A' investigations

A highly appropriate 2D case study was made available at 'mine A'. Stopes were mined from one side of a raise line, from 2 m to a planned 30 m width on strike and about 120 m on dip (Figure 10). A shallow-dipping thrust fault dipped in and out of the reef, causing several panel collapses that were used to calibrate the model. The joint sets at the site were similar to the common joints observed generally across the platinum mines.

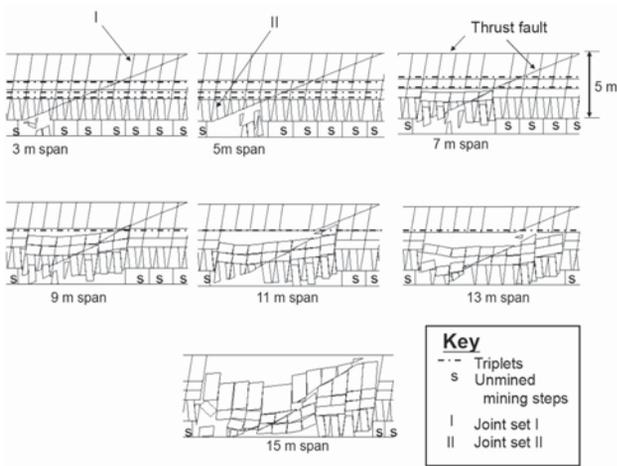
Figure 12—Results of a UDEC model without support

thrust fault and the two joint sets fell out as the span was increased, showing that there is no stable, self-supporting span. At a span of 5 m the rock mass collapsed up to triplet I (1.3 m above the stope). An increase of the span by 2 m resulted in a migration of the unstable zone up to triplet II at 2.0 m above the stope. The conditions at spans of both 5 m and 7 m were observed underground at mine A in unsupported or under-supported panels. At a span of 9 m, the entire rock mass below triplet III (at a height of 2.7 m) became unstable. At a span of 15 m, a collapse occurred up to the horizontal thrust fault at 4.1 m above the stope.

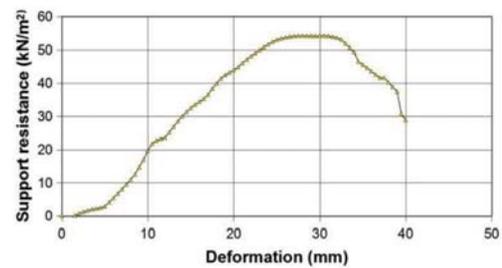
Figure 13—Support resistance with a 99% confidence, assuming large blocks (supported by at least three poles)

A support system of 170 mm diameter mine poles spaced 2 m × 2 m on dip and strike was originally used at the mine. A downrated support resistance of 50 kN/m² was assumed from underground measurements. A curve for the elongate support system is provided in Figure 13. The results of the models are shown in Figure 14. Stable conditions were predicted up to a span of 9 m. At a span of 11 m the model showed that parting had occurred on all three triplets as well as at 4.1 m above the stope. A collapse occurred up to triplet III at a span of 13 m, which is a modest improvement of 4 m over the unsupported scenario.

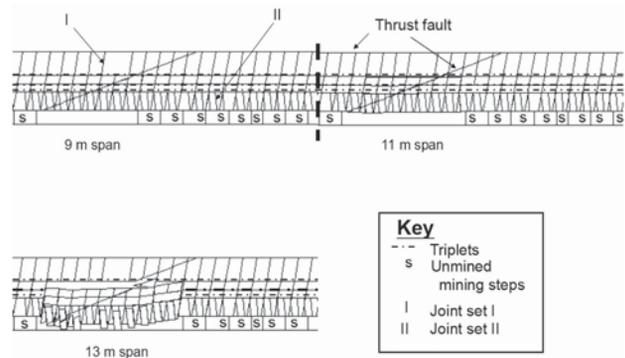
Figure 14—Results of a UDEC model with a support resistance of 50 kN/m²

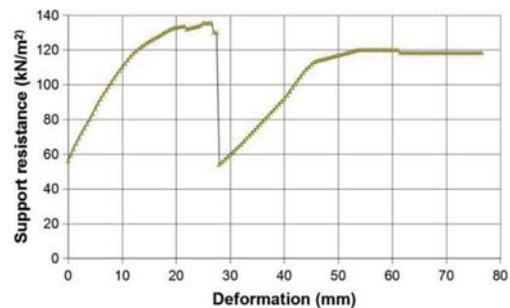
Figure 15—Support resistance profile for the second support system

A new support system was introduced to the mine, which included larger diameter mine poles and packs. This condition was modelled assuming a downrated support resistance of 135 kN/m². In the model, only the mine poles were prestressed (to 150 kN) and the profile of support resistance to closure was determined from underground measurements (Figure 15). A great improvement, both in stable panel span and rock mass conditions, was achieved by this support system (Figure 16). Unstable conditions occurred at a span of 19 m and a final collapse at 22 m. Note that parting initiated at 4.1 m above the hangingwall, when the span reached 17 m. The modelled unstable conditions were observed underground.

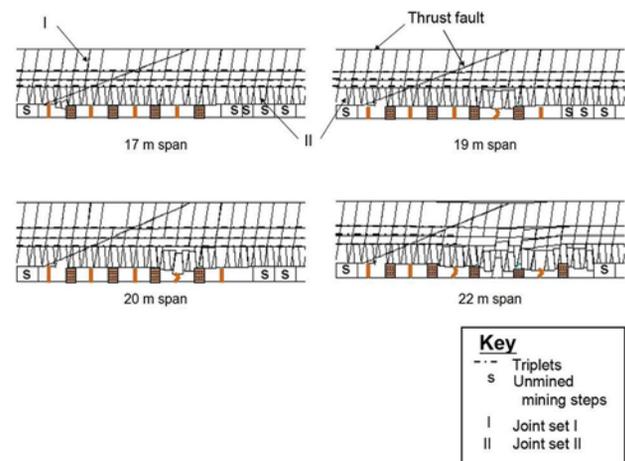
Figure 16—Results of the UDEC model for a pack-elongate support system with a support resistance of 139 kN/m²

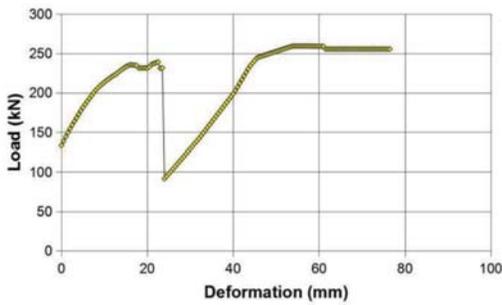
Figure 17—Final support resistance profile (100 kN/m² at installation)

A support system which was prestressed to 100 kN/m² at installation and provided a peak resistance of 200 kN/m² (Figure 17) was introduced to the mine. This support system was technically able to support a rock height of 5 m, with only about 5 mm deformation. To ensure worst-case conditions in the model, a second horizontal discontinuity,

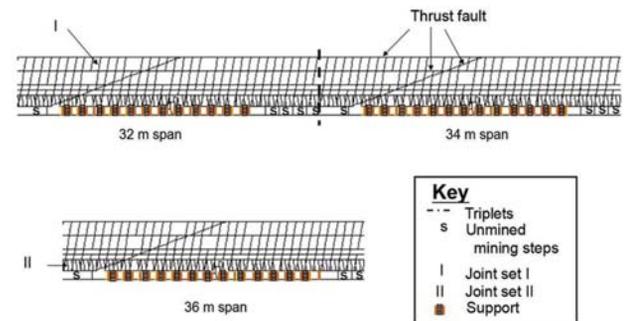
Figure 18—Results of the UDEC model for a support resistance of 200 kN/m². The support-to-face distance was kept to a maximum of 2.8 m

with properties similar to the thrust fault, was set up at 6.1 m above the stope. This was slightly higher than the support capacity. The results are shown in Figure 18. Spans were increased in the model to a maximum of 36 m and stable conditions were predicted in all runs. However, it should be noted that FOGs occurred in the face area when the maximum support-to-face distance was 3.6 m. These FOGs did not occur in the model when the support-to-face distance was reduced to 2.8 m, and this was also confirmed by underground observations. The peak support resistance used at this mine was very high, and it may be unrealistic to apply as a best practice for preventing large-scale instabilities. Mitigation strategies based on knowledge of the height and behaviour of potentially hazardous structures are preferred.

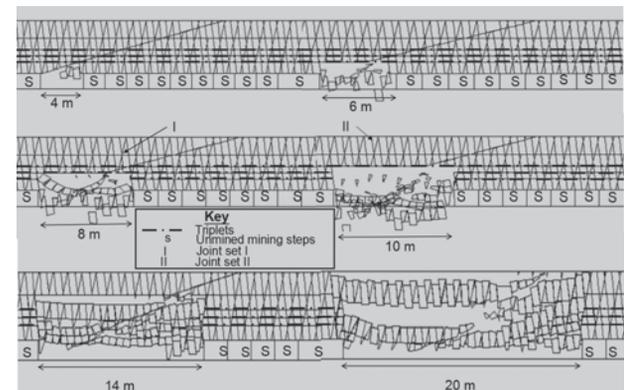
Figure 19—Unsupported model, vertical deformation exaggerated 10x

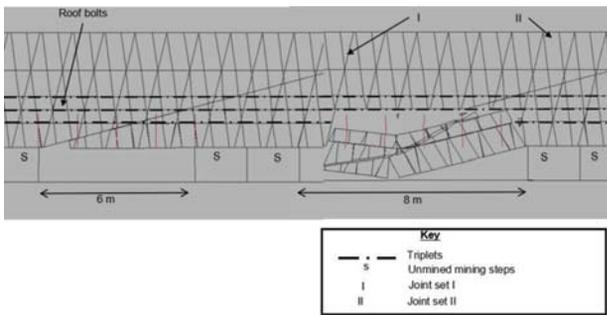
Figure 20—Results of the UDEC model with 18 mm diameter, 1.8 m long, full-column resin roofbolts; vertical deformation exaggerated 10x

A set of models was run with 18 mm diameter, 1.8 m long full-column resin roofbolts, spaced 1.5 m × 1.5 m. The reinforcement properties shown in Table IV were applied in the models, which provided a support resistance of 48 kN/m² over the length of the bolts. The results of the investigation are shown in Figure 20.

Stable conditions with minor FOGs were observed until a span of 8 m. Note that the reach of the bolts extended to just beyond triplet I. The panel collapse occurred up to triplet II at

exactly the same span as in the unsupported models. Importantly, the supported models were able to control most of the FOGs. Suitable surface support is needed to control the small falls between the bolts.

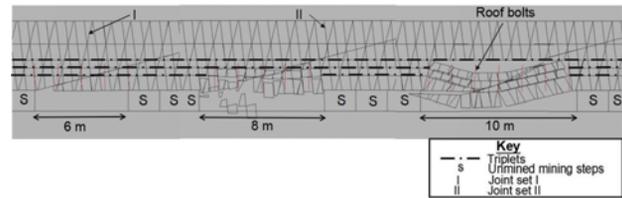
Figure 21—Results of the UDEC model with 18 mm diameter, 2.4 m long, full-column resin roofbolts; vertical deformation exaggerated 10x

A set of models was run to test the effects of increasing the bolt length to 2.4 m. The results showed unstable conditions at a span of 8 m and a collapse at 10 m (Figure 21). The unstable conditions at 8 m were probably the result of parting on triplet II and bolt yield. A collapse occurred up to triplet III at a span of 10 m; again as observed in the unsupported model.

An investigation was conducted to determine the effect of changing the support resistance on stability. The spacing of roofbolts used in Figure 21 was reduced to 1.5 m × 0.8 m. The support resistance was thus increased from 48 kN/m² to 92 kN/m², but the length and diameter of the bolts were kept the same. The results showed an improvement in span with support resistance, with the critical span increasing from 10 m to 12 m (Figure 24). A similar set of models (with the higher support resistance) was run with the triplets at 1.3 m

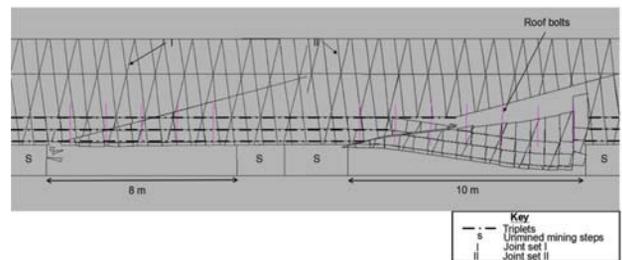
Figure 22—Results of the UDEC model with 18 mm diameter, 2.4 m long, full-column resin roofbolts (triplet at 0.2 m); vertical deformation exaggerated 10x

The model shown in Figure 22 (thrust fault at 20°) was re-run once more with a pre-tension of 38 kN on each bolt at installation. A collapse occurred at a smaller span (Figure 23). The reason for the earlier failure is not clear. Previous modelling work by consultants showed that a small pre-tension on tendon support elements definitely improves deflection and thus stability. However, the thrust structure was not included in those models.

A set of models was run to determine the effect of k-ratio on stability. The height and orientations of discontinuities were as shown in Table V, and all parameters as for the model depicted in Figure 22, except the k-ratio, which was reduced to 0.5. The results show that k-ratio does affect stability conditions, and the decrease in k-ratio resulted in a decrease in stable-span width (Figure 26) for the given support and geotechnical conditions. A collapse occurred at 8 m (2 m less than in Figure 22). A similar set of models was run at depths of 200 m and 1000 m, keeping the k-ratio at 0.5. The stable span was the same at 200 m, but there was an improvement at 1000 m (Figure 27).

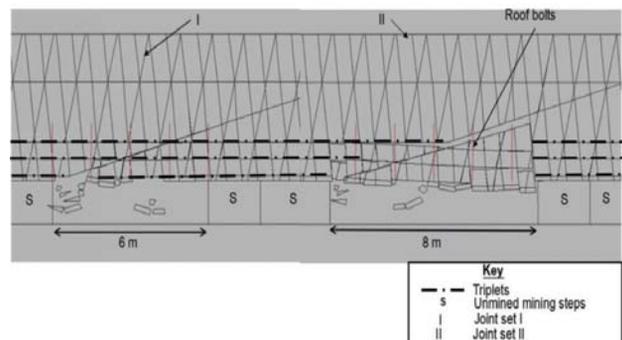
Figure 23—Results of the UDEC model with pre-tensioned 18 mm diameter, 2.4 m long, full-column resin roofbolts (triplet at 0.2 m); bolts pre-tensioned to 38 kN, vertical deformation exaggerated 10

Pre-tensioning of the bolts resulted in premature unstable ground conditions at 8 m. The reason for the earlier collapse is not clear. Note that much larger lumps fell out during the collapses, which is also observed underground in areas supported with roofbolts.

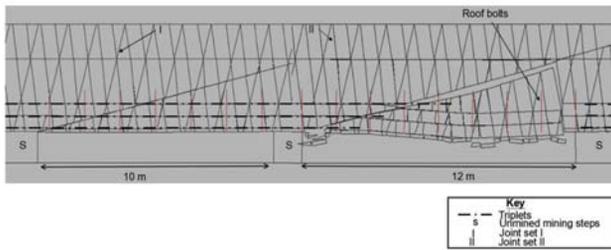
Figure 24—Results of the UDEC model with 18 mm diameter, 2.4 m long, full-column resin roofbolts at a spacing of 1.5 m × 0.8 m (triplet at 0.2 m); vertical deformation exaggerated 10x

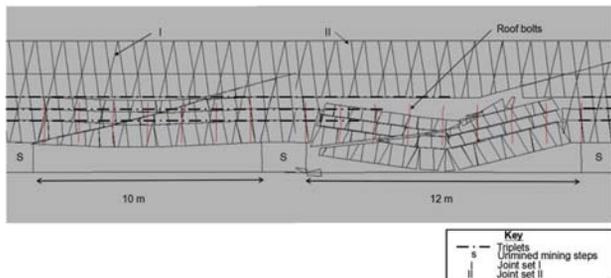
Figure 25—Results of the UDEC model with 18 mm diameter, 2.4 m long, full-column resin roofbolts at a spacing of 1.5 m × 0.8 m (triplet at 1.3 m); vertical deformation exaggerated 10x

(same as in Figure 21). In this instance the bolts did not penetrate through the upper triplet, but the critical span remained at 12 m (Figure 25). However, significantly more vertical displacement was calculated at a span of 10 m in this model than when the triplets were closer to the reef, due to

parting on the upper triplet. Parting took place on this upper triplet at the same span as a collapse in the unsupported scenario (10 m), but the support was able to prevent a collapse and increased the critical span by 2 m.

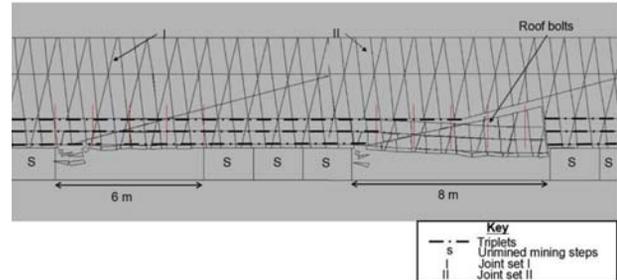
Figure 26—Results of the UDEC model with 22 mm diameter, 2.4 m long, full-column resin roofbolts (triplet at 0.2 m and $k = 0.5$) at 400 m depth below surface ; vertical deformation exaggerated 10x

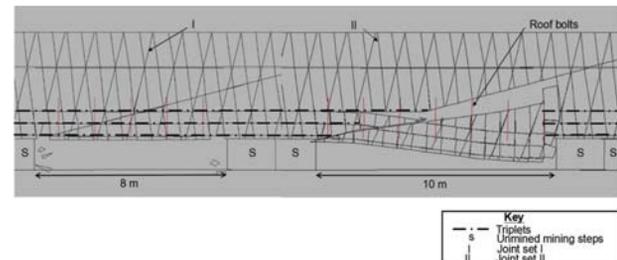
Figure 27—Results of the UDEC model with 22 mm diameter, 2.4 m long, full-column resin roofbolts (triplet at 0.2 m and $k = 0.5$), at 1000 m depth below surface; vertical deformation exaggerated 10x

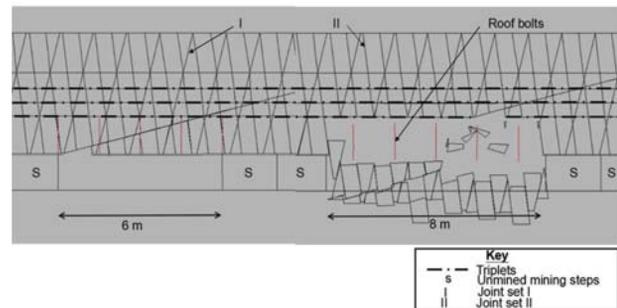
Figure 28—Results of the UDEC model with 18 mm diameter, 1.8 m long, full-column resin roofbolts, lowest triplet beyond the reach of the roofbolts; vertical deformation exaggerated 10x

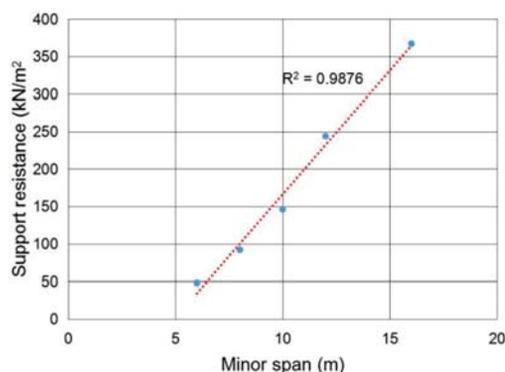
Figure 29—Relationship between span and support resistance for 1.8 m long roofbolts and triplets above 1.3 m

Under ideal conditions, the maximum achievable stable span with a bolt spacing of 1.5 m × 1.5 m (48 kN/m²) was shown to be about 8 m. Larger stable spans are often observed underground, even with the same tendon support as used in the models. It should be emphasized, though, that the shallow-dipping thrust fault is not always in the vulnerable position modelled. The models are showing a worst-case scenario. Should it be possible to determine where these structures exist with a high degree of confidence, it would be possible to mine safely at larger spans, accounting for these structures where they exist. At mine B the thrust structures were easily identifiable. Spans of 10 m were mined successfully in areas where the thrust structure did not intersect the stope hangingwall. This scenario agrees with the results shown by the model without a thrust structure (Figure 11). However, the areas affected by the thrust structure had to be properly supported on a separate support system using 4.5 m and 6.0 m long anchors on a close spacing. The actual length and support resistance were calculated at the height of the structure above the hangingwall. Since the introduction of this system, instances of large FOGs have reduced almost to zero, except for instances of human error.

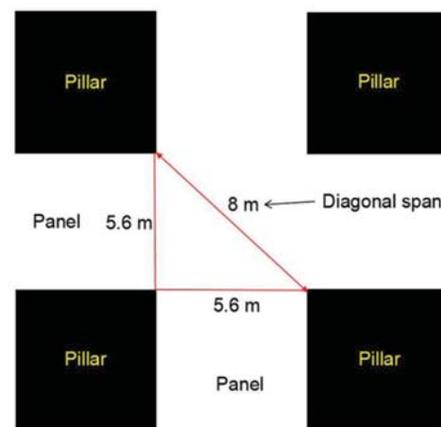
Figure 30—Excavation spans to accommodate a critical diagonal span across an intersection

It should be noted that the model assumed an infinitely long panel (into the page). However, in reality there are intersections, or holings, between orthogonal panels. These intersections represent areas of larger span and should also be treated differently, or the spans of the panels should be reduced to ensure that the diagonal across the intersection does not exceed the critical span. For an 8 m critical span, a safe panel span for two equal sized panels intersecting would be 5.6 m (Figure 30).
