Modelling and analysis of the Brumadinho tailings disaster using advanced geospatial analytics

Synopsis

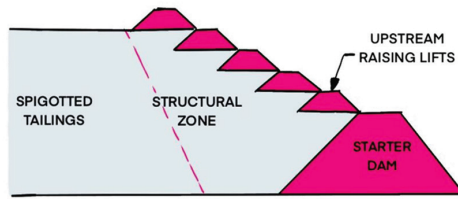
Figure 3—Overview of upstream tailing dam construction method (redrawn from McLeod, Murray, and Berger, 2003)

This economical construction method is very common in low seismic risk areas. A cross-section illustrating the construction method is shown in Figure 3 (Soares, Arnez, and Hennies, 2000). In this method, the fresh tailings are deposited on top of the previously placed tailings. This requires the tailings to provide support for the dam and as such makes this type of dam potentially more prone to failure where the tailings are of low strength and materials may be prone to liquefaction (McLeod

and Bjelkevick, 2017). Most of the tailing dams that have failed in the past few decades, were constructed using upstream construction (Rico *et al.*, 2008). This method is mostly suitable for arid regions and requires more careful supervision and water management than other methods.

The Brumadinho Córrego do Feijão tailings dam, which failed in January 2019, was constructed using the upstream method. Upstream constructed TSFs are not permitted in Chile and Peru (and recently in Brazil as a result of the failure) due to the higher probability of failure under static and dynamic loading (Breitenbach, 2010; Valenzuela, 2018).

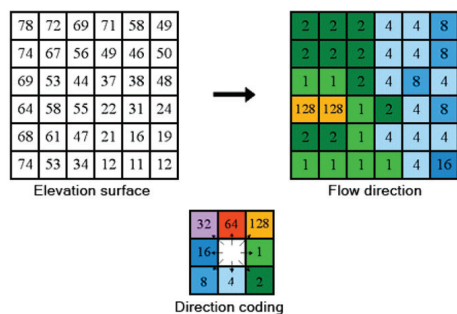
Figure 4—Generation of flow direction raster (Mahboob *et al.*, 2019b)

grid was generated to represent flow in several directions with unique colour symbols, where the colours represent directional distribution of flow (Figure 4).

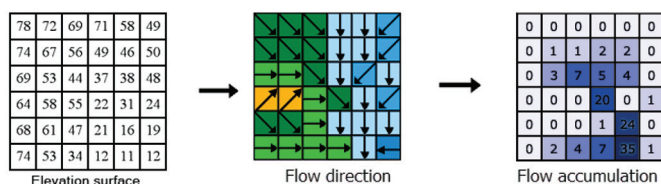
Figure 5—Generation of flow accumulation raster from flow direction (Mahboob *et al.*, 2019b)

The flow direction raster was then used to generate the flow accumulation map to highlight the total accumulated flow from higher to lower elevation based on the specified threshold value for the pixels (Figure 5). It is noteworthy that flow accumulation plays a vital role in dam failures, surface landslides, and subsurface land subsidence (Liu *et al.*, 2014).

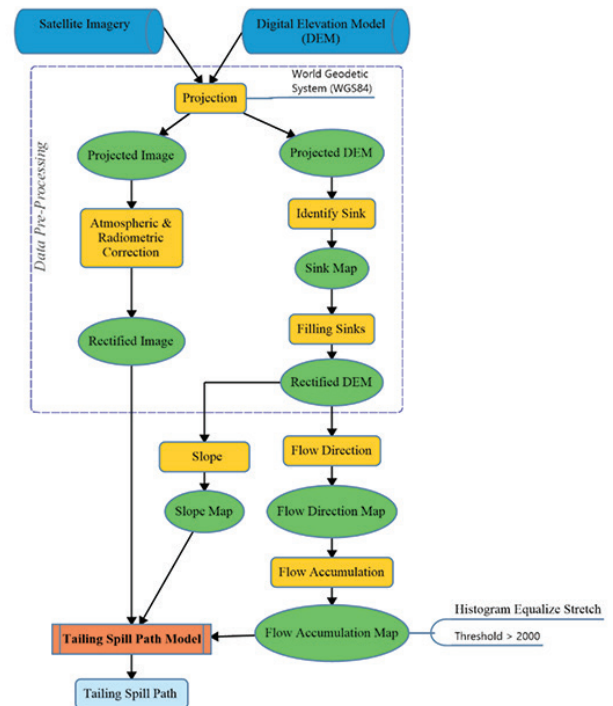
Figure 6—The work flow followed to create the TSP model

For the delineation of tailing spill paths, the threshold was examined by applying the histogram equalize stretch to the flow accumulation raster. It helps to determine the minimum number of cells that contribute to generating flow into the target cells. This threshold was found to be the most sensitive parameter of the TSP model for determining the spill path accurately. The lower the threshold value, the lower will be the number of cells that can contribute to generate the flow. The model was tested for the Brumadinho Córrego do Feijão tailings dam for threshold values starting from 100 and increasing in steps of 100 till the flow accumulation started towards the downslope cells. The final threshold value was found to be greater than or equal to 2000. The model was further validated on another TSF (Samarco dam disaster) located in a similar region to assess its accuracy under certain conditions. The work flow and Python code for the development of the TSP model are given in Figure 6 and Appendix-A, respectively.

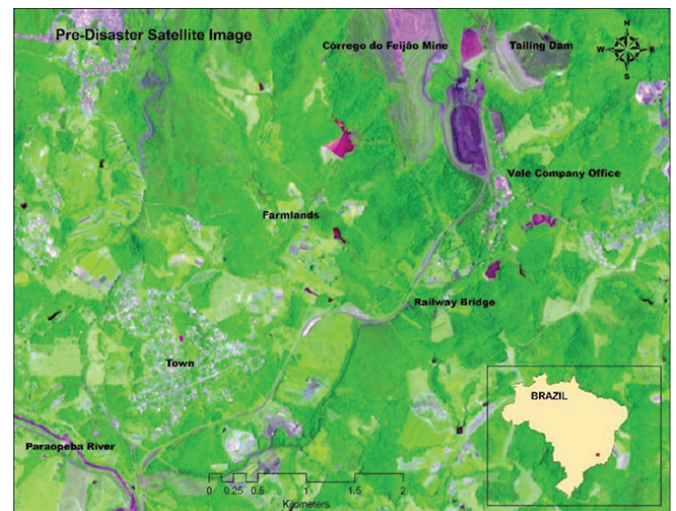
Figure 7—Pre-failure Sentinel-2A satellite image of the Brumadinho Córrego do Feijão TSF area (green, near-infrared, and red bands highlighted as R, G, and B)

The pre-failure Sentinel-2A satellite image of the Brumadinho Córrego do Feijão TSF is given in Figure 7. The dark and light green tones represent the forest cover and farmlands respectively. The whitish-grey colour represents the semi-urban region (towns and villages), and the dark purple colour highlights the freshwater resources. The TSF is shown as dark grey, which might be related to the altered chemical materials in the tailings.

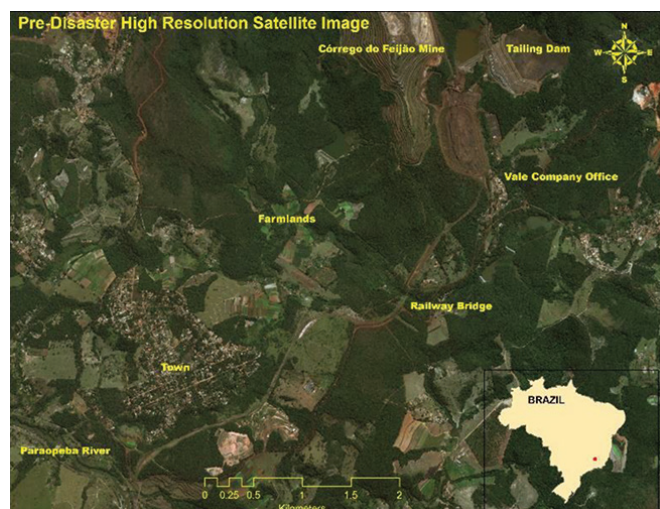
Figure 8—High-resolution DigitalGlobe satellite image before Brumadinho Córrego do Feijão TSF failure

In addition to this pre-failure satellite image, the high-resolution DigitalGlobe satellite image acquired from Google Earth was also analysed to assess the significant elements at risk due to TSF failure (Figure 8).

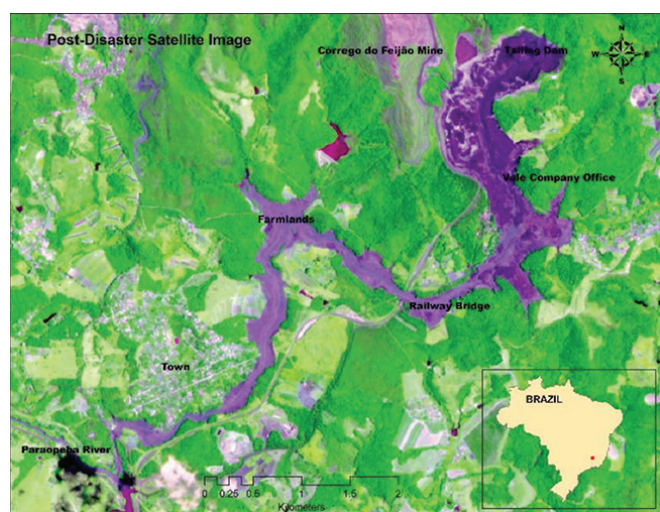
Figure 9—Post-failure Sentinel-2A satellite image of the Brumadinho Córrego do Feijão TSF area, tailing spills highlighted in purple (green, near-infrared, and red bands highlighted as R, G, and B)

The post-failure Sentinel-2A satellite image (Figure 9) shows the spill and the extent of destruction caused by the failure. After mapping of the affected area, the digital footprint of the tailings spill was extracted and overlaid on the high-resolution imagery for detail damage analysis, as shown in Figure 10.

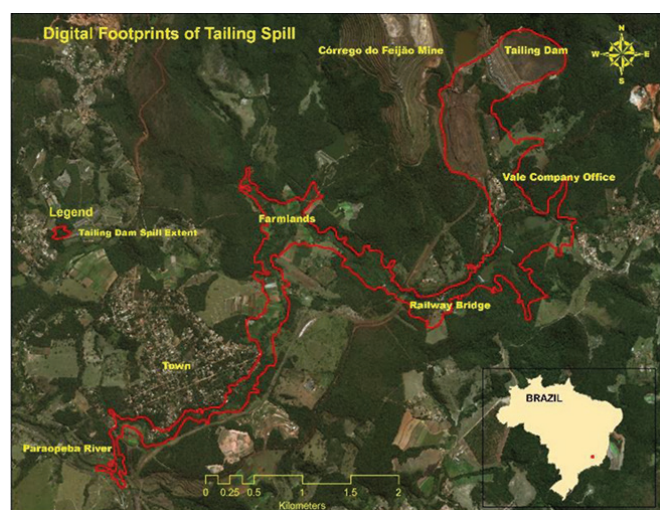
Figure 10—Digital footprint of tailing spill (red) overlaid on high-resolution satellite image

The results show that the total area of the spill was about 3.1 km². A straight line from the start (the TSF) to end of the flow (Paraopeba River) measured 6 km. However, the length of the spill measured along the centre line of the flow path was about 10 km. The main infrastructure affected comprised the Vale administrative office, a railway bridge, some farmlands in the northwest, and houses located in the southern side of the town. A considerable portion of the tailings ran into the Paraopeba River, causing significant pollution.

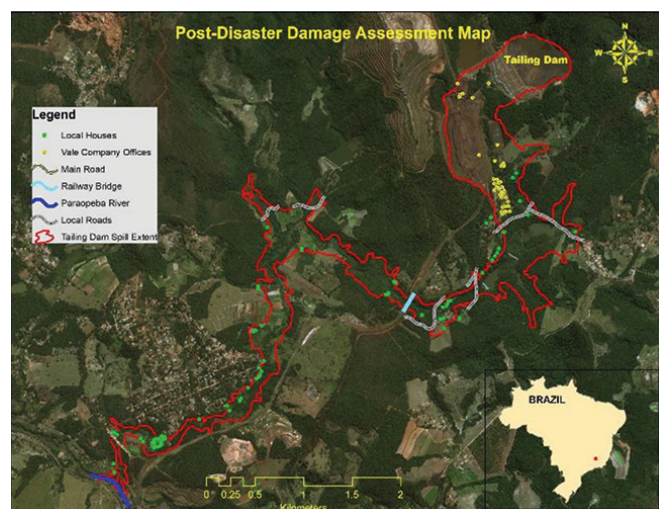
Figure 11—Detailed damage assessment map post-failure

A total of 109 buildings were damaged; 36 belonged to Vale and the remaining 73 were local residences (Figure 11). Some farmlands were wiped out and left under a sea of mud with depths of around 8 m. Seven sections of local roads, one main road, and one railway bridge were severely damaged. Field pictures from post-failure are given in Figure 12, showing the collapsed bridge (Figure 12A), aerial views of the catastrophe (Figures 12B and F), and demolished roads and houses (Figures 12C–E).

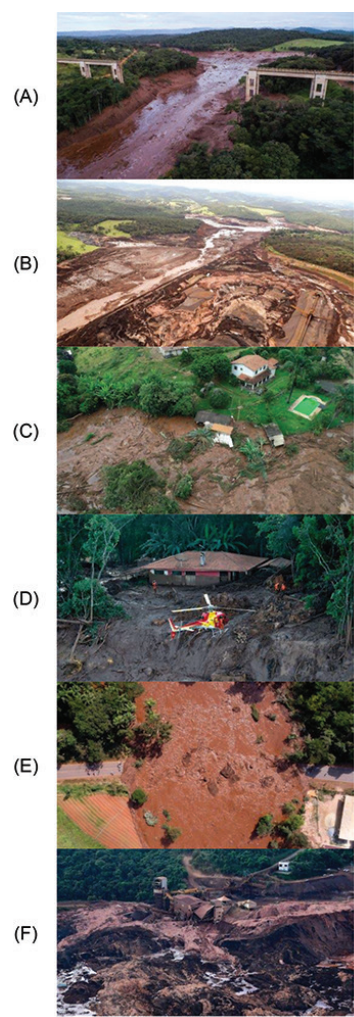
Figure 12—Field pictures of post-failure damage. Railway bridge (A), aerial views (B and F), houses (C and D), and destroyed road (E) Source: Bonaccorso (2019)

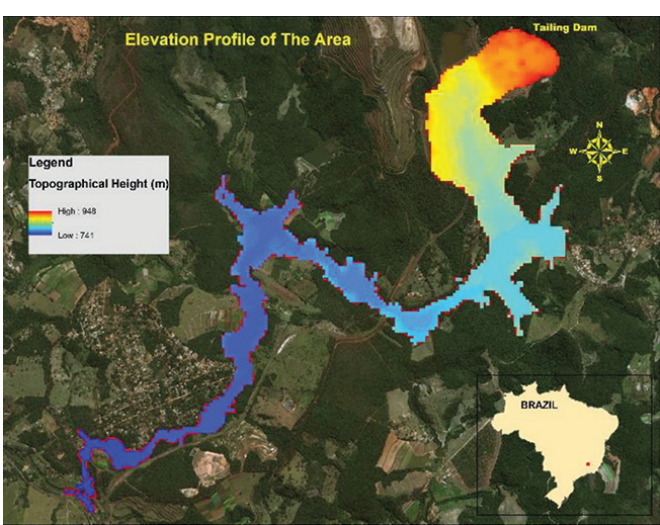
Figure 14—Pre-failure topographical digital elevation model of the tailings spill area

The input of the model is the raw DEM and satellite image of the study area. The model can generate several output maps such as processed DEM, processed satellite image, elevation, slope, flow direction, flow accumulation, and the potential path that the liquefied tailings will take. The elevation map showed that the vertical height variation from Brumadinho Córrego do Feijão TSF to the Paraopeba River was 207 m (from 948 m to 741 m above mean sea level), as shown in Figure 14.

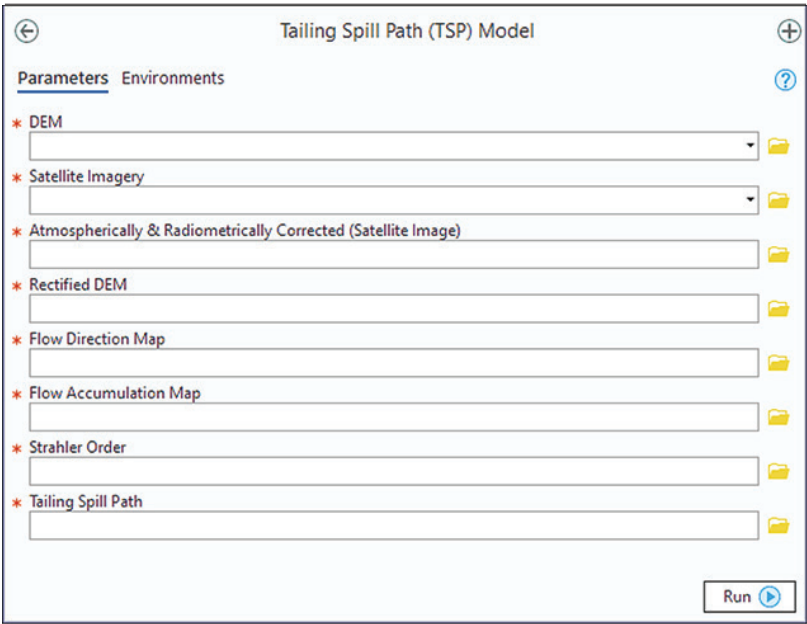
Figure 13—Graphical user interface (GUI) of the TSP model

For the back-propagation modelling of the TSF failure, the TSP model was developed and applied to predict the potential path of the tailings spill based on the DEM of the area. The Graphical User Interface (GUI) of the developed model is shown in Figure 13.

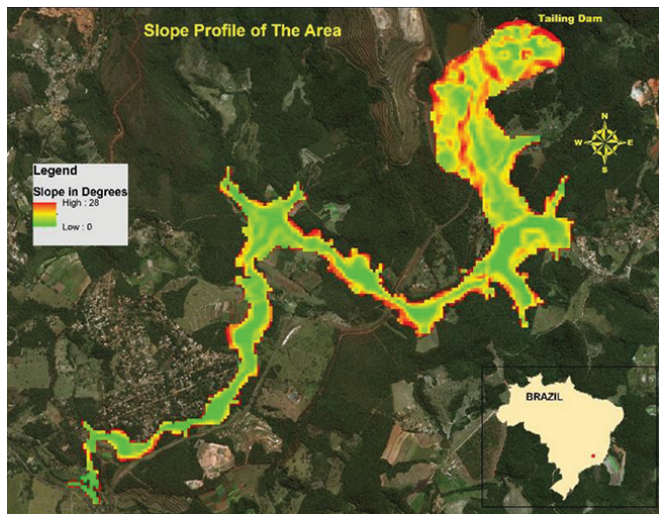
Figure 15—Pre-failure topographical slope profile of tailing spill path

The results of slope analysis (Figure 15) showed a slope profile of between 0 and 28 degrees with the maximum slope of 28 degrees at the TSFs and zero towards the Paraopeba River.

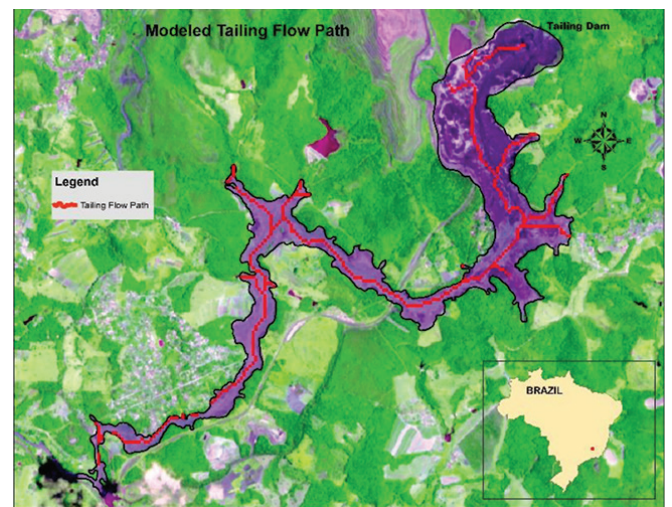
Figure 16—Modelled tailing spill path (red) overlaid on real tailing spill extent (black)

The developed model was applied to delineate the potential tailings flow paths, before the failure. The results show that the potential spill path as predicted by the TSP model using geospatial analytics matched the actual extents of the tailing spill, shown in Figure 16.

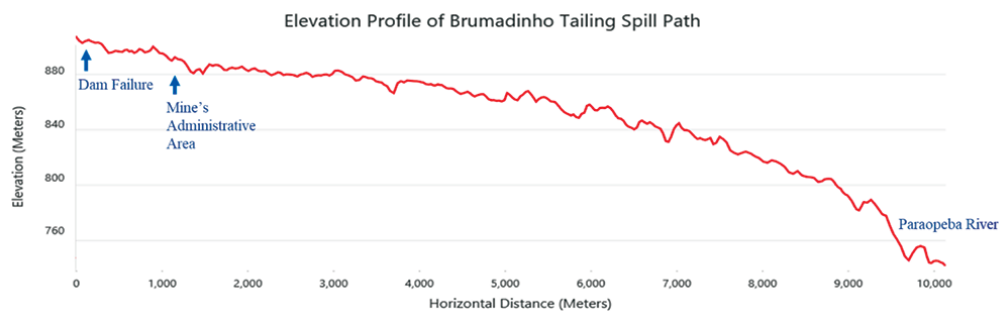
Figure 17—Elevation profile of Brumadinho tailings spill path

The elevation profile of the predicted tailings spill path was also extracted – illustrated in Figure 17. The elevation difference is 207 m with an average topographic slope of 2.07% over the 10 km horizontal distance to the Paraopeba River.

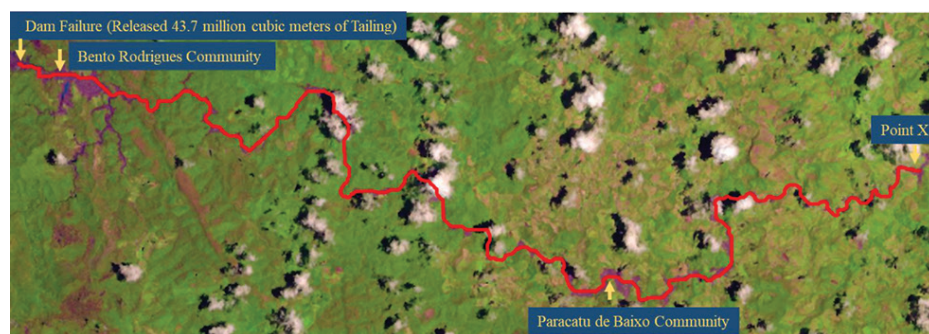
Figure 18—Spatial footprint (red line) of the Samarco TSF spill modelled by TSP (map scale 1cm : 1km)

A TSP model was developed for TSFs located in mountainous terrain and was further validated for the Samarco Tailings dam of Brazil. The Samarco TSF failure, which occurred on 5 November 2015, also constituted a major disaster in the history of the mining industry. Figure 18 shows the potential tailings spill path (red line) from the Samarco TSF as predicted by the TSP model, overlaid on the post-failure satellite image. The results illustrate

that the predicted tailings flow path is in accordance with and within the actual tailings spill extent, hence validating the model.

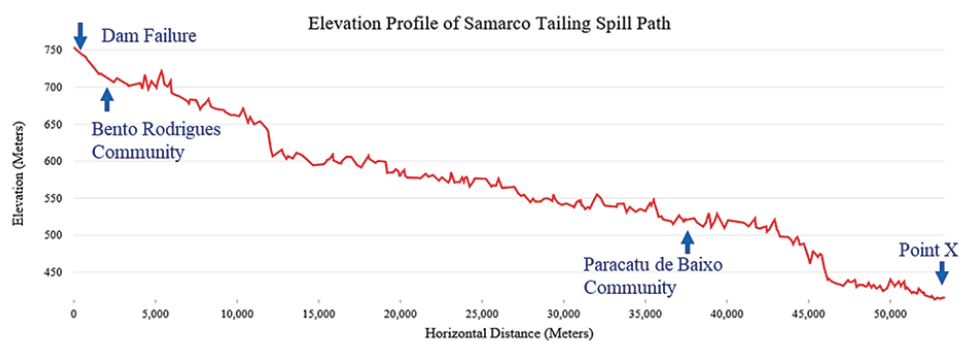
Figure 19—Elevation profile of Samarco tailing spill path

This TSF failure devastated two communities, Bento Rodrigues and Paracatu de Baixo, located about 2 km and 38 km away from the collapsed dam (do Carmo *et al.*, 2017). The section in Figure 19 shows the modelled tailings flow up to point X in Figure 18, which is 50 km away from the start of the spill. Modelling was stopped at point X due to the presence of thick cloud cover in the next satellite image. In this case, the elevation difference is 804 m with an average slope of 2.2%.
