Mechanical properties and damage mode of cemented tailings backfill in an acidic environment

Y. Huang¹, G. Wang¹, Y. Rao², and W. Liu²

Journal of the Southern African Institute of Mining and Metallurgy, vol. 121, no. 6, pp. 317–324.

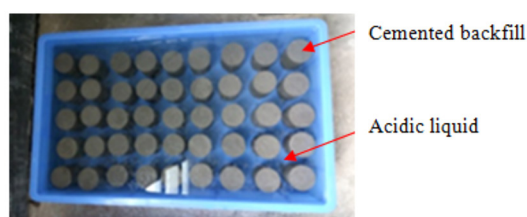
Figure 1—Container for soaking CTB samples

The reagent used in the experiment was 98% concentrated sulphuric acid, and the water was from the laboratory of Jiangxi University of Science and Technology. First, a certain amount of water was filled into a plastic bucket. To ensure that the amount of water was constant in every test, the water level was marked on the bucket. The volume of water in the bucket was chosen so that the solution level in every test was 2 cm above the CTB surface. Then the pH meter probe, calibrated using pH buffer solutions, was inserted into the water. The concentrated sulphuric acid was slowly dripped into the water using a dropper, with continuously stirring using a glass rod, until the pH of the solution reached the required test value. Lastly, the sulphuric acid solution was poured into the plastic frame of dimensions 62 × 36 × 13 cm (Figure 1). Using the method of accelerating the corrosion rate, the sulphuric acid solution was discarded after soaking for 10 days. The acidic solution was replenished five times at 10-day intervals to the 60th day.

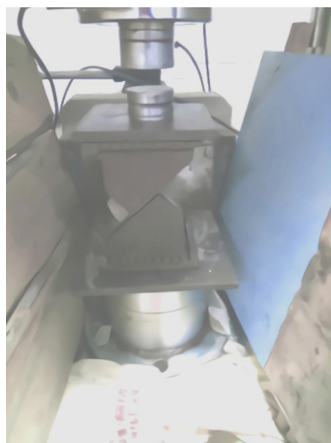
Figure 2—Shear experiment

After the CTB samples had been soaked for the set number of days, twelve samples were taken from each of the different acidic solutions and gently rinsed with tap water. The samples were placed in a drying oven for 24 hours at a temperature of 100°C . An RMT-150C rock mechanics test system was used to test the compressive strength (DZ/T 0276.19-2015, China) and the variable angle shear strength of the samples (DZ/T 0276.25-2015, China). Three samples from a group were tested for uniaxial compressive strength. The shear test was done at angles of 30° , 45° , and 60° (Figure 2). Three samples were tested at each angle. The tests were done on samples with ages of 10, 20, 30, 40, 50, and 60 days.

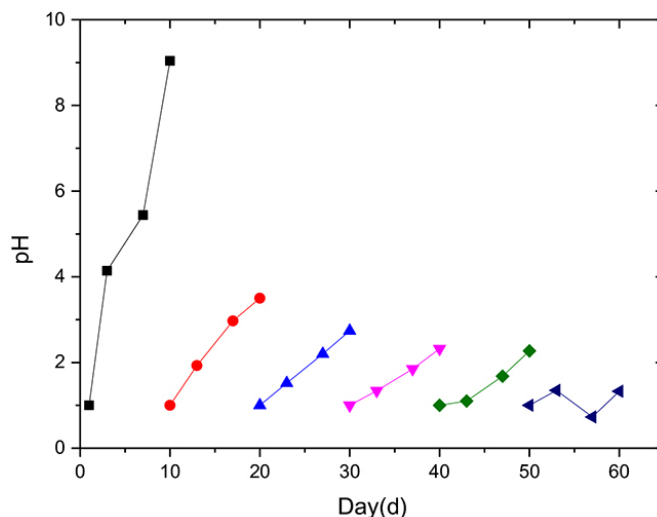
Figure 3—The change in pH of sulphuric acid soaking solution at pH 1

It can be seen from Figure 3 that from zero to 10 days the pH of the solution changes from acidic to alkaline. The pH gradually rises from 1 to 9, and there is a large amount of H^+ consumption, mainly by the $\text{Ca}(\text{OH})_2$ dissolution reaction. From 10~50 days, the change of pH value is like the change rule for 0~10 days, although the solution remains weakly acidic. This suggests that the dissolution rate of $\text{Ca}(\text{OH})_2$ is slowing; the surface of the CTB and the pore structure are covered by gypsum crystals and colloids, hindering the reaction from proceeding inside the CTB, thus the chemical reaction rate is lowered, and the phenomenon becomes more obvious with increasing time.

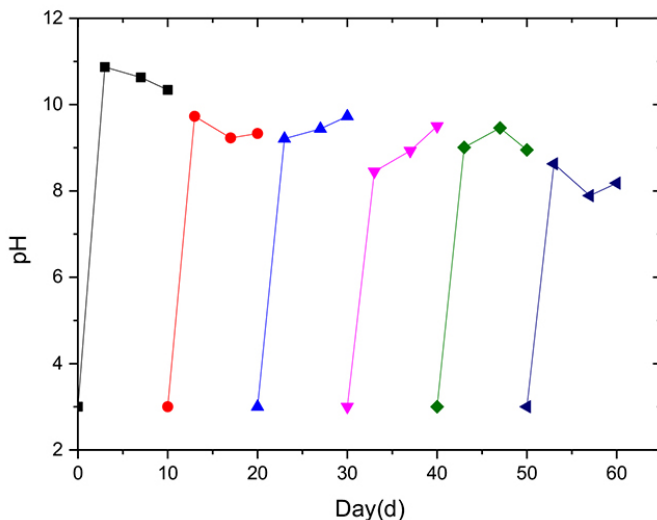
Figure 4—The change in pH of sulphuric acid soaking solution at pH 3

From Figure 4, the pH of the P3 solution changes from 3 to 11 over the first 3 days. Due to the presence of colloidal compounds such as hydrosilicate, tobermullite, *etc.* it is not easy to store in this alkaline environment, which provides a favourable

chemical environment for the formation of colloids. But the colloids are observed in this solution, although the amount is less than for P1, indicating that the rate of chemical reaction in the acidic environment is slowed down. After 3 days, the pH jumps slightly, and the chemical reaction tends to be relatively stable.

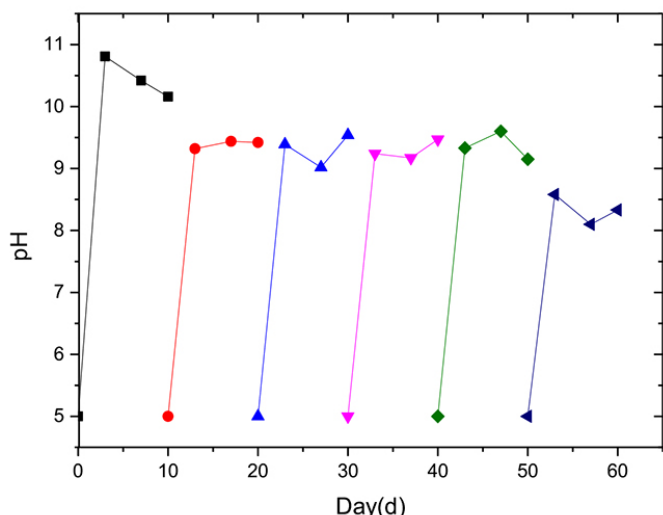
Figure 5—The change in pH of sulphuric acid soaking solution at pH 5

The pH change of the solution under P5 condition is like that of P3. As shown in Figure 5, the pH of the solution becomes alkaline at 3 days, and then tends to be stable. The solubility of hydrogen ions in this environment is weaker than that in the P3 environment. No formation of colloids was observed in this acidic environment.

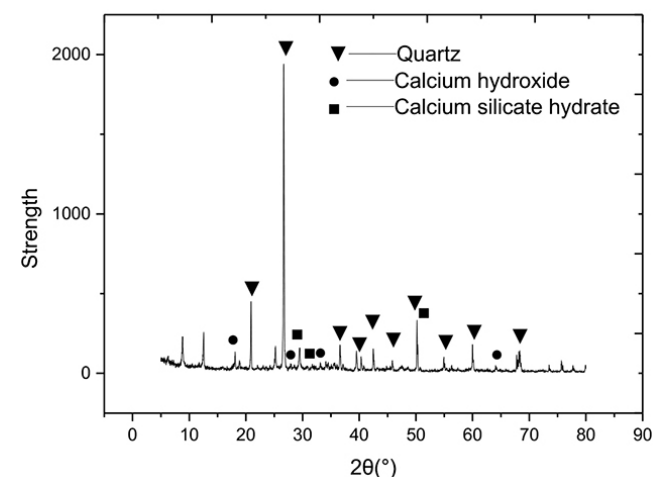
Figure 6—XRD spectrum of the prefilled CTB

For reasons of brevity, only the XRD spectra of the CTB in the P1 environment, for 60 days of corrosion and before immersion, is presented (Figures 6 and 7). Before corrosion, the spectrum depicts mainly the hydration reaction product C-S-H. When the sample immersed in pH 5 sulphuric acid is corroded for 10 days, in addition to the hydration product, there is a diffraction peak of Aft ($6CaO \cdot Al_2O_3 \cdot 3SO_3 \cdot 32H_2O$, Aft). Under these conditions, the amount of ettringite, which filled the micropores of the test piece and optimized the pore structure, was limited. As the etching time increases, the number of $Ca(OH)_2$ and Aft diffraction peaks decreases, and the number of $CaSO_4 \cdot 2H_2O$ peaks increases. The sample immersed in pH 1 sulphuric acid exhibits a very minor Aft diffraction peak. The number of $CaSO_4 \cdot 2H_2O$ diffraction

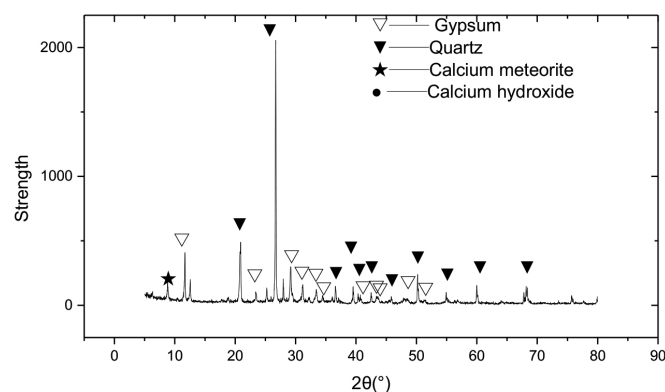
Figure 7—XRD spectrum of CTB after soaking for 60 days at pH 1

peaks decreases, and the sample immersed in pH 3 sulphuric acid shows a similar pattern to that of pH 1. The number of Aft diffraction peaks was larger than that of CTB under the P1 environment, and the number of $CaSO_4 \cdot 2H_2O$ diffraction peaks greater than in the P1 environment. With the progress of corrosion, the amount of gypsum gradually increases, the porosity of the CTB also increases, and the degree of corrosion increases. A large amount of ettringite and gypsum generates expansion stress inside the test piece. When the expansion stress is greater than the internal tensile stress, micro-cracks are formed and the internal pore structure begins to deteriorate.

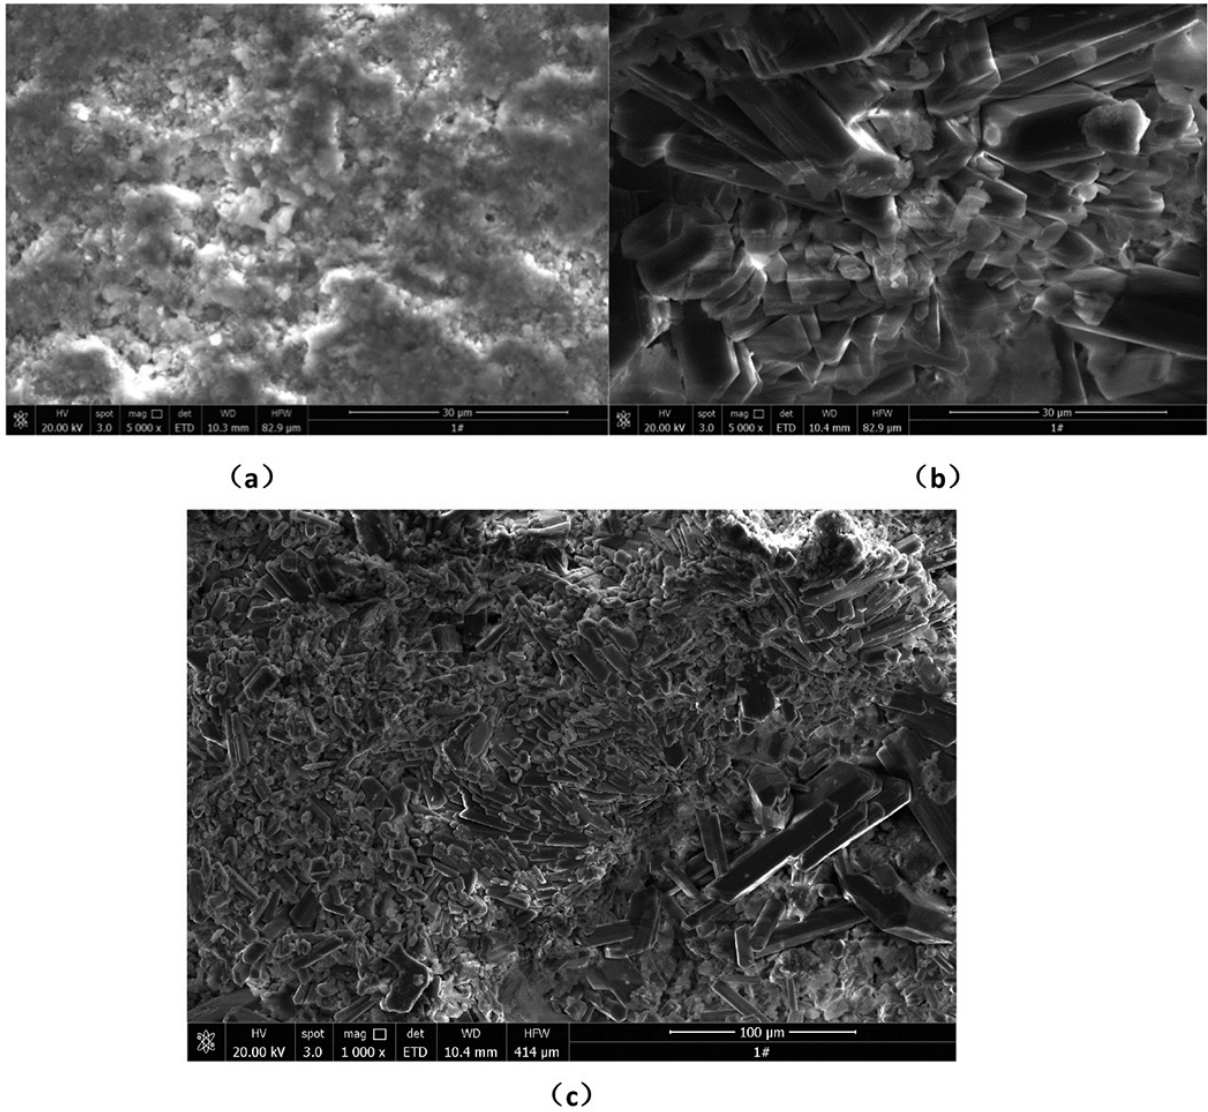
Figure 8—SEM micrographs of corrosion products after soaking in P1 sulphuric acid solution for 60 days. (a) Before etching, 5000x, (b) after etching, 5000x, (c) after etching, 1000x

Figures 8a and 8b are SEM micrographs of the corrosion products. The backfill is dense before corrosion, and several columnar crystals appear after corrosion. According to Qiao *et al.* (2019), the morphologies of ettringite and gypsum are needle-like. Several ettringite crystals are visible in Figure 8c.

It also can be seen from Figure 8 that in an acidic environment, in the long run, the degree of corrosion damage of the CTB is correlated with the corrosion time. That is, the longer the corrosion time, the more serious the deterioration of the sample. In the first instance, corrosion causes the porosity of the CTB sample to increase, hence the effective force area decreases under the load. Therefore, the mechanical strength

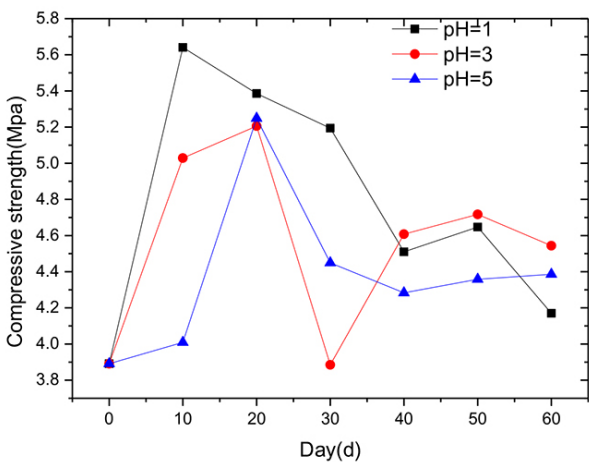
Figure 9—The change in uniaxial compressive strength of CTB with time

Figure 9 shows the change in the uniaxial compressive strength of CTB with time. The trends in the three pH environments are basically similar, rising first and then falling, indicating that the pH has an impact on the strength of CTB. In P1 the CTB reached a peak strength of 5.6 MPa in 10 days, an increase of 45%. In P3 and P5 the CTB reached peak strength of 5.2 MPa in 20 days, an increase of around 34%. This indicates that during the initial stage of corrosion in sulphuric acid the strength of CTB increases. Similar results were obtained by Zhao *et al.* (2016) and Li *et al.* (2014). After 60 days of corrosion, the CTB samples in P1, P3, and P5 increased in strength by 7.1%, 16.7%, and 10.4% respectively, compared with the strength before corrosion. Although there is a slight overall gain in strength over time with exposure to sulphuric acid, the initial increase in strength (during the first 10 or 20 days) deteriorates significantly with time. This is because during the first stages of corrosion the ettringite or gypsum crystals fill the pores, so that the strength of CTB is improved. With increasing of corrosion time, sulphuric acid solution gradually penetrates the CTB, weakening it. In the first instance, the reaction results in an increase in the internal

porosity of CTB, thus decreasing of effective stress area, with a consequent decrease in compressive strength. Compounding this, the amount of gypsum and other expansion products generated by the chemical reaction increases, resulting in expansion

stresses in the CTB, which lead to micro-cracks and a further reduction in strength. The maximum intensity of the three pH environments is different, perhaps due to the aggressiveness of the solution. The aggressiveness of the P1 solution is higher than P3 and P5, hence the rate of chemical reaction is higher, therefore the time to reach the strength peak value is shorter for P1 than for P3 and P5.

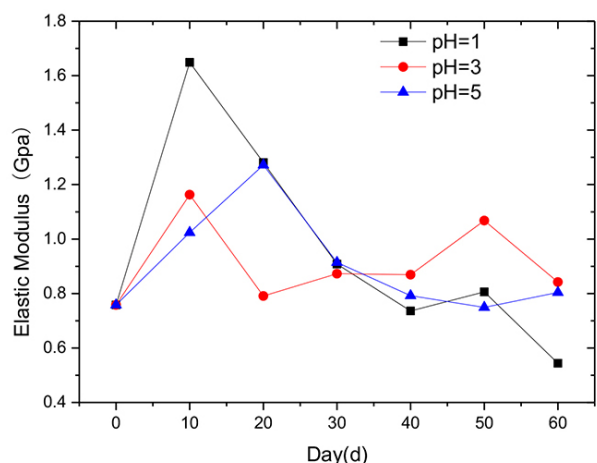
Figure 10—The change in the elastic modulus of CTB with time

Figure 10 shows the change in the elastic modulus of the CTB with time. The basic trend in the three pH environments is an initial increase in the elastic modulus followed by a gradual decrease. In P1 and P3, the elastic modulus reached its peak value after 10 days. The peak value for P1 was 1.6G Pa, an increase of 118% compared with the pre-corrosion value. The peak value for P3 was 1.2 GPa, 40.5% above the pre-corrosion value, and for P5 the maximum elastic modulus was reached at 20 days, with an increase of 67.8% compared with the pre-corrosion value. Although the pH affected the elastic modulus significantly in the early days, there is no positive correlation between elastic modulus and pH. After 60 days of corrosion, the relative changes for P1, P3 and P5 were 28.3%, 8.4%, and 6.1% respectively, indicating that longer exposure had little effect on the elastic modulus of the filling. The modulus of elasticity can

be used as an index for judging the susceptibility of a material to elastic deformation – the larger the elastic modulus, the greater the stress required for elastic deformation, which is basically consistent with the change in compressive strength of backfill. During the initial stage of corrosion, the solution fills the CTB's pores, and the degree of cohesion of the filler particles is high, which makes the elastic modulus increase. The change in behaviour may also be related to the degree of cement hydration of the test piece. With increasing corrosion time the porosity increases, the cohesion between the filler particles decreases greatly, and the elastic modulus of the filler decreases. The test results fluctuate because of the dispersion and the difference in the degree of erosion. The reason may be the different solubilities of the solutions.

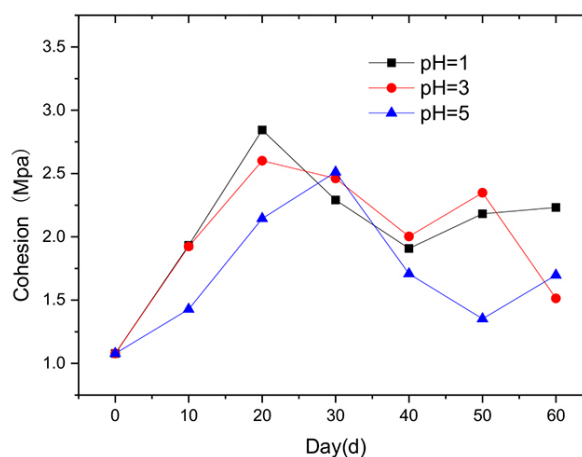
Figure 11—The change in cohesion of CTB with time

Figure 11 illustrates the trend of cohesion of CTB with time. The cohesion increases at first and then decreases for all the different pH solutions. The cohesion of CTB in P1 and P3 reaches its peak at 20 days, with strengths of 2.8 MPa and 2.96 MPa, respectively, increases of 167% and 150% from the pre-corrosion value. The CTB in P5 reaches its peak strength of 2.5 MPa at 30 days, increasing by 132%. After 60 days of corrosion, the cohesion values of the CTB in P1, P3, and P5 increased by 106%, 40.4% and 57.4% respectively, compared to the pre-corrosion value. This indicates that sulphuric acid enhanced cohesion during the early stages, but this effect deteriorated during the later stages. On the one hand, the gypsum produced by the chemical reaction fills the pores of CTB, which increases the compactness of CTB and its overall cohesion. On the other hand, acid corrosion will destroy the hydration products, such as $\text{Ca}(\text{OH})_2$, and destroy the intermolecular cementation. With increasing corrosion time, the damage will intensify, and the cohesion will deteriorate. The cohesion values in P1 and P3 peak earlier than in P5; this is related to the solubility of the ions. The range cohesion values depends mainly related on the dispersion of the samples.

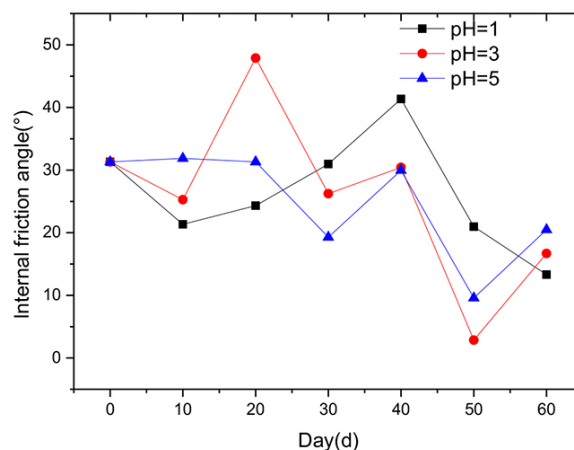
Figure 12—The change in internal friction angle of CTB with time

Figure 12 shows the changes in the friction angle of CTB with time. The internal friction angle, although fluctuating, generally decreases in all the solutions. The change range of the internal friction angle of CTB in P5 solution is relatively small, with a maximum of 31.9° , and a minimum of 9.6° . The change in P1 is a maximum of 41.4° , and a minimum of 13.3° . The

chemical reaction rate in the P5 solution is slow, and the reaction products are few. The chemical reaction rate in the P1 solution is the fastest, and the reaction products are more than in P3 or P5. Therefore the pores of CTB in P1 are filled more completely than in P3 and P5, thus the change range of friction angle in P1 is smaller than in P3 and P5. It appears that the internal friction angle of CTB is related to porosity.

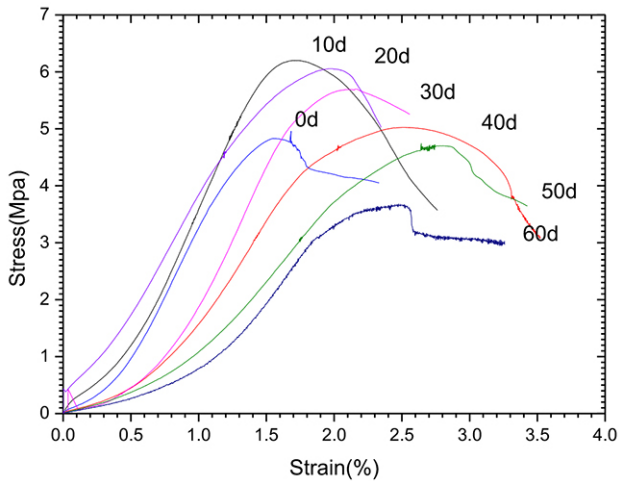
Figure 13—Stress-strain curves for CTB at pH 1 at different ages

Figure 13 depicts the stress-strain curve of CTB in P1 after corrosion for 0, 10, 20, 30, 40, 50 and 60 days. As corrosion progresses, the peak stress f_c of CTB first increases and then decreases. The elastic modulus of the corroded CTB is taken from the slope of the straight line in the elastic deformation stage on the measured stress-strain curve. The peak secant deformation modulus E_p is taken from the ratio of the peak stress f_c to the peak strain ϵ_c on the measured stress-strain curve. Both E_c and E_p at first increase and then decrease. After soaking for 10 days, E_c and E_p increased by 22.2% and 16.1% respectively. After 60 days, the modulus of elasticity decreased to 0.41 times that of the CTB before corrosion, and the peak modulus of deformation reduced to 0.47 times the pre-corrosion value. The peak strain ϵ_c is proportional to the corrosion time; this increased by 66.67% after 60 days of soaking.

- The first stage is the initial deformation stage: CTB is in the initial stage of stress-strain, the graph's curved section is slightly concave upward, and the micropores and micro-cracks in the material are compacted. With prolonged corrosion time, the pore content in CTB increases and the compaction process is more obvious in CTB.

- The second stage is the elastic deformation stage, in which the stress-strain curve of CTB is approximately linear, and the steeper the straight line, the larger the elastic modulus. At the initial stage of corrosion, the elastic modulus of CTB tends to increase. As the corrosion time increases, the elastic modulus gradually decreases.

- The third stage is the yield stage, and the slope of the curve segment decreases as the stress increases. In the initial stage of corrosion, the strength of CTB will increase, and the higher the peak strength, the more obvious is the yield deformation process. As the corrosion time increases, the strength of CTB will gradually decrease.

- The fourth stage is destruction. As the deformation increases, the load-carrying capacity of CTB gradually decreases.

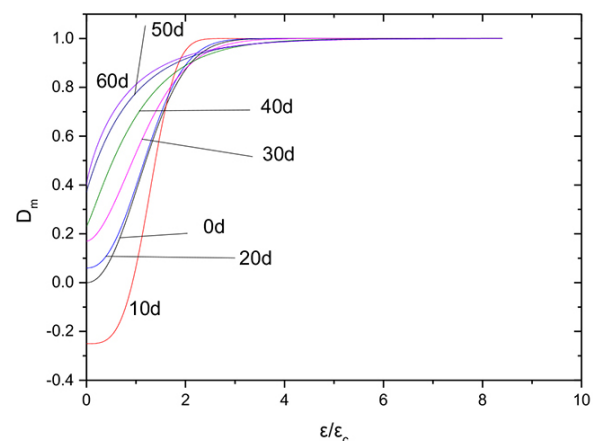
Figure 14—Evolution curve of damage model of CTB corrosion

Assuming that CTB is only corroded, the loaded strain $\varepsilon = 0$; at this time $D_m = D_t$. When only the damage is considered, $E_t = E_0$; at this time $D_m = D$. According to the test data and the result of Equation [7], the evolution curve of the corrosion damage model of CTB samples as shown in Figure 14 is obtained.

properties deteriorate. Compounding this, the amount of gypsum and other expansion products increases due to the corrosion, and when the expansion is greater than the internal cohesiveness of CTB, microfractures are formed. In a corrosive environment, the degree of damage deterioration of CTB increases with increasing strain. At the initial stage of loading, the micropores and defects inside the CTB are 'compacted' (the compaction stage). With the gradual increase of strain, the micropores and micro-cracks in CTB continue to expand and develop into macro-cracks, and the damage is intensified. When the stress on the test piece reaches its peak, the damage is at a maximum.
