PlatMine pillar strength formula for the UG2 Reef

B.P. Watson¹, R.A. Lamos², and D.P. Roberts³

Journal of the Southern African Institute of Mining and Metallurgy, vol. 121, no. 8, pp. 437–448

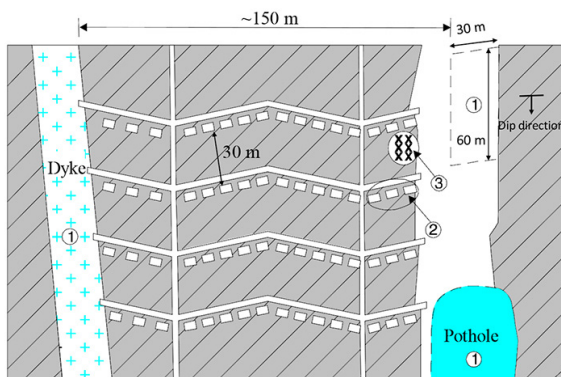
Figure 2—Plan view of a typical conventional mining layout with (1) regional stability pillars, often entailing loss of ground, (2) in-panel (crush) pillars; (3) local timber support (Jager and Ryder, 1999)

The in-panel pillars shown in Figure 2 are for a breast mining configuration, meaning that the faces are advanced on strike. These in-panel pillars are often located 1.5 m to 2.0 m below a gully (Figure 3) used to assist with ore removal to the boxholes or local orepasses. The zone between the gully and the pillar is termed a siding (Figure 3). Some mines do not make use of sidings (Figure 3), so that the in-panel pillar is higher on the gully side than on the panel side. Gully heights vary between 1.8 m and 2.5 m. Thus, typical pillars under these conditions could have a height of 2.3 m on the up-dip side and 1.5 m on the down-dip side.

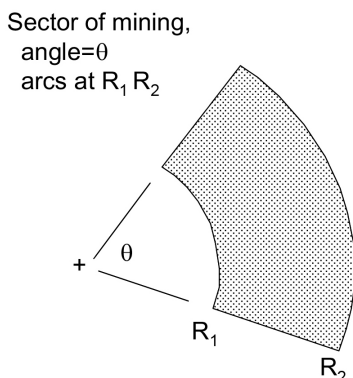
Figure 4—Areas of remote mining, well outside the centre (+) of the area of interest (Watson *et al.*, 2008)

Pillar loads were estimated using pseudo-3D, elastic, boundary displacement-discontinuity element modelling software, MinSim (COMRO, 1981) and MINF (Spottiswoode and Milev, 2002). Mine plans were digitized, capturing – in each instance – an area large enough to provide realistic stress conditions. Usually, these conditions were inferred by direct modelling and subsequent elimination of superfluous abutting mining windows. In many cases, it was necessary to estimate a correction factor (CF), based on a comparison of coarse-grid average pillar stress (APS) values on large pillars near the areas of interest, with and without a large flanking area of mining. Such factors were generally less than 1.2 (20% correction), and were, where feasible, checked using Equation [1] (Ryder *et al.*, 2005). This equation may be used if there is a large area of mining with roughly uniform convergence S over a sector bounded by radii R_1 and R_2 (Figure 4).

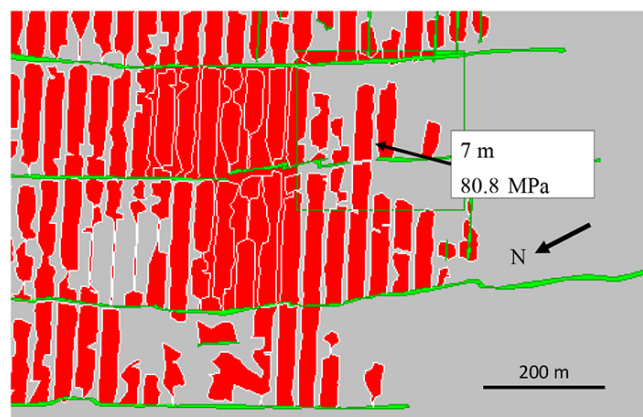
Figure 5—Dip pillar geometry: mined area in red, solid area grey (grid size 0.5 m, depth 660 m, dip 9° , slope width 1.4 m, $k = 1$)

A system of regularly spaced, stable, Merensky Reef rib pillars at a mine on the western side of the Bushveld (western limb) provided an unusual quasi-2D situation where the numerical models could be validated against an analytic solution. Figure 5 depicts the geometry of this control site.

A 7 m wide by 1.4 m high dip pillar, with 28 m mined-out panels on either side, was observed *in situ* to be just beginning to scale ($CC=1$). The APS provided by the MinSim model was 80.8 MPa. This result compared favourably with an analytic estimate of 82 MPa using tributary area theory.

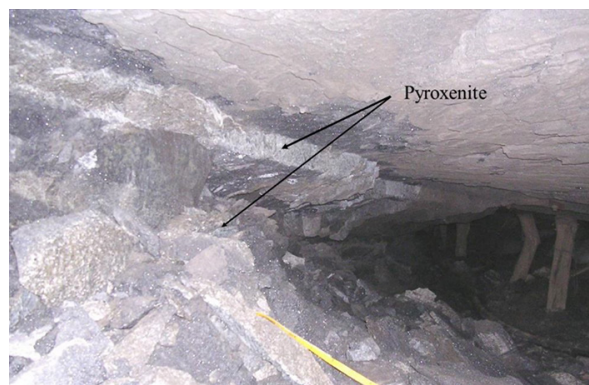
Figure 6—A typical composite pillar used in the statistical evaluations

Data on failed and unfailed pillars was collected from a total of four sites at three separate mines near the town of Thabazimbi (see Figure 1) for ML regression analyses. The pillars were composite, consisting mainly of chromitite with one or two narrow pyroxenite bands of variable width above the pillar centre (Figure 6). The immediate hangingwall and footwall (floor) materials were pyroxenite and anorthosite, respectively.

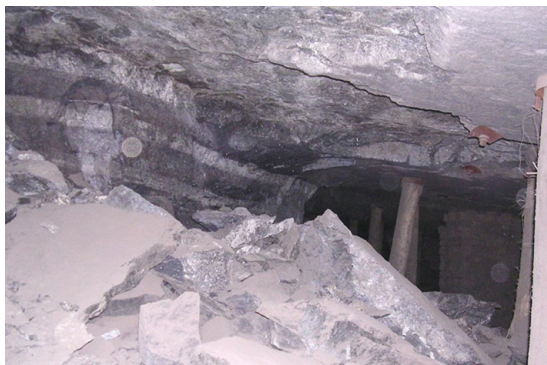
Figure 8—Down-dip side of Pillar 8. View away from panel face

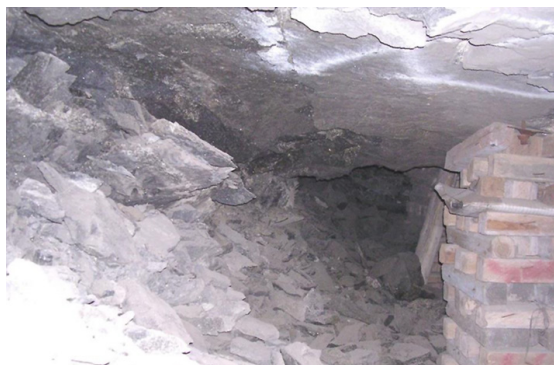
Figure 10—Down-dip side of pillar 3

Pillars 2, 3, 6, 7, and 8 (Figure 9) were highly fractured (Figure 10) and between 70 mm and 200 mm of closure was estimated from adjacent mine poles. These pillars were obviously in an advanced stage of crushing. Pillar 1 and 4 (Figure 9) were also heavily fractured but fracturing in the hangingwall adjacent to the pillars suggested that the cores were still intact.

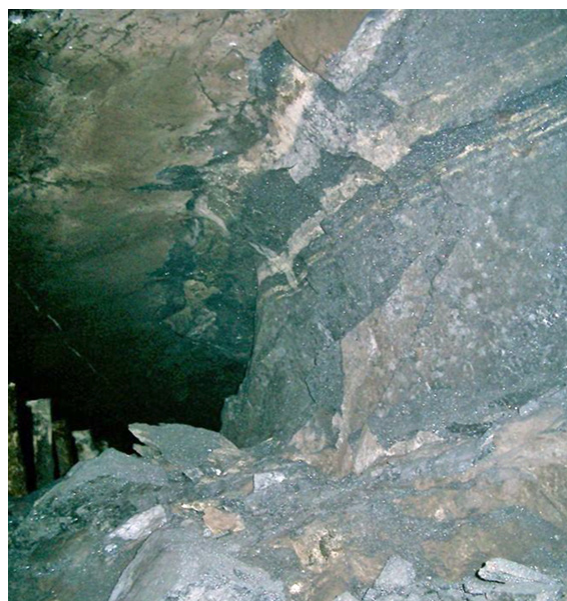
Figure 12—Significant damage to pillar 5 and adjacent hangingwall

Figure 12 shows the condition of pillar 5, suggesting that the pillar was highly stressed.

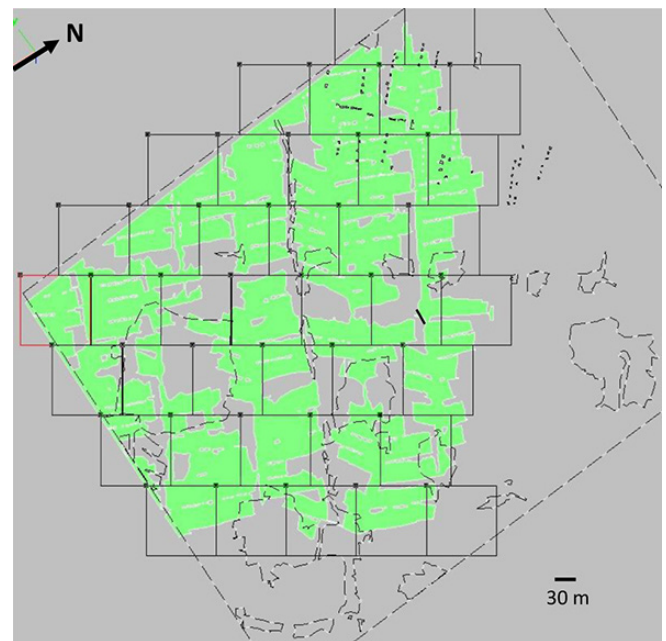
Figure 13—Mine C UG2 mining, modelled with 0.5 m grid size. Overlying Merensky Reef mining (5 m grid size) is shown by dashed lines and the UG2 mining is shown in green (depth 350 m – 650 m, dip 20°, middling 30 m)

The Merensky Reef was mined many years before the UG2, and some remnant pillars were left on the Merensky horizon. The middling between the two reefs is about 30 m. Subsequent mining of the UG2 Reef occurred under some of these remnants, providing, in some cases, both solid and crush pillars in a single panel. The condition of the recorded UG2 pillars was determined from visual observations. Thirty of these pillars were very heavily damaged and presumed failed. Modelled elastic stresses on the UG2 pillars ranged up to several hundred MPa due to the presence of extensive Merensky over-mining and scattered stress-concentrating remnants. The modelled geometry is shown in Figure 13. Each square represents a separate model.

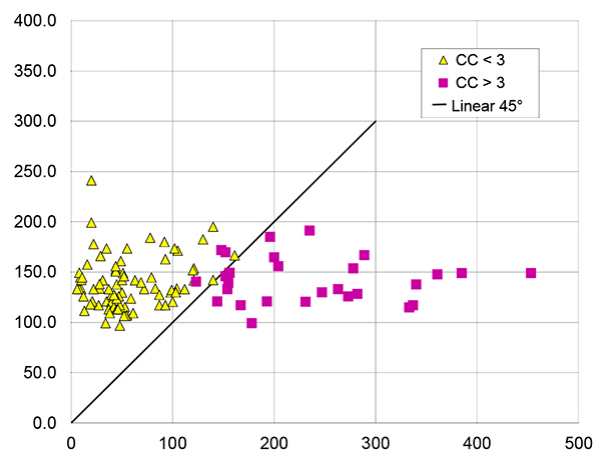
Figure 14—Back-analysis of Mine C UG2 pillars. Failed pillars are all 'condition 4' – exact date/geometry at failure not known. Triangles represent unfailed pillars, and squares failed

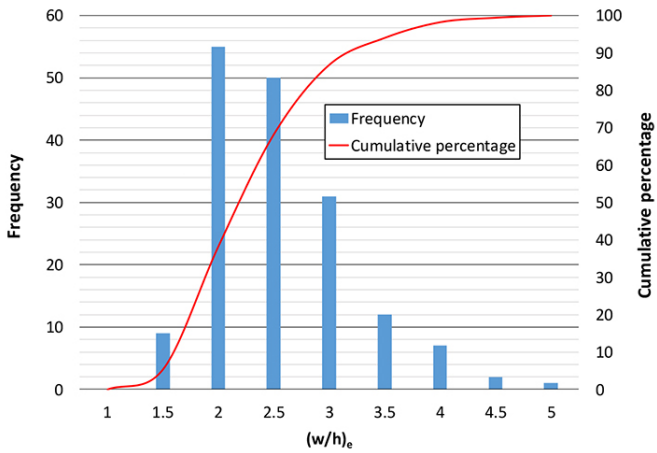
Figure 15—Distribution of pillar w_e/h_e in the database

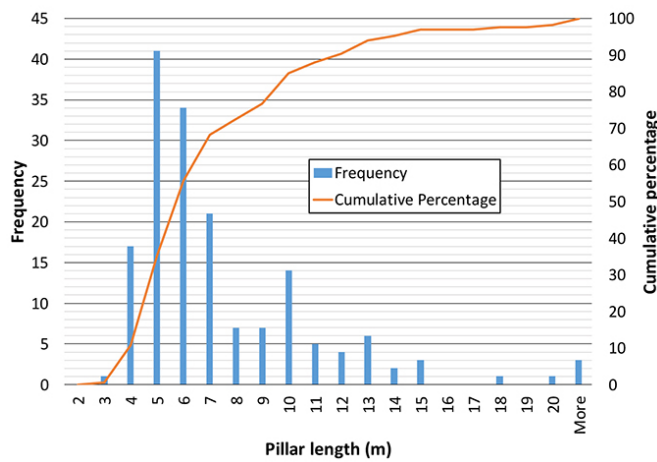
Figure 16—Distribution of pillar lengths in the database

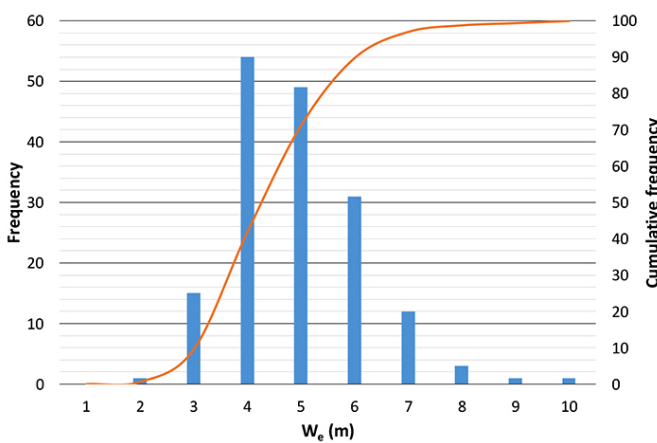
Figure 17—Distribution of pillar w_e in the database

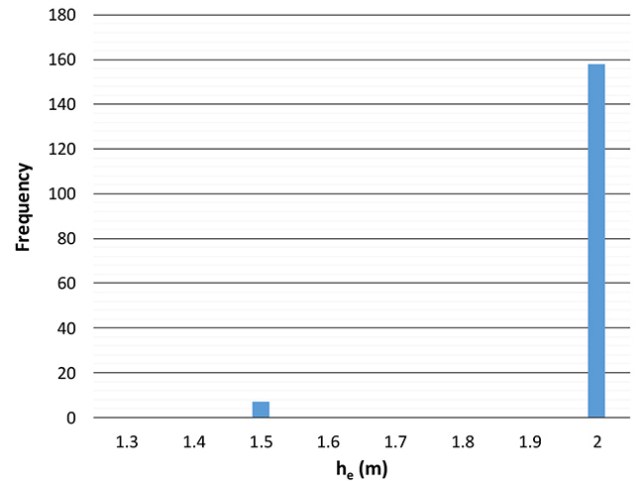
Figure 18—Distribution of pillar h_e in the database

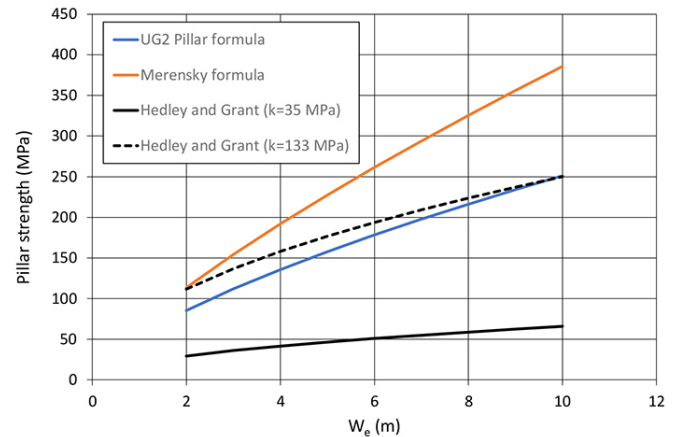
Figure 19—Comparison between the UG2 formula (Table IV), Merensky formula (Watson *et al.*, 2008) and Hedley and Grant formula (1972) for square pillars of 2 m height

(1972). For completeness, the Hedley and Grant formula with $k = 133$ MPa (Martin and Maybee, 2000) is included in the figure.

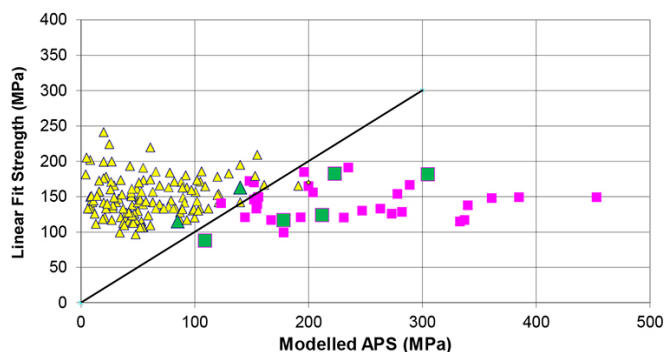
Figure 20—Back-fit strengths, using the power pillar-strength formula. Triangles represent unfailed pillars, and squares failed. Green symbols are distribution of $h_p = 1.5$ m pillars in the database

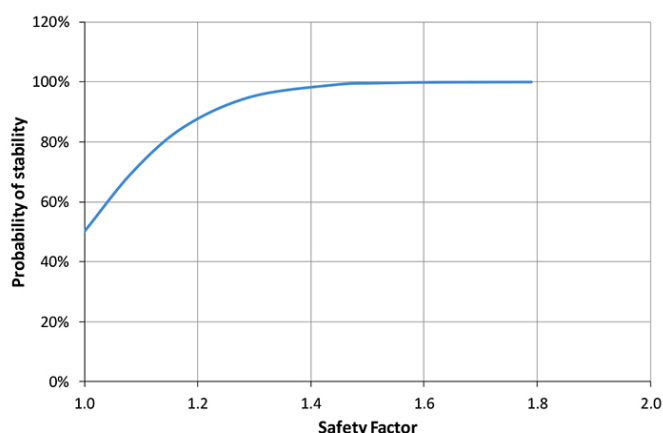
Figure 21—FOS for the pillars in the database as a function of probability of stability, based on the power formula back-fit analysis ($\log S = 0.068$)

The value of S (Table IV) was used to determine a range of safety factors, which are plotted as a function of probability of stability in Figure 21. The analyses include the presence of stable

cases (low SFs) and the failed cases. This graph may be used when designing stable UG2 pillars with dimensions within the range of the database. The analysis suggests that a SF of 1.62 will provide a probability of stability of 99.9%, based on the limited data in the database.

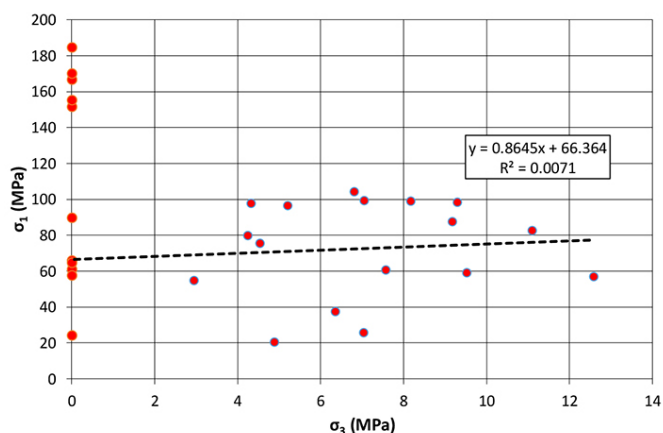
Figure 22—Uniaxial and triaxial UG2 chromitite strength test results from Impala Platinum (Gardner and Bosman, 2014)

2014) shows a significant variation in strength (Figure 22), with a mean UCS of 71 MPa and a standard deviation of 14.2 MPa. Kersten (2016) also observed a significant variation in chromitite strength (Figure 23), with a much higher mean value than that provided in Figure 22. Observations indicate that such a variation in strength could exist within a single pillar. If the mean strength of 138 MPa in Figure 23 (Kersten, 2016) is representative of the pillar materials in the pillar strength database (as described in this paper), then the K -value in Table IV (67 MPa) is about 50% of the UCS. York and Canbulat (1998) suggested a critical rock mass strength for Merensky Reef at about 64% of a typical 50 mm diameter cylindrical sample.

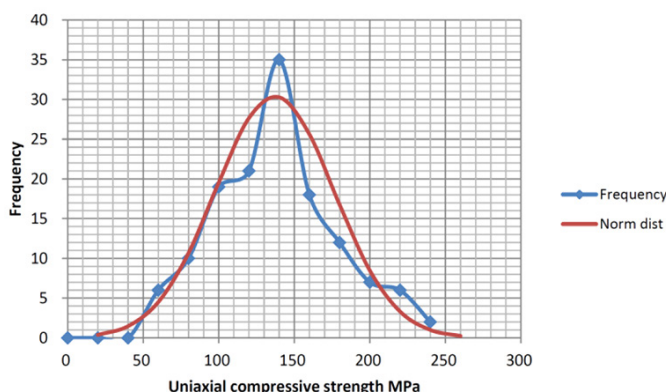
Figure 23—Distribution of UCS values for chromitite (Kersten, 2016)

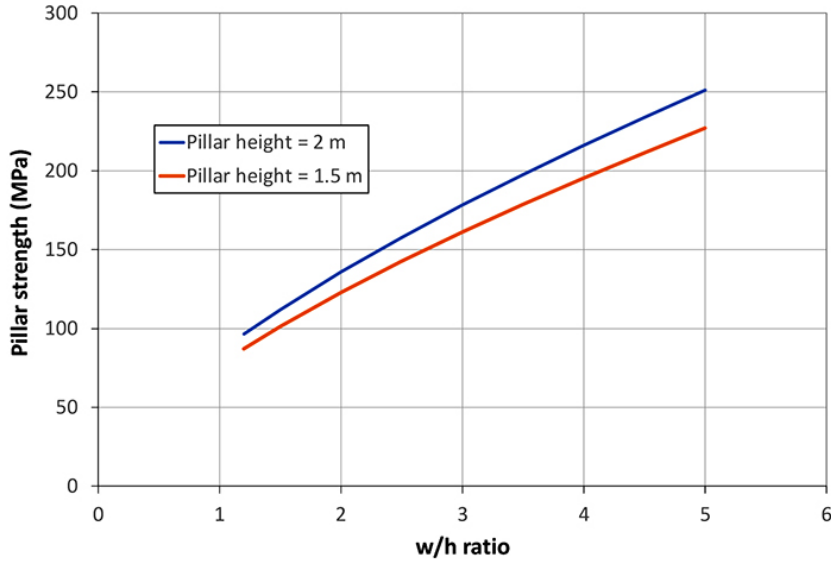
Figure 24—Comparison of pillar strength for pillars of 1.5 m and 2.0 m height, using the 'new' formula

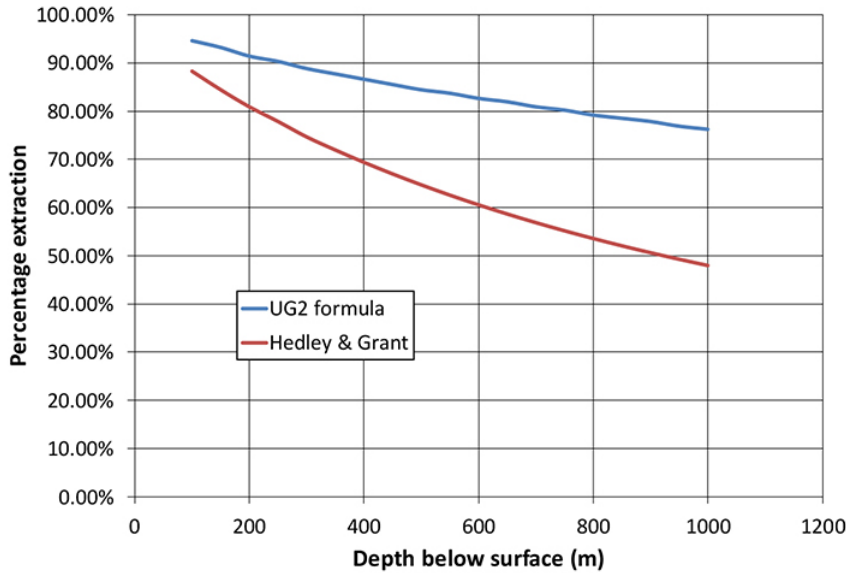
Figure 25—Extraction ratios with depth for pillars designed using the 'new' and currently used Hedley and Grant (1972) formulae ($k = 35$ MPa), assuming square pillars of 2 m height, bord widths of 8 m and SF of 1.6
