Bord-and-pillar design for the UG2 Reef containing weak alteration layers

Journal of the Southern African Institute of Mining and Metallurgy, vol. 123, no. 5, pp. 245-252

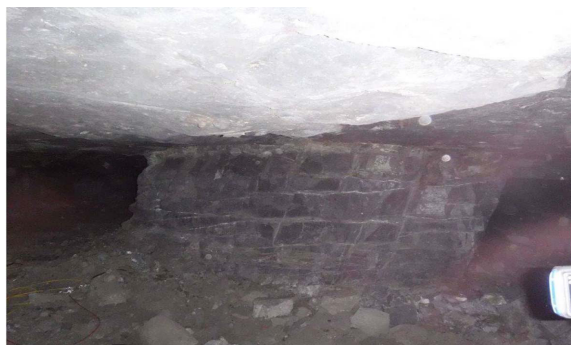
Figure 2—A pillar in the level 2 failure zone with horizontal joints and vertical tensile cracks visible

Figures 2-9 illustrate photographs of the pillars taken during the underground visits. The presence of the alteration zone in the pillars is evident in some of these photographs and a close-up view is given in Figure 7.

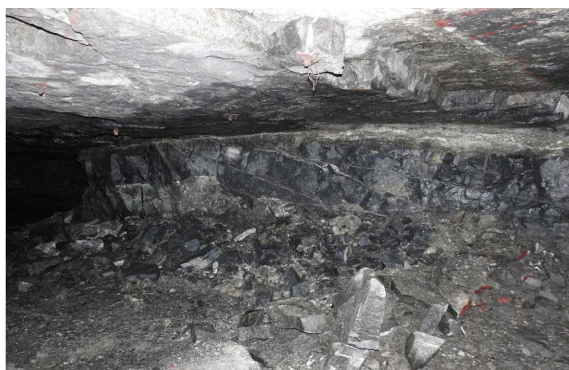
Figure 3—Failure of a pillar facilitated by the alteration zone and the presence of subhorizontal jointing in the level 2 failure zone

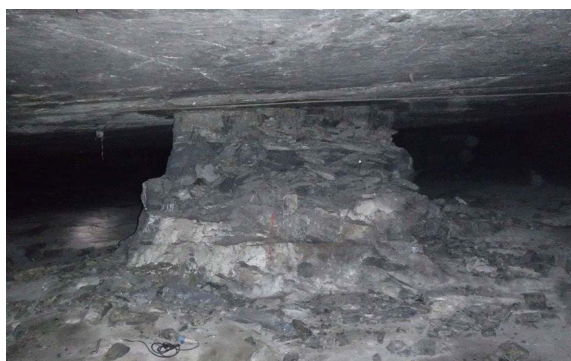
Figure 4—A pillar in the level 3 failure zone illustrating extensive scaling and failure. The core of this pillar is deemed to be still intact

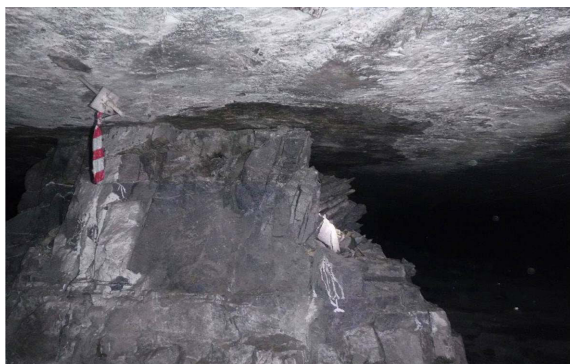
Figure 5—A pillar in the level 3 failure zone. The original size of the pillar is clearly indicated by the change in colour on the hangingwall

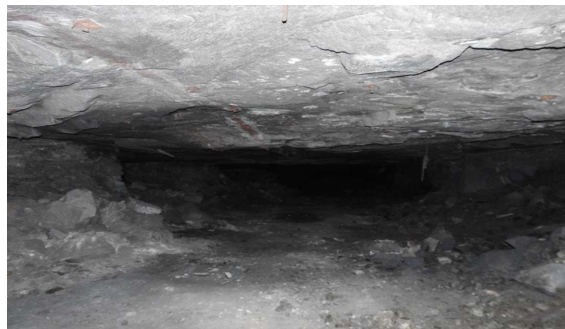
Figure 6—Pillar condition in the level 4 failure zone. The pillars are crushed, but some contact with the hangingwall is still maintained. The large spans indicate that the pillars were not cut to the planned design

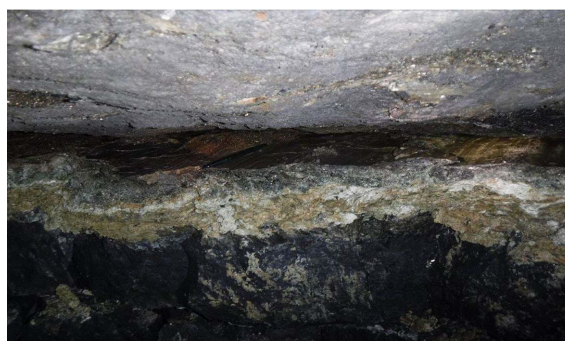
Figure 7—A close-up view of the alteration layer in the level 4 failure zone. The material is wet and it shows evidence of slickenside surfaces. There is a gap between the pillar material and the hangingwall in this area

The weathering of the alteration layer was evidently because of exposure to atmospheric conditions. The presence of water and the high humidity had transformed the geological alteration layer into a weak 'clay layer' that seemed to have no cohesive properties and a very low friction angle. This needs to be tested in the laboratory in future to better quantify the properties. The alteration zone was squeezed out between the reef-hangingwall contact in many areas.

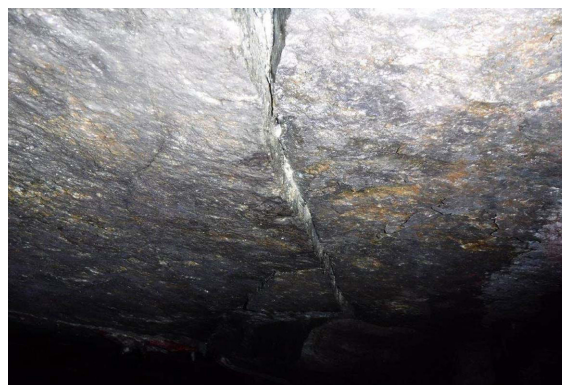
Figure 8—Tensile cracks in the hangingwall of the level 5 failure zone

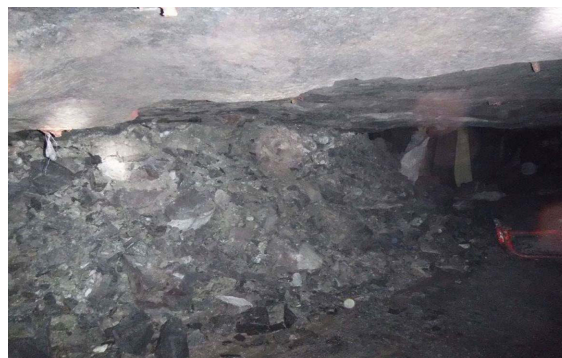
Figure 9—Completely crushed pillars adjacent to the decline

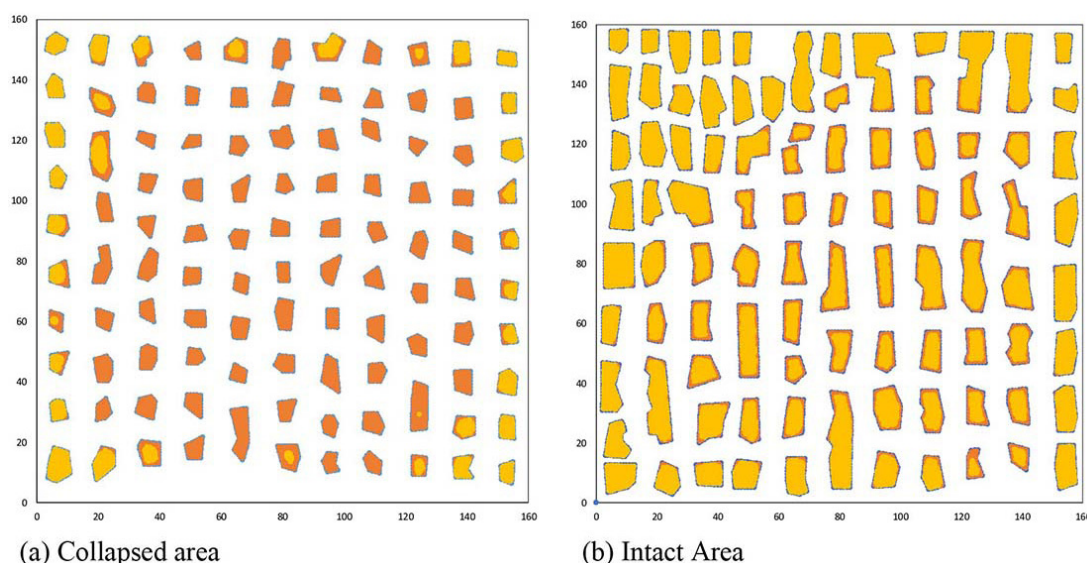
Figure 10—Simulation of pillar failure for the two areas. The orange colour denotes failure and the yellow denotes intact pillars (after Couto and Malan, 2022)

As described in Couto and Malan (2023), TEXAN modelling with the limit equilibrium model was used to simulate the pillar failure at Everest platinum mine. The model is described in detail in Napier and Malan (2007, 2021). The limit equilibrium model is an elegant model to use for pillars where there is a weak layer present at the hangingwall/pillar contact as the model contains a frictional interface at this position. The drawback of the model, however, is that it is symmetrical, with partings at both the hangingwall and footwall contacts, and the friction angle is similar for these partings. The limit equilibrium model contains a large number of parameters and various simulations were conducted to obtain a best calibration of the model. The details of these simulations are given in Couto and Malan (2023) and will not be repeated here. Table I illustrates the calibrated parameters. Two areas were simulated, referred to as the collapsed area and the intact area. The collapsed area was in the level 5 area in Figure 1 and the intact area was in level 1. As explained below, the only difference in calibrated values for the two areas was the interface friction angle. The reason for the difference

is described in Couto and Malan (2023). It was assumed that the presence of water was an important difference between the intact and the collapsed areas. The alteration layer was dry in the intact area and moist in the collapsed area. The friction angle of the pillar contact was, therefore, probably lower in the collapsed area than in the intact area. No laboratory test results of these friction angles are available and this material needs to be tested in future. It should be noted that the limit equilibrium model does not include a cohesion component. This implies a zero cohesion, which is considered to be a good approximation of the characteristics of the alteration layer.

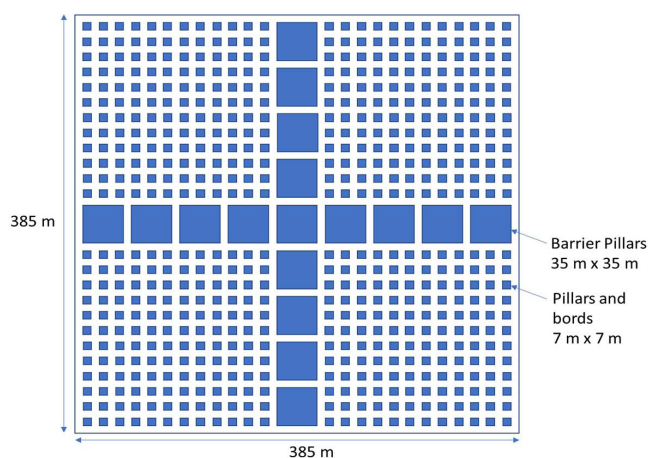
Figure 11—Proposed mining layout

The proposed mining layout for these geotechnical conditions is shown in Figure 11. Note that the diagram shows only part of the layout to illustrate the inclusion of barrier pillars. Each 'compartment' will contain 144 pillars of size 7 m × 7 m and will be surrounded by large barrier pillars with holings at specified distances. The modelling was based on a depth of 200 m. The limit equilibrium model parameters obtained from the calibration exercise described above were used for the simulations. This is deemed a worst-case scenario in terms of pillar strength.

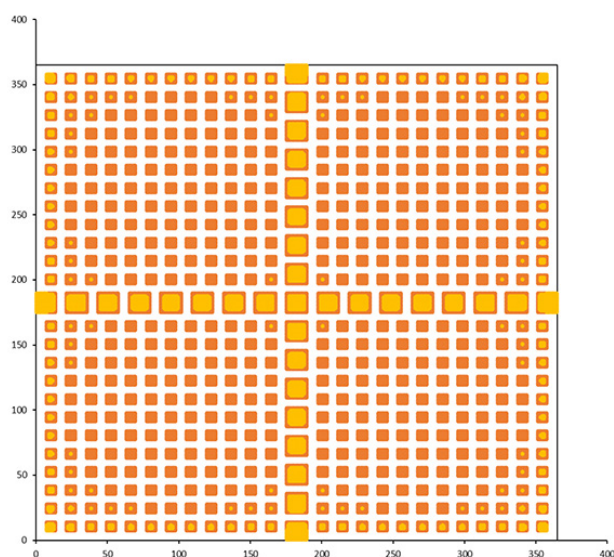
Figure 12—Simulated pillar failure if the barrier pillars are of a size 15 m × 15 m. The orange colour denotes failure and the yellow denotes intact rock

Figures 12 to 16 illustrate the simulated pillar failure for different barrier pillar widths. The objective of this modelling was to determine if the barrier pillars will survive the complete collapse of all the in-panel pillars on a scale similar to the Everest platinum mine collapse. Note the extensive failure of the in-panel pillars in all cases. Some spalling is noted on the 15 m and 20 m wide barrier pillars after the collapse of the in-panel pillars. For the current model calibration, it is therefore recommended to use at least 25 m wide pillars. To ensure safe travelling throughout the mine in case of large collapses, the split barrier option presented in Figure 17 may be a good solution. The simulated amount of scaling on the pillars is only minor and not more extensive than that experienced by the solid 35 m wide pillars. This option gives an extraction ratio of 69%. Although less than the typical 75%, it should be considered that it is very difficult to maintain excavation stability for these ground conditions and the slightly lower extraction ratio will make safe mining possible.

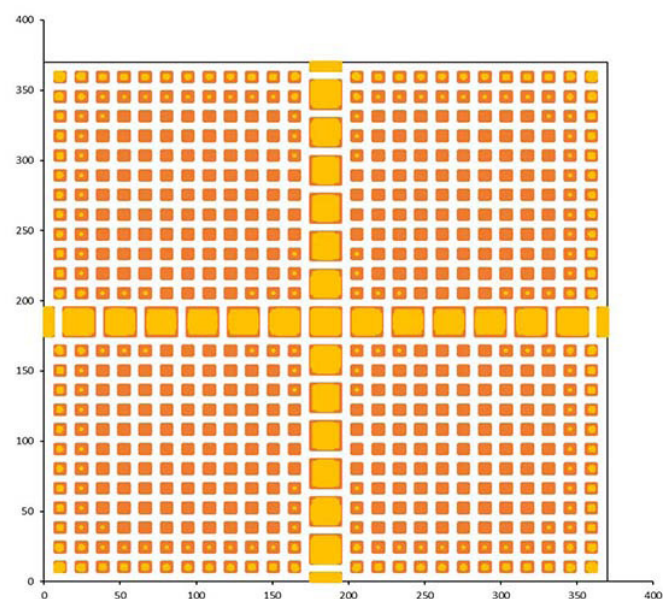
Figure 13—Simulated pillar failure if the barrier pillars are of a size 20 m × 20 m. The orange colour denotes failure and the yellow denotes intact rock

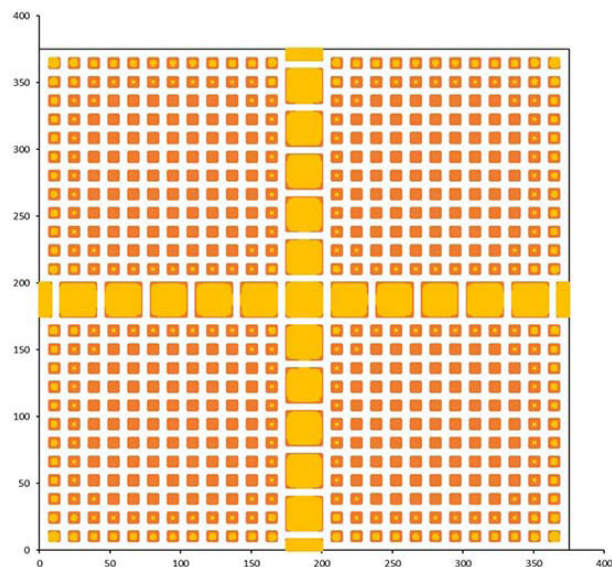
Figure 14—Simulated pillar failure if the barrier pillars are of a size 25 m × 25 m. The orange colour denotes failure and the yellow denotes intact rock

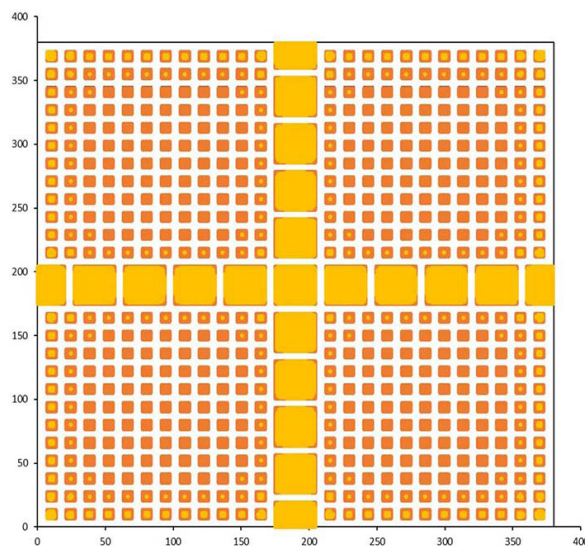
Figure 15—Simulated pillar failure if the barrier pillars are of a size 30 m × 30 m. The orange colour denotes failure and the yellow denotes intact rock

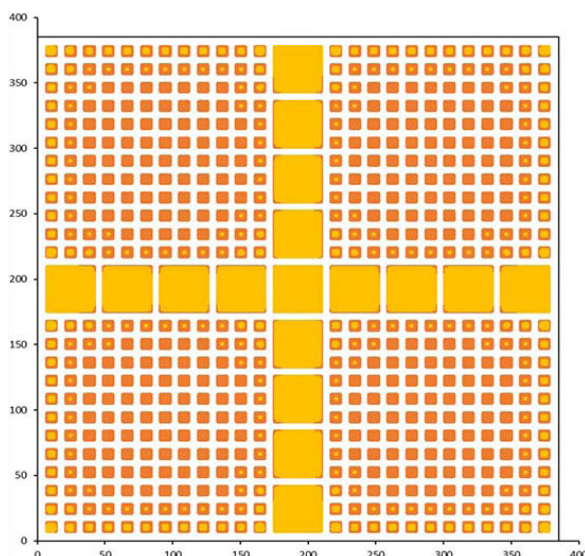
Figure 16—Simulated pillar failure if the barrier pillars are of a size 35 m × 35 m. The orange colour denotes failure and the yellow denotes intact rock

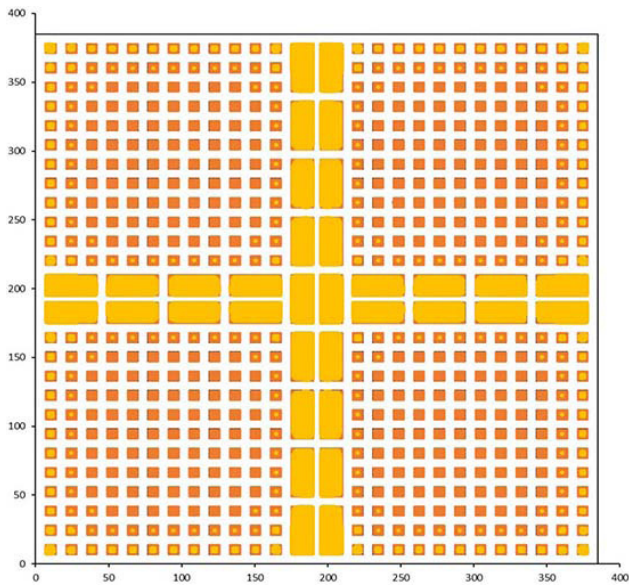
Figure 17—Simulated pillar failure for ‘split’ barrier pillars of a size 35 m × 35 m (each portion 15 m × 35 m). The orange colour denotes failure and the yellow denotes intact rock
