A practical approach to determine the role of rockbolts in stoping gullies

by J.P. Gouvea¹ and T.R. Stacey²

Journal of the Southern African Institute
of Mining and Metallurgy, vol. 124,
no. 1. pp. 7-14

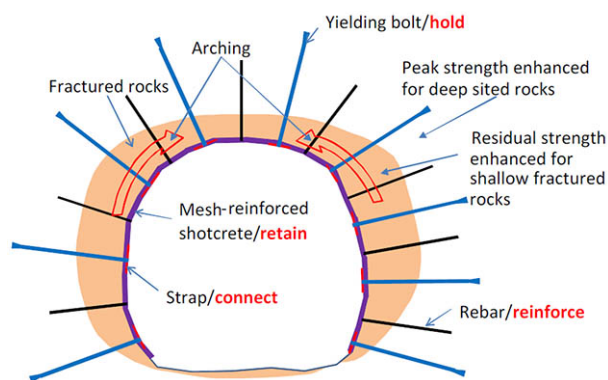
Figure 1—Functions required to provide a reliable support system (modified after Cai and Kaiser, 2012)

The fundamental support functions of rockbolts have remained consistent throughout the years (refer to Figure 1):

- Reinforce the rock mass
- Contain fractured rock
- Retain the deformation compatible surface support
- Facilitate connection between rockbolts and surface support with non-failing connection elements (nuts, plates, strapping, rope lacing *etc.*).

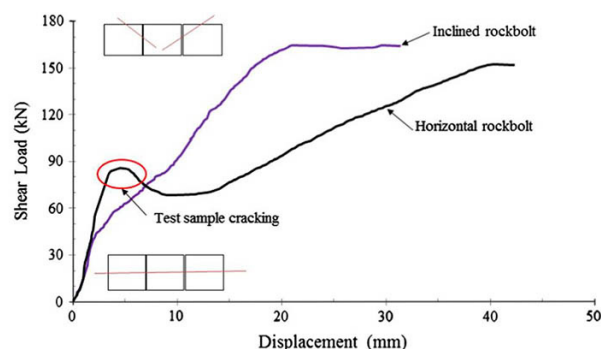
Figure 2—Shear load and shear displacement of rockbolts for different orientations (after Li *et al.*, 2016)

Combinations of loading imposed on a rockbolt (not necessarily only under the influence of gravity) have a significant impact on the overall performance of the bolt. Rockbolts usually experience a combination of tensile and shear loading. Double shear laboratory tests conducted by Ayres and Gardner (2014) to quantify the effect of different installation angles on the performance of rockbolts indicated that failure loads were higher as the shear component decreased relative to the tensile component. Similarly, Li *et al.*, (2016) reported that the variation in rockbolt installation angle relative to discontinuities affects both the peak support load and the rigidity of the support (Figure 2). They found that a higher initial stiffness is achieved by installing a rockbolt perpendicular to a weakness plane rather than at an acute angle. However, in contrast, a higher peak shear load is achieved by installing rockbolts at an acute angle to discontinuity planes owing to the tensile component.

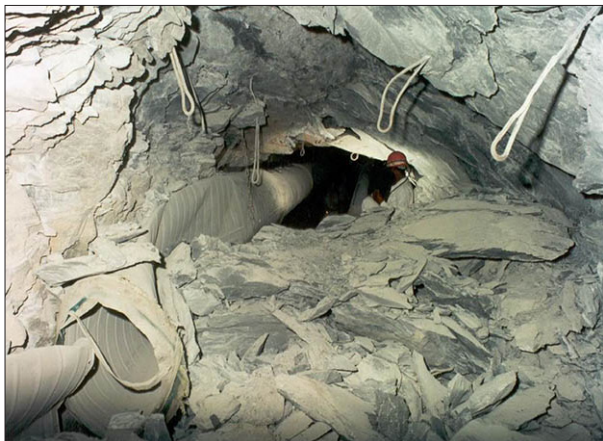
Figure 3—Examples of seismic damage to underground excavations (photograph by W.D. Ortlepp)

In deep-level, hard rock environments, seismic events can pose considerable risks to mining operations (Figure 3). The selection of suitable rockbolt support units in burst-prone conditions is reliant on the appropriate identification of likely rockburst damage mechanisms (Ortlepp and Stacey, 1994). Each mechanism influences a support system differently and as such, should be considered separately (combination loading is also possible). Owing to the difficulty of predicting the location and magnitude of seismic events and the direction of loading, the demand on support is unknown. Furthermore, the capacities of support systems are also unknown, resulting in a situation of design indeterminacy. A potential solution is to install a conservative amount of support that is then likely to prevent, or at least limit, rockburst damage (Stacey, 2011).

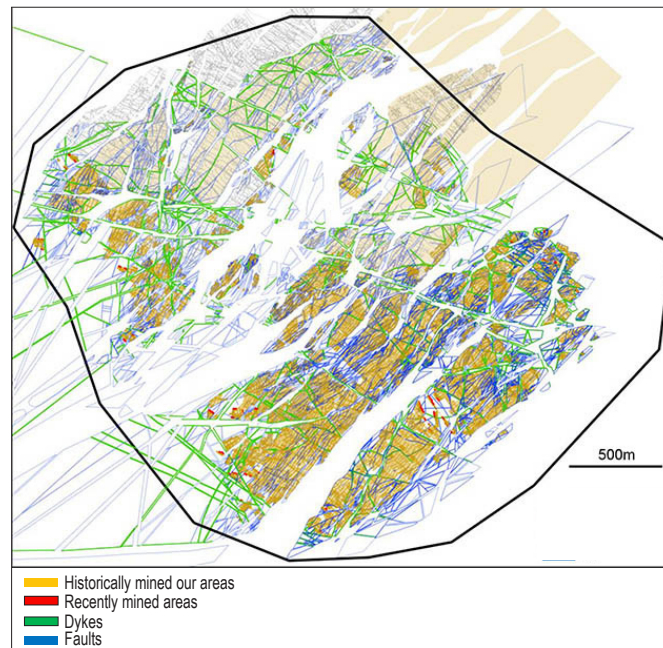
Figure 4—Regional plan view of the study site (not to scale)

The narrow tabular orebody, 1 m thick on average, dips at some 21° towards the south. Owing to a combination of faulting and intrusions in the area, a conventional scattered mining method (Hamrin, 1980) is used. The operation is a marginal mine (low grade) with a large footprint as shown in Figure 4.

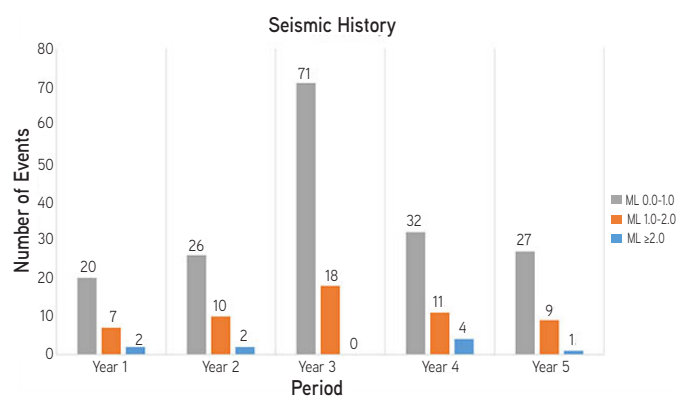
Figure 5—Historical seismic activity rate for events with magnitude larger than zero

True facebursts are rare and do not demonstrate a trend. In most cases, minimal or no damage has occurred to the workings following events of magnitude less than 2.0. Events larger than this, and any unusual seismic occurrences, are investigated individually to determine their impact in order to verify the site response. Figure 5 illustrates a 5-year history of seismic events of various magnitudes

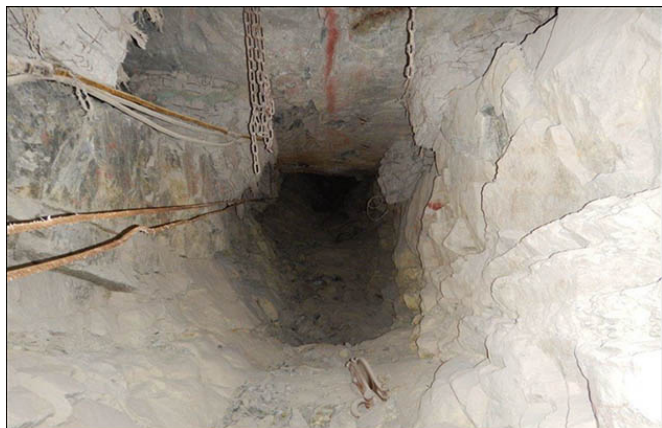
Figure 6—Historical practice - no rockbolts or mesh installed along the gully hangingwall

Historically, timber packs were installed on both sides of stope gullies (Figure 6). These gullies are not used only for travelling purposes, but also to move broken rock from the panel face on a cyclical basis. In 2002, stope gullies were classified as the second highest risk excavations in the South African hard rock mining industry (Naidoo, Leach, and Spencer, 2002).

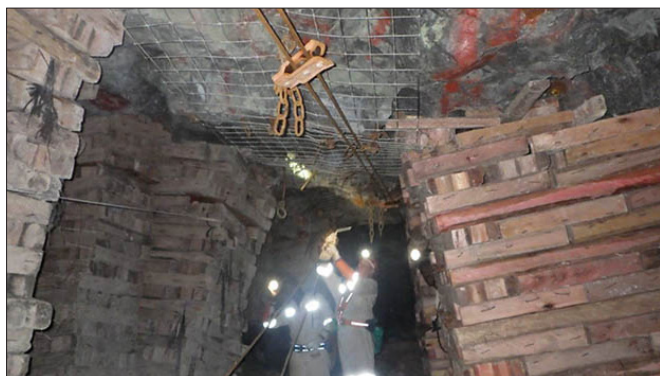
Figure 7—Introduction of gully rock bolts and welded mesh

Soon after the SIMRAC report was published (Naidoo, Leach, and Spencer, 2002), the study site adopted the support recommendations in the report, which included the introduction of welded mesh and rockbolts along the gully hanging wall (Figure 7).

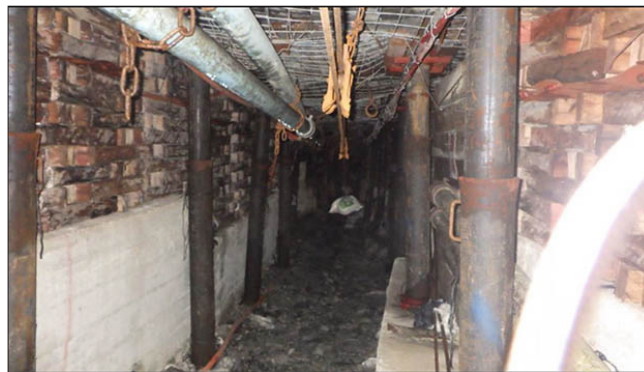
Figure 8—Extensive rehabilitation strategies

The introduction of welded mesh and rockbolt support at in-stope gullies was well intended, but it unfortunately had unexpected ramifications. Since the inherited principles pertaining to the installation angle and protrusion of rockbolts appeared in the mine support standards, these aspects became auditable by the Department of Mineral Resources. Frequent non-compliance with the standards resulted in mine-wide stoppages. To avoid further stoppages by mining regulators, elaborate mesh and rockbolt rehabilitation strategies were implemented, at unsustainable cost (Figure 8).

The rehabilitation costs, in the range of R7 000 to R12 000 per linear metre, were significant considering the strike length of the stope gullies. In spite of these efforts, the study site still experienced stoppages.

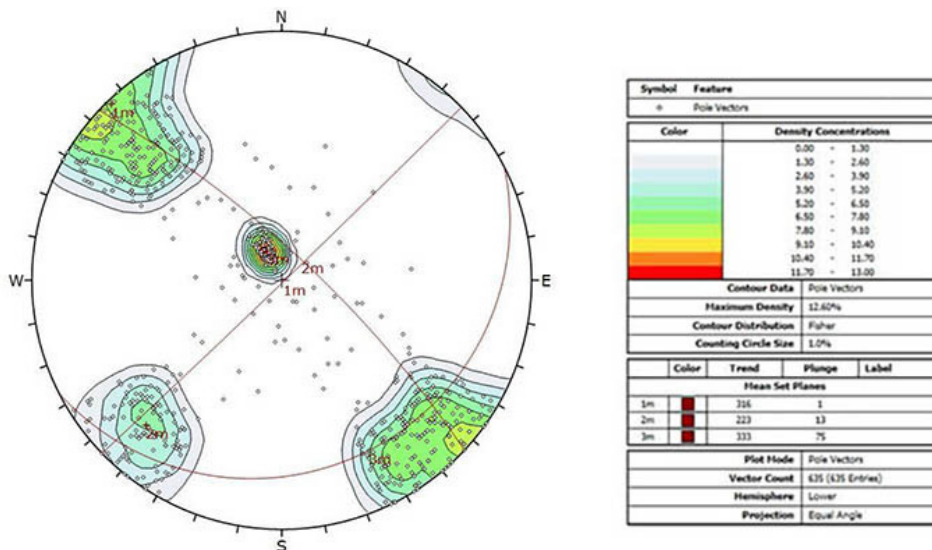
Figure 9—Stereographic projection of discontinuity sets

Figure 9 depicts the selection of discontinuities for the quantification of joint sets.

Three joint sets, and a random joint set, can be observed from the stereonet projection. Joint set 1 was considered as two separate joint sets (J1 and J1i) due to the variability in dip direction. Most of the identified joint sets are steep dipping (J1, J1i, and J2), with one flat dipping joint set (J3 - bedding planes). Joint sets J1 and J2 are orthogonal and when interacting with the flat dipping joint set J3 can create key blocks. For each discontinuity mapped, the following parameters were recorded:

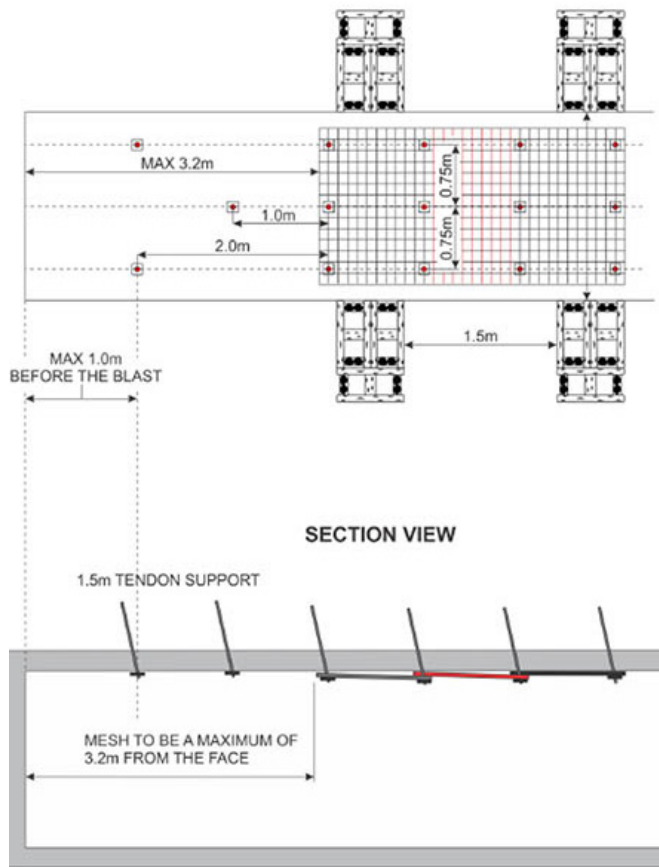
Figure 10—Gully support standard

JBlock, a keyblock stability model (Esterhuizen, 2003), was utilized in the comparative assessment, rather than to provide absolute answers. JBlock is a probabilistic approach to keyblock analysis, providing qualitative or comparative analyses relating to falls of ground and support layouts (Esterhuizen and Streuders, 1998). JBlock has been shown to be useful in estimating the relative hazard of rockfalls in tabular mining layouts in South Africa (Joughin *et al.*, 2012a; 2012b). The model geometry for the JBlock analyses was derived from the study site's mine standards booklet as depicted in Figure 10.

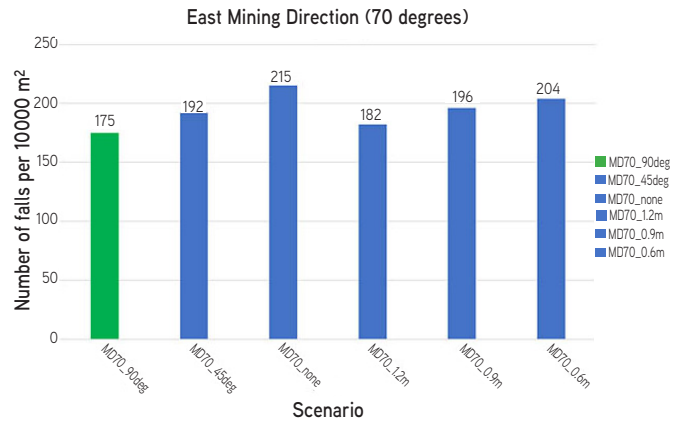
Figure 11—Comparison between simulations for an East mining direction

Figures 11 and 12 compare the current support standard (MD70_90deg and MD250_90deg) and the effectiveness of the

support system in the cases of protruding rockbolts and bolts installed at an acute angle. In the graphs, the green bar (far left) represents the current support standard and the blue bars (the second and subsequent bars) represent the performance of the support system when protruding rockbolts and bolts installed at an acute angle are prevalent. For comparison purposes, the numbers of falls of ground have been normalized relative to the exposed face area in the model. A value of 10 000 m² of exposed gully face area was used for normalizing.

A very low probability exists for failures in gullies. On average, 187 rockfalls were simulated per 10 000 m² of exposed gully face area mined for the current mine support standards. The numbers of rockfalls increase to 223 per 10 000 m² mined, on average, when no rockbolts are installed. The failures indicated by the keyblock analysis were at the gully face, prior to installation of the packs along the gully shoulders. Such failures were not observed underground, nor recorded in the mine's fall of ground database: they may take place during blasting, and/or are controllably removed during barring activities. The conclusion from the keyblock modelling is that protruding rockbolts and bolts installed at an acute angle in gullies at the study site did not contribute significantly to the rockfall hazard in the stoping gullies.

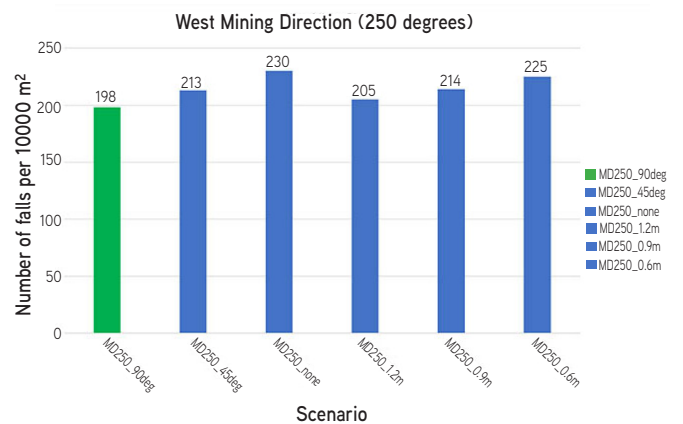
Figure 12—Comparison between simulations for a West mining direction

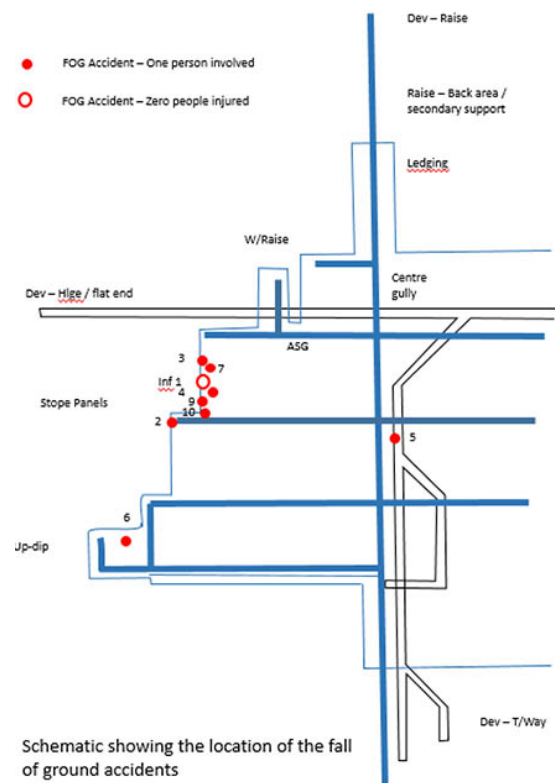
Figure 13—Schematic of fall of ground accident locations

were assessed. Falls of ground were responsible for 14% of accidents on the mine. This percentage was deemed significant considering the severity of such accidents. Figure 13 indicates the general locations of falls of ground in the period that was assessed.

The majority of fall of ground accidents occurred in the stoping environment, as expected. Fall of ground number 2, as depicted in Figure 13, is situated in a gully where rockbolts were being installed. However, the fall was not a result of protruding rockbolts or rock installed at an acute angle.

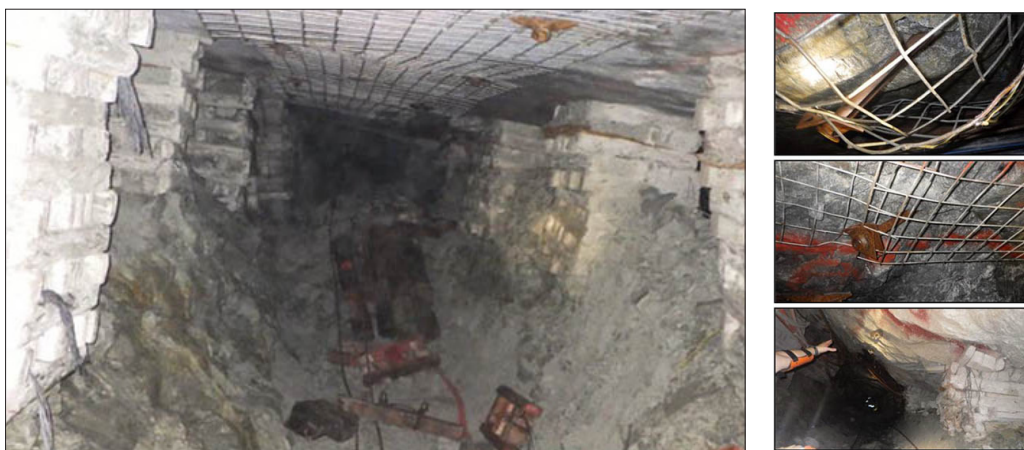
Figure 14—General gully excavation and support conditions

Underground inspections were carried out at 24 workplace gullies across the mine. A total distance of 1240 linear metres was inspected to identify protruding rockbolts and bolts installed at an acute angle. Most of the rockbolts were installed at an angle less than 70° to the hangingwall (68%), and many were protruding by more than 30 cm (11%). Rockbolts were installed at an average angle of 45° to the hangingwall. However, in the 1240 m inspected in the 24 workplaces, no instabilities were observed relating to protruding rockbolts, nor to bolts installed at a flat angle (refer to Figures 14 and 15).

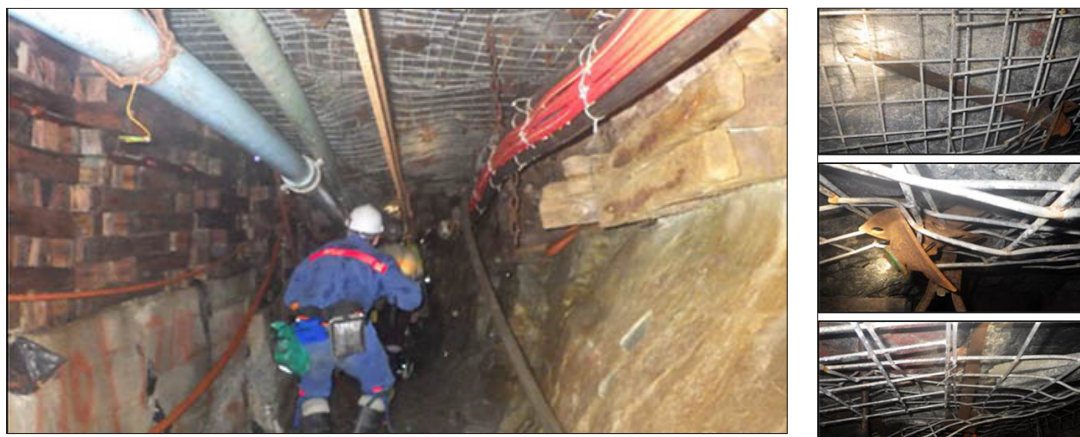
Figure 15—Protruding rockbolts and bolts installed at an acute angle

Some of the underlying reasons for the acute installation angles and protruding gully rockbolts were practical and/or situational constraints. Congestion with broken rock restricts the height of the gullies and results in operators adjusting the angle of

installation to suit the required tools and equipment (hand-held drilling). Installation angles were normally flatter in the direction of advance, which under these circumstances can be considered favourable. Protruding rockbolts were not mainly attributed to the fallout of small rocks from the hangingwall of the stope gully, but to undulating or uneven hangingwall conditions. The loading interaction between the welded mesh and rockbolt faceplate prevents the faceplate from being pushed flush against the rock wall.
