# Fracture behaviour patterns of cusp-replacing fibre strengthened composite restorations

SADJ October 2015, Vol 70 no 9 p390 - p395

**Objectives:** To investigate and compare, *in vitro*, the fracture behaviours of three types of cusp-replacing posterior composite resin restorations.

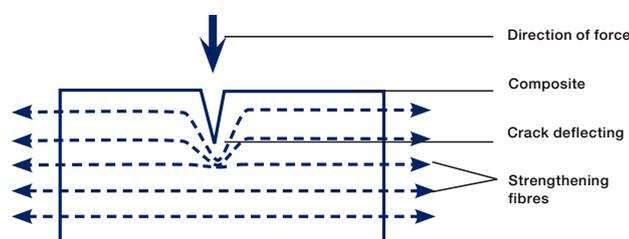
Figure 1: Fibres act as a crack-deflecting mechanism

It has been proven in various research projects<sup>1,3,15</sup> that fibre reinforcement of composite resin strengthens the composite resin material.<sup>6,18-20</sup> Recent research studies found that using fibre-reinforced composite as a sub-structure under composite restorations can improve the load-bearing capacity and may offer one alternative in overcoming some potential problems of composite restorations in high stress-bearing areas.<sup>7,16-20</sup> (Figure 1)

The fibres may act as a crack-deflecting mechanism (Figure 1), changing the fracture behaviour of the composite resin material to that of a material with quasi-ductile fracture behaviour.<sup>6,19,22,24</sup>

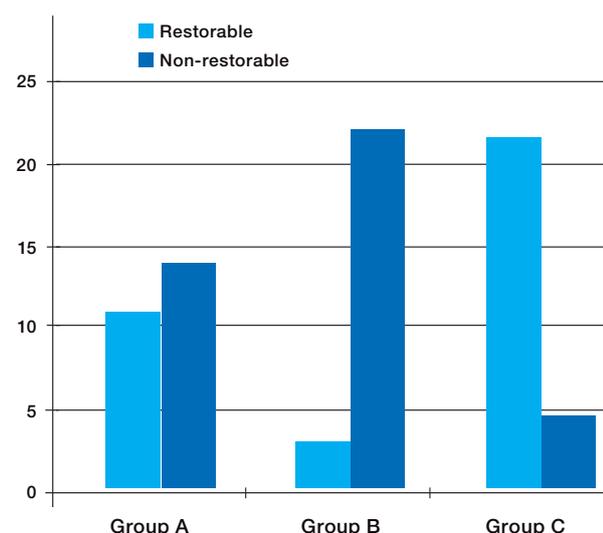
Graph 1: Comparison between restorable and non-restorable fractures

Fractures which were restorable occurred in 44% of cases (11 of 25 specimens) in Group A (control - QuiXfill), in 12% (3 of 25 specimens) in Group B (Aelite and nano-scale glass fibre reinforcement) and in 84% (21 of 25 specimens) in Group C (QuiXfill placed on everStick). (Graph 1) These data differences were statistically significant (Fishers Exact Test,  $p < 0.05$ )

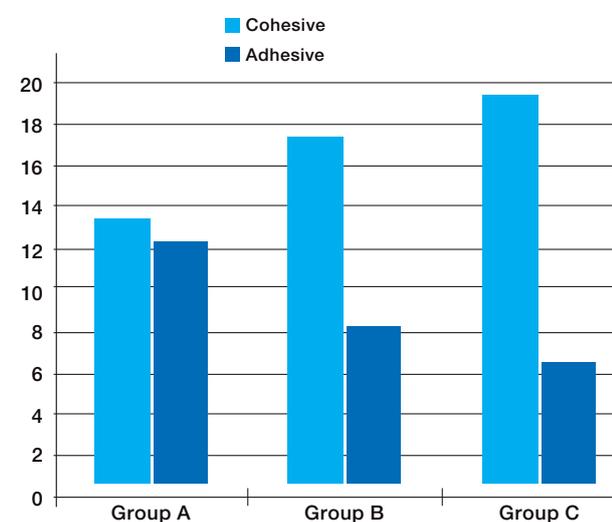
Graph 2: Frequency of cohesive and adhesive fractures

According to the literature<sup>35,36,42</sup> some researchers also use a broad classification system based on the type of fracture, being either cohesive or adhesive. (Photos 2 and 2a). A more detailed investigation of fracture patterns in the current study (Graph 2) show that in Group A, the fractures were more or less evenly distributed between cohesive and adhesive types (Graph 2). 52% or 13 out of 25 specimens were cohesive fractures (Photo 3 and 3a). This differs from the finding of Taha (2011)<sup>51</sup> who found mainly adhesive fractures. In Group B most of the fractures were cohesive (68%, 17 out of 25 specimens), while in Group C 76% (19 out of 25) of fractures were cohesive, and 16% (4 out of 25 specimens) of fractures were adhesive. This is similar to the finding of Tezvergil (2005).<sup>49</sup> In all 76% of cohesive failures the fracture occurred between the fibre substructure and the composite resin as illustrated in Photo's 4 and 4 (a).

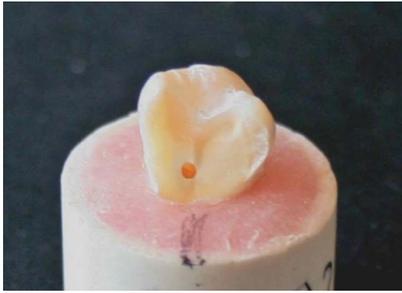
Photo 1: Fracture exposing pulp

The composite resin reinforced with nano-scale glass fibre reinforcement (Group B – Aelite) fractured in 28% of cases (7 out of 25) in such a manner that pulp tissue was exposed. (Photos 1 and 1a). This was the only group in this study in which pulp-exposing fractures occurred. These catastrophic type of fractures have also been reported to occur when conventionally-filled composite resin was placed on a substructure of short multi-directional fibre composite.<sup>23</sup>

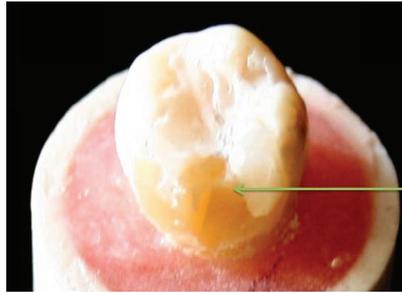
Photo 2: Cohesive fracture (occurred inside the restoration itself)

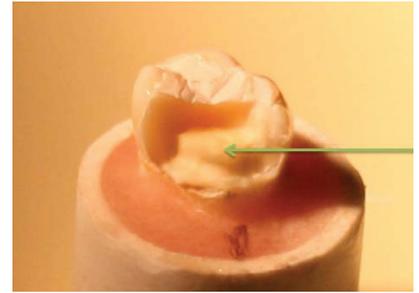
Photo 3: Adhesive fracture (occurred at the adhesive interface)

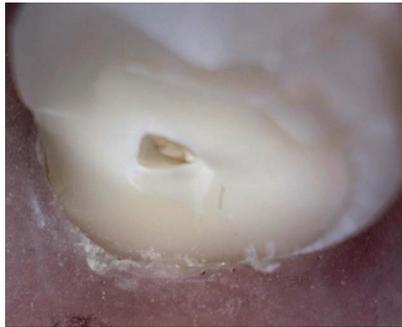
Photo 1a: Fracture exposing pulp (x10 magnification)

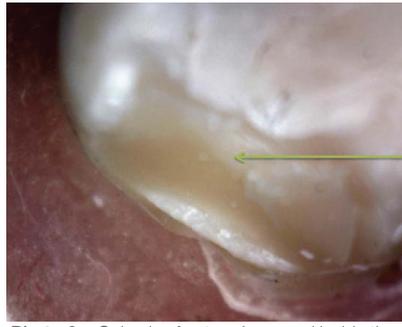
Photo 2a: Cohesive fracture (occurred inside the restoration itself) x10 magnification

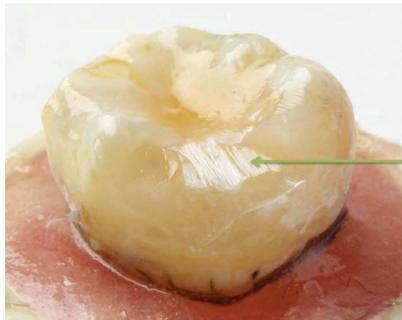
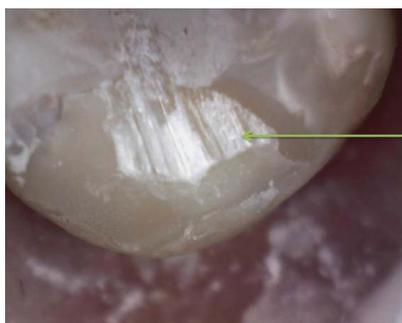
Photo 4: Fracture between fibre sub-structure and composite resin

Photo 4a: Fracture between fibre sub-structure and composite resin (x10 magnification)
