Keurbooms Estuary floods and sedimentation

Eckart H. Schumann¹

estuary morphology;
barrier dune; mouth migration;
river floods; ocean waves

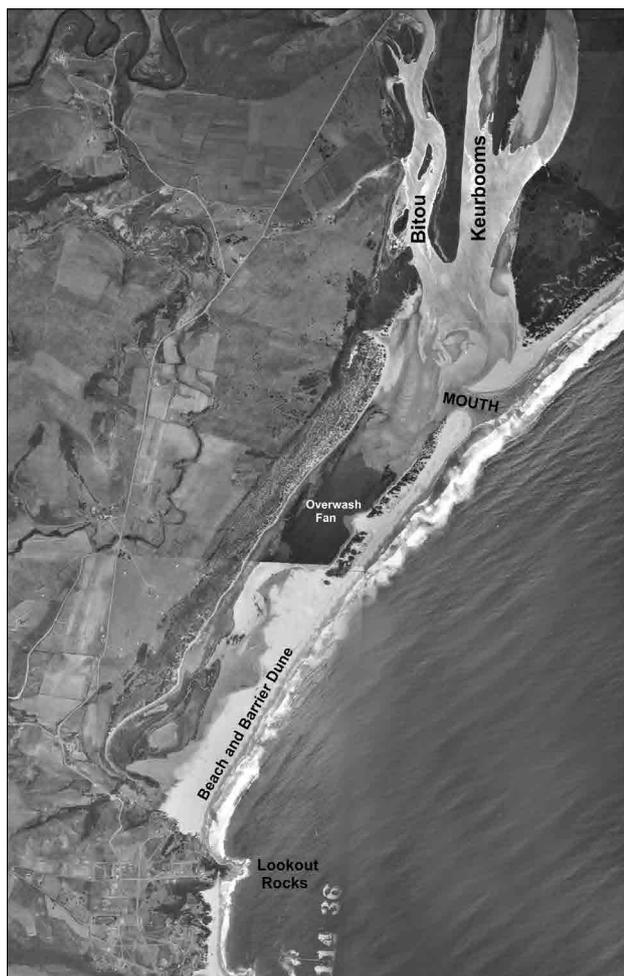
Figure 2: An aerial photograph of the Keurbooms Estuary in 1936.

At the time, the mouth was still situated at the northern end of the barrier dune, while a complex system of sandbanks is evident on the estuary side. The barrier dune extending southwards had a sparse collection of vegetation, while a prominent overwash fan is indicated. Farther south, the wide beach/barrier dune seems void of vegetation, with marine sediments extending some distance into the back-barrier lagoon. On the western side there appears to be a number of channels with zoster-covered sandbars.

Fromme³ analysed the mouth migrations using a set of 14 aerial photographs over a period of 44 years. The first two photographs from 1936 (Figure 2) and 1942 show the mouth still in the northerly position, while all the other 12 photographs located it in the centre of the barrier dune, some 2 km north of the Lookout Rocks. The mouth position over the 19 years from 1961 to 1980 varied over a distance of around 500 m.

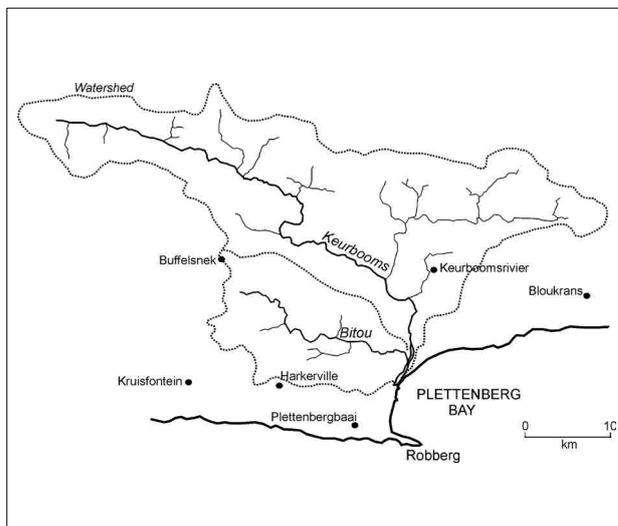
Figure 3: Catchment areas of the Keurbooms and Bitou Rivers.² The rainfall stations used in the analysis are shown.

The catchments of the Keurbooms and Bitou Rivers are shown in Figure 3 and have areas of 859 km² and 237 km², respectively.² The mean annual run-off of both catchments was estimated to lie in the range of 70 x 10⁶ m³ to 160 x 10⁶ m³ by Duvenhage and Morant.⁵ On the other hand, Fromme³ calculated a median discharge of 8.29 x 10⁶ m³ per month over a period of 56 years. These values correspond to an average inflow between 2.2 m³/s and 5 m³/s, although these values include occasional floods, which means that the daily flow from the two rivers is probably considerably less.

Stations were selected on the basis of being relevant to the two river catchments, i.e. they needed to be close enough, and positioned on the southern side of the Tsitsikamma Mountain range. On this basis, the six stations shown in Figure 3 were selected to represent rainfall in the catchments. Mean values for every day over all six stations were calculated, the advantage being that missing values from any one station would not impact too greatly on the final value.

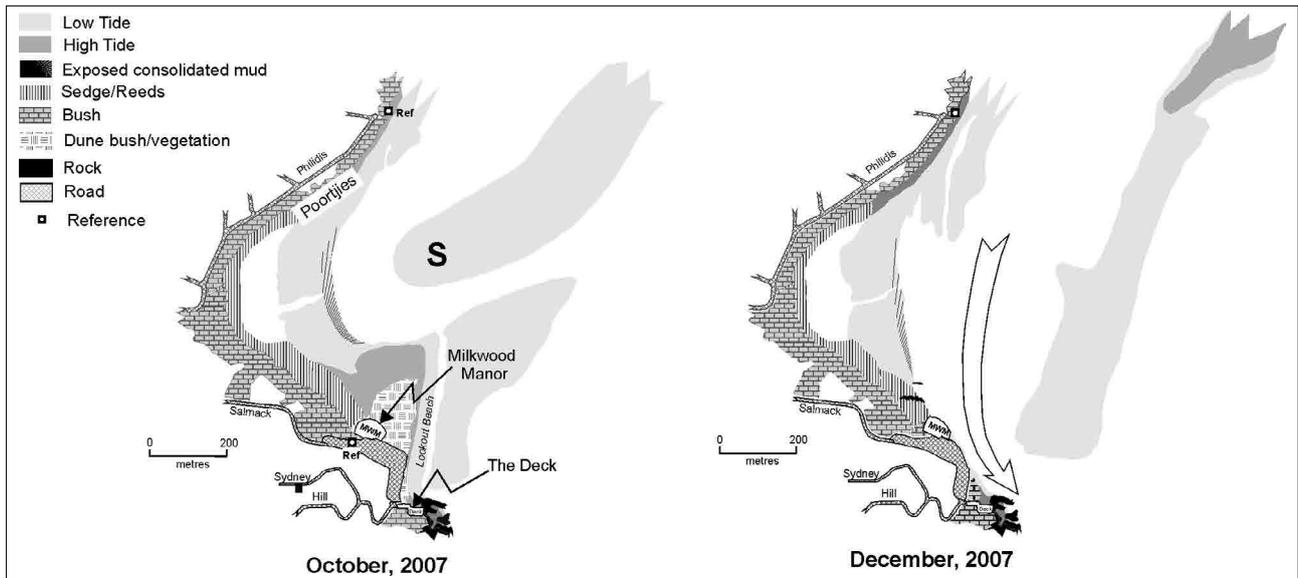
Figure 6: Sediment structure maps in the Keurbooms Estuary on the given dates. The legend gives the structures depicted, while the October 2007 map identifies sites mentioned in the text. The arrow depicts the main floodwater flow.

Cooper²³ found that in such tide-dominated estuaries, floods typically erode accumulated sediment and deposit some of it as an ephemeral delta. This is what happened here, and Figure 6 shows that in December

a new subtidal barrier dune had formed with its tip some 400–500 m seawards of the previous position.

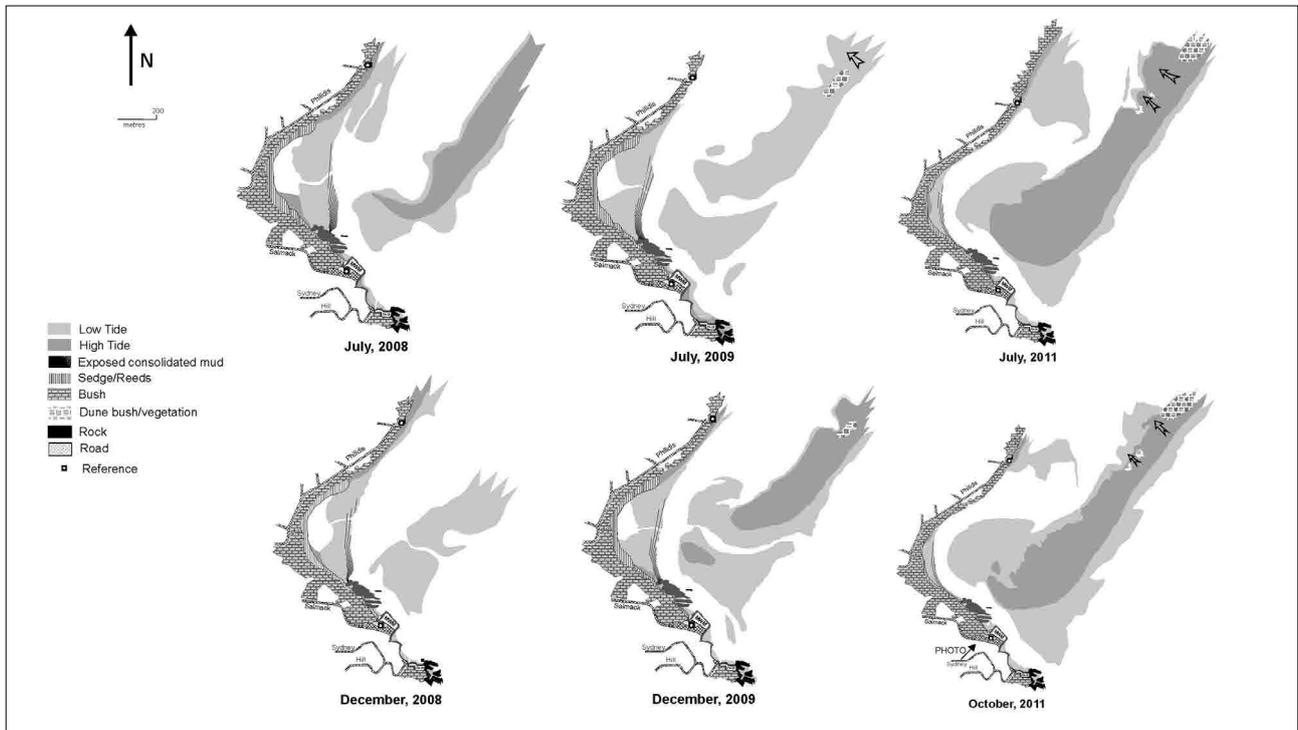
Figure 7: Sediment structures in the Keurbooms Estuary on the given dates. The arrows on the barrier dune indicate washover points.

After the massive flood in November 2007, Figure 7 shows the changes over the next 4 years. It is expected in such tide-dominated estuaries that reworking of the barrier dune by wave action should move it back more or less to its previous orientation within a relatively short period,²³ and this movement is evident by July 2008. It had also accumulated subaerial sand.

It appears that extreme wave events, such as those of September 2008, can also cause breaching of the barrier dune. The channel evident in December 2008 (Figure 7) remained operative for more than a year before it was eventually closed when the northward extending longshore delta became too long.

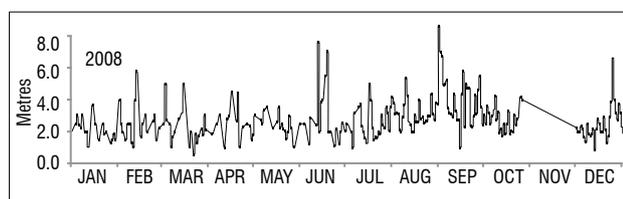
Figure 8: Daily significant wave heights from voluntary observing ships data for 2008. The dots indicate the values of wave height, joined by the thin line. There are numerous days when there were no data.

The reasons for the changes can then probably be found in Figure 8. The VOS data showed that very high wave conditions occurred around 1 September, with wave heights greater than 8 m. At the time there was also considerable damage reported from other coastal areas along the south coast. Such storm waves would have eroded the barrier dune, with extensive washover areas occurring. One such washover was probably sufficiently large to form a channel, and once formed, water would have selectively exited along this channel. Moreover, the waves penetrating over the barrier dune would have been responsible for the erosion of the sand delta at Poortjies.

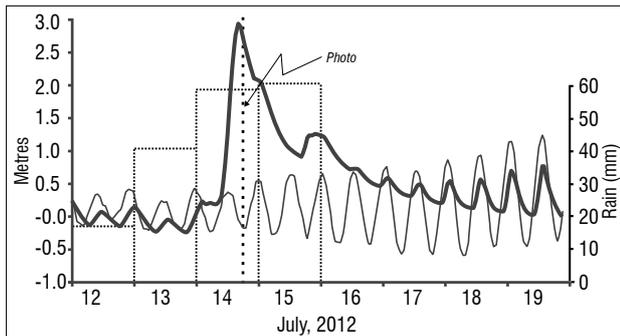
Figure 9: Hourly sea level data from Mossel Bay (light line), hourly water level data from the N2 gauge (dark line), and daily rainfall records (dotted line). The time at which the photo in Figure 11 was taken is shown.

The rainfall, sea level at Mossel Bay, as well as the water level at the N2 gauge are depicted in Figure 9, starting on 12 July and ending eight days later when conditions had returned to normal. In addition, Figure 10 shows that high wave conditions were experienced at the time, with peak wave heights close to 8 m being reported. Inspection of Figure 7 shows that in July and October 2011, overwash points were observed on the barrier dune south of the more heavily vegetated section. These points were evident, both from a lowered dune profile where waves had penetrated over the dune, and the washover fans where sand had subsequently been deposited in the estuary. These points were particularly vulnerable to breaching by the floodwaters and Figure 9 shows that the water level in the estuary rose rapidly from about midday on 14 July in response to the continuing rain from 12 July onwards. Such a damming up of water behind the barrier dune would have been caused by the convoluted exit channel past Poortjies being too small and obstructive to accommodate the volume of water flowing into the estuary.

The flood water level reached its maximum and then from about 5pm on 14 July there was a rapid decrease. The reason for this decrease can be seen in the photograph in Figure 11, taken just after the peak water level had been reached (Figure 9).

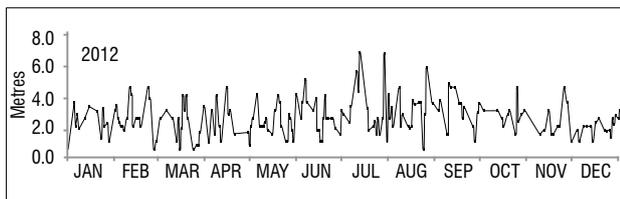
Figure 10: Daily significant wave heights from voluntary observing ships data for 2012.
