Microbial water quality of treated water and raw water sources in the Harare area, Zimbabwe

Keywords: microbial water quality, faecal contamination, H₂S strip test, R2A agar test

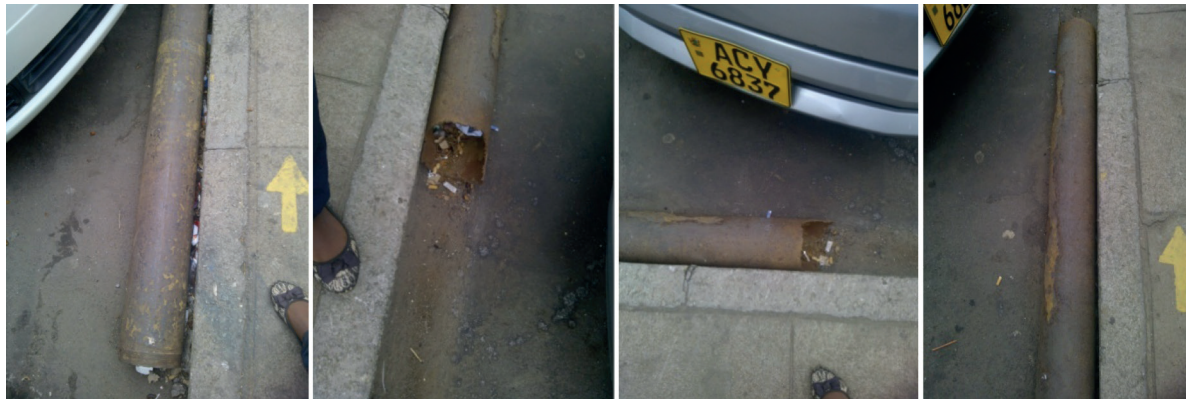
Figure 1

Rusty iron pipes removed from the distribution chain in the CBD

Harare is located 1 500 m amsl, and has a population of 2.1 million people and a land area of 872 km² (Census, 2012). The water supply infrastructure has 6 000 km of water pipes. Of this length, 200 km of iron pipes have so far been replaced with polyvinyl chloride (PVC) pipes. The city's water supply infrastructure was originally designed to supply 350 000 people and has been progressively upgraded to supply 1.5 million people (Census, 2012). The current population expected to benefit from this infrastructure is approximately 4.5 million people, three times more than its current capacity (Census, 2012). Over the years, maintenance of the pipelines and the treatment plant were given priority over a complete upgrade of the water supply infrastructure. The projected water demand of 1 400 000 m³/d for 2015 is much more than the combined capacity of Lake Chivero and Manyame, which has a combined storage capacity of 727 417 000 m³ (Nhapi, 2009). The pipes used are asbestos cement (AC) and a steel type. The AC type is vulnerable to breakage due to ground movement, both during and after the rainy season, as well as due to soil expansion and contraction (Nhapi, 2009). The steel pipes corrode with age resulting in an increased leakage rate and burst frequency (Nhapi, 2009).

The first interview was carried out with Mr Freddy Chinyavanhu of the GA Laboratory. He provided insight on how water quality is tested at their laboratories. He also discussed the limitations that have been encountered in the assessment of water quality at national level and how external input may improve water quality testing services. The second interview was conducted with the Drug and Toxicology Information Services personnel. They explained how they have been holding workshops to assist the community in handling general poisoning cases. They also held workshops with hospital staff at Corporate 24 and Parirenyatwa Hospitals to better equip them to deal with poisoning cases, including those that present with diarrhoea, which may then be confused with gastro-enteric disease. The third interview was conducted with the City of Harare Quality Assurance Office laboratory technicians. They explained the purification process that water undergoes before being supplied to the general public. They also provided insight on the laboratory tests performed in Quality Assurance to ensure the safety of the end users of water from the Morton-Jaffray Treatment Plant and the limitations they encountered in water quality testing and service delivery. Their names were however withheld for privacy purposes. Interviews with other members of staff alerted me to the upgrades to the pipeline system, whereby old rusty pipes were being replaced with new PVC type pipes. The old pipes are shown in Fig. 1 on the next page.
