# Recognition of materials and damage on historical buildings using digital image classification

Meroño JE, Perea AJ, Aguilera MJ, Laguna AM. Recognition of materials and damage on historical buildings using digital image classification. *S Afr J Sci*. 2015;111(1/2), Art. #2014-0001, 9 pages. <http://dx.doi.org/10.17159/sajs.2015/2014001>

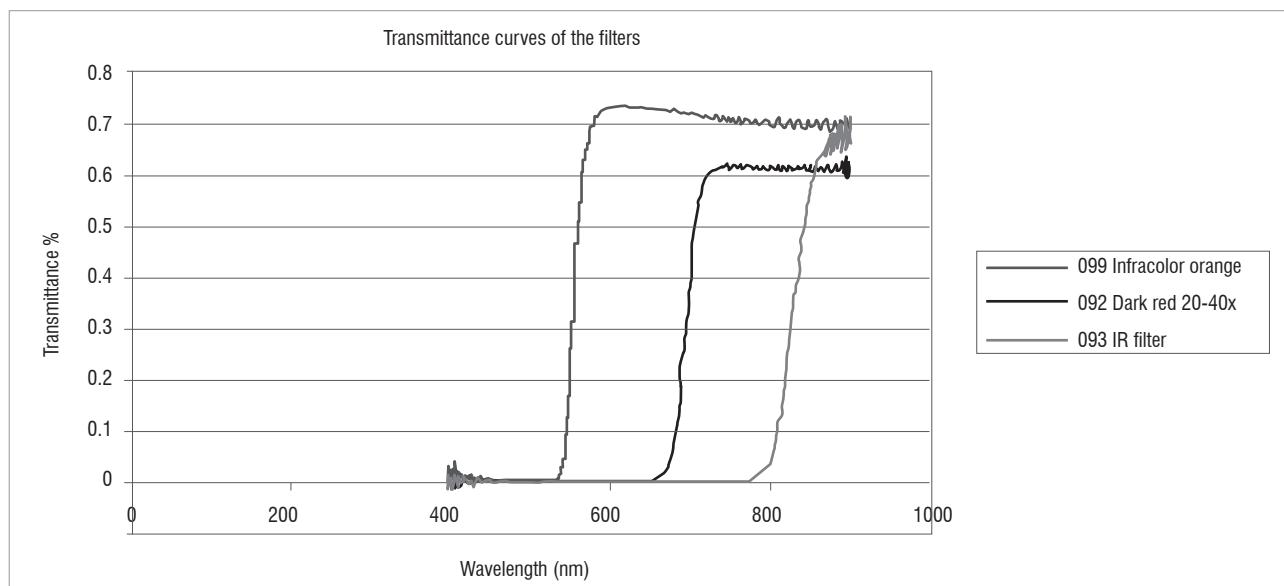
Figure 1 shows that the filter absorbs almost all light until a wavelength of approximately 550 nm and consequently filters all the spectral information corresponding to ultraviolet and the visible portion composed of blue and green. Part of red is also reflected; hence, the light passing through the filter will be formed by infrared and the orange area.

Figure 1: Transmittance curves of the B+W 099, 093 and 092 filters.

The choice of the filters to use in this study was based on previous results obtained by the working group.<sup>28</sup> These filters, whose transmittance curves are shown in Figure 1, were characterised using a calibration sphere Li-Cor 1800-12.<sup>29</sup> The filters were obtained from B+W (Berlin, Germany).

This filter has a transmittance curve characterised by an inflection point in the wavelength region of 690 nm. This curve indicates that the filter eliminates the ultraviolet response and practically the entire visible portion, except for dark red. As a result, the light beam will be characterised by an infrared and partly dark red spectrum.

This filter eliminates ultraviolet and the entire visible portion as it screens the beam of light up to the area close to 830 nm, which is already in near infrared.

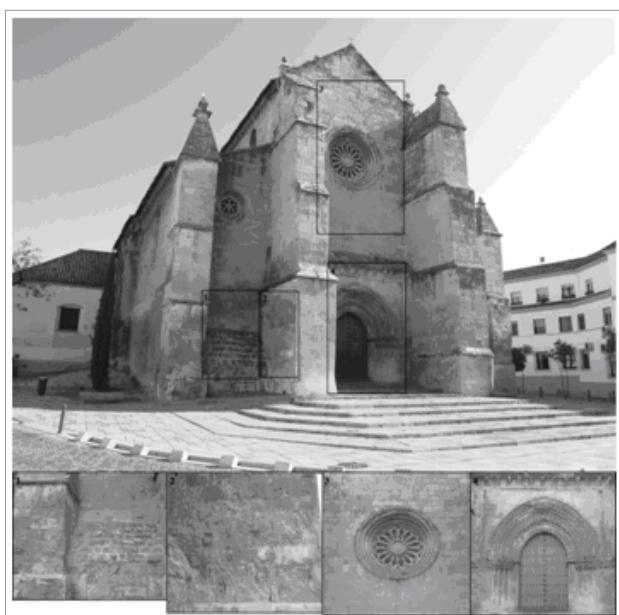
Figure 2 shows the four study areas selected for the characterisation of the materials and their alterations. These areas have important damage and they need to be restored. Four false colour photographs were taken of each area, using the camera with: (1) no filters, (2) a B+W 099 filter, (3) a B+W 092 filter and (4) a B+W 093 filter.

Figure 2: The Santa Marina Church, Córdoba. Insets: Areas of the building that were studied.

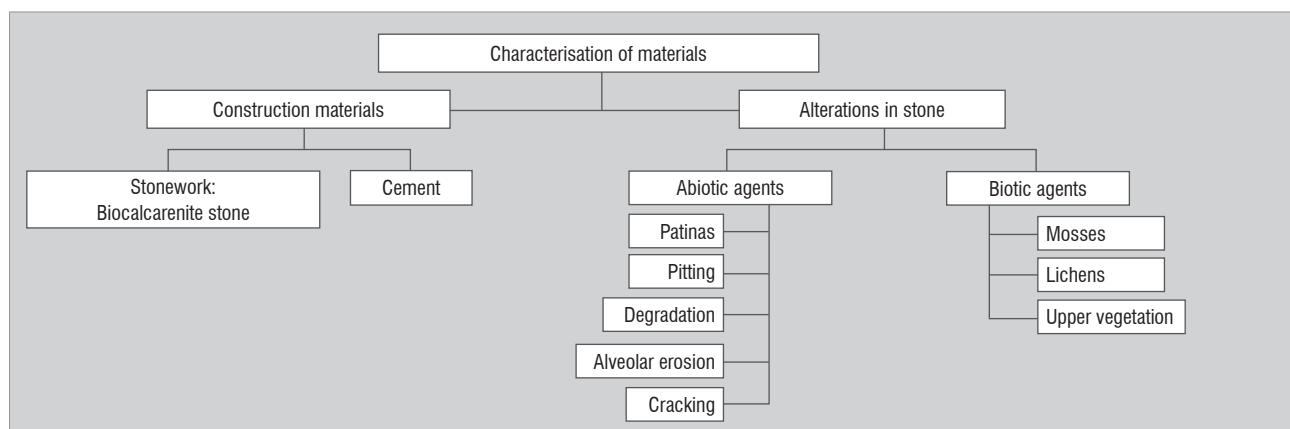
previous studies carried out on the church, in which the pathologies affecting the facade were plotted using traditional techniques.<sup>26</sup> In Figure 3, a diagram shows the characterisation of materials and alterations in the stone obtained in the aforementioned research.

Figure 3: Characterisation of materials on the church facade.

Based on the characterisation of materials and changes in the stone shown in Figure 3, the legend defining the classes to be automatically differentiated was obtained. The different uses of the legend are listed in Table 2.

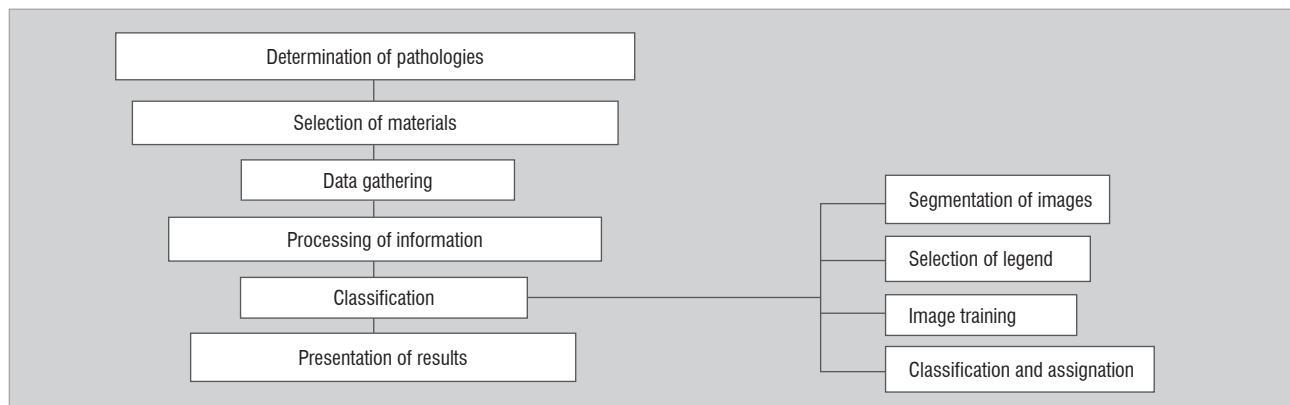
Figure 4 shows a diagram of the methodology followed in this study to identify the pathologies from the classification of hyperspectral images taken. The object-oriented classification technique applied is described below.

Figure 4: Phases for the identification of stone pathologies.

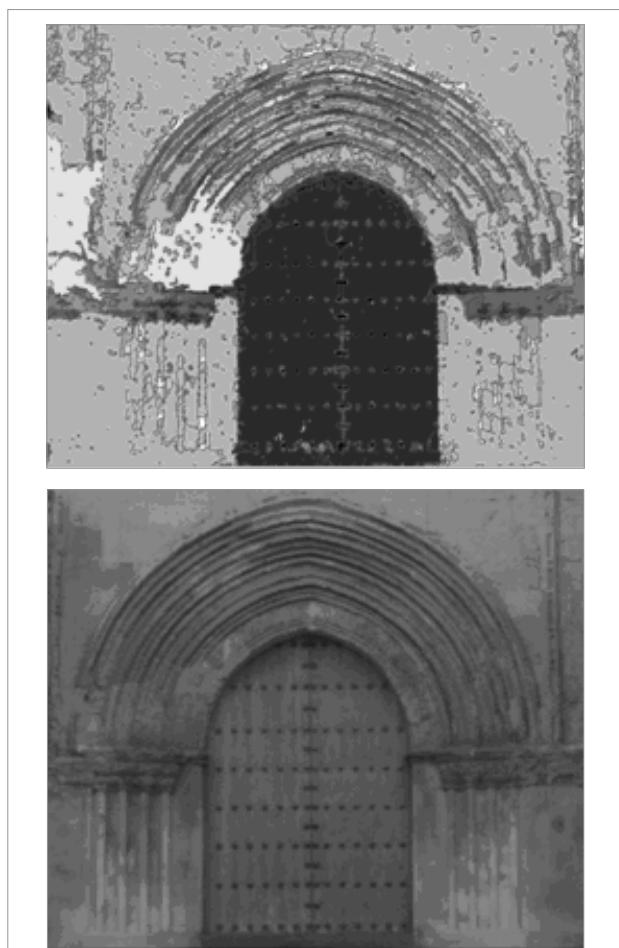
Figure 5: Comparison between the segmented composition (upper) and the original composition (lower) of the main door of the Santa Marina Church, Córdoba.

Image segmentation requires the performance of numerous tests to obtain a result that provides the best fit with reality. To obtain adequate results, various segmentation tests were carried out on each wall analysed using different configuration parameters until the appropriate segmentation was found. Figure 5 shows a good segmentation of the main door of the Santa Marina Church. The settings chosen for each wall are outlined in Table 1.

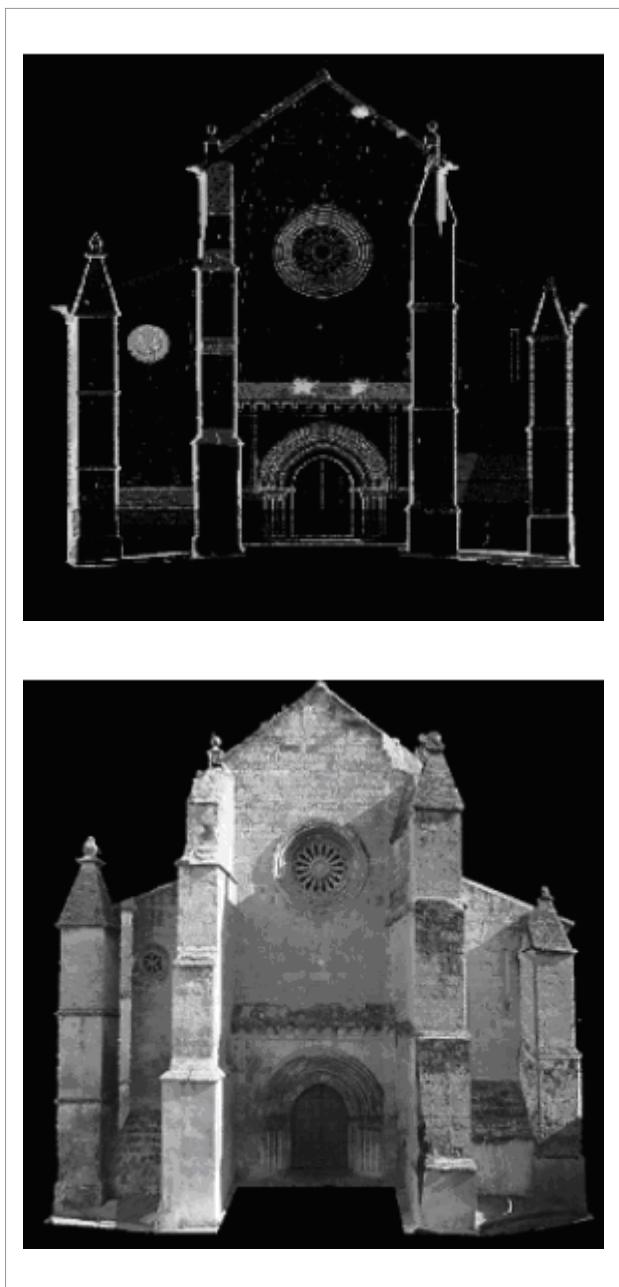
Figure 6 shows an orthophotograph of the façade based on a real colour photograph. This photograph was a high-resolution orthophotograph (3735 x 2610 pixels) in which measurements and annotations could be made, showing the three-dimensional structure of the morphological details found on the façade of the building.

Figure 6: Virtual model of the façade (upper) and orthophotograph of the façade (lower) of the Santa Marina Church.

Figure 5 shows a virtual model of the principal façade.

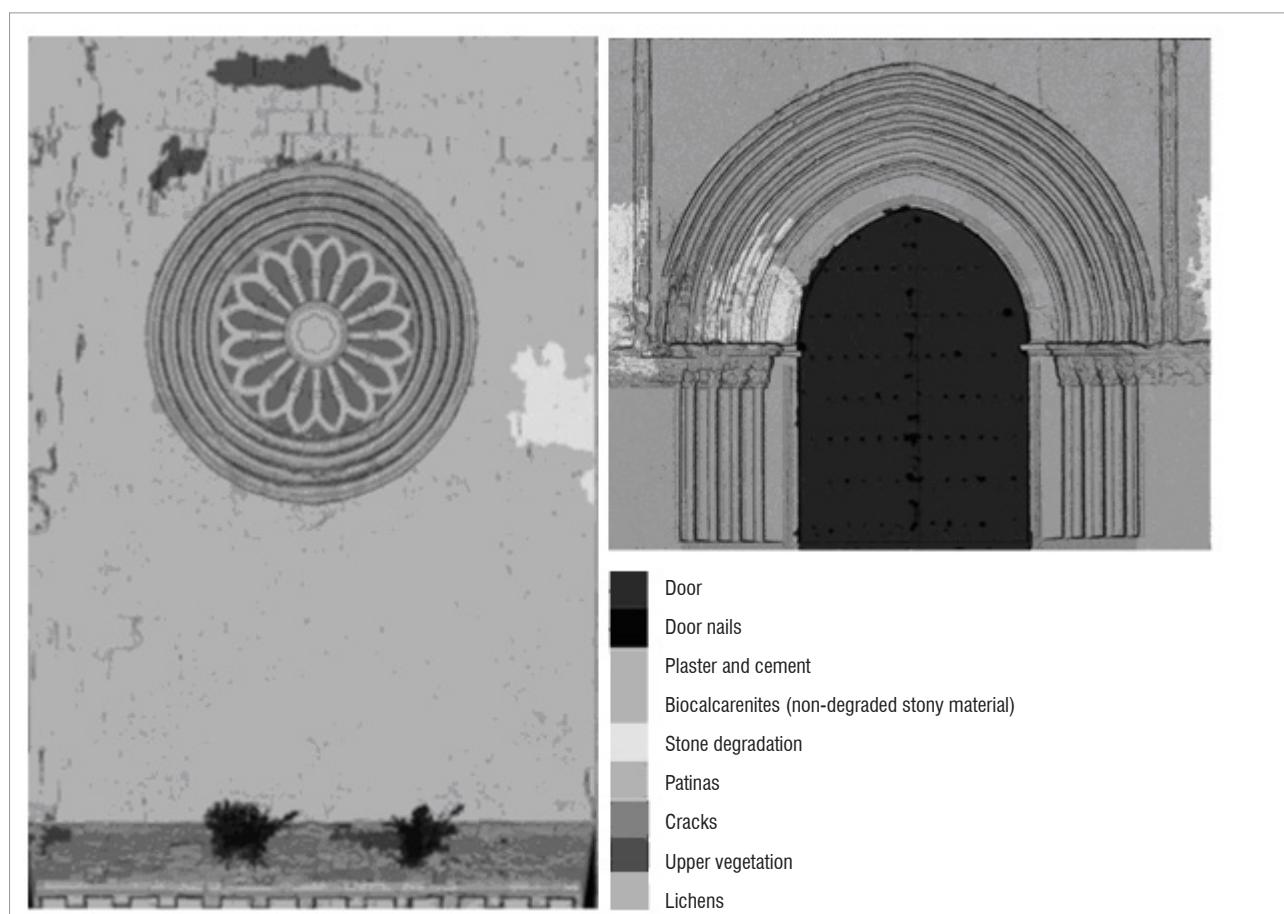
Finally, the corresponding orthophotographs were obtained based on the classified images and using the three-dimensional model of the façade obtained with the terrestrial LiDAR. These orthophotographs already had metric characteristics in which measurements could be taken, allowing the exact position of the detected pathologies to be determined and the exact surface area affected by these pathologies to be quantified (Figure 7).

**Figure 7:** Object-oriented classifications of the rosette (left) and of the main door (right) of the Santa Marina Church.
