# Building capacity of communities to monitor the effects of rehabilitation techniques in degraded catchments

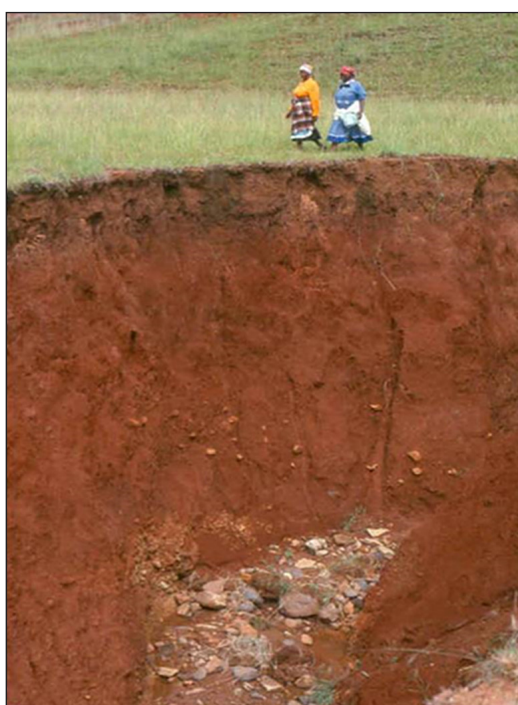
**Figure 1.** Gully in the Okhombe area, located in the Upper Thukela catchment area

Okhombe is located in the Upper Thukela catchment area in the province of KwaZulu-Natal, South Africa (28° 42' S; 29° 05' E) at an altitude ranging from 1 000 to 1 800 m amsl. Most of the Okhombe area is steep, with the flat land characterizing the upper plateau. A number of streams and the Okhombe River cut through the area and flow into the Thukela River. The area receives approximately 800 to 1 265 mm of rain per annum. Most of the precipitation falls in the months of October to March (Schulze, 1997), accounting for up to 82% of the total annual rainfall (Dollar and Goudie, 2000). Despite its high annual rainfall, Okhombe does occasionally suffer from drought periods. The area also experiences hail and thunderstorms. The high amount of precipitation during the summer period has led to significant soil nutrient leaching and severe erosion along the slopes (Fig. 1).

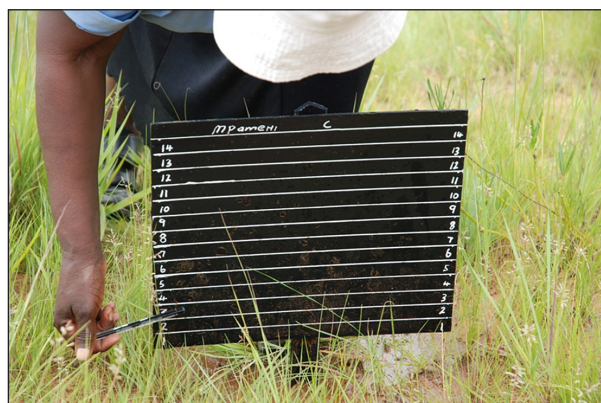
A splash board is a simple device to measure the extent of soil detachment as a result of rain splash (Ellison, 1944). It was constructed by attaching a central shaft to a rectangular board on which parallel horizontal lines were drawn equidistant apart, forming 14 x 1 cm wide bands. Each band within the board was numbered from 1 (closest to the ground) to 14. The splash board was placed within the area to be monitored in such a way that the bottom edge of the board was 5 cm above the soil surface (Fig. 2). Soil particles which become dislodged from the soil surface during a rainfall event are ejected upwards, some of which adhere to the surface of the board. By noting the height of staining on the board it was possible for the community to infer the extent of soil loss by rain splash.

**Figure 2.** Splash board showing the extent of soil detachment as a result of rain splash

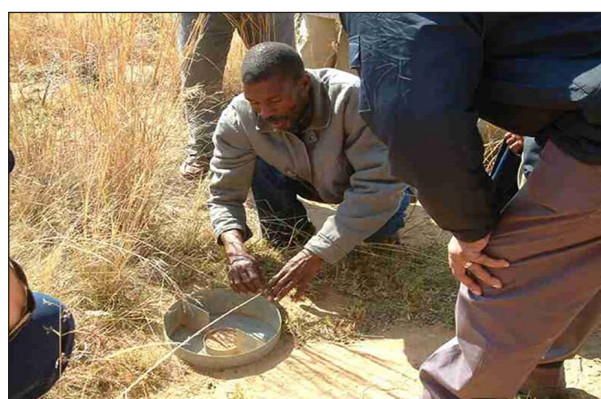
The Morgan splash cup (Fig. 3) was used to measure the quantity of soil particles detached from the soil surface by raindrop impact. It consisted of an inner hollow cylinder, 11 cm long and 10 cm in diameter, which was inserted into the ground until level with the soil surface. The inner cylinder was surrounded by a circular tray, 30 cm in diameter, with a 10 cm high outer wall. The tray was divided into an upslope and a downslope compartment. When positioned on a horizontal surface the apparatus caught all particles splashed from the soil in the inner cylinder while the outer wall prevented the splashing in of most of the soil particles detached by raindrop impact outside the collection tray (Morgan, 1981). Once all water had evaporated from the collection tray and the sediment was completely dry, the dislodged soil was collected separately from the upslope and downslope compartments, carefully transferred into a 15 mL measuring cylinder using a scoop and a small brush and the volume of the soil was measured. The combined upslope and downslope volumes represented a measure of splash detachment while the downslope volume minus the upslope volume was considered a measure of the net downslope splash transport (Morgan, 1981).

**Figure 3.** A Morgan splash cup used to quantitatively measure up- and downslope erosion

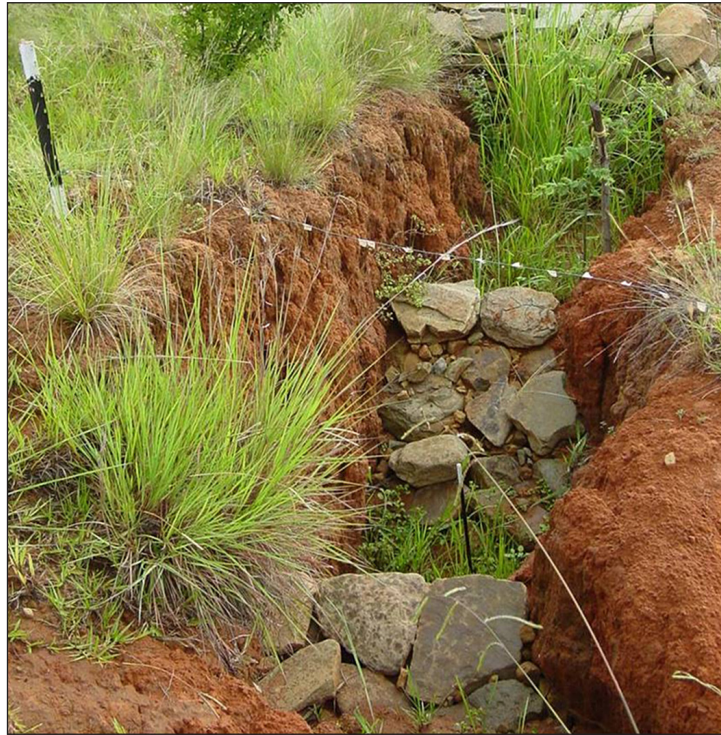
Gullies, locally termed dongas, are larger scale erosion features, which occur extensively within the region. Cost-effective simple techniques for monitoring gully development were needed. A common approach to assess gully development is to measure its cross profile. This approach was chosen and a fixed frame of reference was constructed perpendicularly to the long axis of the gully. At either side of the gully metal fence stakes were driven into the soil and a stiff strand of wire with markings spaced equidistantly apart was attached to the stakes to demarcate the edge of the gully (Fig. 4). Beginning from the left-hand side and always facing upslope, the perpendicular distance from the wire to the gully floor was measured at each marking. The results were then plotted either electronically or manually on graph paper to derive the gully cross-profile. Measurements taken prior to rehabilitation provided the reference profile. The procedure was repeated at approximately 6-monthly intervals to determine changes in gully morphology and assess the effectiveness of gully stabilisation efforts carried out by the community.

**Figure 4.** Gully profile measurement

The donga profile measuring technique required significant modification as initially there was too much flexibility in the donga cross-wire which served as a reference from which the depth to the gully floor was measured. In spite of those problems,

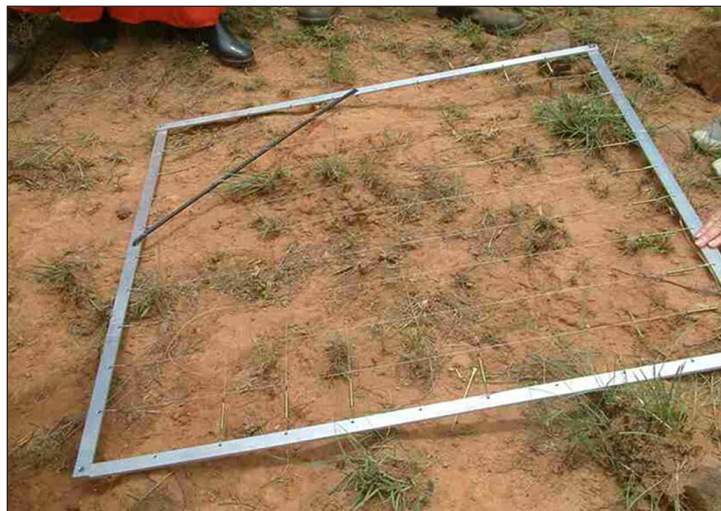
Plant basal cover was determined using a 1 m<sup>2</sup> quadrat which was subdivided into 100 squares (Fig. 5). The quadrat was placed in exactly the same position on each occasion when basal cover was recorded so that changes could be monitored over time. Presence and absence of plant cover were recorded in each square and how much soil was covered by vegetation was then expressed as a percentage of the total quadrat. Initially, squares with rooted cover were marked with the initials of the species encountered (e.g. k for kikuyu) while bare soil squares were marked with a 0. However, since the grassland was heavily grazed and had no inflorescences, identification of species proved to be too difficult for the community members. Consequently, the technique was simplified so that any square in which rooted vegetation was

**Figure 5.** Plant basal cover is assessed using a one square metre quadrat subdivided into 100 squares

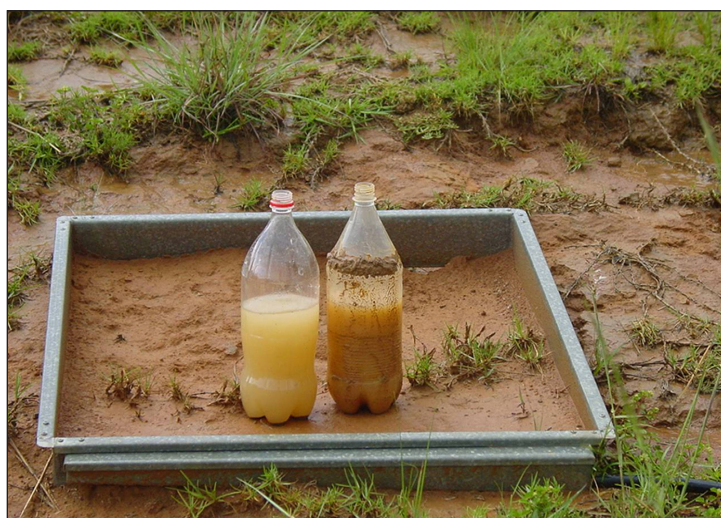
Runoff plots (Fig. 6) were installed to determine runoff water quantity and quality on slopes. They consisted of metal frames measuring 1 m x 1 m. Each frame, 10 cm in height, was inserted into the soil to a depth of 5 cm and connected via a plastic pipe to a 2-L Coke bottle. All runoff water from the plot was collected in the bottle. Once the soil particles contained in the collected runoff water had settled, the depth of the sediment in the Coke bottle was measured with a ruler and served as an indicator of water quality. The volume of the collected water was determined using a measuring cylinder.

**Figure 6.** Runoff water quantity and quality on slopes are assessed using runoff plots

The use of runoff plots proved to be a very effective technique for monitoring the effect of rehabilitation on runoff water quantity and quality. The water collected from the rehabilitated sites was visibly clearer and lower in quantity than that from the eroded sites. Data from the runoff plots at Mahlabathini Makhowane (Fig. 10) demonstrate that total runoff collected over the period from 30 June 2004 to 31 January 2005 from the eroded site (5 137 mm) was 20% higher than that collected from the rehabilitated site (4 132 mm). Although attempts had been made to quantify the amount of silt collected in the bottle using a dip stick, these were often unsuccessful due to the long time it took for the sediment to settle.
