Anisotropic rock mass behaviour in high-displacement ground at CSA mine

G.B. Sharrock[1] and B. Chapula[2]

Synopsis

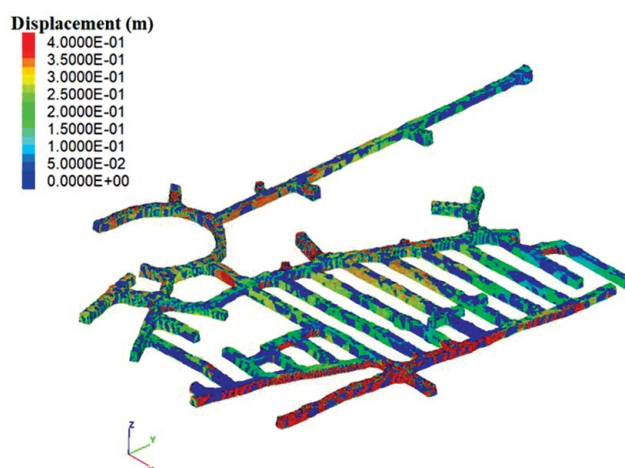
Extensive observational data for damage was collected at 45 sites across the eight levels (8790 to 8580 mRL) to help to understand the key drivers for damage. The first type of data is damage mapping as categorized in Table II, in conjunction with a damage mapping history for each site. The second is lidar laser scanner data, which was used to quantify tunnel convergence at selected tunnels on the lower levels of the mine (see Figure 4).

Figure 4—Total displacement: 8610 mRL (March 2017

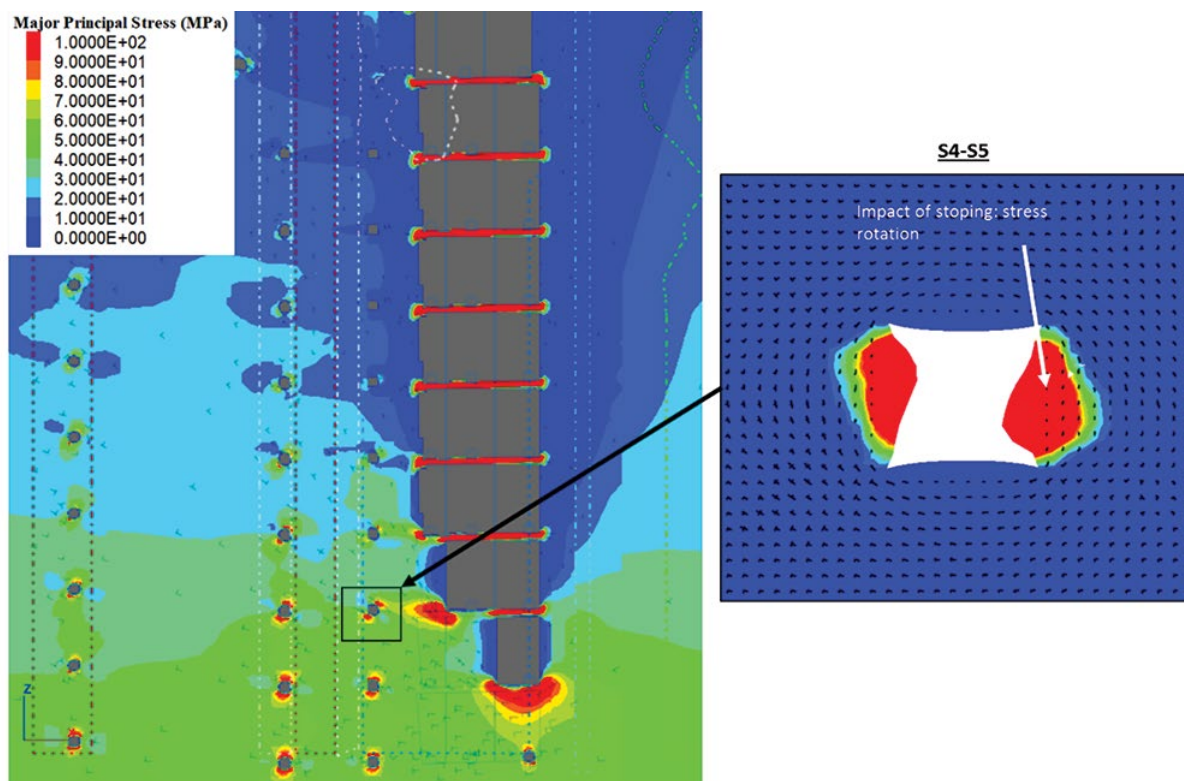
Perimeter tunnels aligned with foliation in moderate stress locations experience buckling on foliation. This is a consideration for access drives in moderate to poor quality rock masses or shear zones (*e.g.*, the TSR domain, Figure 2). In these domains significant deformations occur due to stress changes (stress rotation and changes in shear stress) induced by the stope mining front (see Figure 7a). The typical stress path for a perimeter tunnel starts with high concentrations of stress in the excavation back (and to a lesser extent the sidewalls) that occurs when the isolated excavation is first formed. As the mining abutment approaches, shear stress around the excavation rotates and increases, inducing shear and tensile failure in bedding in the excavation sidewalls and corners (see Figure 7a). Stress rotation (Figure 7a) in particular is thought play a key role in

Figure 7—(a) Major principal stress (looking north), (b) plastic strain

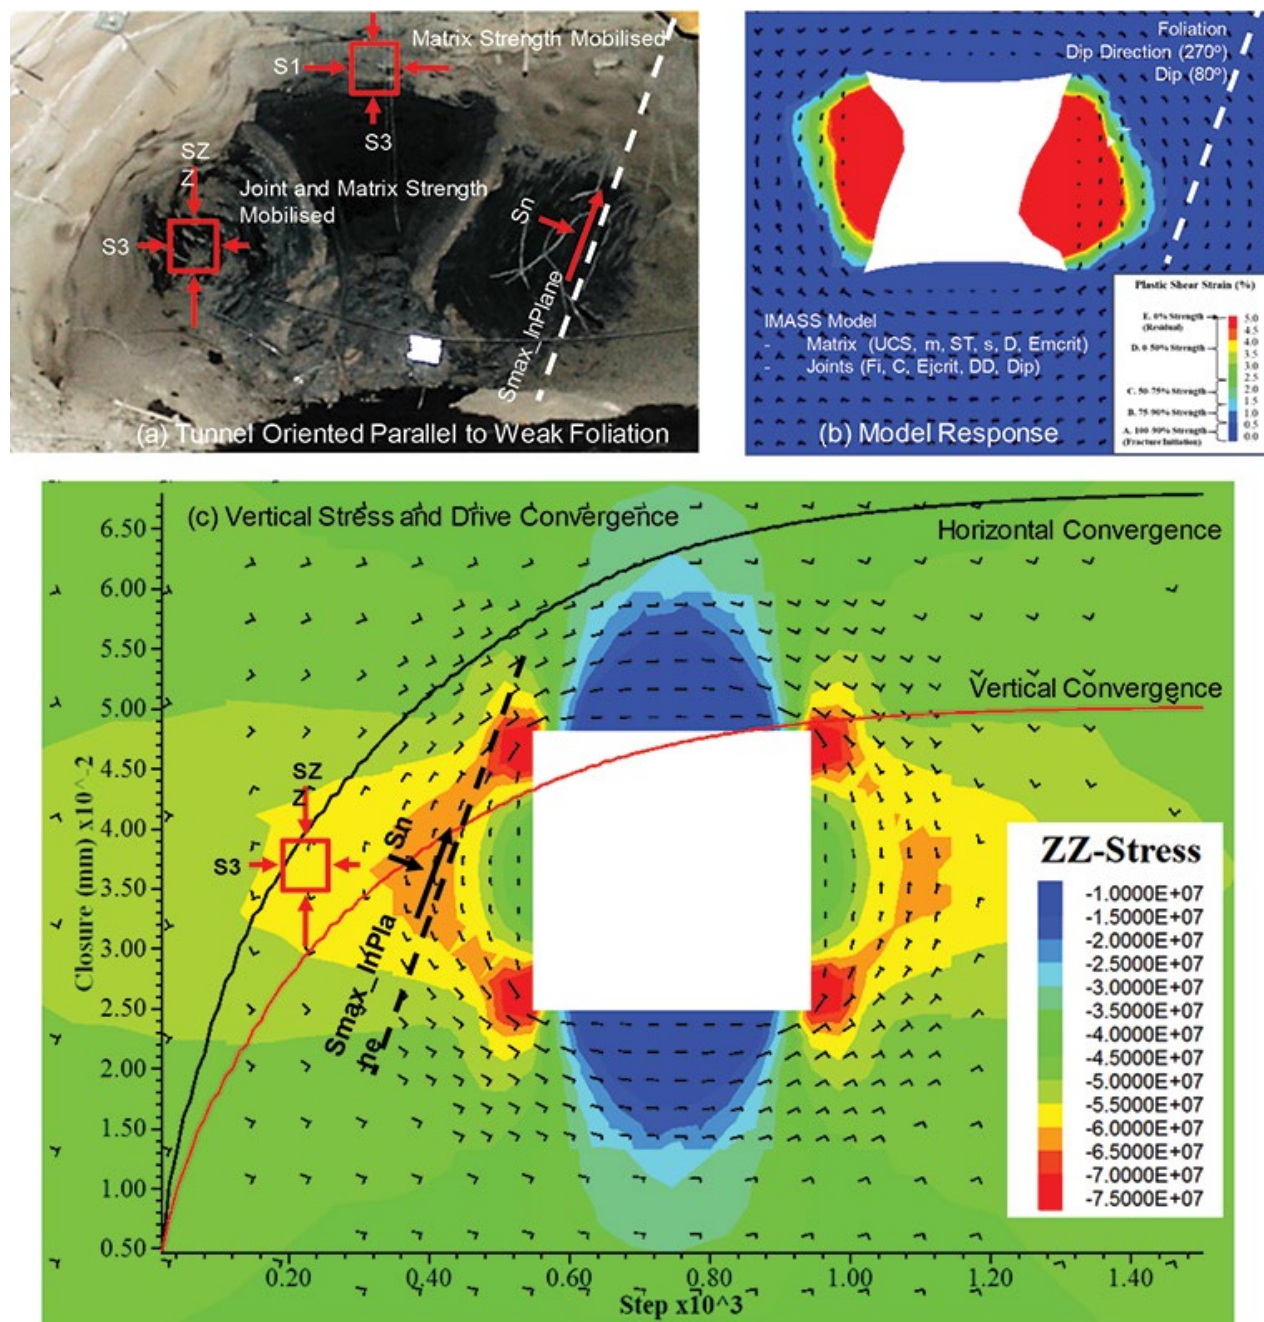
Figure 9 – IMASS model incorporating matrix and joint strength to capture excavation damage

The authors assessed the mechanical response of the tunnel to foliation, using the Itasca Model for Advanced Strain Softening (IMASS) constitutive model available in FLAC3D, which was developed by Itasca to simulate rock mass softening, and strength anisotropy due to embedded planes of weakness within a continuum model (Ghazvinian et al.). Within the IMASS model, zone-based matrix and joint properties are specified. Each of these property sets (matrix and ubiquitous joints) can fail in tension and shear independently of one another. It is noted that the ubiquitous joints provide a weakness orientation in each model zone. These joints however are not an explicit representation of individual discontinuities, such as those included in 3DEC. The shear and tensile strength of the ubiquitous joints can be specified, but stiffness properties are not assigned. For the CSA analyses, parameters in this constitutive model were calibrated to damage observations. The application of IMASS allows the effect of tunnel trend and foliation direction on damage to be captured. At CSA, the matrix strength is most relevant to drive backs (especially on the mining abutment) or the side walls of tunnels driven perpendicular to foliation or where foliation is clamped. By contrast, the joint strength is most relevant to tunnels driven parallel to foliation. Both the matrix and joint strength was calibrated for each geotechnical domain or RQD domain.

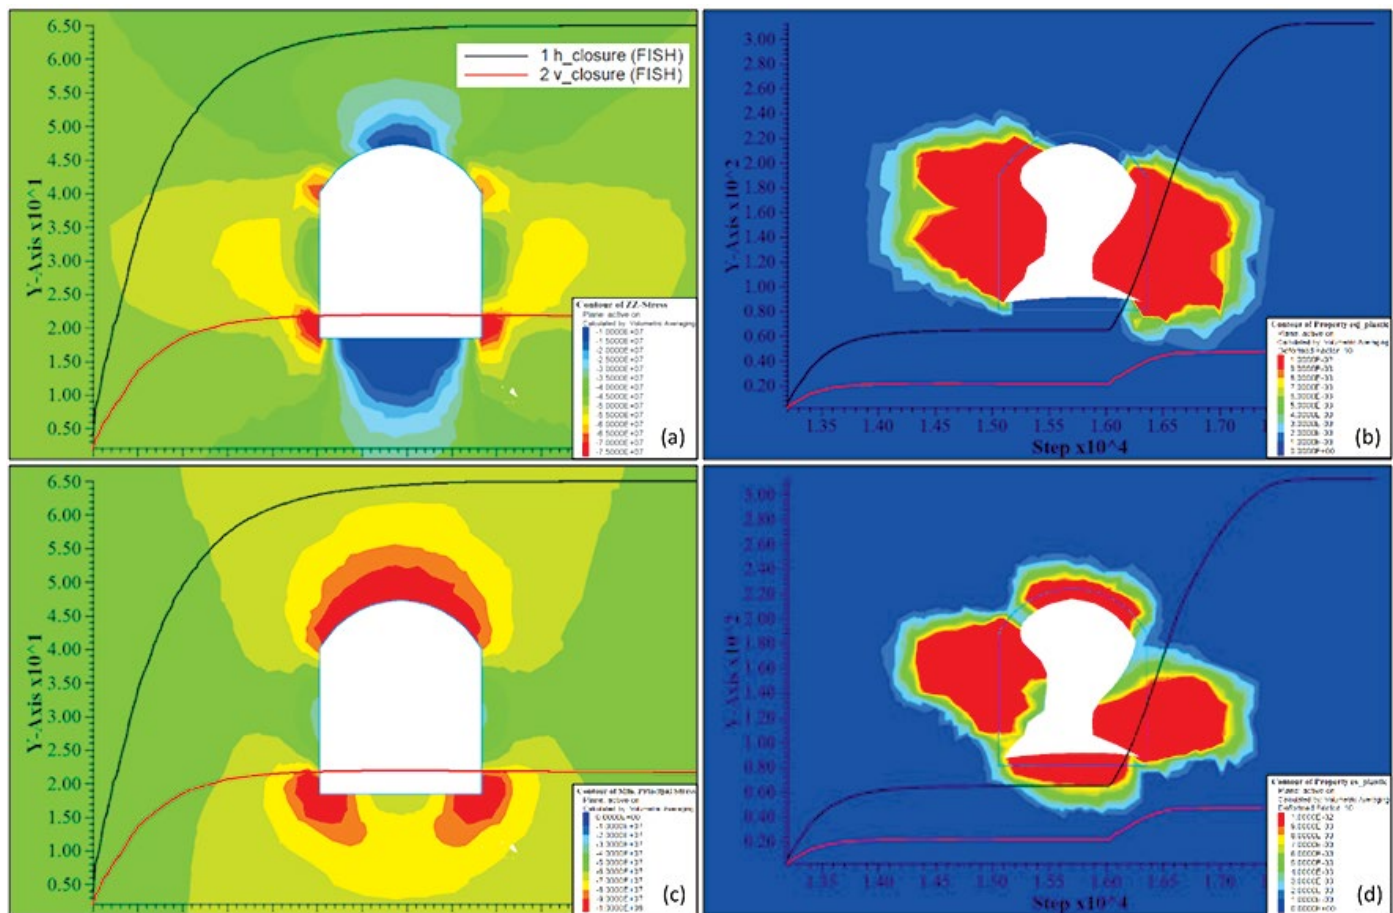
Figure 10—Footwall drive in very poor-quality rock mass at 1700 m (drive trending north)

It is noteworthy that the elastic vertical stress in the excavation sidewalls (see Figure 10a) is approximately 60 MPa and the major principal stress in the excavation backs is around 100 MPa (see Figure 10c). In contrast, plastic strain (matrix damage) in the excavation backs is not significant (Figure 10b) and joint plus matrix damage (Figure 10d) in the excavation sidewalls leads to sidewall failure and bulking.

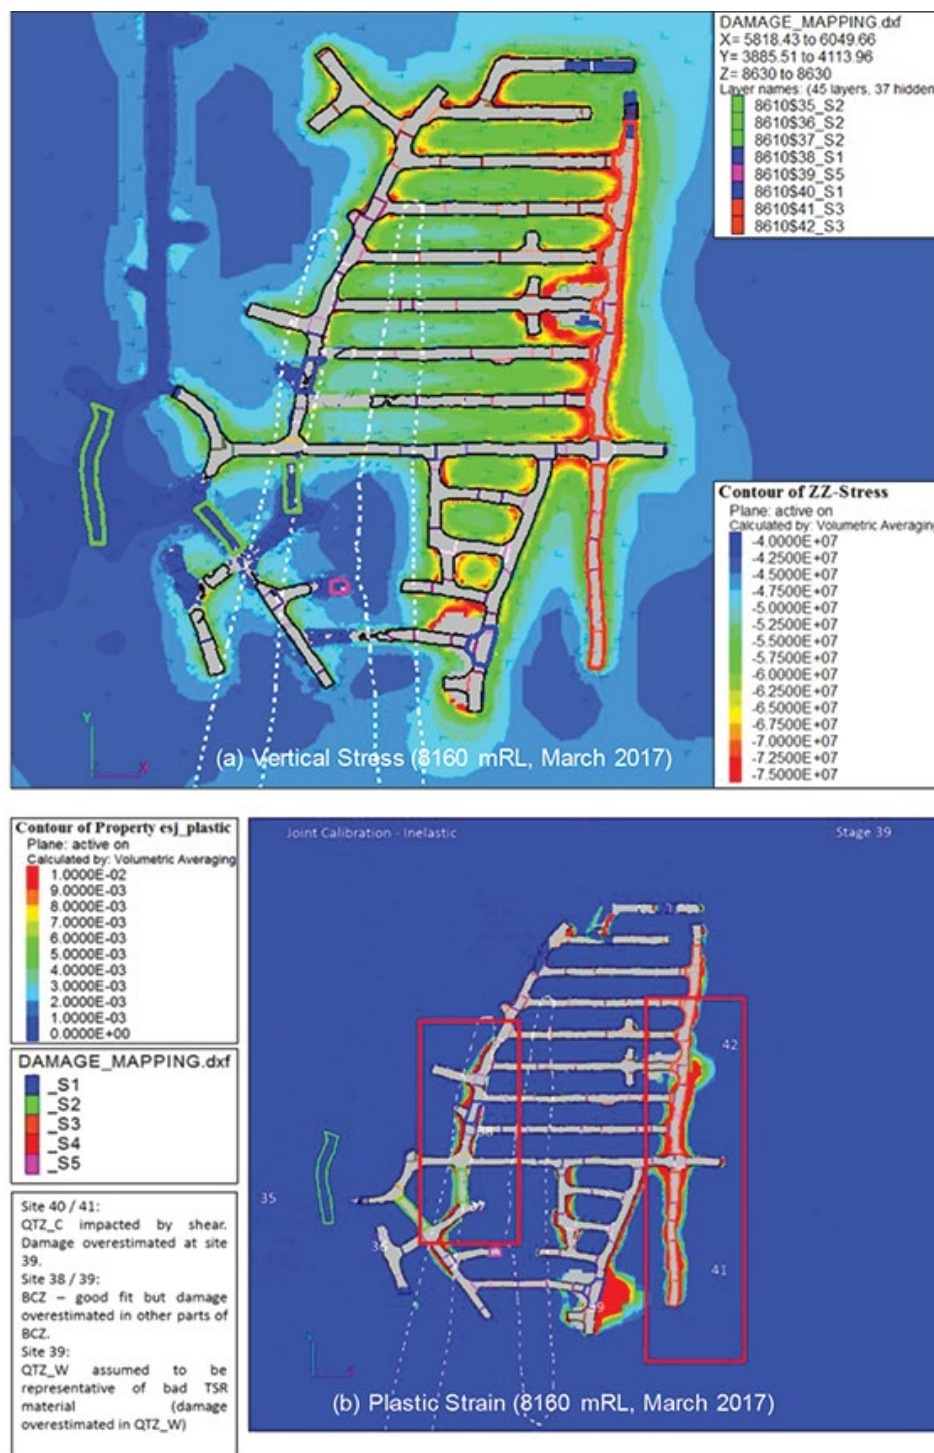
In contrast with perimeter drives, damage in strike drives in the ore zone is more strongly influenced by the mining stress abutment and shear zones (see Figures 11a and 11b). For example, scanline mapping on the 8540 level, which is not in a shear zone, indicates Q' = 13–200. It is noteworthy that on the abutment, high stress states exist not only in the backs of tunnels, but also in the sidewalls, leading to two modes of damage. The first is buckling of excavation sidewalls (and pillar noses) due to overstressing of the foliation. As with the perimeter strike drives, the intensity of buckling damage was found to vary with rock mass quality and vertical stress, rather than with major principal stress. A good example of this mode of deformation is shown in Figure 6, where significant deformation along the ore drive in 8670 level (1530 mbs) is observed. This drive squeezed

Figure 11—8160 mRL, March 2017. (a) Vertical stress, (b) joint shear strain

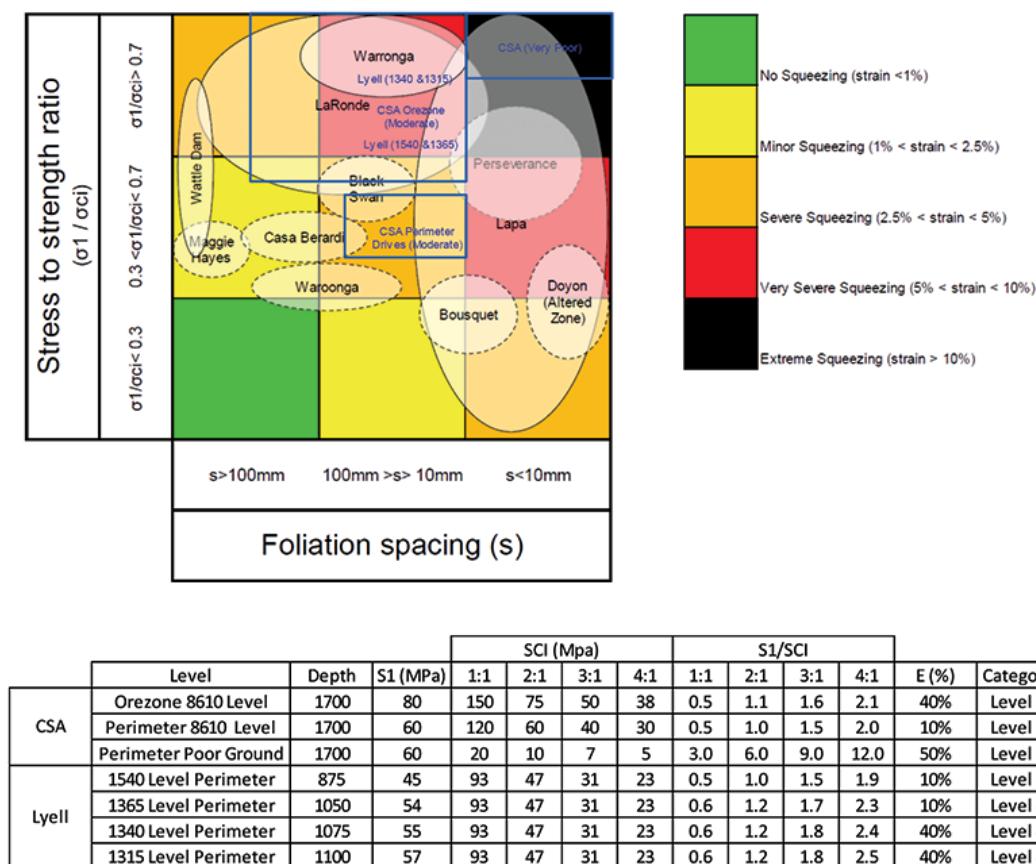
Seven case studies from CSA and Mount Lyell (after Sharrock and Cuello, 2016) have been added to the chart (see Figure 12). In general, the magnitude of damage estimated from the chart is in broad agreement with underground observations. However, a key observation at CSA is the importance and impact of joint alteration, which is not accounted for in the chart. Future work at CSA will seek to better understand the effects of alteration.

Figure 12—Hard rock squeezing index, after Hadjigeorgiou and Karampinos (2017) updated with CSA and Mount Lyell data (8160 mRL, March 2017)
