Impact of deep-hole opencast blasting on the stability of water dams of a close-by underground coal mine

by C. Sawmliana*, R.K. Singh*, P. Pal Roy*, and P. Basu*

Synopsis

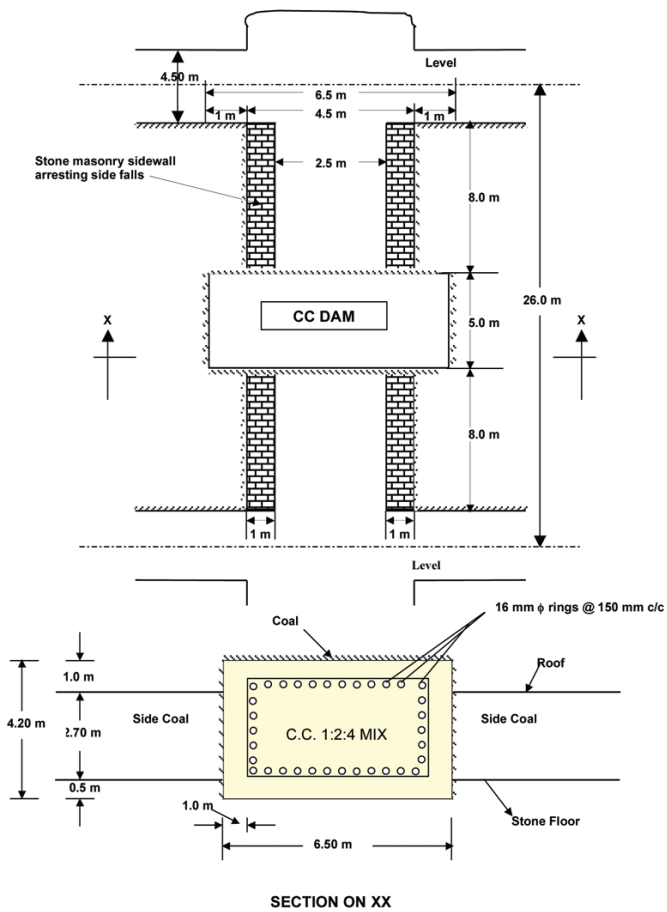
Figure 2—Construction details of water dams

There were 15 dams in No. 3 seam and 16 dams in No. 4 seam of GDK-6B underground mine. During initial inspection of those dams, the presence of water inside the dams as well as the condition of the outer surface of the dams were assessed. Cracks on the outer portion of the walls/plasters were also observed. The constructional details of the water dams are shown in Figure 2. The details of the exposed dimensions of the dams are given in Tables I and II.

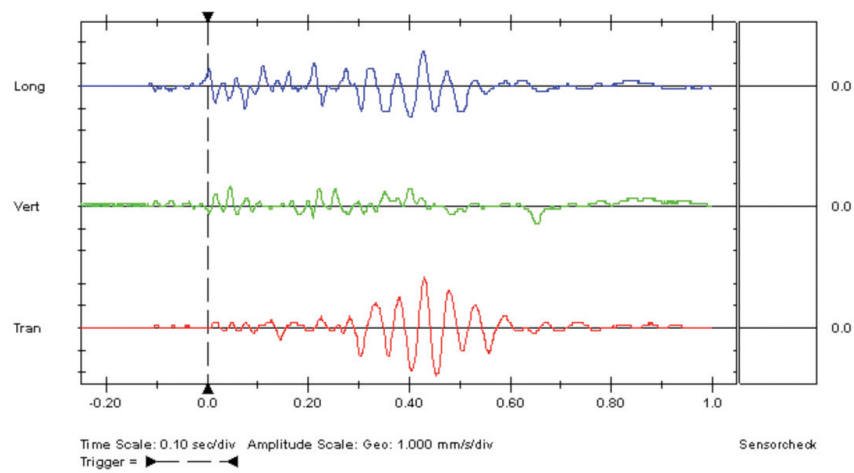
Blast-induced ground vibrations were recorded in terms of peak particle velocity (PPV) in mm/s. Depending upon the distance of monitoring points near the particular water dam in the underground mine from the blasting face in the Opencast mine and the amount of explosives detonated in the blasting round, the vibration data varied from 0.50 mm/s to 5.9 mm/s. The maximum magnitude of vibration recorded during shovel bench blasting was 2.70 mm/s in the roof near dam no. 6A, Seam 3 with a dominant peak frequency of

21 Hz. The corresponding vibration in the pillar was 2.10 mm/s with associated frequency of 20 Hz. The blast wave signatures (at 2 048 samples per second) recorded in roof and pillar are shown in Figures 4 and 5. The blast was performed at 727 m away from the above mentioned dam. The total amount of explosives detonated in the blasting round was 9 020 kg whereas the maximum explosive charge detonated in a delay was 675 kg. No detachment of any loosened chip was observed at this level of vibration.

Figure 4—Blast wave signature recorded in roof near dam 6A

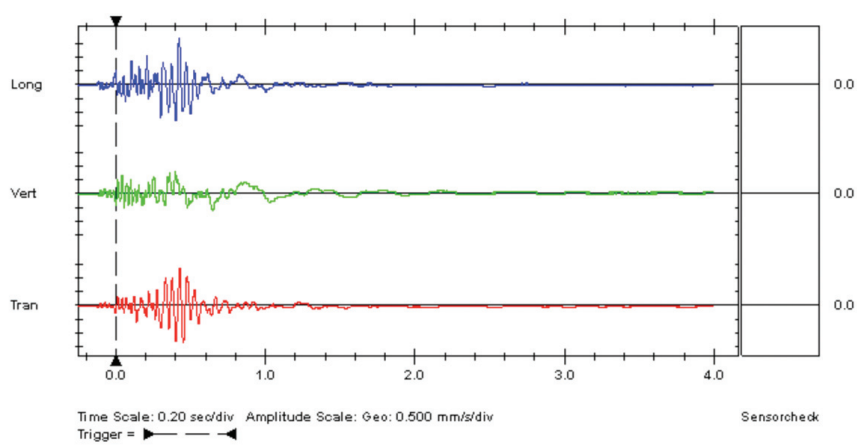
Figure 5—Blast wave signature recorded in pillar near dam 6A

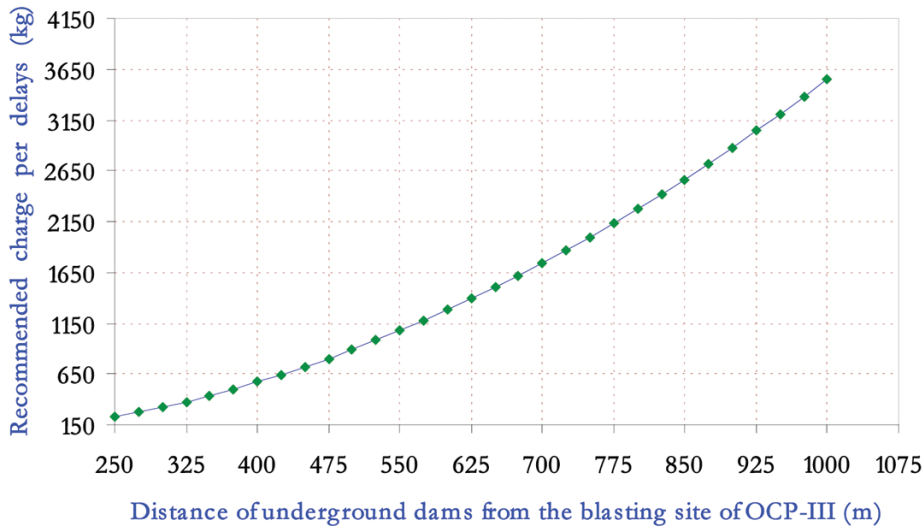
Figure 7—Recommended charge per delay to be fired in a round of blasting at OCP-III to contain vibration within safe limits for the safety of water dams

The maximum amount of explosive weight to be detonated in a delay for opencast blasting at OCP-III considering the safety of underground water dams has been calculated based on the regression Equation [8]. The recommended charges per delay to contain ground vibration within the safe and permissible limit (25 mm/s) are given in Figure 7.
