Determination of the degree of thermal exposure to the lower head of the Three-Mile Island Unit 2 nuclear reactor using metallography

Synopsis

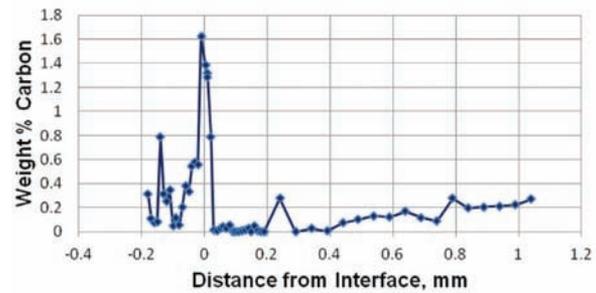
Midland As-Fabricated

Figure 10—Quantitative carbon analysis, using standards with the Cameca EMPA, of one of the Midland as-fabricated specimens. Note that the carbon content on the cladding side of the interface is about 1.6 wt%, while it is zero from a depth close to the interface on the base metal side to about 0.4 mm

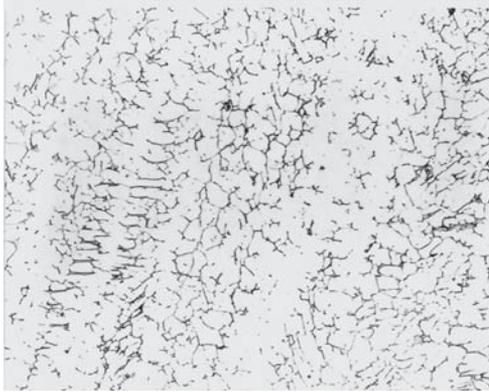
Figure 15 shows the microstructure of the delta ferrite in the as-fabricated Midland specimen. The 308L weld metal composition is balanced to yield about 12.5% delta ferrite, which eliminates hot cracking during solidification. It has a fine interconnected, 'lacey' morphology. Figure 16 shows an example of the complex carbide clusters, quite common in F-10, in the cladding at the interface. Note also the crack that has formed. Figure 17 shows an example of delta ferrite heated high enough to dissolve the $M_{23}C_6$ carbide that was in the delta ferrite at its interface with the austenitic matrix.

Figure 15—Example of the delta ferrite in the cladding of the Midland-2 specimen (modified Murakami's reagent, 200X)

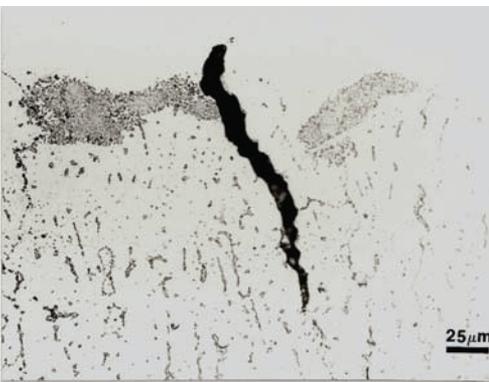
Figure 16—Example of carbide clusters in the cladding at the interface with the base metal, plus a crack in the cladding at the interface. The specimen was electrolytically etched at 6 V dc using concentrated NH_4OH to darken the carbides (400X)
