# Investigation of the mechanism for fire-side corrosion in coal-fired boilers in South Africa

Furnace wall tubes from 600 MW subcritical boilers at three coal-fired power stations were sampled and the fireside deposits examined to determine the mechanism of fireside corrosion. This involved an in-depth investigation into the morphology and composition of the fireside deposits and the conditions of the furnace that enable this type of attack. SEM-EDS analysis revealed high concentrations of oxygen, iron, and sulphur, QEMSCAN and XRD analyses identified the presence of  $\text{Fe}_3\text{O}_4$ ,  $\text{Fe}_2\text{O}_3$ ,  $\text{FeS}$ , and  $\text{FeS}_2$ . Differential thermal analysis showed thermal activities at temperatures of 500–600°C, 900–1100°C, and 1100–1250°C, which are associated, respectively, with  $\text{FeS}_2$  oxidation to  $\text{FeS}$  and  $\text{Fe}_2\text{O}_3$ , at 475–525°C, formation of aluminosilicates at 925–1100°C, and melting of  $\text{FeS}$  around 1190°C. The absence of sodium and potassium eliminates the contribution of molten alkali sulphates to the corrosion. The consistent coexistence of iron sulphide and iron oxide is indicative of the substoi

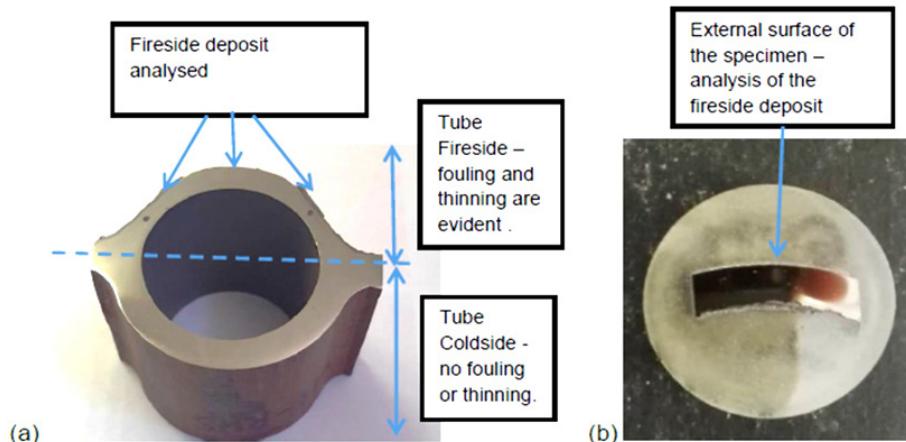
Cross-sections of the tubes with attached fireside deposit were prepared for SEM-EDS and QEMSCAN evaluations as shown in Figure 1. Two tube ring cross-sections were removed from each

Figure 1—Cross-section of the tube prepared for microstructural examination and SEM analysis (a) at 10 o'clock, 12 o'clock, and 2 o'clock positions, and (b) mounted QEMSCAN specimen

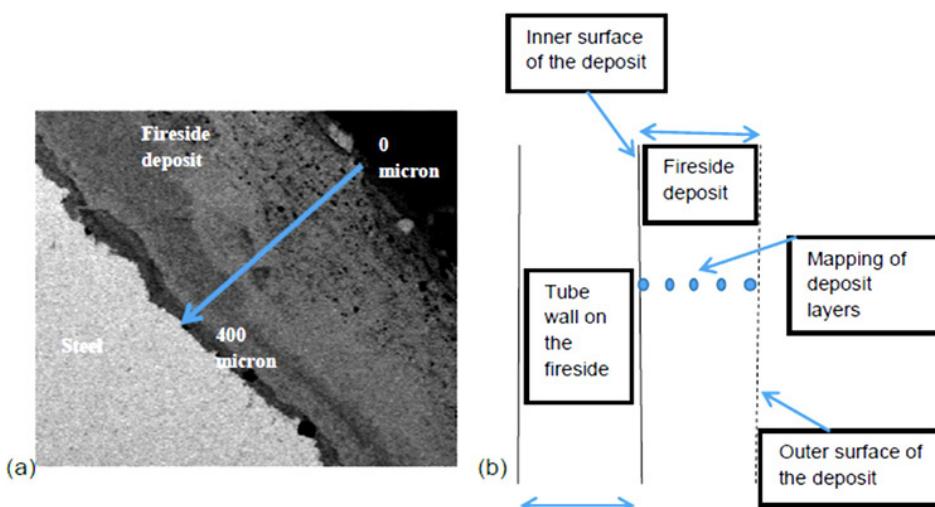
Figure 2—(a) SEM fireside deposit mapping from outer to inner layer, (b) layout of EM and QEMSCAN deposit analysis on the fireside of the steel surface

tube with the deposit still intact. Figure 2 illustrates the way the fireside deposit was analysed and characterized. The cutting was done under dry conditions to avoid contamination from fluids.

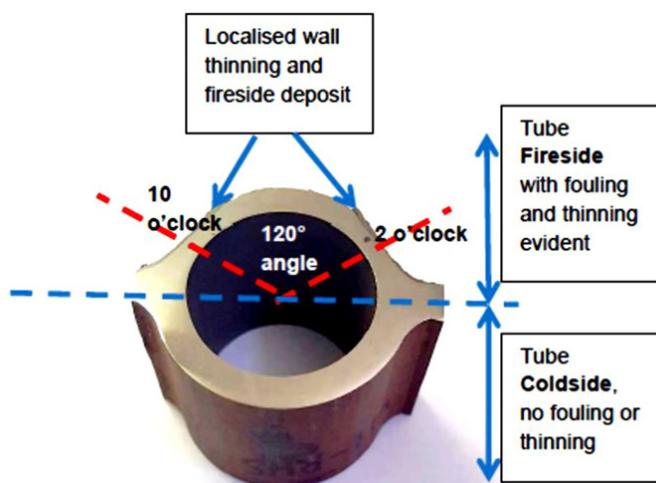
Figure 4—Samples prepared for SEM analysis with fireside deposit located at the 10 o'clock and 2 o'clock positions of the fireside of the tube

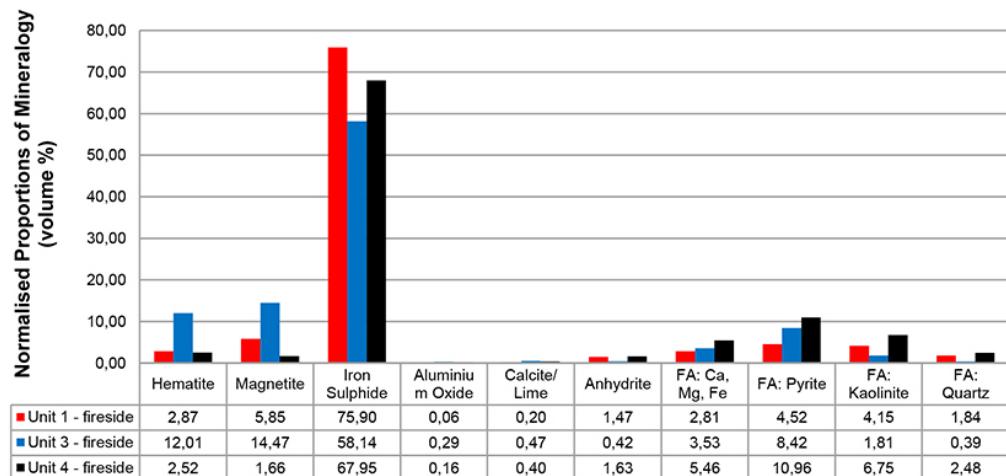
( $\text{FeS}_2$ ). These results correlate with the high iron and sulphur concentrations in the middle and innermost layers detected by SEM-EDS. Figure 18 and 19 give the mineralogical composition of the fireside deposits from stations A and C respectively. The fireside deposit thickness was measured at a maximum of 1.2 mm for Station A and 0.53 mm for Station C.

Figure 18—Quantitative mineralogy estimates of the fireside deposits for Station A

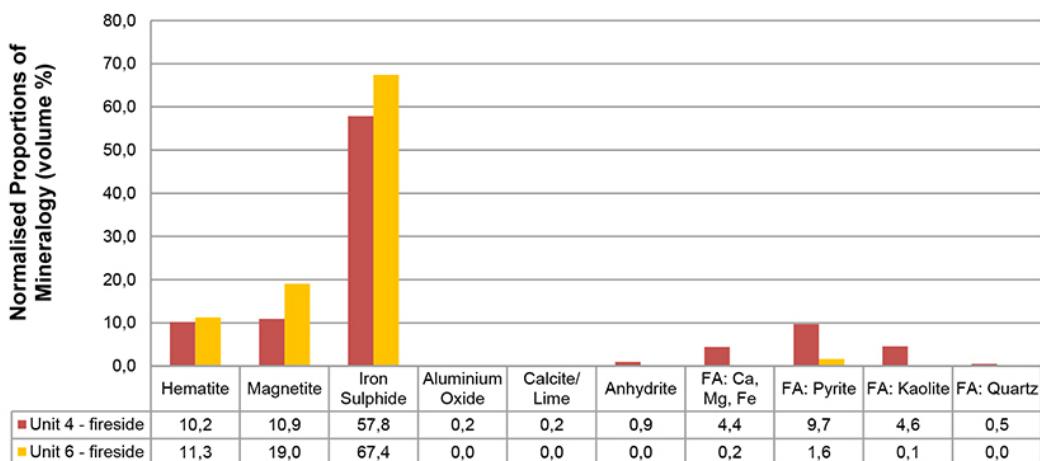
Figure 19—Quantitative mineralogy estimates of the fireside deposits for Station C

**Station C:** The fireside deposit on the tubes from both units of Station C showed high levels of pyrrhotite. Differences were seen in the concentrations of magnetite; the fireside deposit from unit 6 had higher concentrations than unit 4. The difference in the morphology of unit 4 and unit 6 fireside deposits may be indicative of the different furnace environments. The high concentration of pyrrhotite and iron oxide phases in unit 6 samples suggests the existence of alternating oxidizing and reducing conditions, whereas in unit 4 it appears that conditions were reducing for a longer time, which resulted in the formation of pyrrhotite and minimal iron oxide phases.
