# Void filling and water sealing in a decline in the Kalahari Manganese Field

by I. Serepa<sup>1</sup> and N.C. Steenkamp<sup>1</sup>

## Synopsis

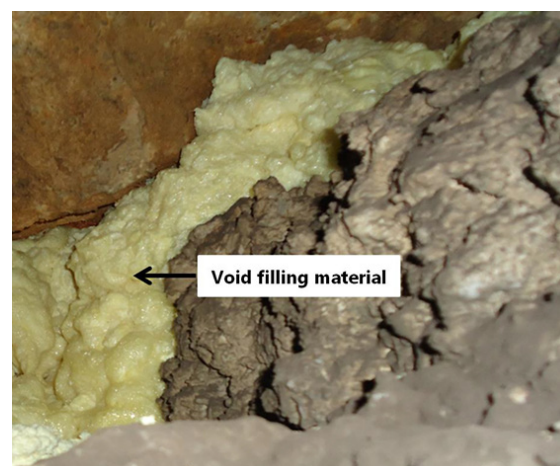
Figure 8—Void-filling material

filling and a water-sealing product. The exact composition of the polymers cannot be disclosed due to confidentiality agreements. The void-filling material that was recommended is pumped as two polymer fluids that are mixed in the nozzle prior to injection. The mixture of the two components is exothermic and produces 'foam' that rapidly expands to fill the void and then harden (see Figure 8). The setting time is estimated to be one minute. Considering that the void-filling material would flow down-dip, the filling of voids commenced from the bottom of the decline and progressed up-dip. One row of holes was filled at a time, starting with the holes on the sidewalls and followed by the hole in the hangingwall.

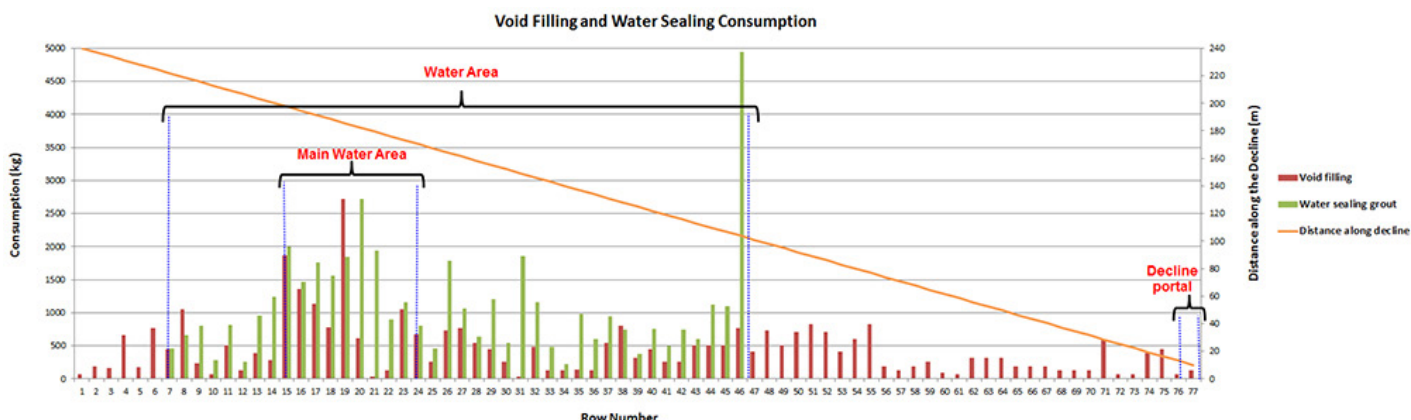
Figure 11 shows the consumption of void fill and water-sealing grout. The consumption of void fill was generally low around the portal and increased towards the groundwater ingress areas. This would suggest that the void fill material is affected by the presence of flowing groundwater. The challenge therefore was to apply correct batching of the void fill material. The mixture needed to remain fluid enough to migrate throughout the required volume

Figure 11—Sectional consumption of void fill and water-sealing grout
