The ongoing evolution of stope panel support at Impala Platinum Limited

by N.D. Fernandes* and L.J. Gardner*

Synopsis

Stope panel support, narrow reef stoping, improving workplace safety.

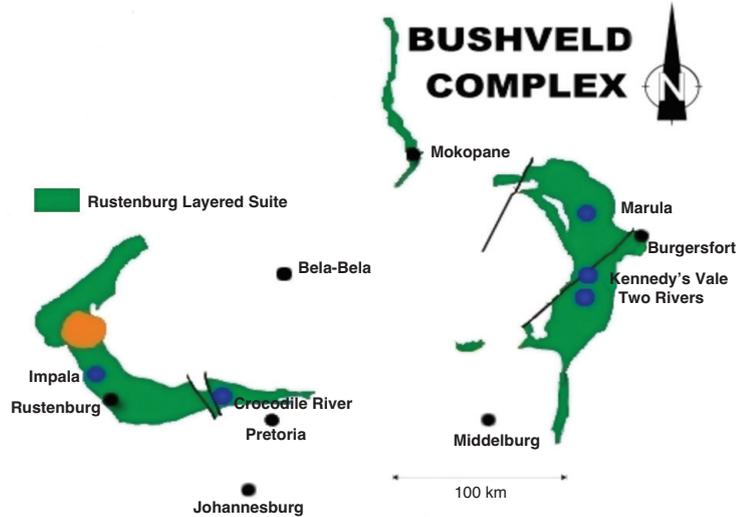
Figure 1—Geological map of the Bushveld complex

Impala Platinum Limited is the world's second largest Platinum Group Metal (PGM) producer. The company's main mining lease area (Rustenburg operations) is situated some 30 km north of Rustenburg in the North West Province, along the western lobe of the Bushveld Complex (see Figure 1). The lease area measures some 12 000 hectares.

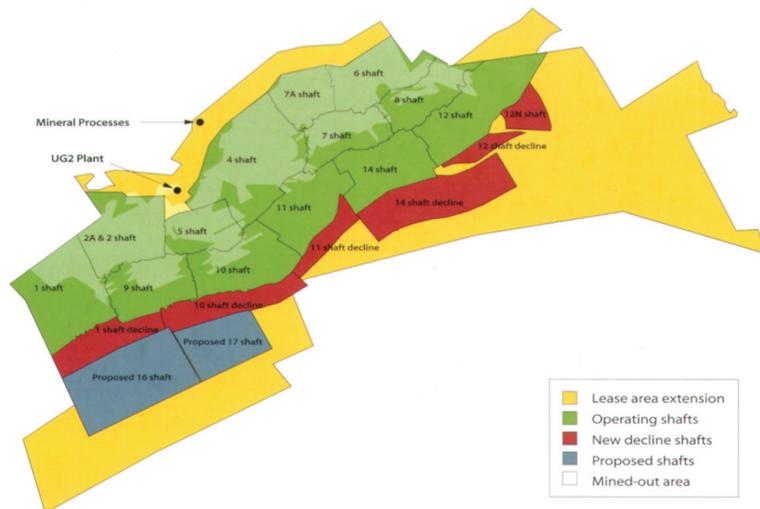
Figure 2—Shafts and workings on the Rustenburg lease area

The geological sequence in the lease area dips at approximately 9 degrees to the north-east. Two PGM-rich horizons are exploited; the Merensky economic horizon and UG2 chromitite seam. These two horizons are separated by an 80 to 100 metre middling. Aside from opencast operations, thirteen shaft systems are currently used for access and mining purposes, at depth of 30 to 1 200 metres below surface (see Figure 2).

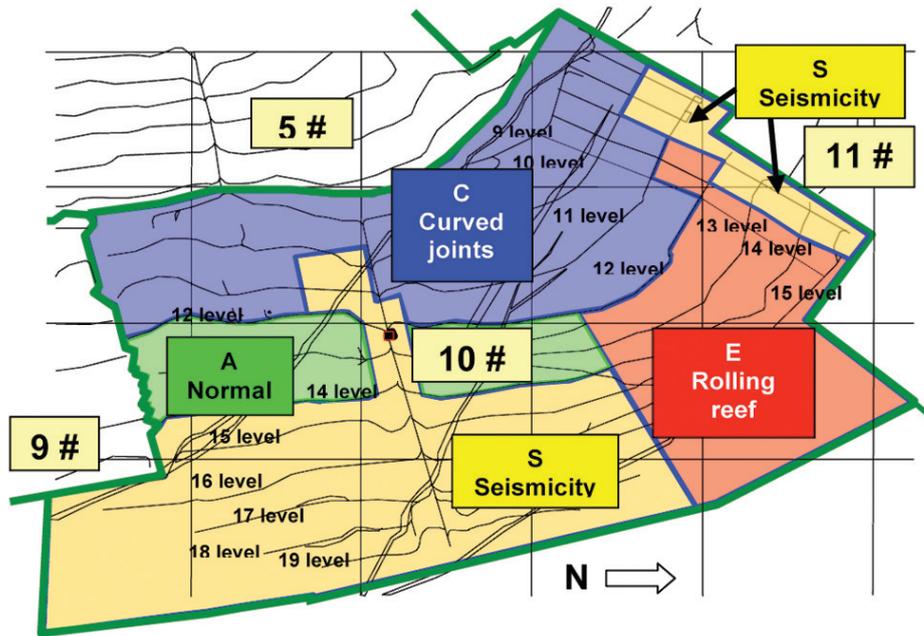
Figure 3—Ground control districts for a particular shaft

A copy of the ground control plan for the Merensky reef workings on a particular shaft (not to scale) is shown in Figure 3. Following the development of the ground control plan, support strategies were prescribed for each identified GCD and the mine's support standards were revised. This process resulted in a drastic drop in the number of stope panel support standards—the original 32 different standards were reduced to 6 new standards. Due to complex geology in the Bushveldt there are exceptions when conditions are addressed differently.

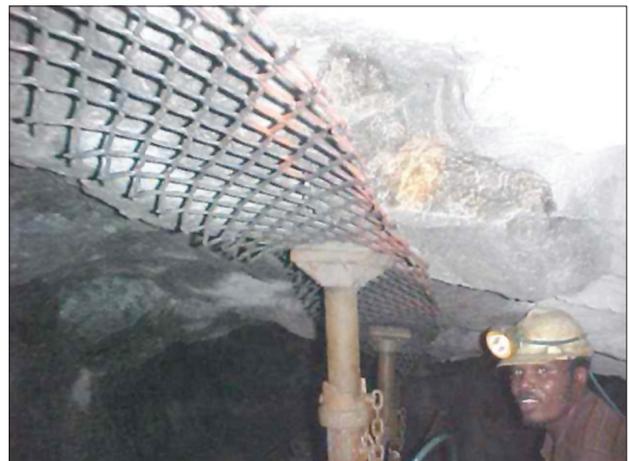
Figure 4—Rock stop strap installation

Experimentation resulted in the adoption of a 15 m long x 30 cm wide 'rock stop strap' for use in conjunction with the temporary jacks. The extruded plastic strapping could allegedly hold up to 750 kg, rolled up quickly for easy storage and was expected to last approximately 3 months in a working stope. Photographs of the 'rock stop strap' are shown below in Figures 4 and 5.

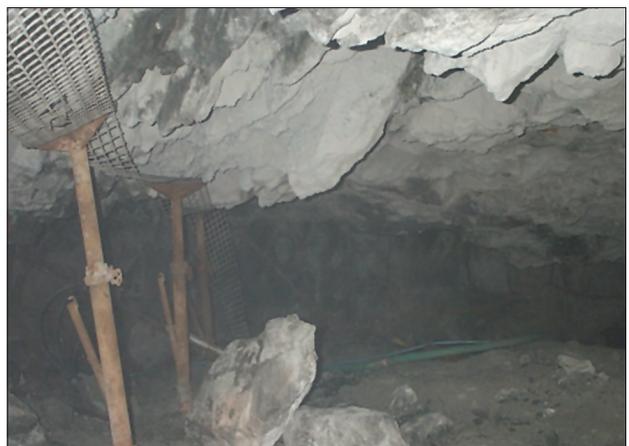
Figure 5—Rock stop strap holding potential fall

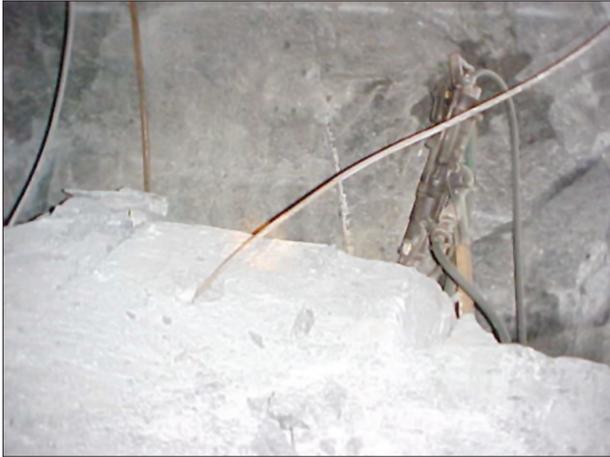
Figure 6—Fall of ground in development end

Three fatal fall of ground accidents occurred in development ends on different shafts during the first quarter of 2004 (an example is shown in Figure 6). The subsequent investigation revealed a need for a more user-friendly tendon support system, with simplified means of installation and pre-tensioning and ideally fitted with some form of load indicator for supervision and quality control purposes.

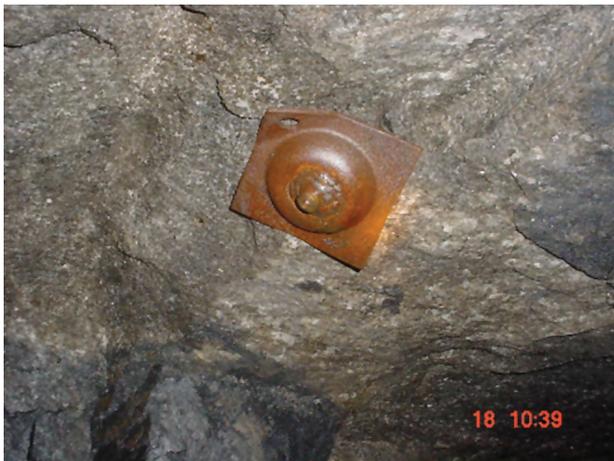
Figure 7—Hydraulically-prestressed tendon when installed

The resulting testing and evaluation process resulted in the introduction of hydraulically-prestressed tendons, supplied by a leading local manufacturer (Figure 7). These made use of the same prestressing equipment as the elongate prestressing units, that was by now well accepted and understood by the mine's workforce. Initially introduced in development ends, these hydraulically-prestressed tendons were also implemented in the stoping panels' advanced strike gullies.

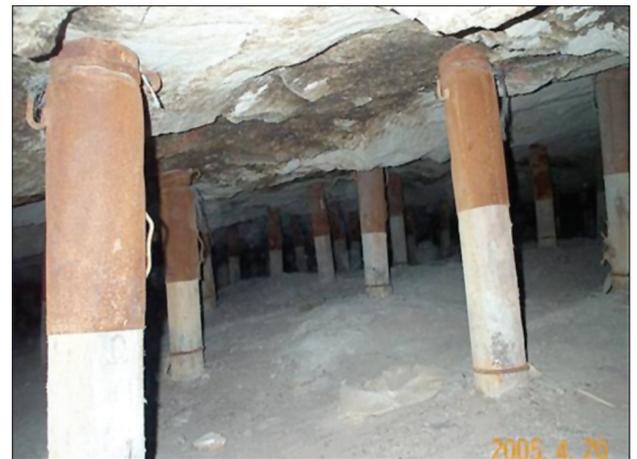
Figure 8—Yielding elongate unit in operation

Experimentation with different types of yielding elongate followed, culminating in the selection of two types of yielding elongates sourced from different suppliers (Figures 8 and 9). Implementation of these yielding elongates began in July 2004, and has continued to the date of writing, as more stoping takes place on deeper levels. The effect of introducing the yielding units, despite the additional cost, was to again drop the number of panel collapses recorded monthly to single figures (for a mine with some 650 stoping panels).

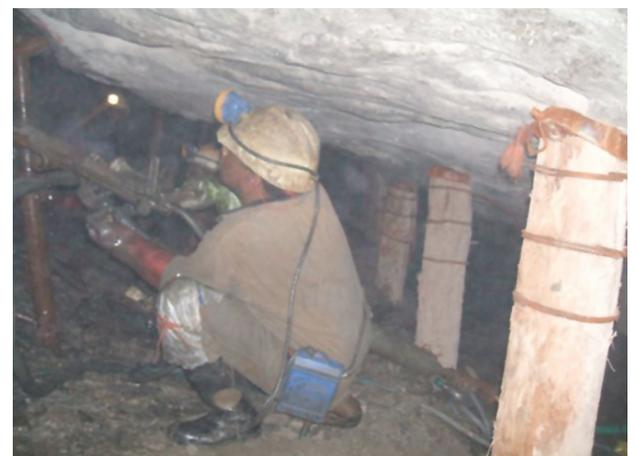
Figure 9—Alternative yielding elongate unit in operation

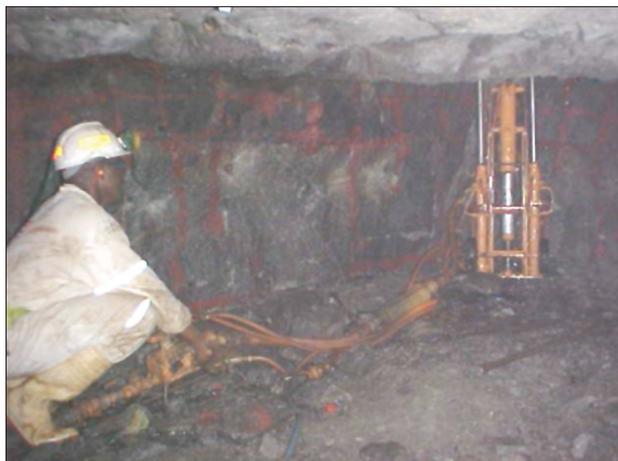
Figure 10—In-stope bolting testing in progress

Trials with suitable installation equipment and different tendon types were carried out during the second half of 2004 (Figures 10 and 11). Based on fall of ground statistics, the focus for implementing in-stope bolting was placed on Merensky stopes. Implementation began in January 2005, but

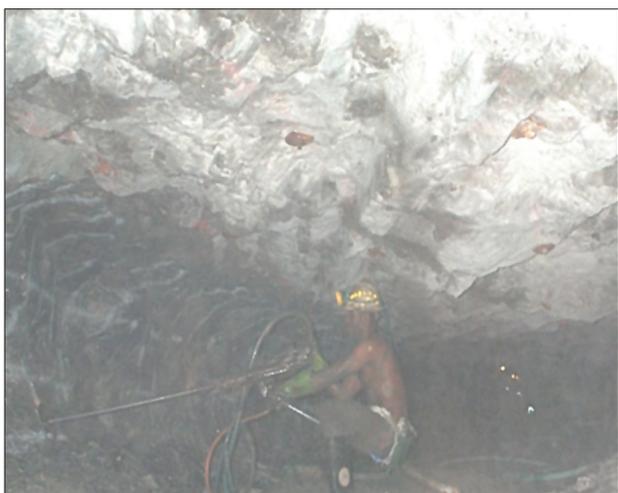
Figure 11—In-stope bolting in operation

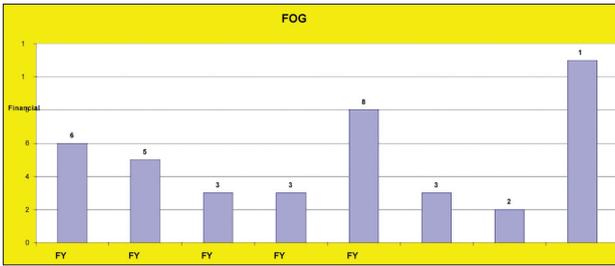
Figure 12—Total rock-related fatalities recorded since 2001

The effects of the various events listed above are shown in the graphs below. Figure 12 shows the total number of rock-related fatalities recorded per financial year (July–June) for

the period 2001 to the present. The general trend is obviously downwards, despite the spike in 2007 (the majority of which were in mechanized sections).

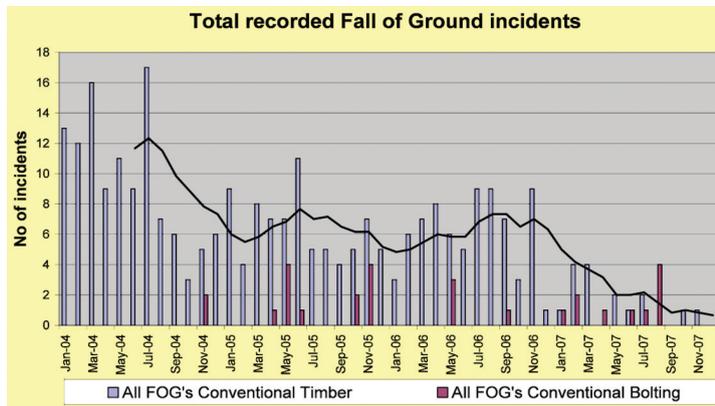
Figure 13—Recorded fall of ground incidents since January 2004

Figure 13 below shows the number of fall of ground incidents recorded in conventional stopes on a monthly basis since just prior to the introduction of ground control districts. Again, the general downward trend is noticeable. During FY2010 a mechanized bord collapsed resulting in 9 fatalities.

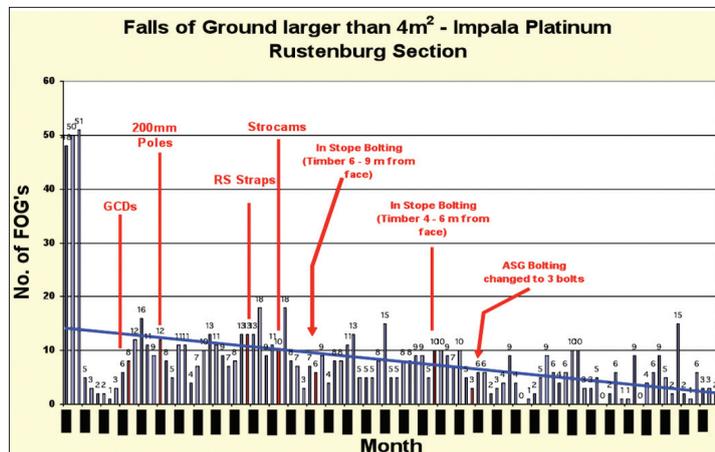
Figure 14—History of large falls since August 2001

Figure 14 presents the history of large falls (greater than 4 square metres) since before the introduction of ground control districts, and points out the dates when different

initiatives were implemented. It should be noted here that the data include both conventional and mechanized stoping areas.

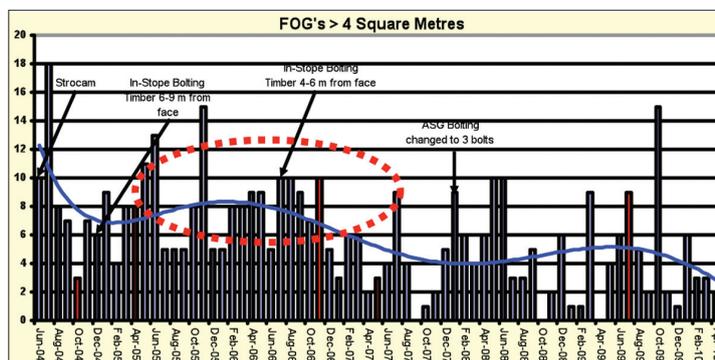
Figure 15—History of large falls since January 2004

Figure 15 again shows the history of falls greater than 4 square metres, but focuses on the period January 2004 to December 2007. Of particular note here is the period highlighted by the oval, which shows the increase in large falls when elongates were moved further back from the face with the introduction of in-stope bolting. When the elongate spacing reverted to the original distance, the large falls were reduced.

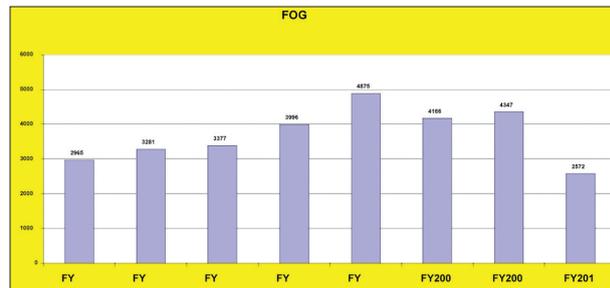
Figure 16—Square metres mined per fall of ground injury

Figure 16, the last of the series of graphs, shows the number of square metres mined per lost time injury for the last 5 financial years. The number of square metres mined relates directly to the amount of hangingwall exposed, which in turn must be worked under and supported. This is, in reality, a measure of the fall of ground risk in stope panels.

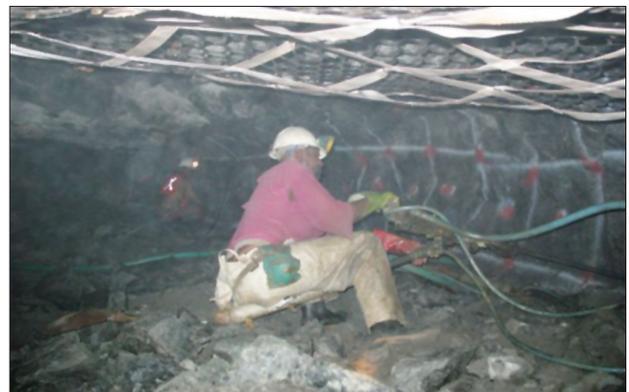
Figure 17—Face area support combination of bolting and netting

Examples of this system are shown in Figures 17 and 18.

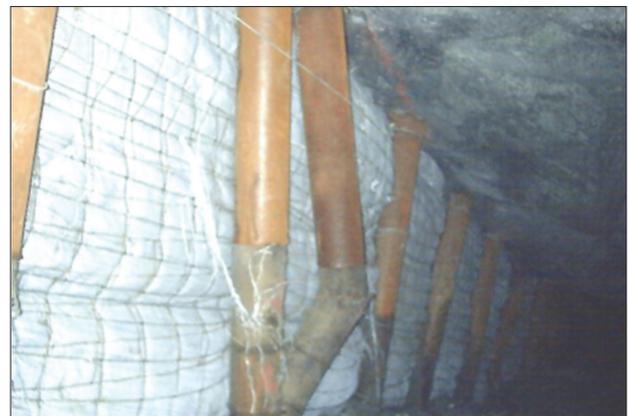
Figure 18—Use of yielding elongates and backfill in back area
