# Managing the geotechnical and mining issues surrounding the extraction of small pillars at shallow depths at Xstrata Coal South Africa

by S.Z. Pethö\*, C. Selai\*, D. Mashiyi\*, and J.N. van der Merwe\*

## Synopsis

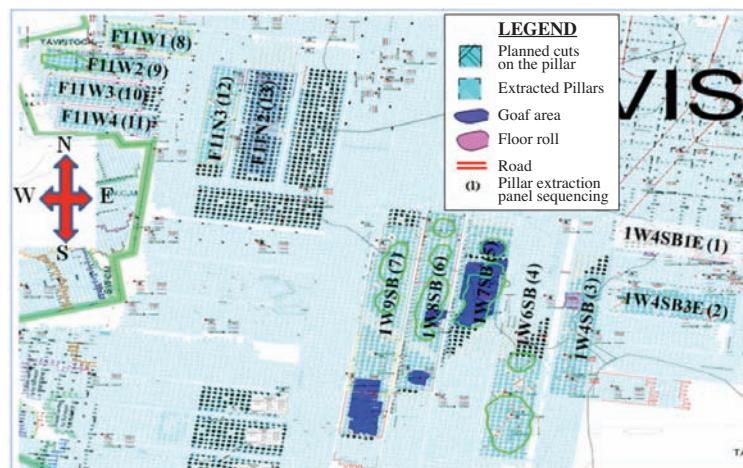
Figure 1—Underground plan showing the location and extent of the 13 panels where pillar extraction has been carried out at Tavistock Colliery

The pillar extraction operation at Tavistock Colliery started during April 2010 with the panels situated on the eastern side of the mine, *viz.* 1W4SB1E and 1W4SB3E (Figure 1). To date the pillar extraction has been effectively carried out on a total of thirteen panels, and there has been goafing in eight of the panels (Table II). A summary of the goafing information for the pillar extraction panels as well as their orientation is provided in Table III.

There has been one recorded incident of a fall of ground (FOG) and a goaf overrun since the inception of pillar extraction operations at Tavistock Colliery. The FOG occurred in panel 1W4SB1E where the pillar extraction operation commenced (Figure 1). The FOG occurred on the off-shift during cutting of the third row of pillars, and was noticed along the roadway R3 from split 14 to split 19 (Figure 11). The fall progressed up to split 12 located adjacent to the waiting place. All the operations were ceased in this panel for the safety of the underground personnel. An extensive

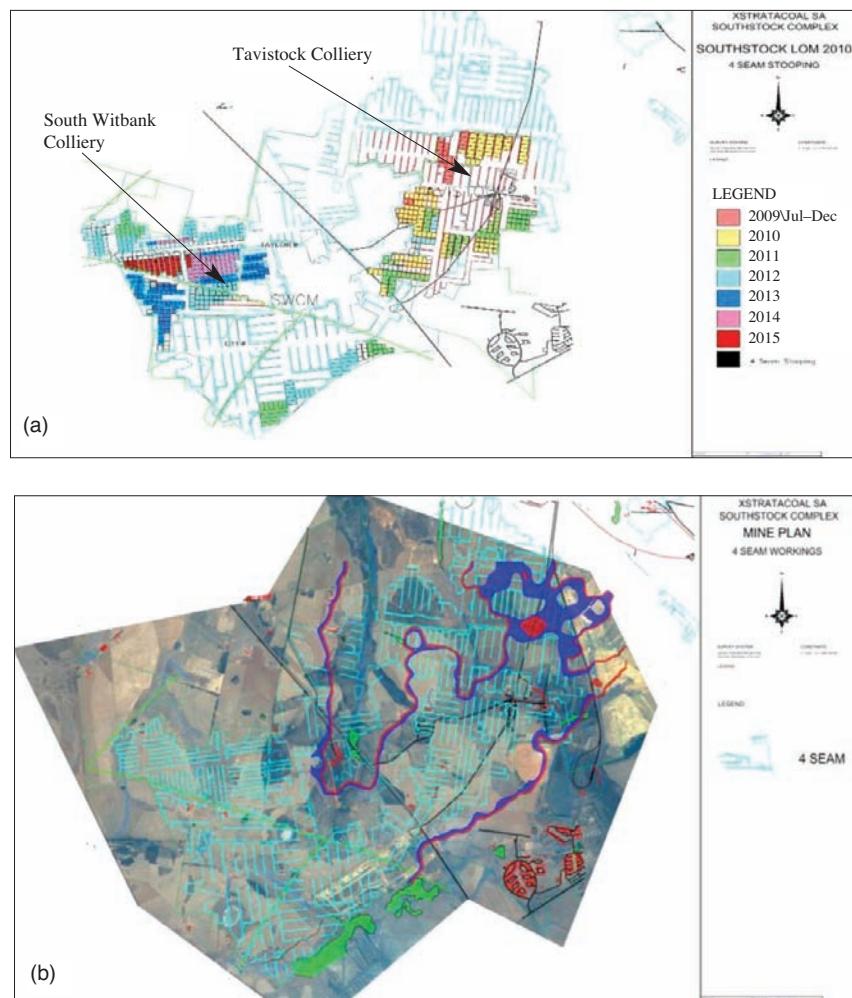
Figure 2—Plan view showing (a) the location and extent of the Tavistock No. 4 Seam pillar extraction and (b) the mining restrictions on surface

The first challenge confronting Tavistock Colliery was the availability of panels originally earmarked for pillar extraction, owing to the restrictions imposed by various surface structures including public and private roads, buildings, and dams (Figure 2).

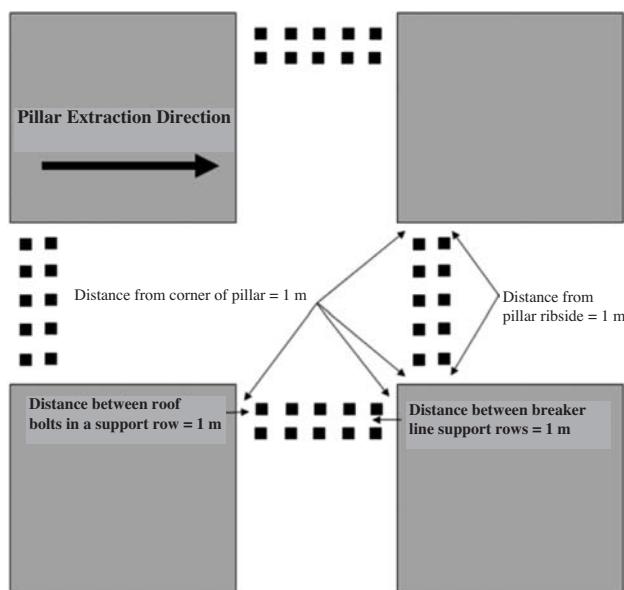
Figure 3—Plan view showing the location of the breaker line support installed

**Support and rehabilitation of the pillar extraction panels**  
It was decided to outsource the re-support of those panels identified for pillar extraction services to a secondary support contractor using hand-held machines, due to the versatility of the equipment and easy access to these old workings. A detailed pillar extraction panel support assessment was also carried out<sup>15</sup>, documented, and signed off by the rock engineering department together with the mining department and project-managed through an independent company towards ensuring that this aspect did not become an issue on the project critical path. In order to keep up with frequent panel relocations, there would need to be at least two pillar extraction panels prepared in advance at all times. Preparation in this regards also involved the pumping of any water, rehabilitating the ventilation infrastructure, sweeping/cleaning, construction of travelling ways and conveyor belts, as well as the power and water supply to the working place. All belt roads and travelling ways would be supported from the beginning of the panel right up to the faces, and this also included the installation of systematic roofbolt breaker lines<sup>5</sup>. Breaker line support (Figure 3) consisted of two rows of 1.8 m long x 20 mm diameter full-column resin-grouted roofbolts installed 1 m apart with five bolts installed per support row, across the width of a bord specifically to:

- Arrest the planned displacement of the roof strata at that point
- Prevent any roof failures from spreading
- Delineate and maintain a clear demarcation between the goaf and the working area.

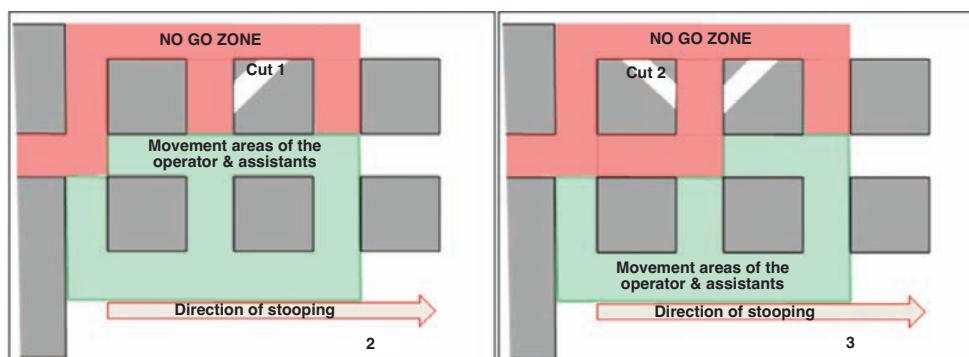
Cut 1 will always be taken on pillar No. 2 first, unless local geological conditions are of such nature that it prohibits the execution of this cut. The No Go zone prohibits any person to enter the indicated area once cutting of the lift/cut starts

When starting cut 2, the operator must position himself in such a way that he is not in the No Go zone, and therefore behind the line of roof bolt breaker line support (and not in the intersection)

Figure 7—Example showing the pillar cutting sequence and no-go zones for the first two cuts taken

A procedure was developed with the main objective to ensure that a standard cutting sequence is adhered to in a pillar extraction section that will define the sequence in which each identified pillar in a row must be cut, the amount and sequence in which individual lifts/cuts from a single pillar must be taken, and importantly indicate the position that the CM operator and his assistant must take in order to ensure that they do not enter into a 'no-go' zone while cutting<sup>17</sup> (Figure 7).

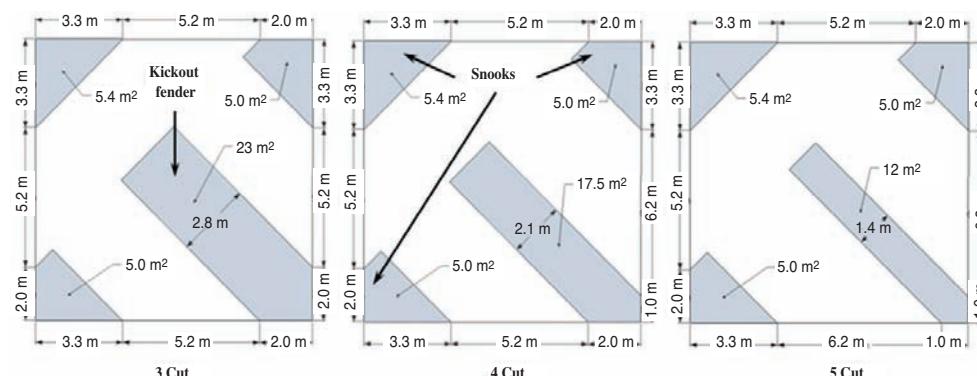
Figure 8—Plan view showing the pillar dimensions for a 10.5 m x 10.5 m pillar for the three different cutting sequences

The pillar extraction operation at Boschmans Colliery was carried out by means of taking only three cuts per pillar (Figure 8) where practicable, and mining four to seven rows of pillars in this manner, after which two rows of intact

- Taking five cuts per pillar instead of only three cuts (Figure 8), where practicably possible (Figure 10)
- Mining of five rows of pillars and leaving only one solid pillar in the centre of the panel of the fifth row, acting as a cushion pillar (compartmentalizes the goaf), instead of mining only four rows of pillars and leaving two complete rows as the stopper rows, in order to reduce the impacts of a windblast.

tively, (Figure 8). From the pillar extraction information gathered to date at XCSA, the relationship of the size and performance of the kickout fender and the roof behaviour is a crucial aspect that needs to be studied in more detail towards garnering a better understanding of the roof failure mechanism for pillar extraction of small pillars at shallow depths. In this regard, the UDEC and FLAC3D numerical modelling packages will be able to provide further clarity and insight.

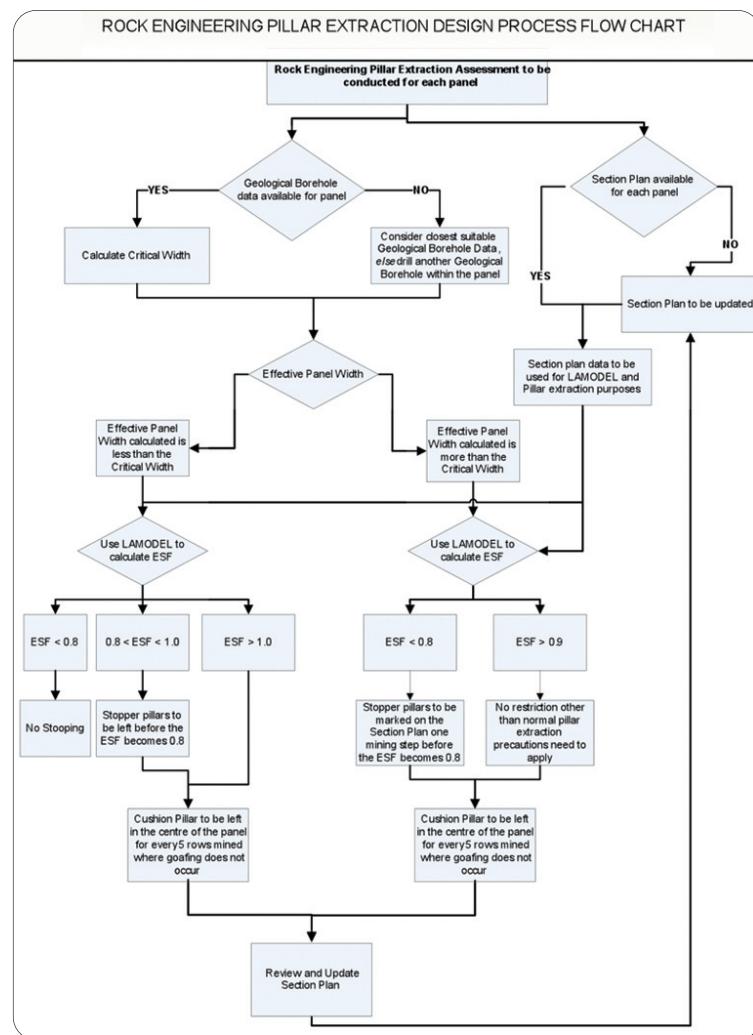
Figure 9—Pillar extraction geotechnical process flow

During this exercise a simple and effective process flow was developed for the pillar extraction operation mining at Tavistock Colliery<sup>8</sup> (Figure 9).

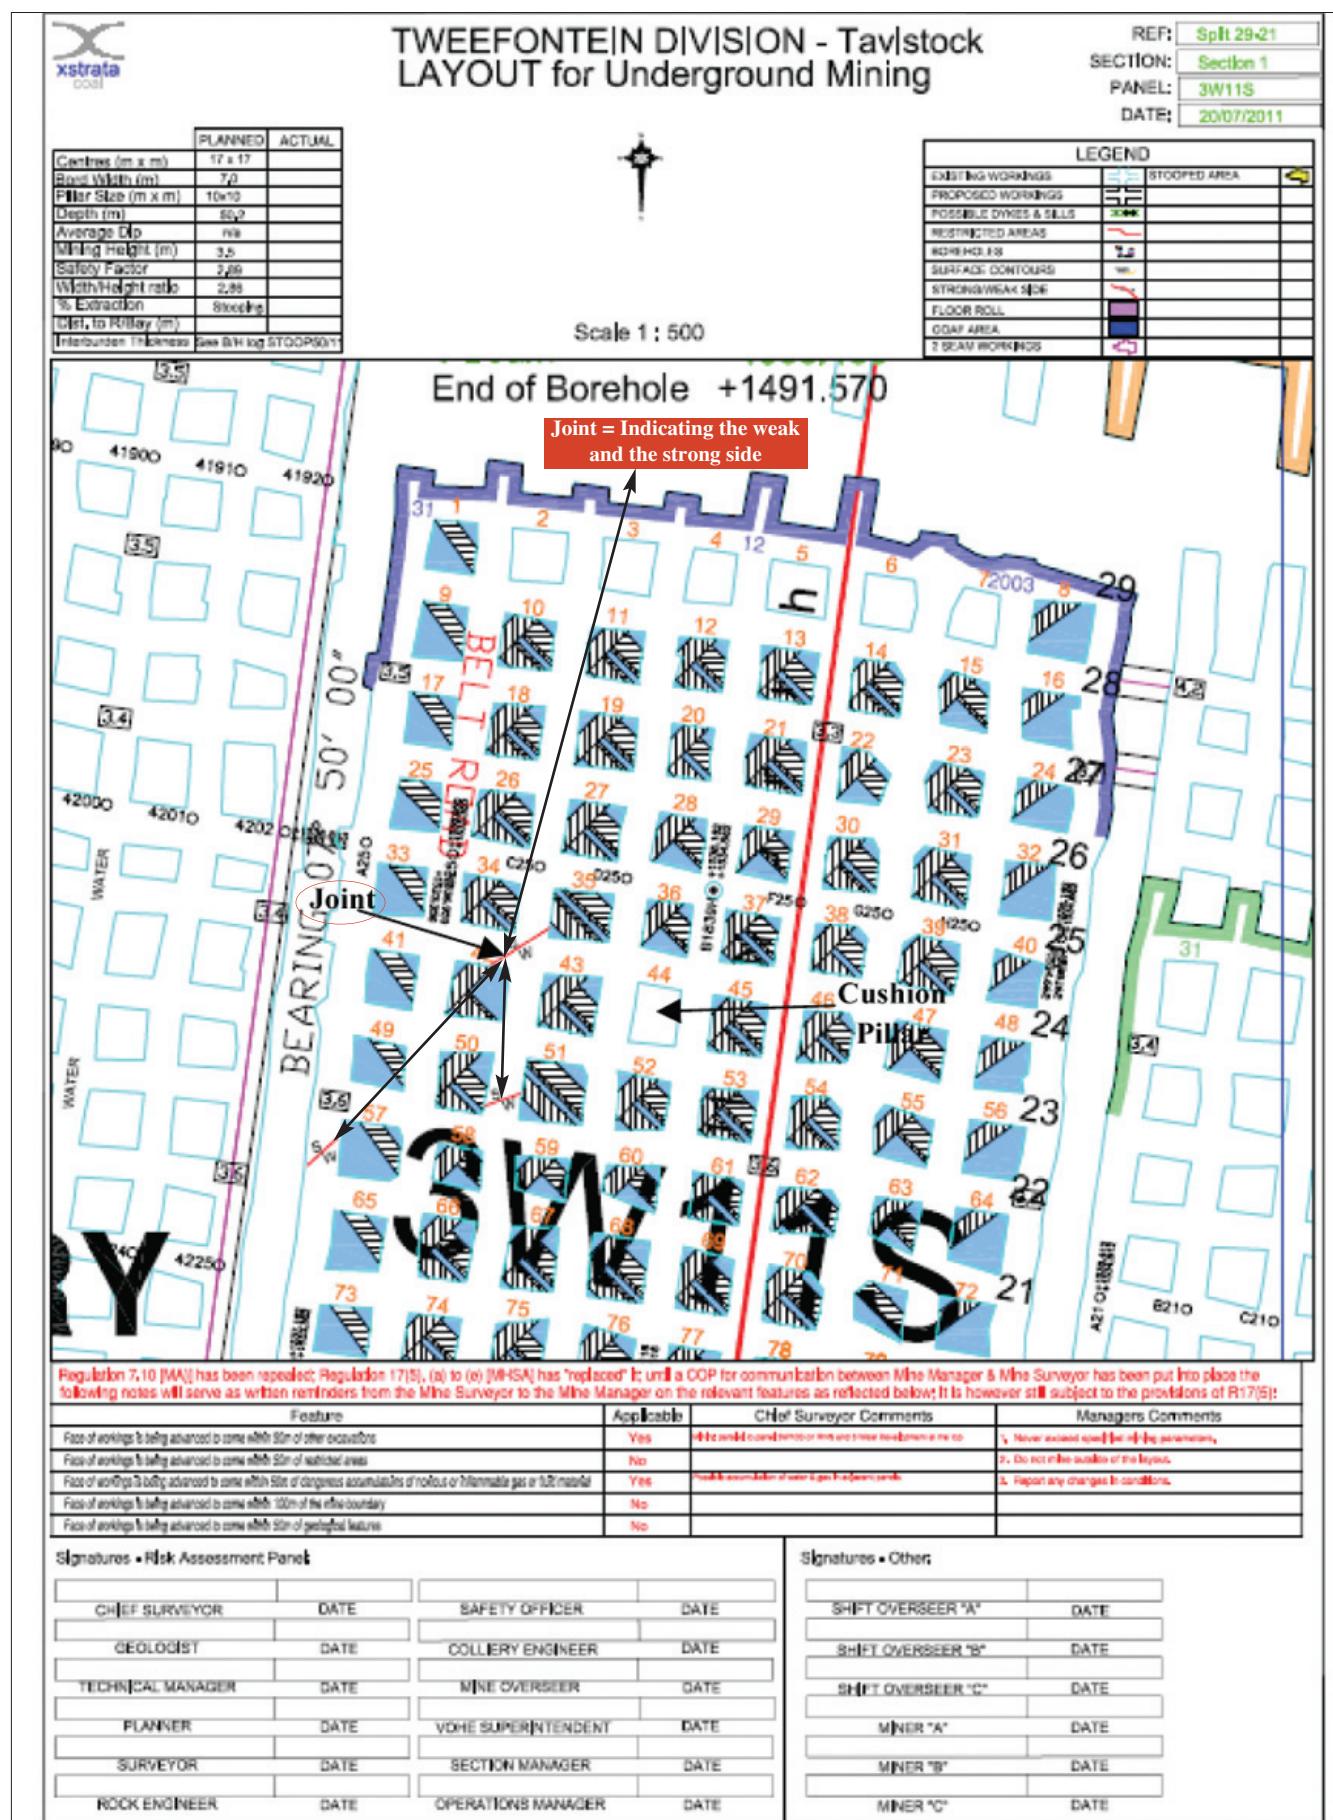
Figure 10—Pillar layout plan showing the cushion pillar and the intended cuts to be taken based on the pillar mapping exercise carried out

Once the information had been captured, a detailed pillar and risk assessment layout plan was generated which forms part of the pillar extraction pre-emptive risk assessment process. A signed-off copy of the pillar layout plan was then provided to the miners (Figure 10).

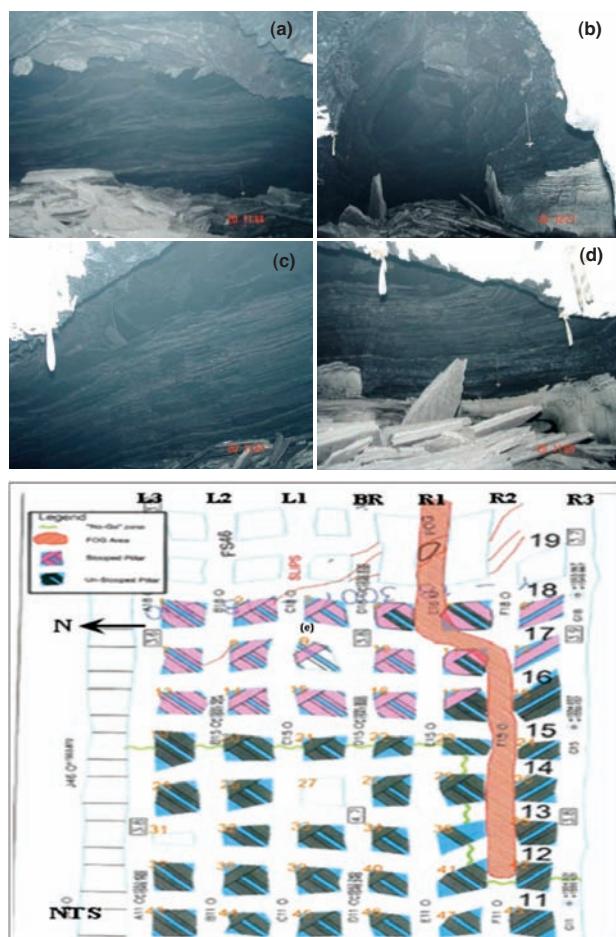
Figure 11—The FOG and plan view showing the planned and actual pillar extraction cuts taken together with the extent of the falls of ground that occurred in panel 1W4SB1E. The photograph taken in various areas show the laminated nature of the immediate overburden and the height of the falls of ground, and also indicate evidence of some overthrusting

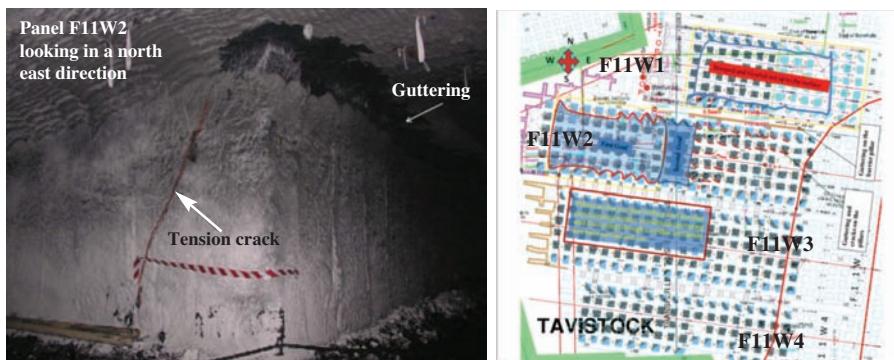
Figure 12—Underground photograph of a pillar and plan showing the panels where cracks and guttering were observed

The mining of panel F11W1 was successfully carried out with a goaf occurring as planned, though not up to surface, and with no abnormal pillar and roof conditions observed prior to the commencement of the pillar extraction operation. It was, however, noted during the process of extracting pillars in this panel that the southern barrier pillar started to develop guttering on the right hand side of panel F11W2 (northern side). After completion of the pillar extraction in panel F11W1, preparations were made to commence with the pillar extraction in panel F11W2. The first goaf happened after nine rows of pillars had been extracted, and this also did not progress up to the surface (Figure 12). After mining a further two rows of pillars the next goaf occurred, which triggered all of the uncompleted goafs (the goaf in panel F11W1 and the first goaf in panel F11W2) to progress. The goafing then proceeded to alternate between the two panels for about an hour. Following this it was noted that the pillars extending from the goaf line backwards had developed an interesting tensile crack extending from the top to the bottom of the pillar corner (Figure 12). This was observed in panel F11W2 and also F11W3, the next panel planned for pillar extraction. These tensile cracks were observed on both the eastern and western sides of the pillars, with minor guttering noted on the southern side of the pillars.

It was concluded that the damage to the pillars observed was as a result of lateral displacement, due to the sudden release of horizontal compression accompanying the progression of the goaf in the adjacent panel. The layout plan was altered to leave four rows of pillars to stiffen up the system, and pillar extraction resumed. A special modified cutting sequence was developed for panel F11W3, taking cognisance of the cracks and guttering. In this sequence the planned cuts on the sides of the pillars where the cracks had developed were removed, in order to prevent the already fractured dislodged corners from falling and thereby causing injuries to personnel or damage to the equipment.

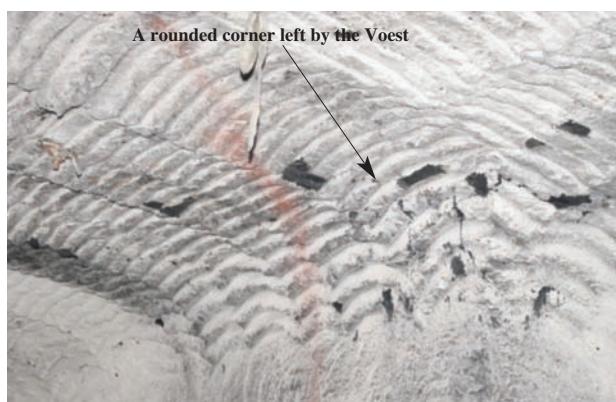
Figure 13—The corner created by the Voest CM showing the scaling that has taken place

Scaling occurred during the extraction of pillars that were originally mined using a Voest CM, which tends to create a rounded pillar corner in the roof (Figure 13). This corner tends to scale off with the stress changes associated with the pillar extraction operation. Two incidences were also reported of the Hilti gun causing this fractured piece of rock to become dislodged, resulting in an injury to an employee during the normal installation of brattices required for ventilation control.
