Effects of mining operations on air and water quality in Mufulira district of Zambia: A case study of Kankoyo Township

D. Muma¹, B. Besa², J. Manchisi¹, and W. Banda²

The Southern African Institute of Mining and Metallurgy

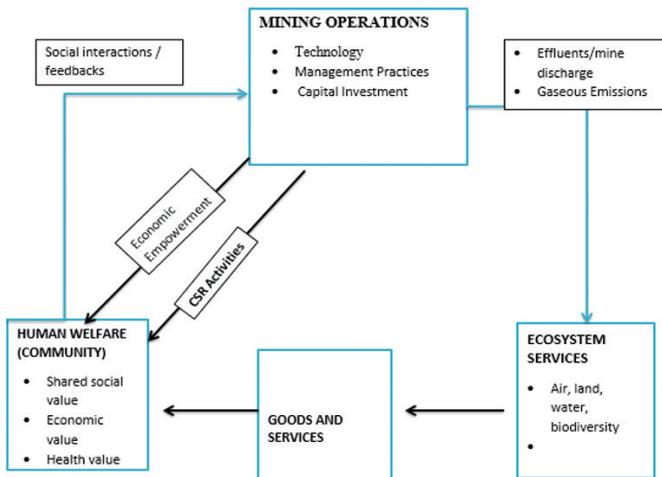
Figure 1 shows the proposed conceptual framework for sustainable mining and environmental management. Sustainable development is an ongoing process, and not a temporary undertaking. It ensures the protection of natural resources and the environment. It also emphasises care for the employee at the workplace and community development in the area of the mining environment (Jozef, 2013).

Figure 1—Proposed conceptual framework for sustainable mining operations and environmental management

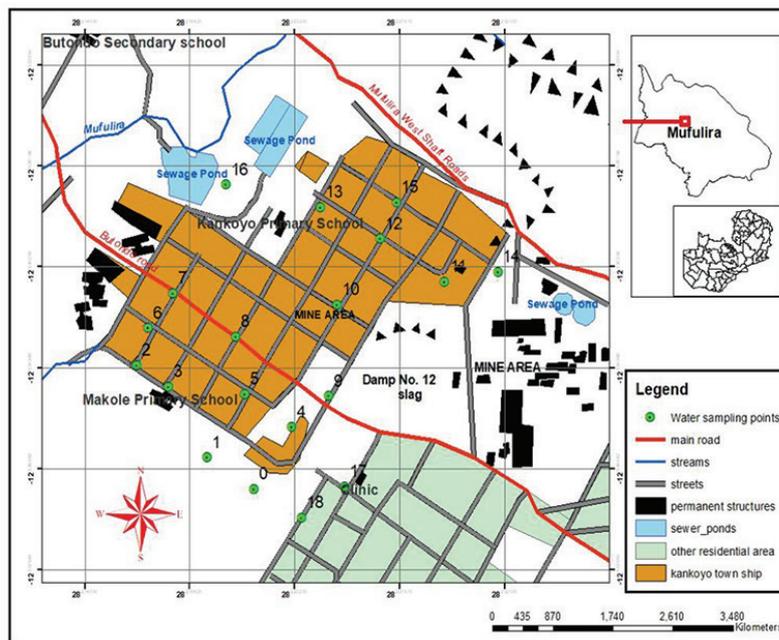
Figure 3—Map showing the water sampling points in Kankoyo Township and surrounding areas (adapted from Chipatu, 2011)

The study was focused mainly on the built-up settlement of Kankoyo Township, where most of the waters samples were collected (Figure 3).

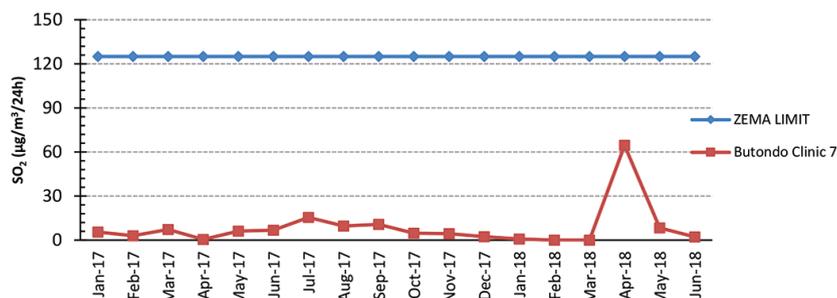
Figure 4—Monthly average SO₂ levels in the Butondo Clinic 7 area. *No readings taken for the months of February and March 2018 due to equipment breakdown

Figures 4–9 show the SO₂ emission trends at the seven weather stations from January 2017 to May 2018.

The 18-month average trends indicate that the SO₂ levels recorded at all the stations were below the ZEMA statutory limit, apart from Kantanshi Clinic 3 and Kankoyo Clinic 5, which had levels of 28% and 44% above the ZEMA statutory limit respectively.

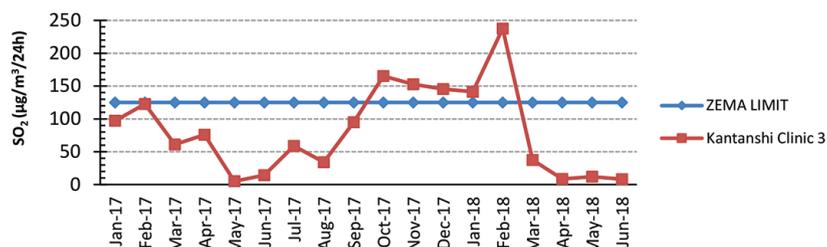
Figure 5—Monthly average SO₂ levels in the Kantanshi clinic 3 area

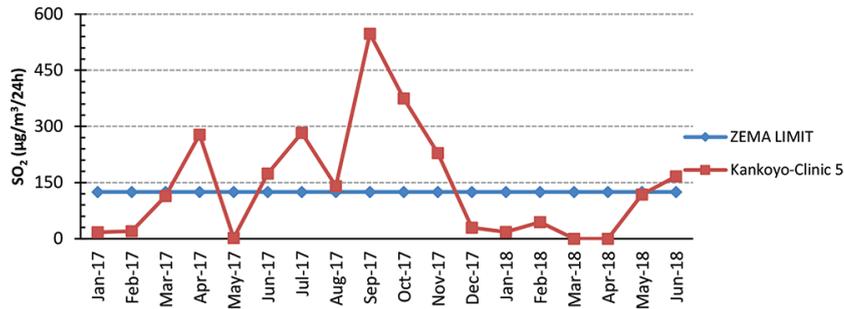
Figure 6—Monthly average SO₂ levels in the Kankoyo clinic 5 area. *No readings taken for the month of March and April 2018 due to equipment breakdown

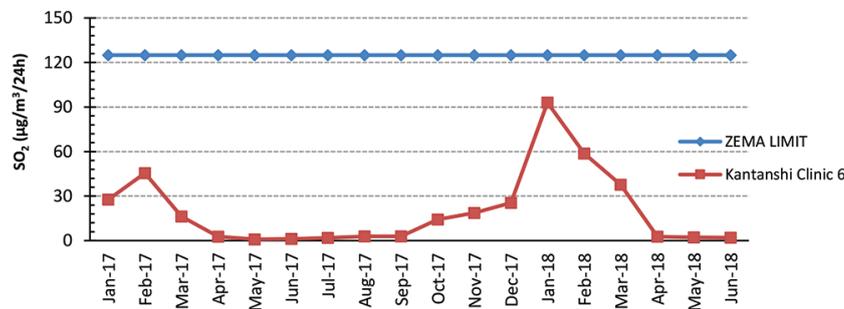
Figure 7—Monthly average SO₂ levels in the Kantanshi clinic 6 area

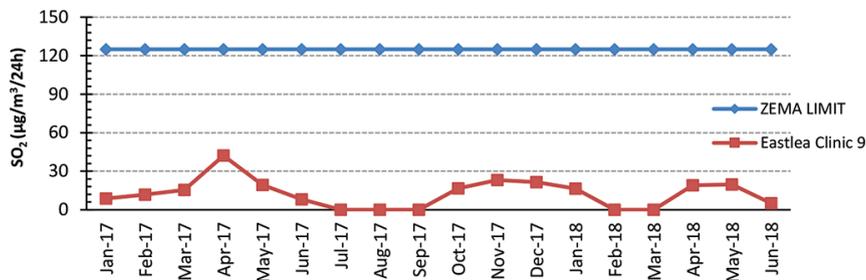
Figure 8—Monthly average SO₂ levels in the Eastlea clinic 9 area. *No readings taken for the month of February and March 2018 due to equipment breakdown

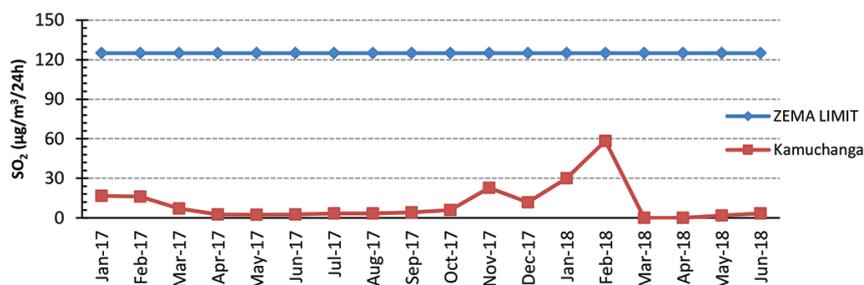
Figure 9—Monthly average SO₂ levels in the Kamuchanga area. *No readings taken for the month of March and April 2018 due to equipment breakdown

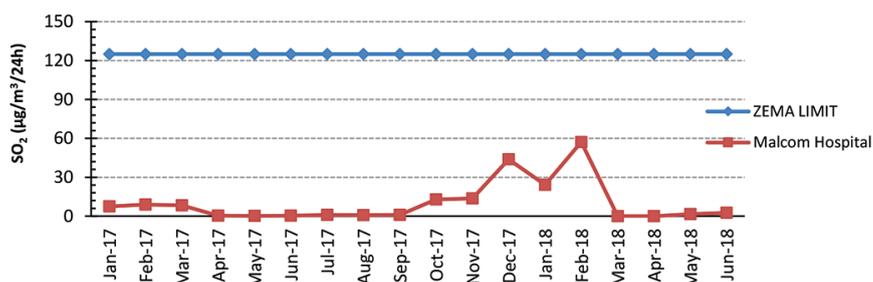
Figure 10—Monthly average SO₂ levels in the Malcom Hospital area. *No readings taken for the month of March and April 2018 due to equipment breakdown

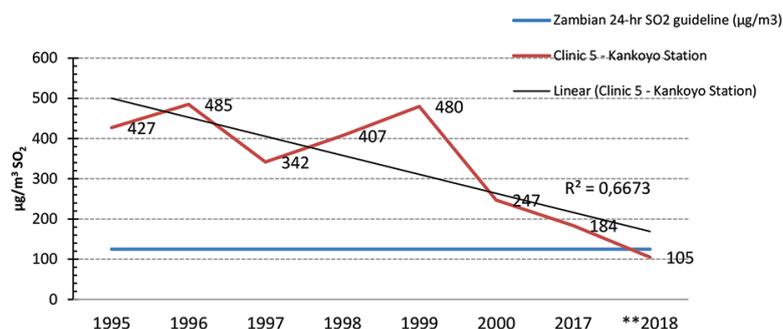
Figure 11 – Average annual SO₂ levels at Kankoyo Clinic 5 station from January 1995 to June 2018

The available information for sulphur dioxide levels for the last two decades for Kankoyo (see Table IX and Figure 11) shows a significant decrease from over 400 µg/m³/24h in 1995 to less than 110 µg/m³/24h in June 2018. The results reflect the massive investments in technology for sulphur dioxide capture in the copper smelting plants after the year 2010, which have improved sulphur dioxide capture by over 90% (Ross and Vries, 2005; Alistair *et al.*, 2012).

The coefficient of determination (R²) of 0.6673 means that about 67% of the variation in the SO₂ emission data is due to variation with time. There has been a significant decrease in SO₂ emissions ($\sqrt{64} = 0.817 \approx 82\%$) with time in the last two decades.

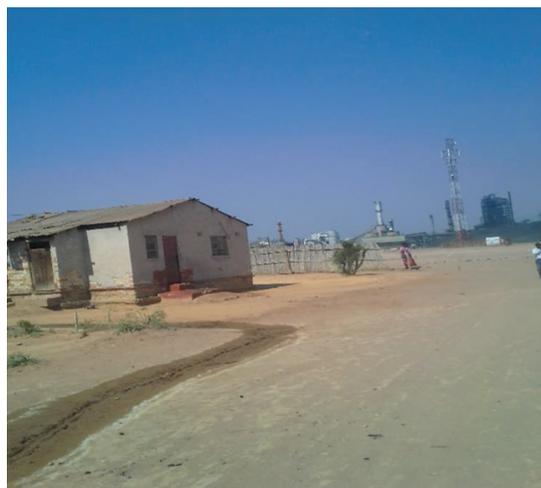
Figure 12—House with iron roof sheet corroded by acid rain (August 2018)

According to residents' perceptions, the adversity caused by copper smelting has reached an extent where it is a danger to the natural and physical environment in Kankoyo Township. The damage caused by excessive SO₂ levels is depicted in Figures 12 and 13. The mining industry needs to formulate clear strategies to address these misconceptions, and to engage the local community of Kankoyo, if it is to survive. Despite the

The environmental impacts of mining operations are significant and quite often severe, especially in Kankoyo Township. The buildings and the surrounding environment have been degraded due to the corrosive effects of acid rain. Residents complain of headaches, coughing, itching eyes and ears, and bronchitis. The mining operations in the Mufulira district are within the catchment area of the Kafue River and other natural water bodies such as the Mufulira and Kansuswa streams. Several studies have shown that concentrations of many dissolved elements are elevated in the Kafue River and its tributaries within the Copperbelt (Lindahl, 2014). The contaminants are mainly from the run-of-mine (ROM) ore and untreated effluent such as the domestic and industrial water from underground and processing plants.

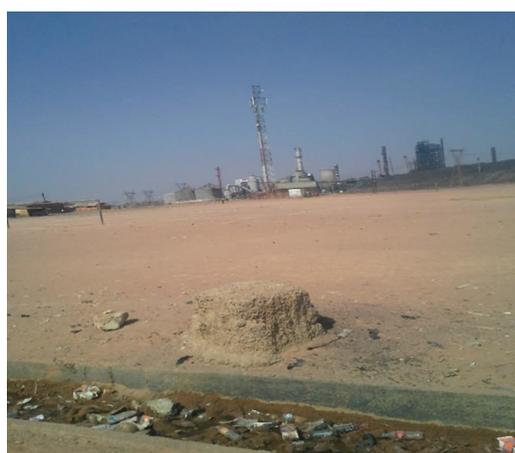
Figure 13—Bare land devoid of vegetation (August 2018)

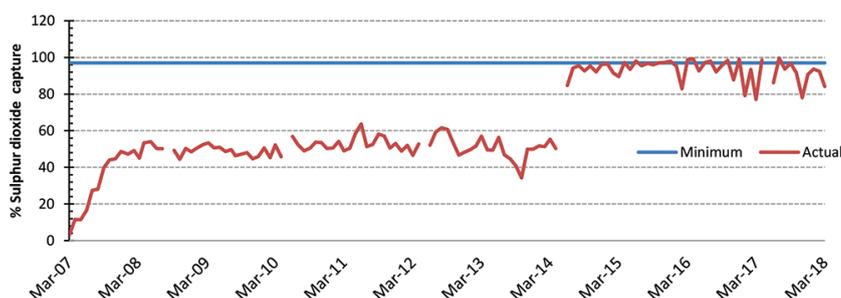
Figure 14—Sulphur dioxide capture trend for the period March 2007 to March 2018. The line at 97% indicates the design capacity for SO₂ capture in the acid plant

The results indicate a significant reduction in sulphur dioxide emissions from the copper smelter. As shown in Figure 13, the average sulphur dioxide capture was 48% from 2007 to 2013 and about 94% from 2014 to 2018. However, the average annual sulphur dioxide levels for 2017/2018 were 144.5 µg/m³ in Kankoyo Township, which is 15.6% above the statutory limit of

125 $\mu\text{g}/\text{m}^3$ in ambient air (per 24 hours). Figure 13 shows the smelter sulphur dioxide capture trends for the period March 2007 to March 2018.

The results given in Figure 13 show a significant reduction in sulphur dioxide emissions from the copper smelter. The average sulphur dioxide capture was 48% from 2007 to 2013 and about 94% from 2014 to 2018. The 46% improvement in sulphur dioxide capture in the four years from 2014 to 2018 is attributed to technological upgrades and good operating practices implemented at the Mopani Mufulira copper smelter. According to Ross and Vries (2005), from the inception of the Mufulira copper smelter in 1937 there was no sulphur dioxide abatement facility. However, the current ISASmelt technology is designed to capture sulphur dioxide in a separate plant and convert it into sulphuric acid, which is sold to other mines. The average annual atmospheric sulphur dioxide level for 2017/2018 was 144.5 $\mu\text{g}/\text{m}^3$ in Kankoyo Township, which is 15.6% above the statutory limit of 125 $\mu\text{g}/\text{m}^3$ per 24 hours in ambient air. This is not an acceptable level of exposure as it may have adverse environmental and health implications for the community.
