# Presidential Address: Managing geotechnical uncertainty and risk in mining

by W.C. Joughin

Affiliation:  
SRK, South Africa.

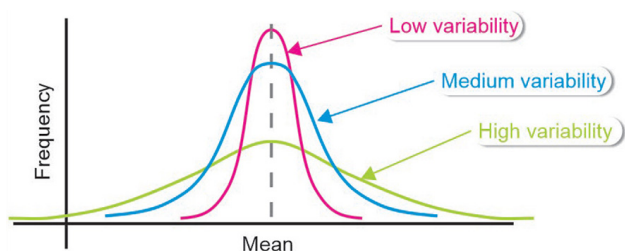
Figure 1—Data distributions and variability

- Variability is a property of nature. Rock mass and soil properties, as well as loading conditions, span a large range of values, which can vary in space and time. Variability can be described with statistics and the probabilities related to variability can be interpreted in terms of frequency of occurrence (Figure 1).

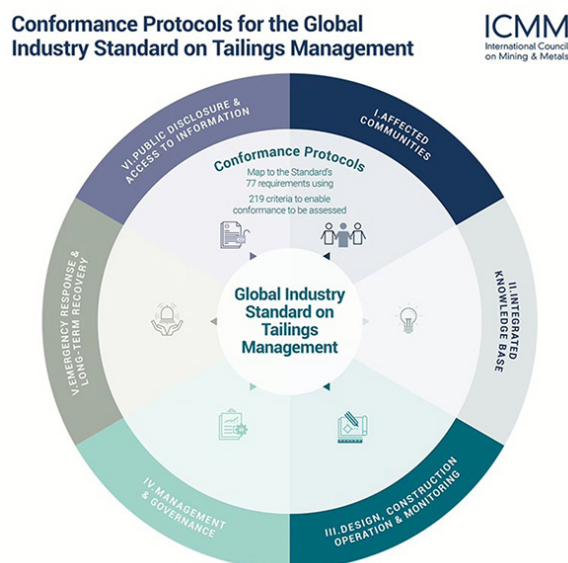
Figure 2—Global Industry Standard on Tailings Management (<https://globaltailingsreview.org/global-industry-standard>)

The catastrophic dam failure at Vale's Corrego de Feijao mine in Brumadinho, Brazil resulted in the loss of almost 300 lives, in addition to the major environmental and social consequences and business interruption. This followed several other highly publicized tailings dam failures, which also had major environmental and social impacts, and triggered a global response. This resulted in the development of the Global Industry Standard on Tailings Management (GISTM) (<https://globaltailingsreview.org/global-industry-standard>). The standard is directed at operators, who are required to take responsibility for and prioritize the safety of tailings facilities through all phases of the life-cycle, including closure and post-closure. There are six topics that must be addressed (Figure 2).

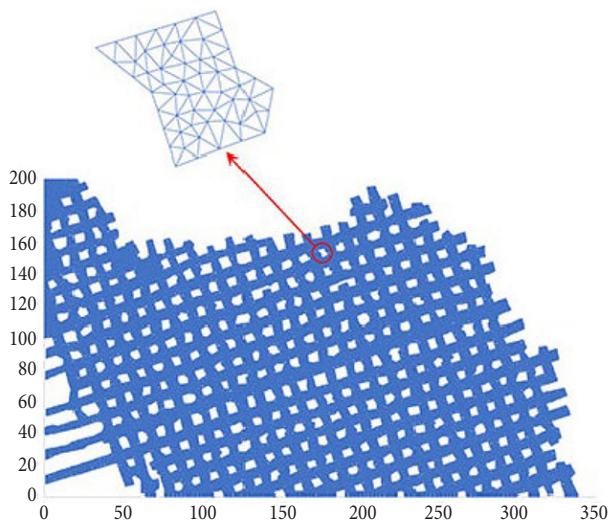
Figure 6—Boundary element elastic modelling of a mine layout on a large scale (after Napier and Malan, 2023)

Boundary element elastic modelling is much simpler and enables mine-scale modelling of pillars (Figure 6). Limit equilibrium models (Figure 7) have been incorporated in these codes to provide a simple representation of the pillar failure mechanism (Napier and Malan, 2007, 2021, 2023; Esterhuysen, and Malan, 2023; Ile and Malan, 2023; Couto and Malan, 2023a, 2023b). The limit equilibrium model effectively represents a shearing layer at both the hangingwall and footwall contacts and progressive spalling of the pillars. As pillars in the model fail, they transfer load to adjacent pillars, which enables the simulation of a pillar collapse on a mine scale. The effect of support, such as backfill, can also be simulated using the limit equilibrium model.

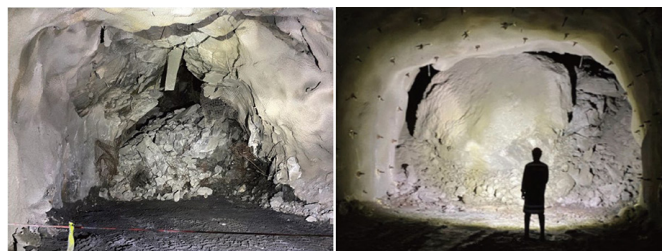
Figure 15—Photographs of rockburst damage on 1079 level

also extended from the intersections, which are larger, into the crosscuts. Figure 15 shows some of the intense damage in tunnels on 1079 level.
